NY DEP Sewer video
Pre-accident inspection
October 16, 2006

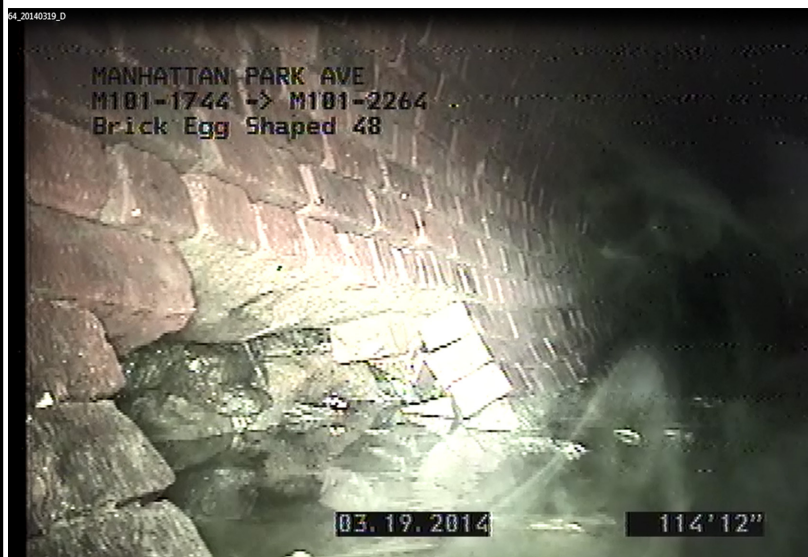
NY DEP Sewer video
Post-accident inspection
March 19, 2014

Camera inspection of the
sewer was performed after
the accident

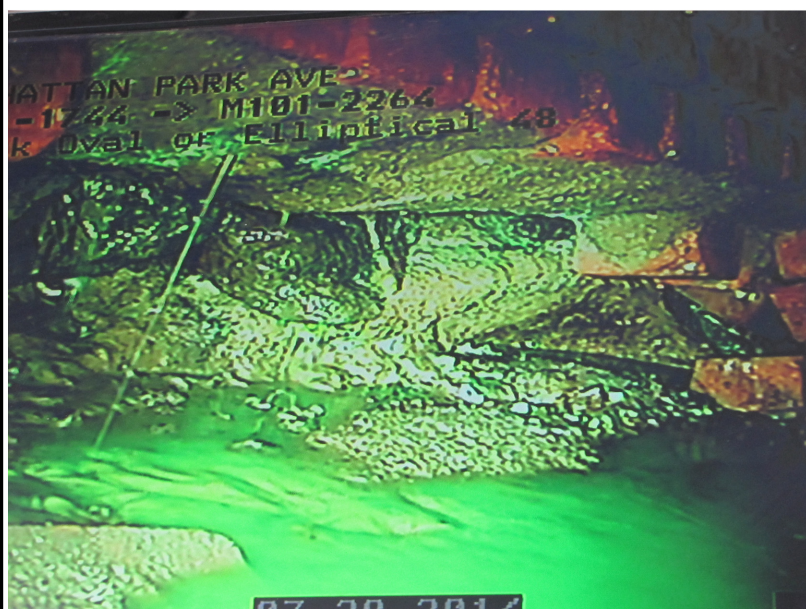
NY DEP Sewer video
Post-accident inspection
March 28, 2014

Flourescent dye was introduced
at the location of the gas pipe
failure and observed flowing
into the sewer
