# Car Damage Report

Date of Derailment 4-24-19

Location Et Worth TX

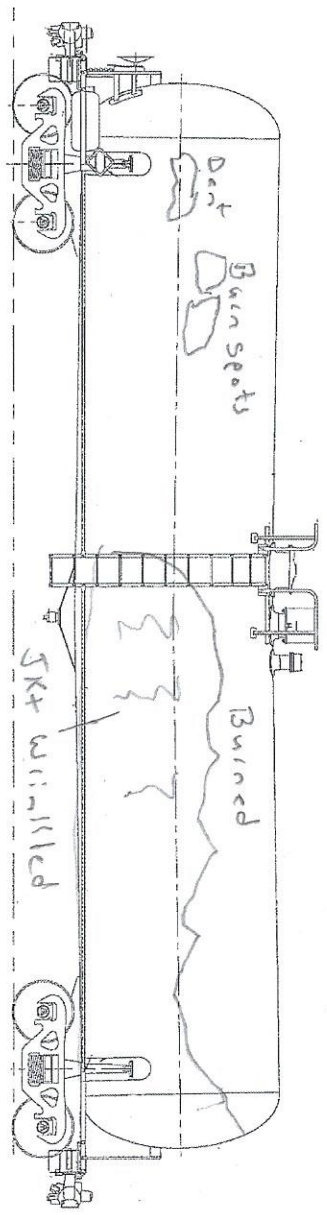
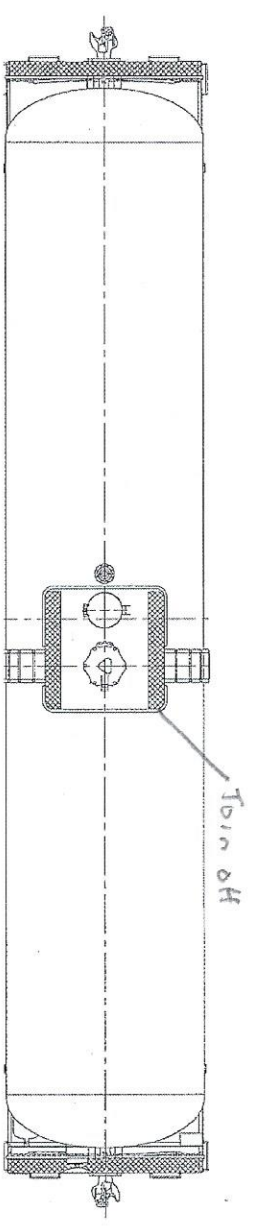
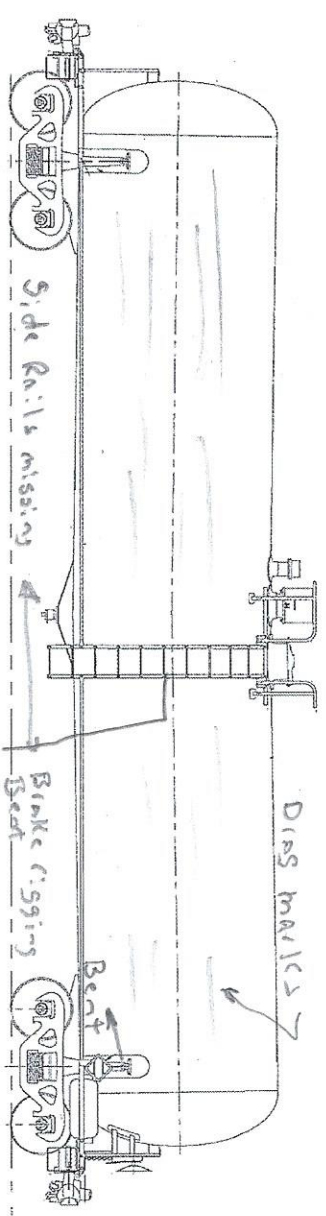
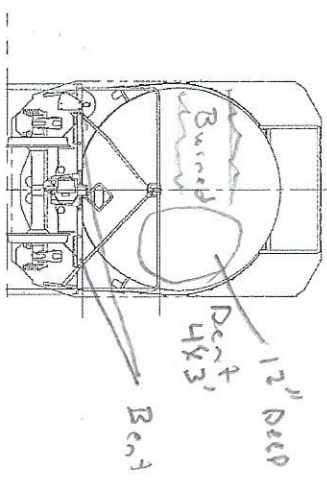
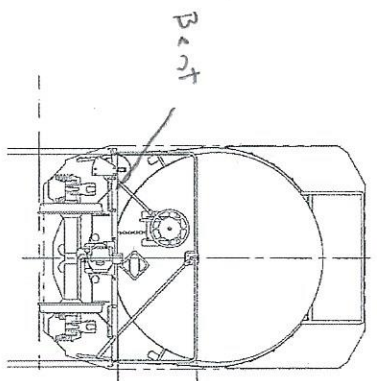
Car Number TILX 191488

Top fittings MW OK MH Bent RED OK  
 Bottom Outlet Leg S OK Handle DH Salco OK  
 Shell Tear Thermal No Mech No  
 Draft Sill A OK B Bent  
 Head Shield A Dent B OK  
 Skid Condition OK

PRD didn't function

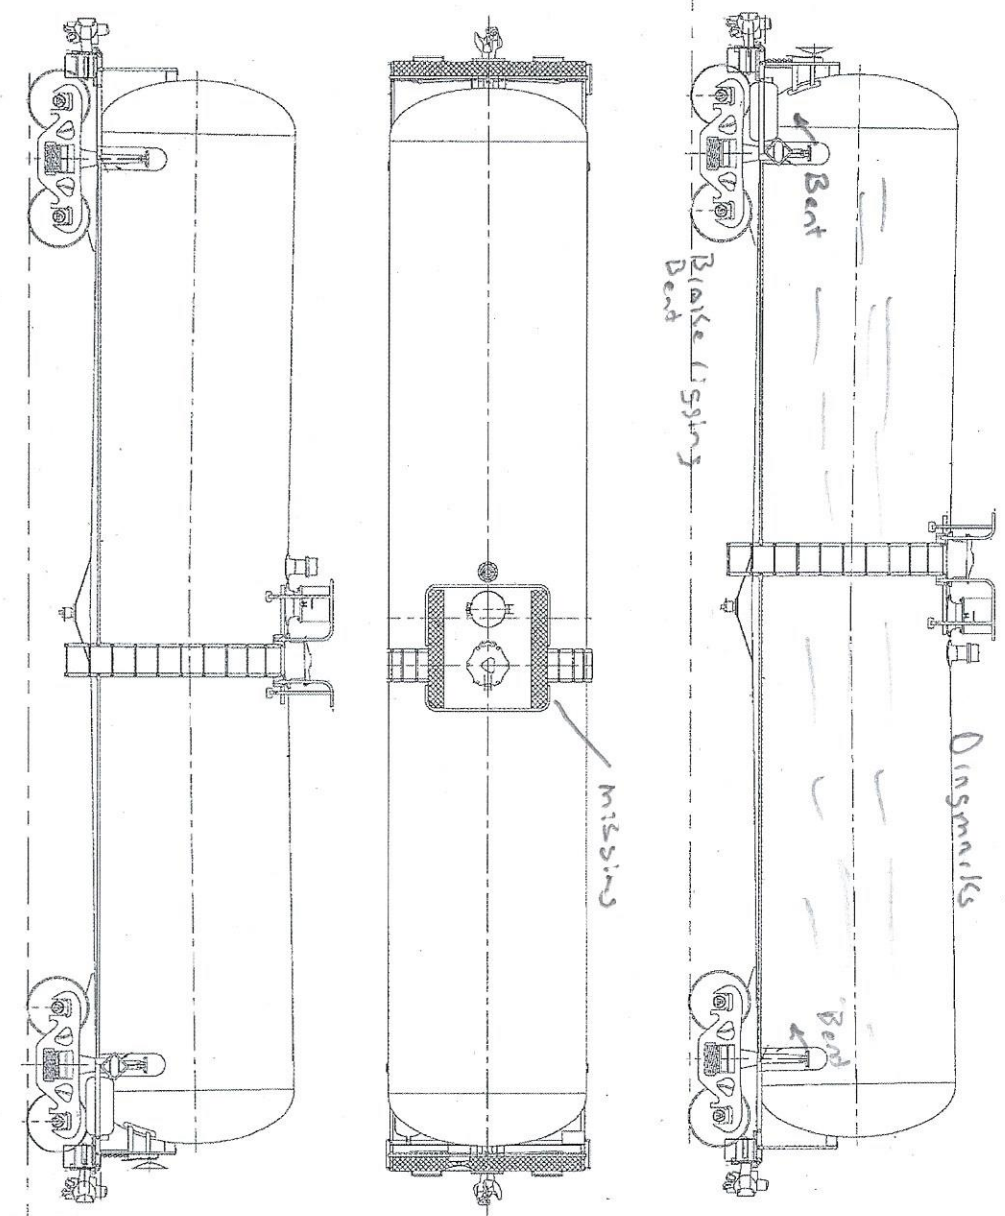
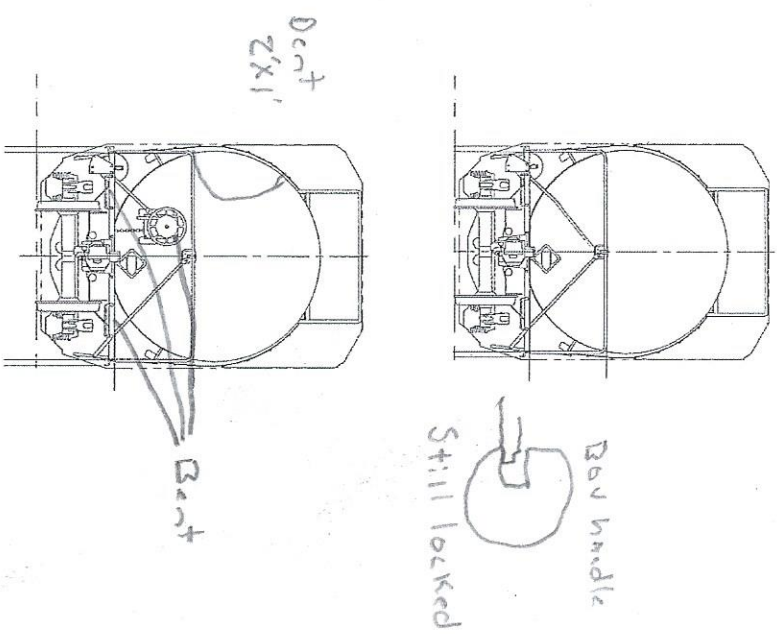
Car Number TILX 198946

Top fittings MW OK MH OK  
 Bottom Outlet Leg S OK Handle DH Salsco Bent \*  
 Shell Tear Thermal No Mech No  
 Draft Sill A OK B Bent  
 Head Shield A OK B OK  
 Skid Condition OK

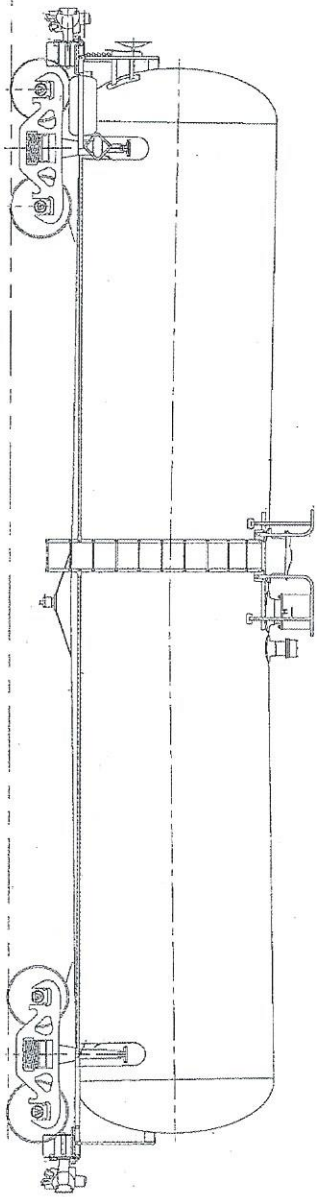
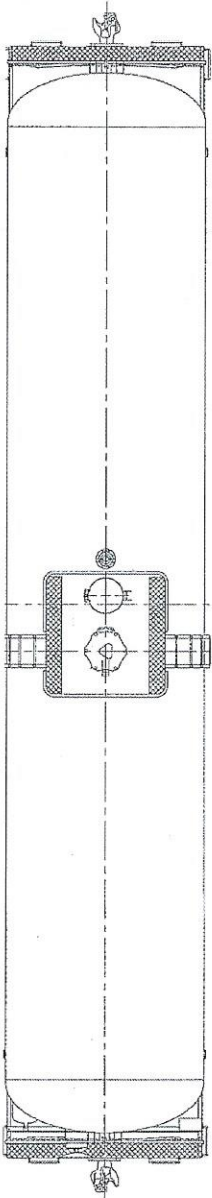
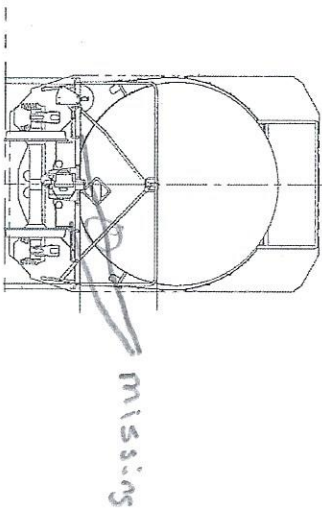
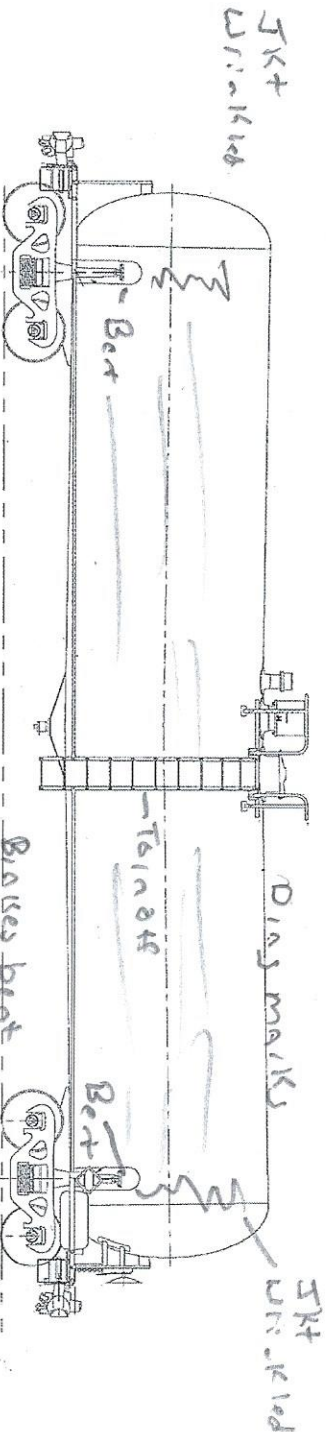
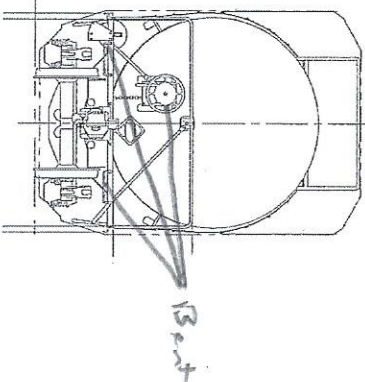
Car Number TILX 194329

Top fittings MW OK MH OK Bent lid SAICD  
Bottom Outlet Leg S OK Handle DH TAIN OK  
Shell Tear Thermal No Mech NO  
Draft Sill A Bent B OK  
Head Shield A OK B OK  
Skid Condition DK

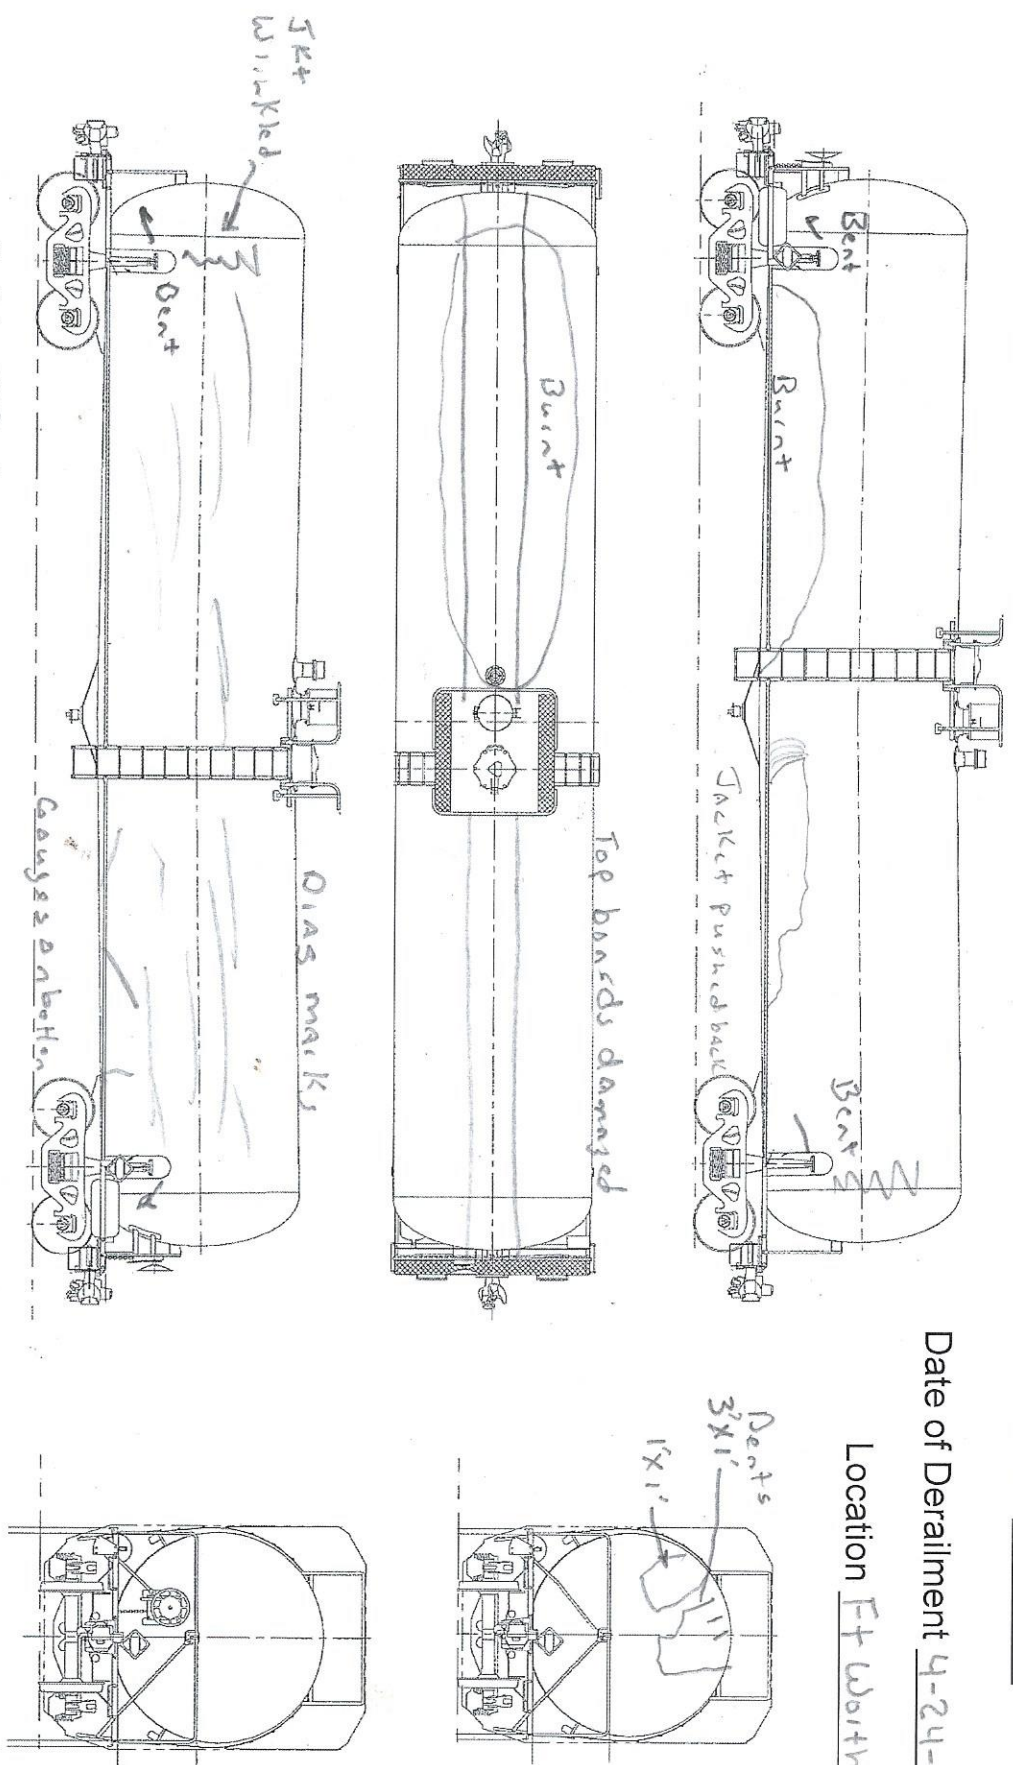
Car Number TLX 351873

Builder TRN  
Built Date \_\_\_\_\_  
DOT 117R150W  
File# \_\_\_\_\_  
Loss of Commodity Yes / No ? Leak  
31808

Top fittings MW OK MH OK  
Bottom Outlet Leg So OK Handle DH OK  
Shell Tear Thermal No. Mech No. \_\_\_\_\_  
Draft Sill A Bent B OK  
Head Shield A Dent B OK  
Skid Condition OK  
Sill Crushed

\* inspect bottom  
After unloaded

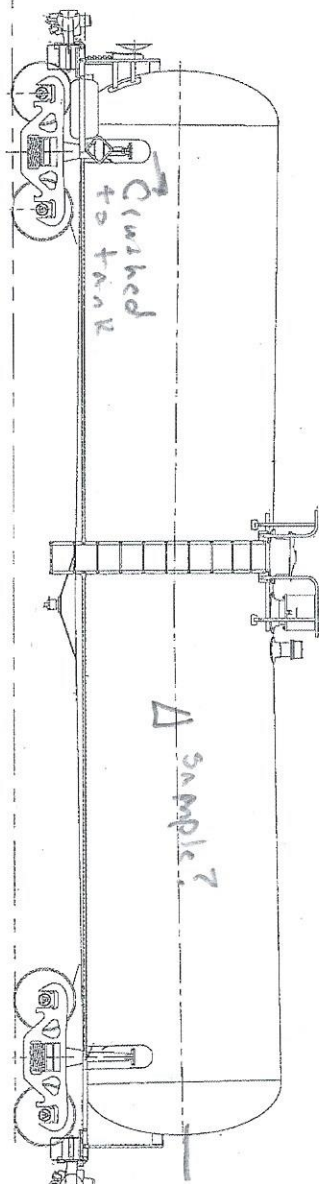
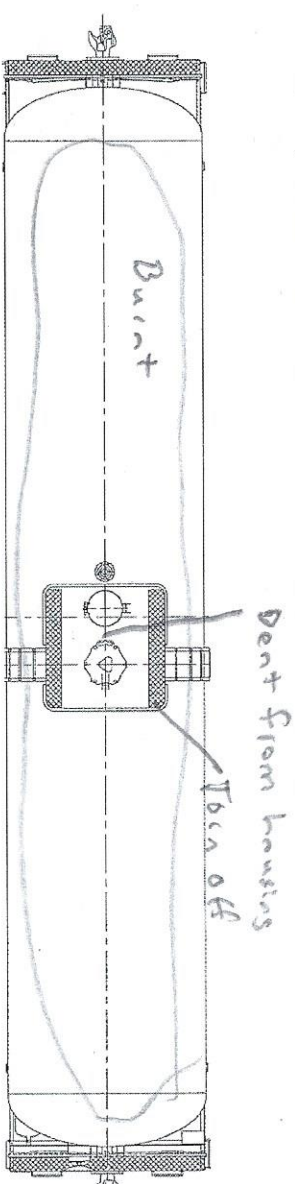
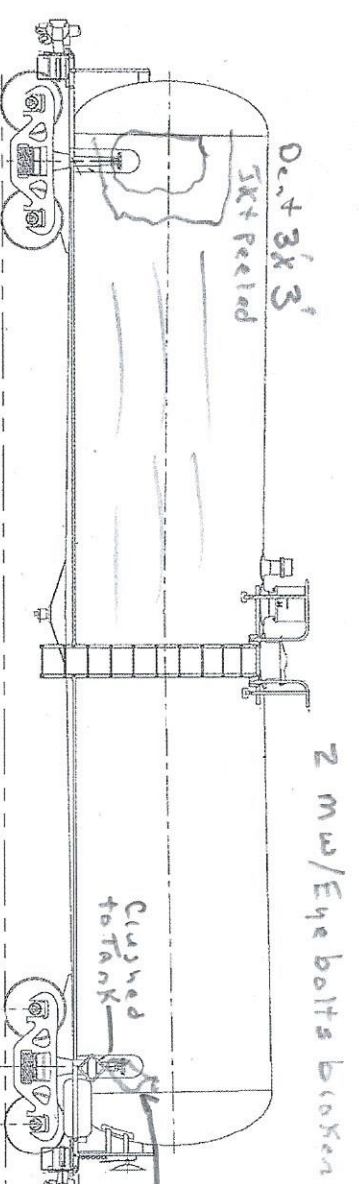
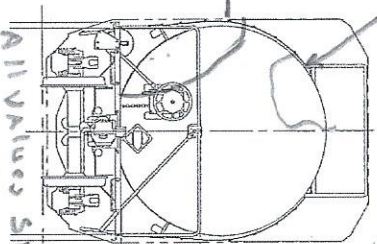
Car Number UTLX209403

Top fittings MW OK MH Sheared off  
 Bottom Outlet Leg OK Handle DH Torn off  
 Shell Tear Thermal No Mech Yes  
 Draft Sill A OK B OK  
 Head Shield A OK B Dent  
 Skid Condition OK

1489 Gals Recovered

\* Hold NTSB BL Body balster Couper

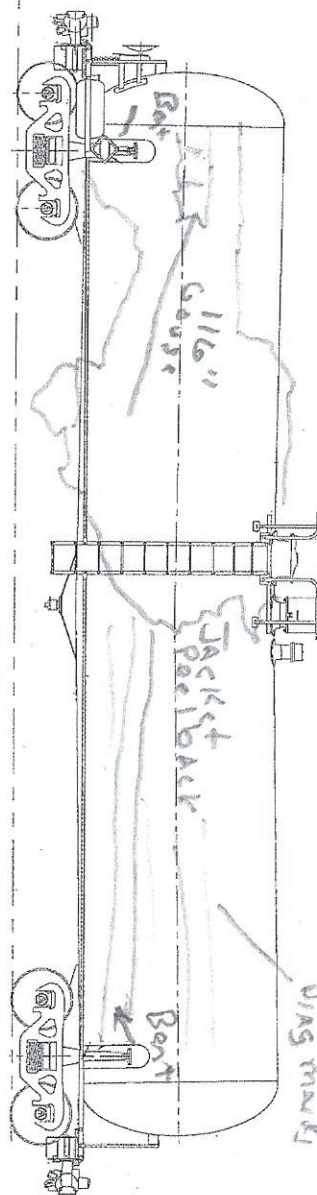
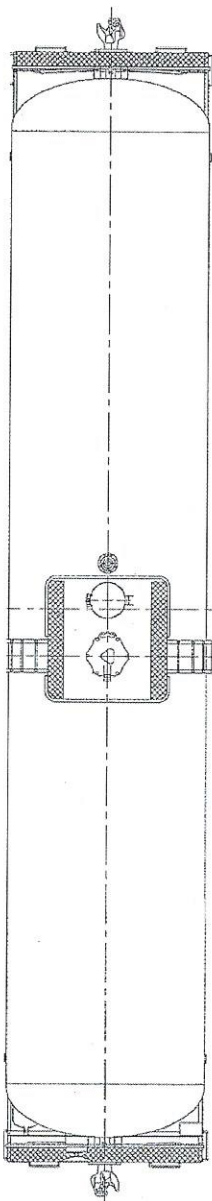
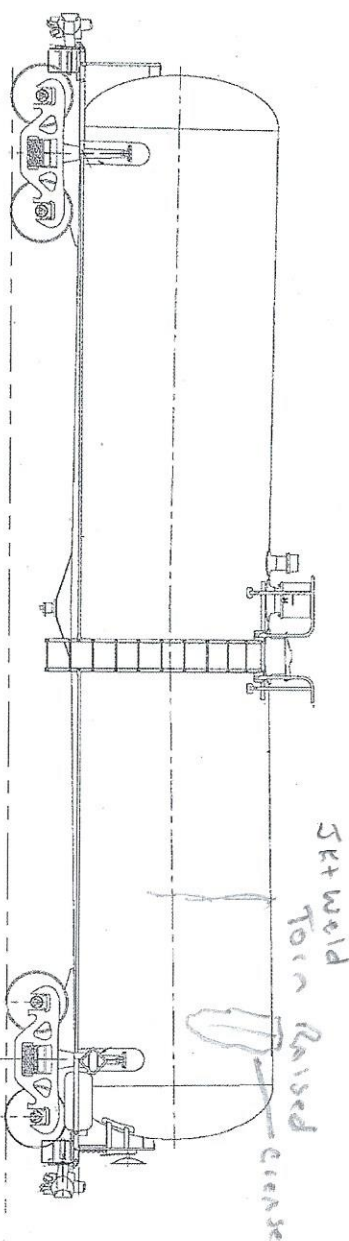
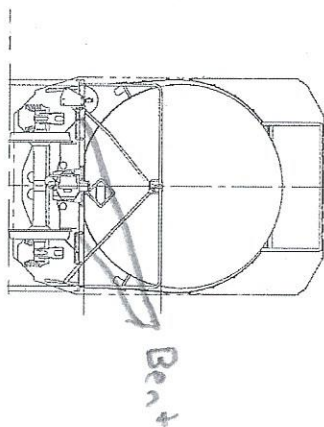
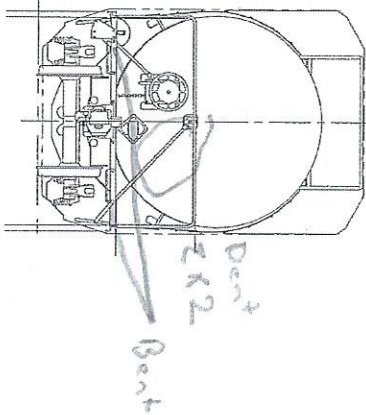
Car Number TLX 363368

Top fittings MW OK MH OK  
Bottom Outlet Leg SOK Handle DH torn off  
Shell Tear Thermal No \_\_\_\_\_ Mech No \_\_\_\_\_  
Draft Sill A Bent B Bent  
Head Shield A OK B Bent  
Skid Condition OK  
ARR ST-470

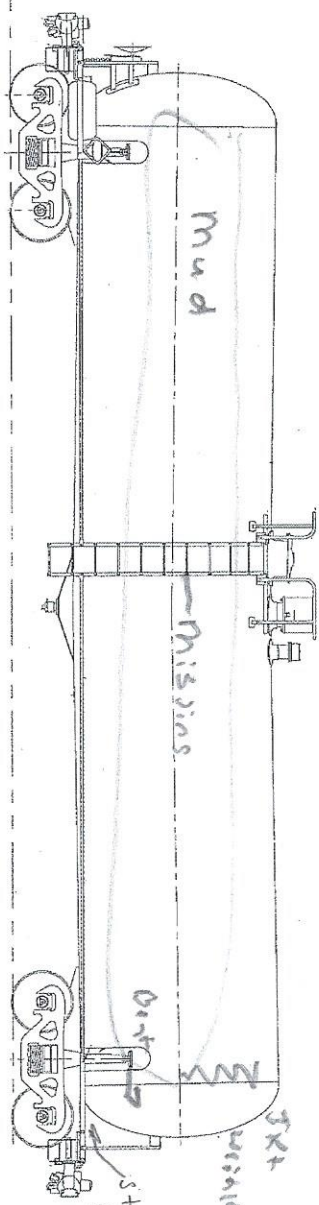
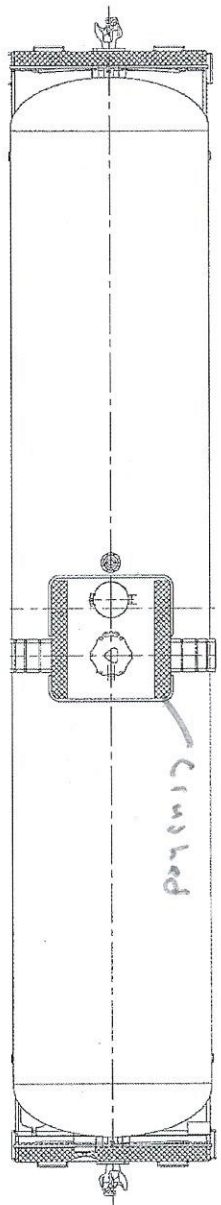
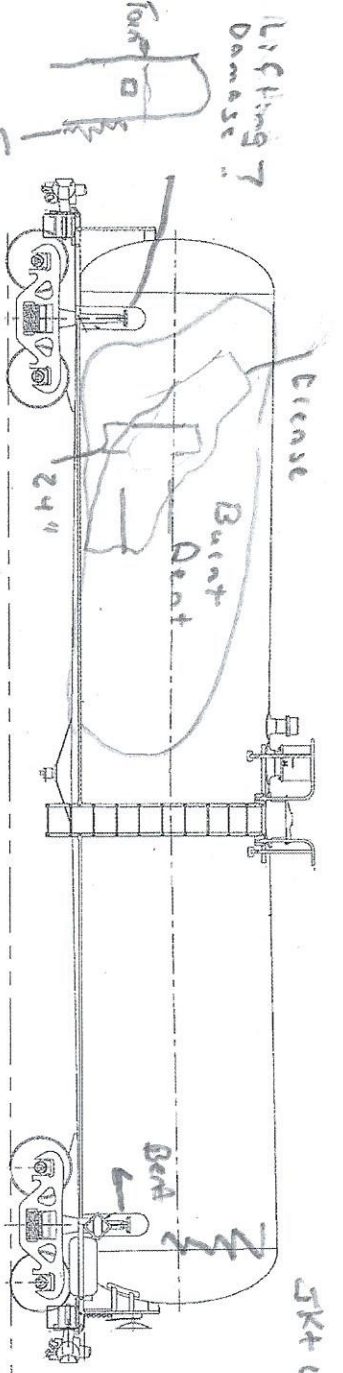
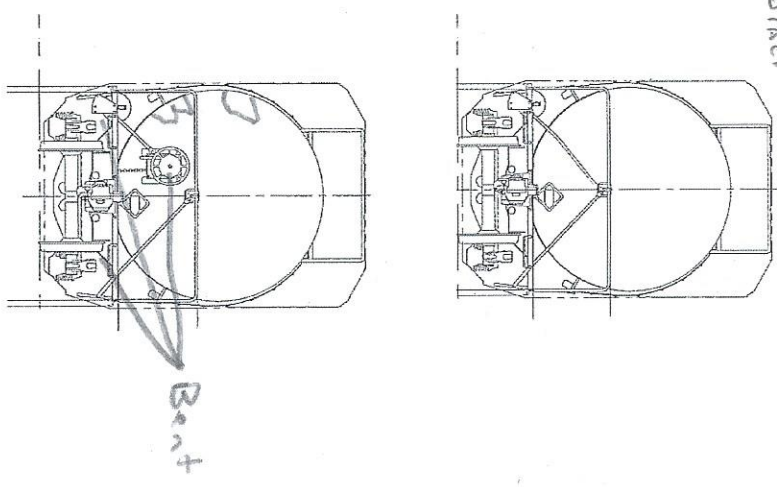
Car Number GATX 225797

Top fittings MW DK MH OK  
 Bottom Outlet Leg SOK Handle DH Bent  
 Shell Tear Thermal No Mech No  
 Draft Sill A Thermal HB B DK  
 Head Shield A OK B OK  
 Skid Condition OK

\* Remove head + Tacket  
 for inspection

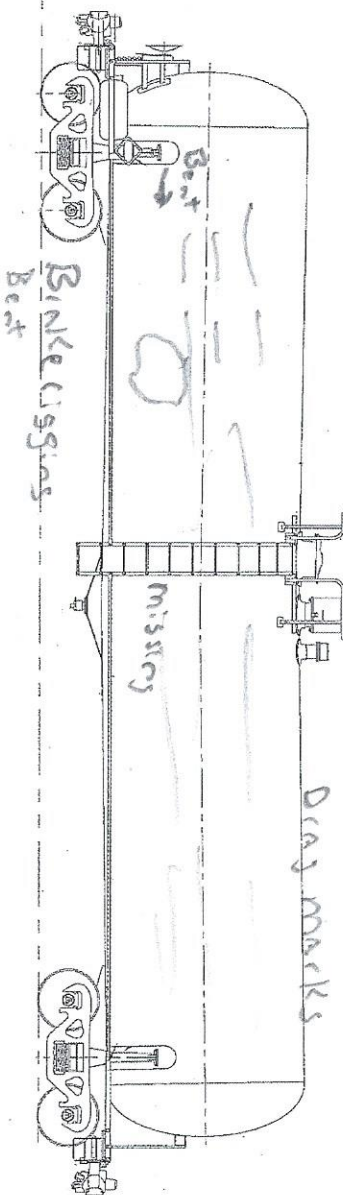
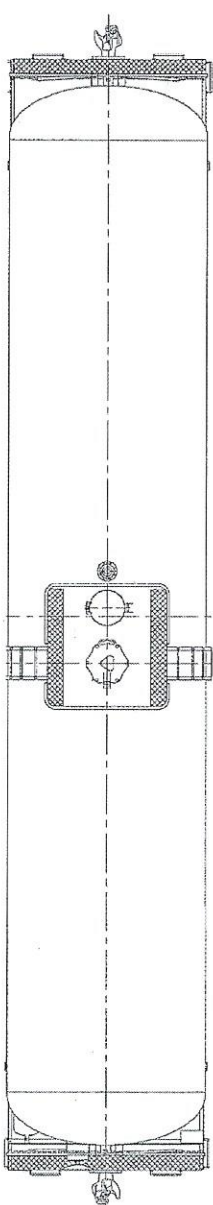
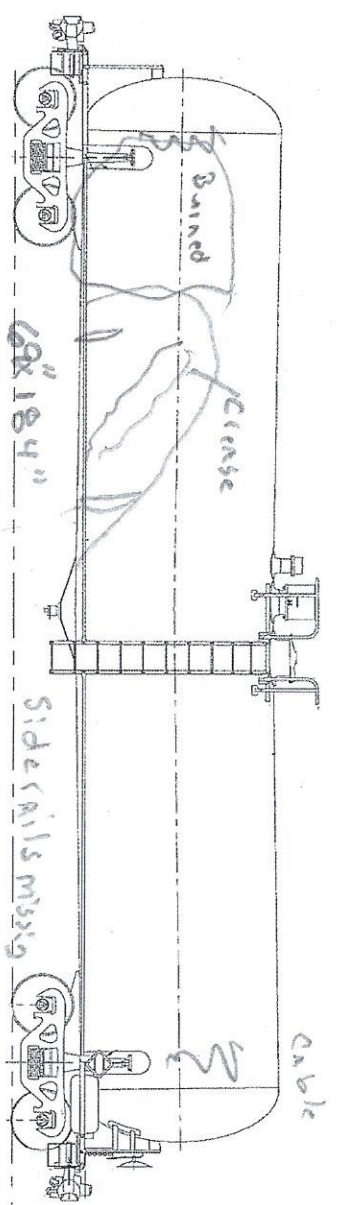
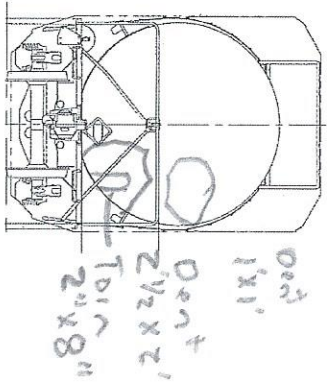
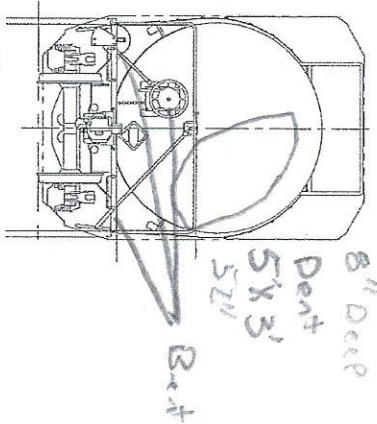
Car Number ILX 198738

Top fittings MW OK MH OK  
 Bottom Outlet Leg Sok Handle DH toin off  
 Shell Tear Thermal No Mech ? Remove Stk  
 Draft Sill A Bent B Bent  
 Head Shield A Bent toin B Bent  
 Skid Condition DK

KNTSB Hold  
Remove Inocket  
Veinon → Reinspect @ center BoV Orig - Reposition Ball Leak stopped  
Don

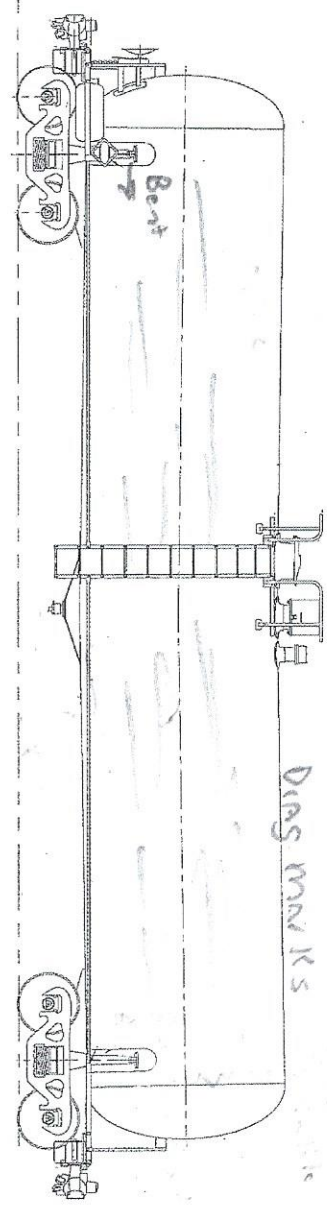
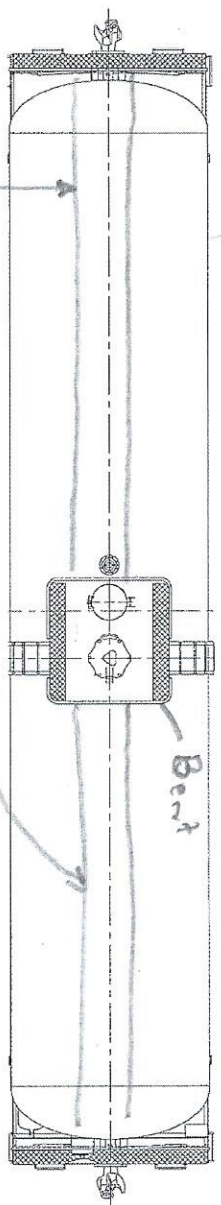
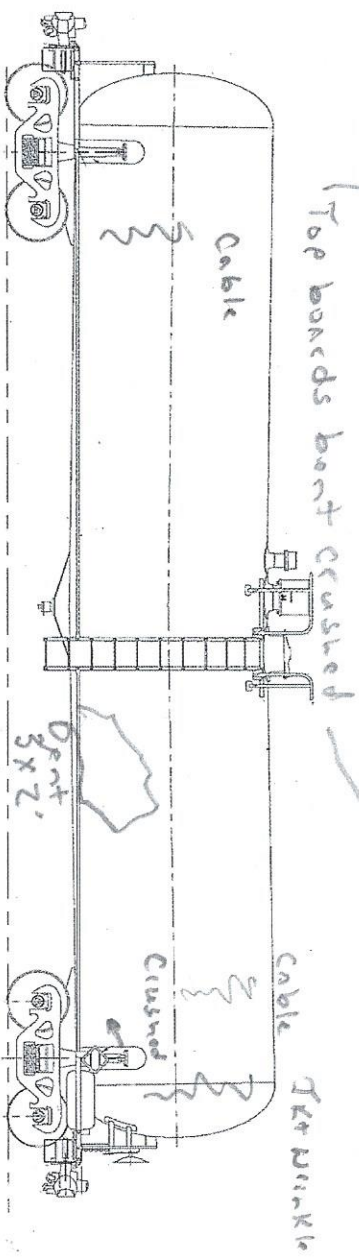
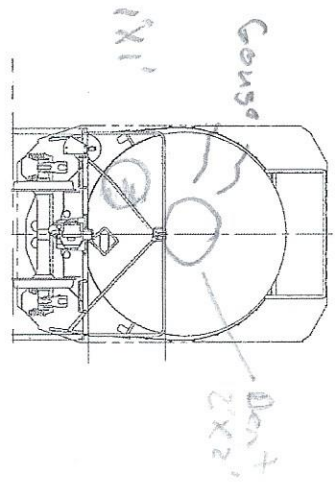
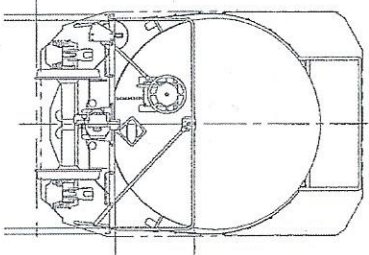
Car Number TILX 351793

Top fittings MW OK MH OK  
 Bottom Outlet Leg S OK Handle DH Burried  
 Shell Tear Thermal NO Mech NO  
 Draft Sill A Bent B Bent  
 Head Shield A OK B OK +  
 Skid Condition OK

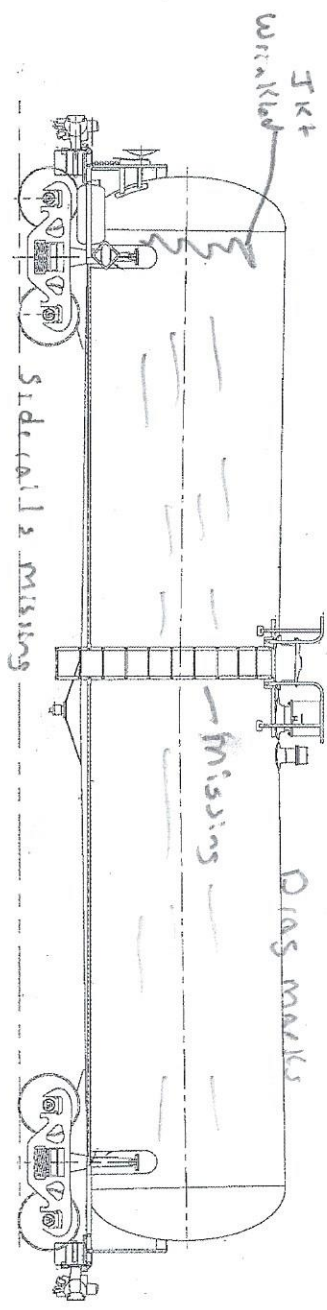
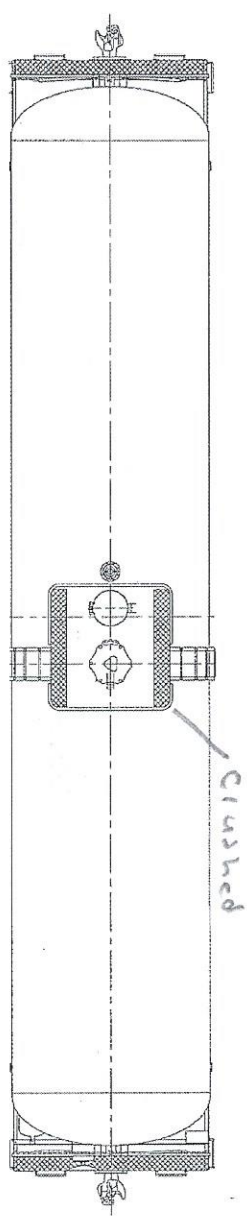
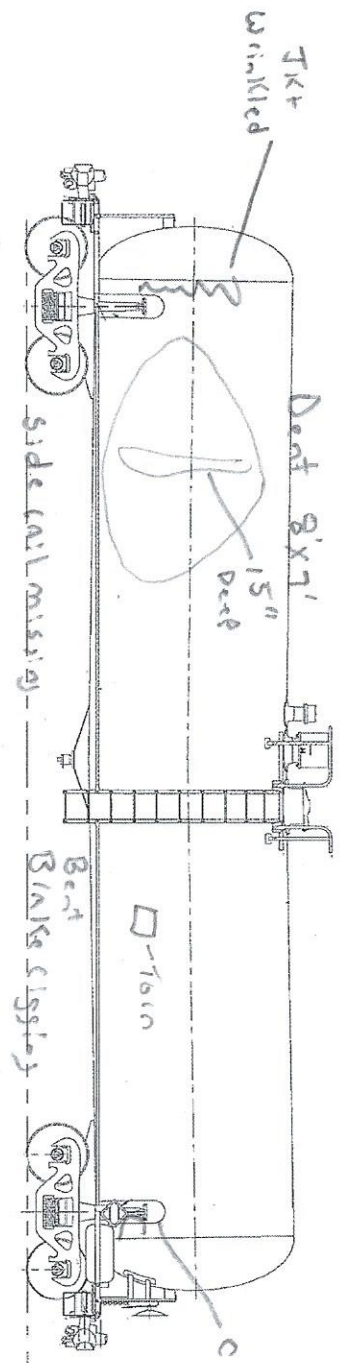
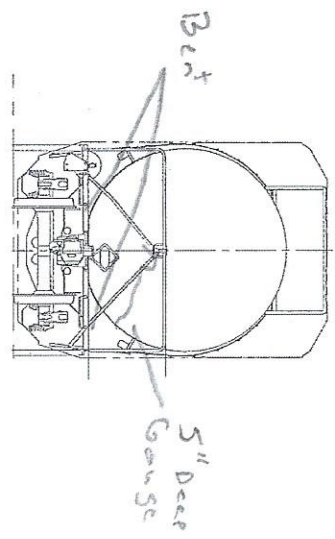
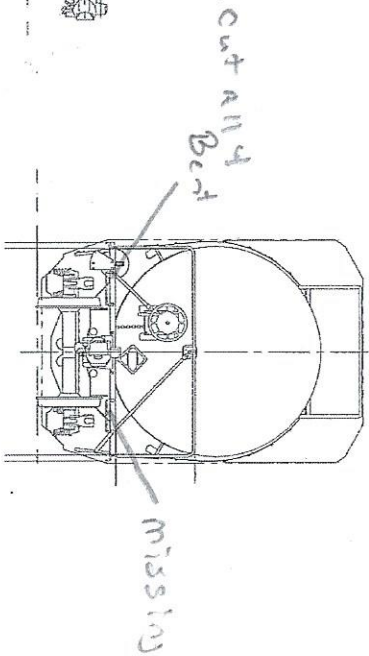
Car Number FURX 160011

Top fittings MW OK MH OK  
 Bottom Outlet Leg S OK Handle DH Toin OK  
 Shell Tear Thermal No Mech No \_\_\_\_\_  
 Draft Sill A OK B Bent  
 Head Shield A Bent gauge B OK  
 Skid Condition OK

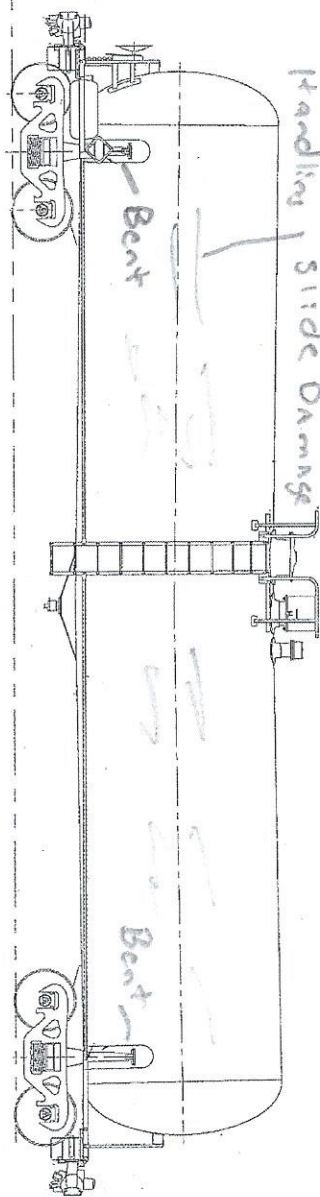
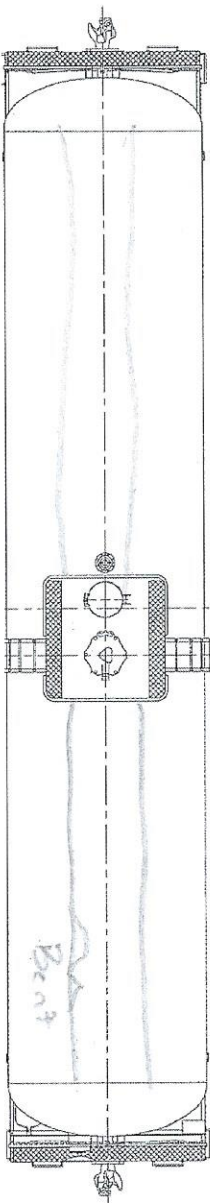
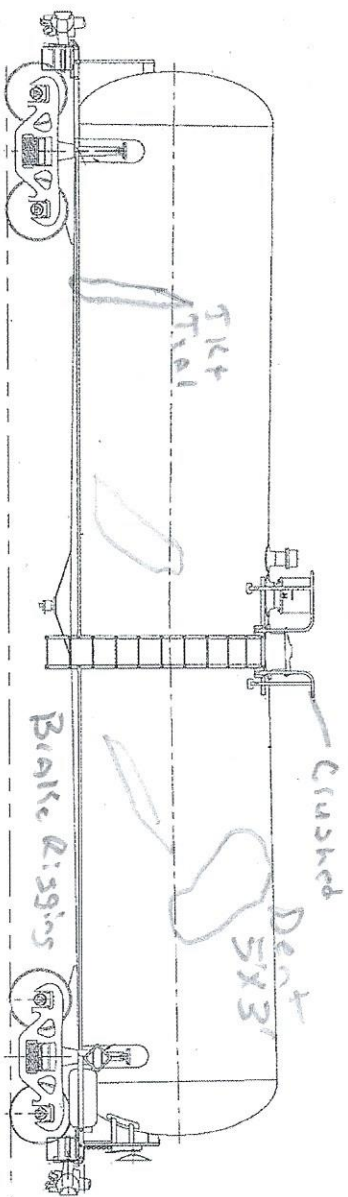
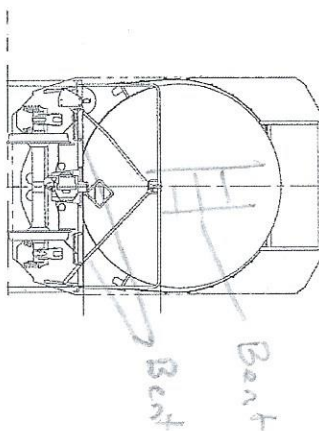
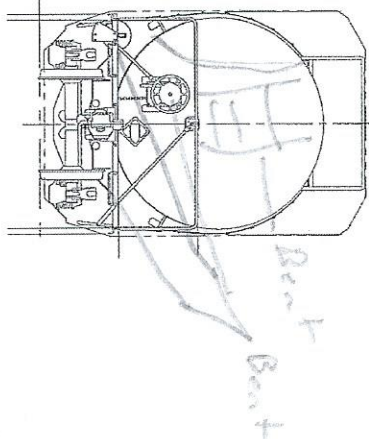
Car Number TILX 352058

Top fittings MW OK MH OK  
 Bottom Outlet Leg S OK Handle DH Salco  
 Shell Tear Thermal No Mech No  
 Draft Sill A Bent B OK?  
 Head Shield A OK B Bent  
 Skid Condition Damaged OK

GPS? impact

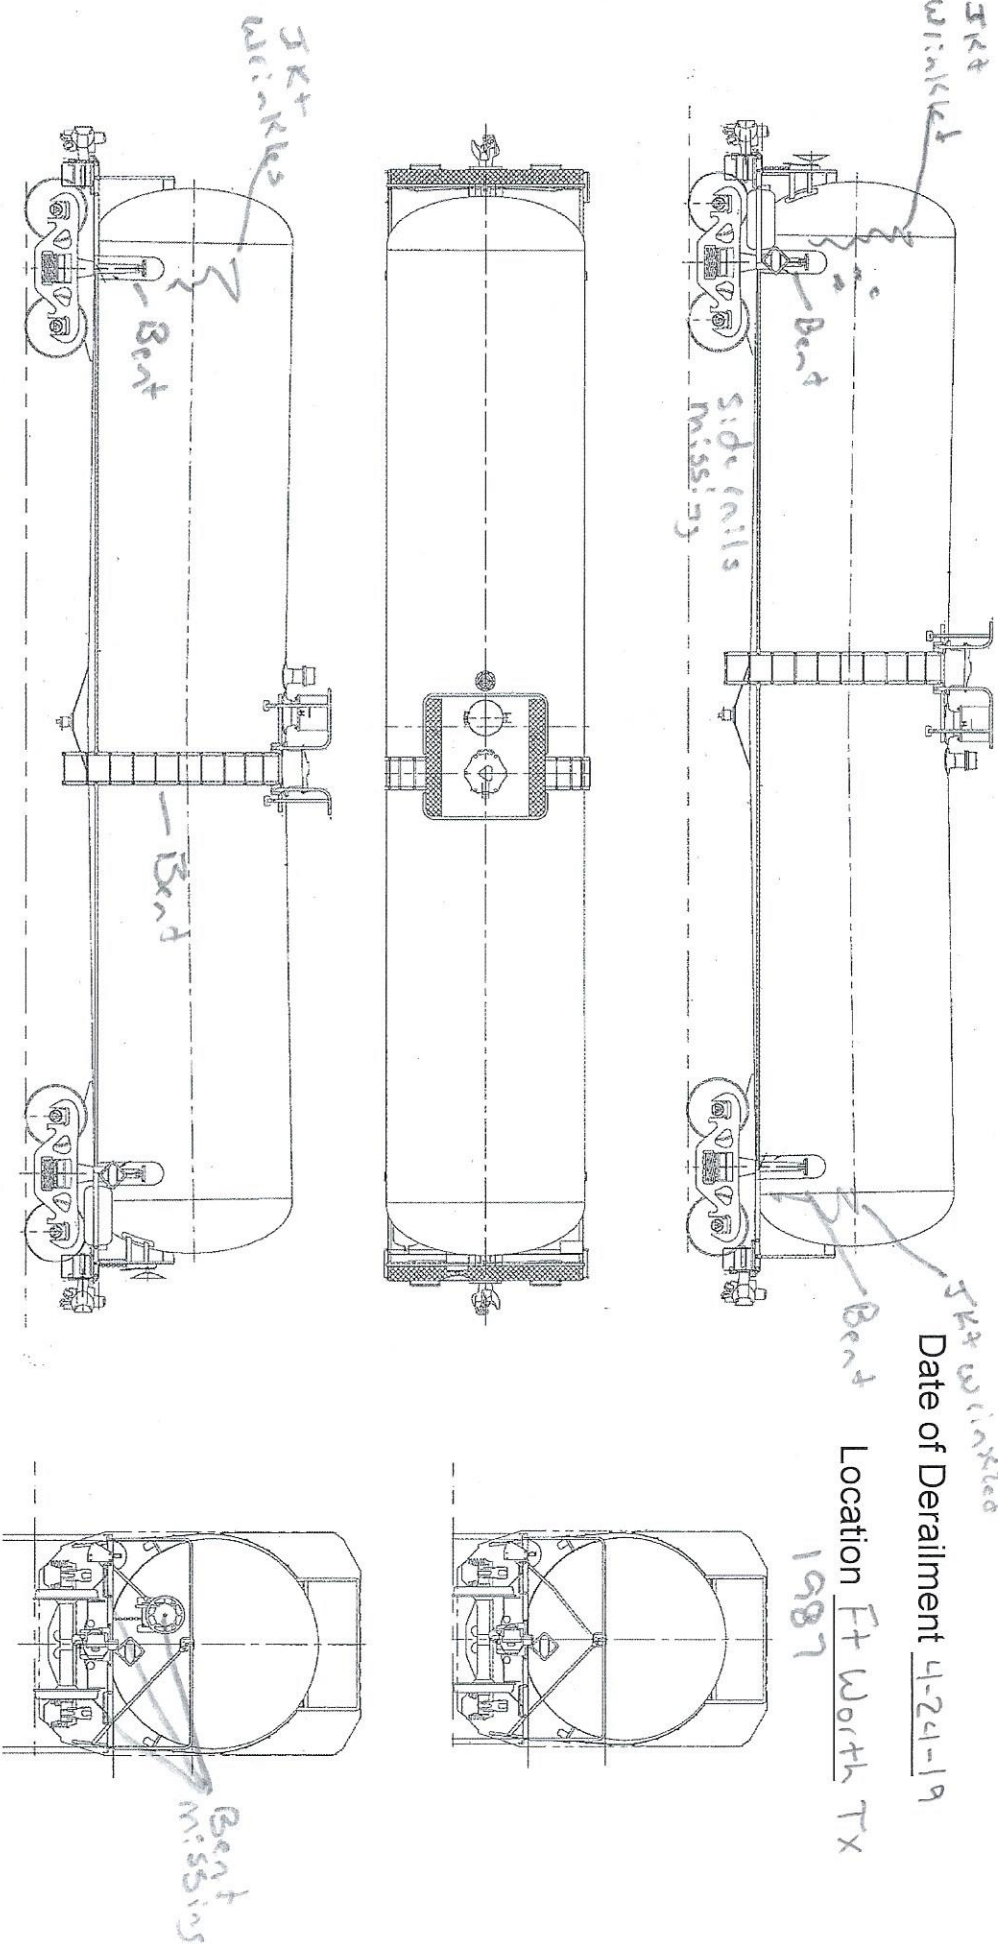
Car Number TILX363454

Top fittings MW OK MH DK  
Bottom Outlet Leg OK Handle DH Bent  
Shell Tear Thermal No Mech No  
Draft Sill A Bent B Bent  
Head Shield A OK B OK  
Skid Condition OK

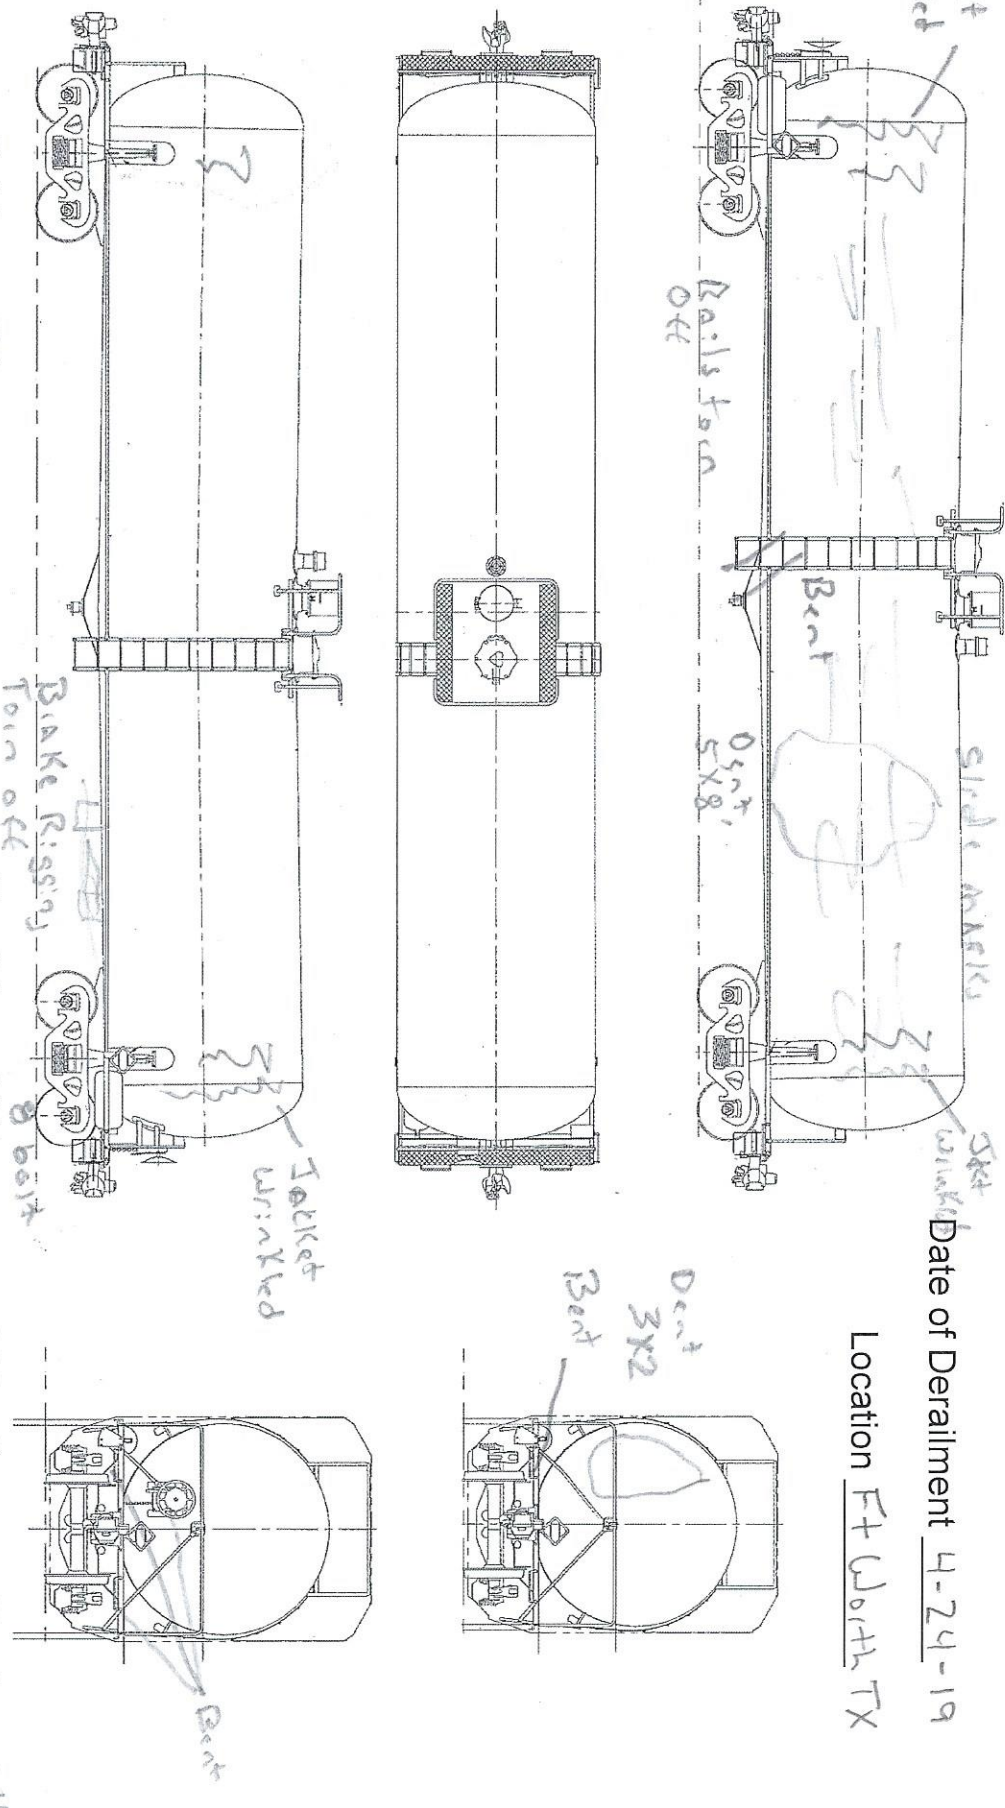
Car Number UTLX 207573

Socket wrinkled

Rails torn off

Bent

Slide marks

Skid marks

Top fittings MWOK MH OK Muds on all  
Bottom Outlet Leg SOK Handle DH UTC  
Shell Tear Thermal No Mech NO  
Draft Sill A OK B OK  
Head Shield A Dent B OK  
Skid Condition OK CR ST

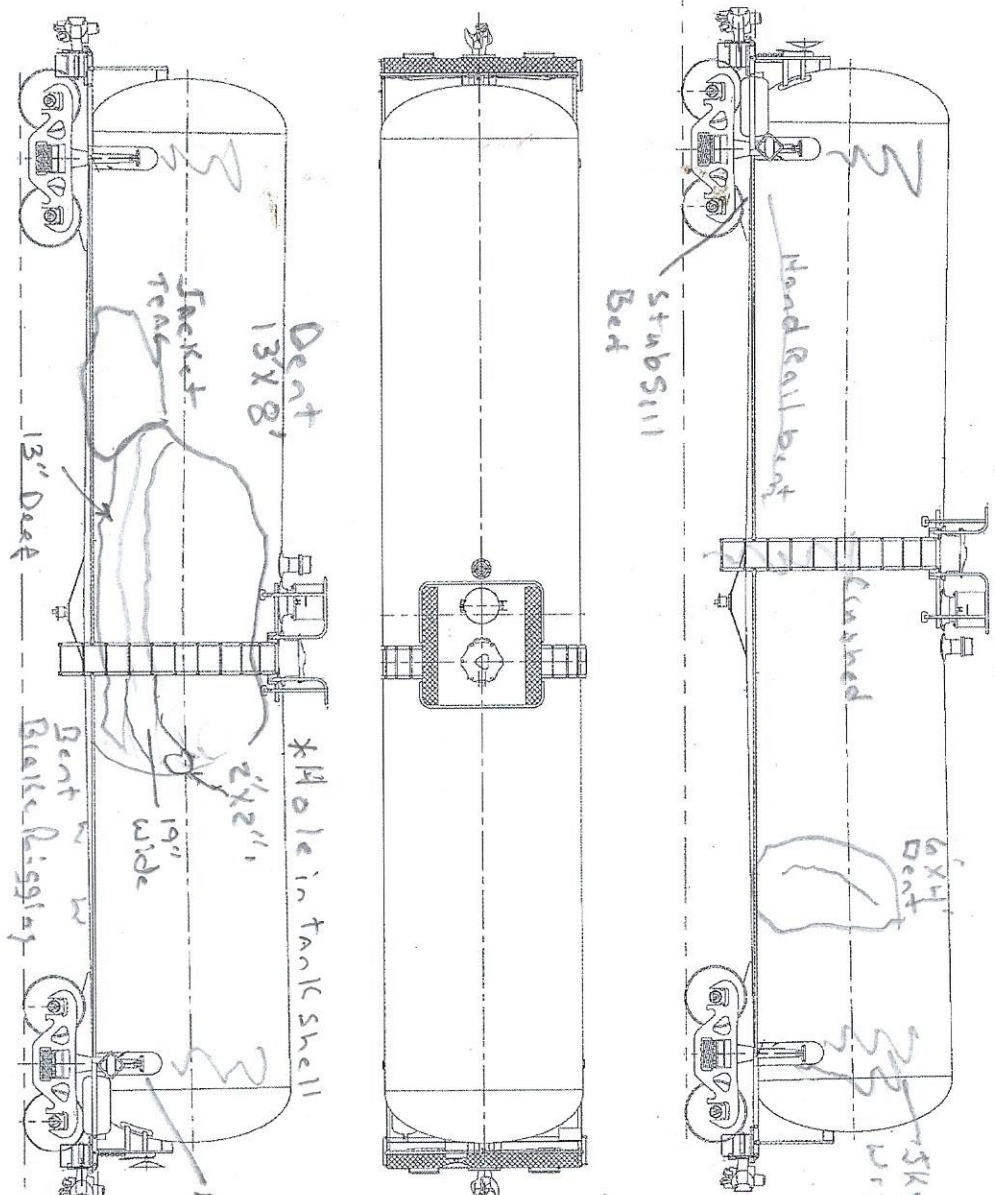
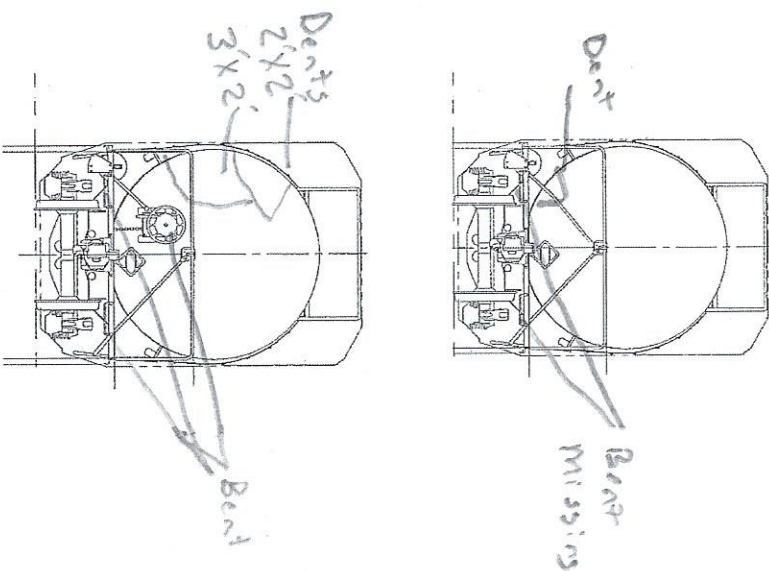
Car Number UTLX 289301

Top fittings MW OK MH Nozzle bent  
 Bottom Outlet Leg OK Handle DH Leaking 2 Bow  
 Shell Tear Thermal No Mech Yes Bent  
 Draft Sill A Bent B Bent  
 Head Shield A Dent B Bent  
 Skid Condition OK

78" of Outgase

\* Remove Truck At hook NTSB Hold Tank Shell Coupon
