# Car Damage Report

Date of Derailment 4-24-19

Location Et Worth TX

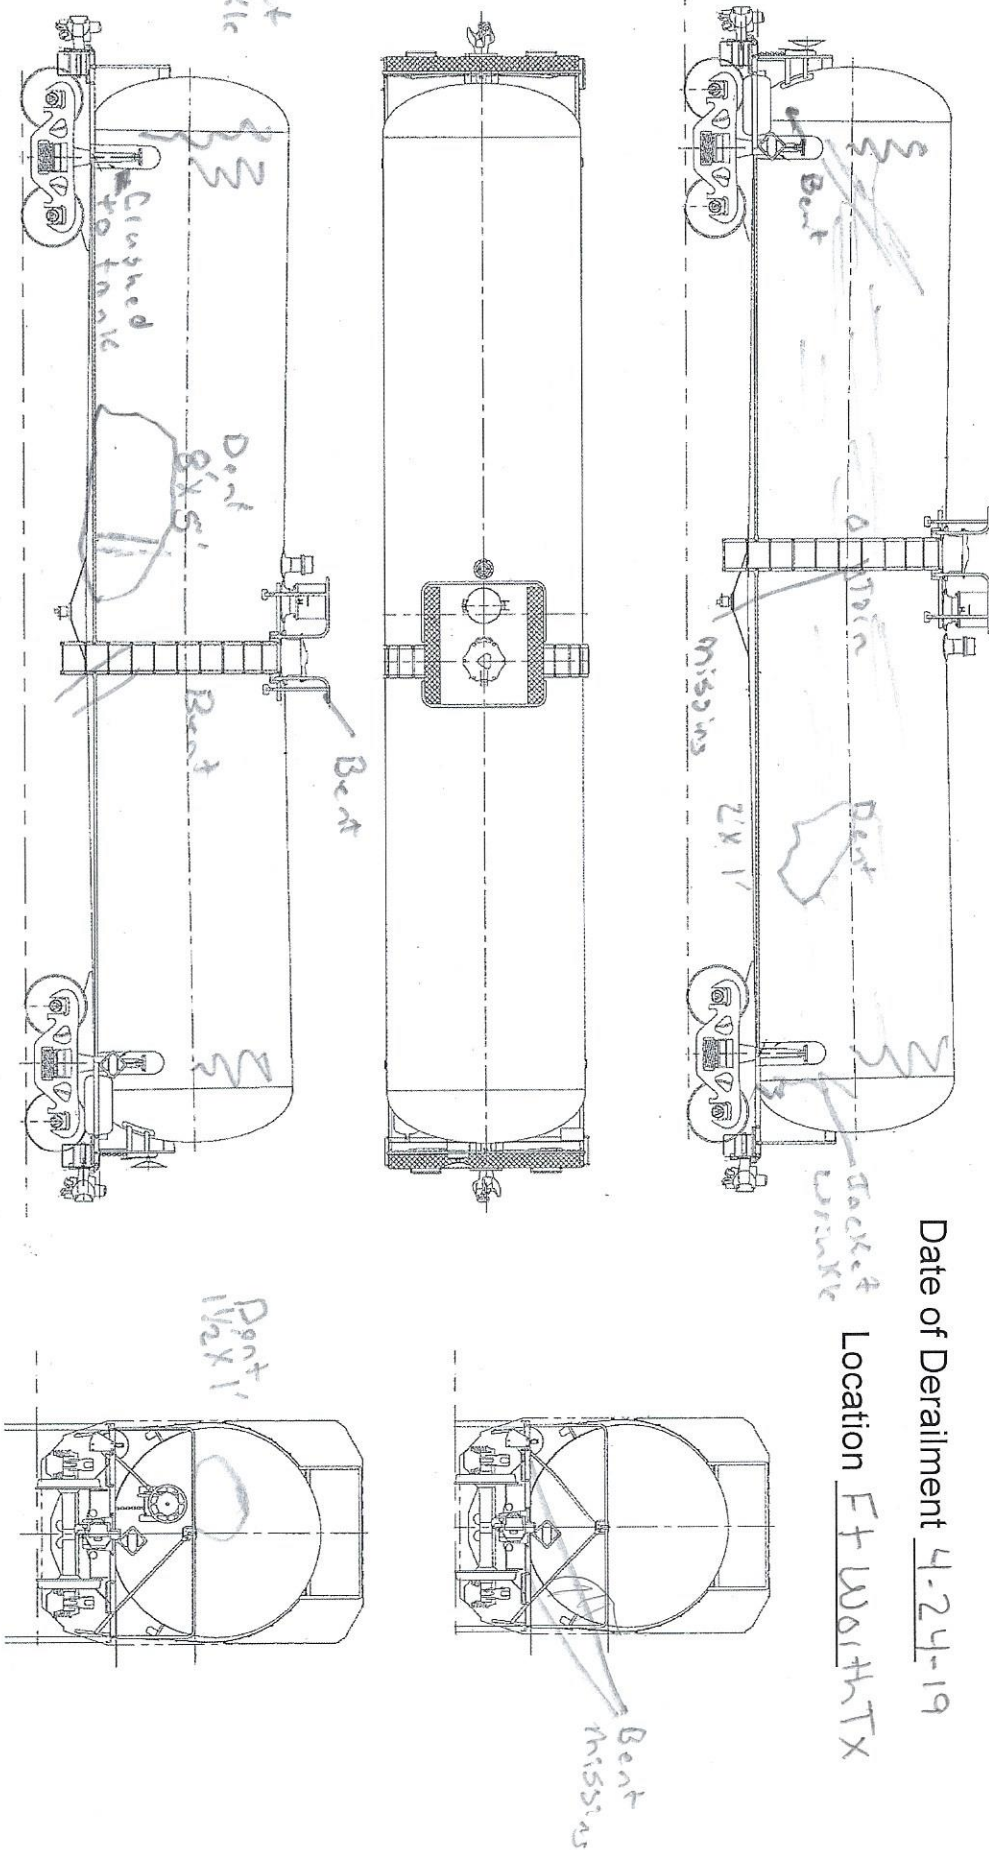
Car Number TLX 199078

Top fittings MW OK MH OK  
 Bottom Outlet Leg SoK Handle DH Salco Bent  
 Shell Tear Thermal No Mech No  
 Draft Sill A Dent B Torn OK HG  
 Head Shield A Bent B Bent Torn  
 Skid Condition Bent down center

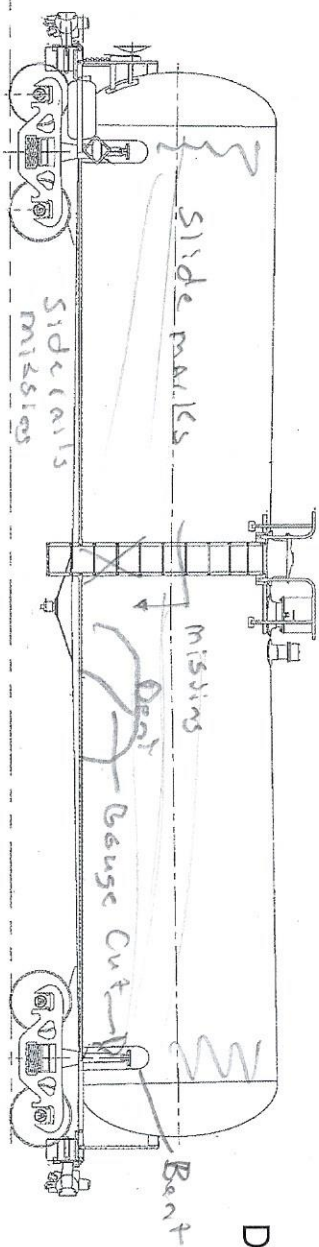
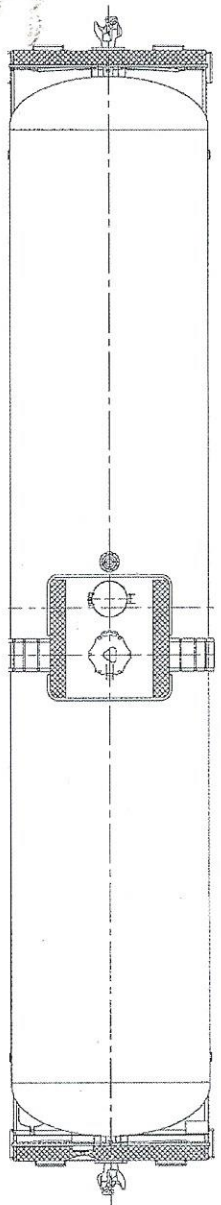
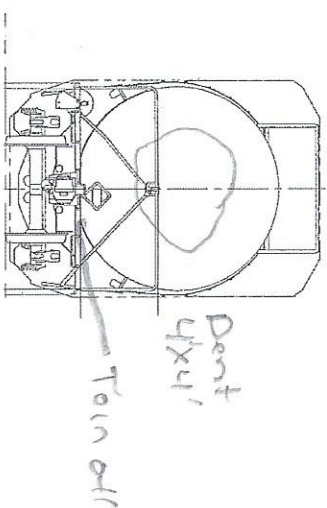
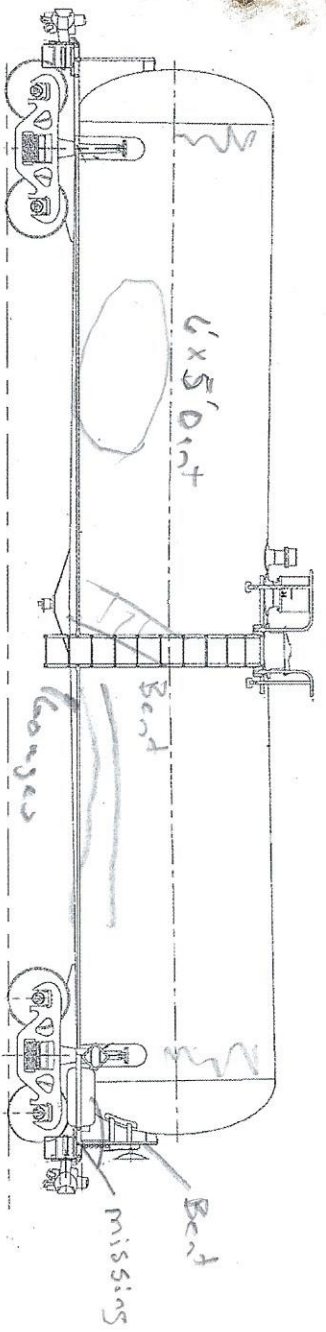
Car Number FURX160030

Top fittings MW OK MH OK  
 Bottom Outlet Leg S OK Handle DH Bent CBX  
 Shell Tear Thermal No Mech No \_\_\_\_\_  
 Draft Sill A Bent Pass B Bent  
 Head Shield A Dent B OK  
 Skid Condition OK Leg Skewed

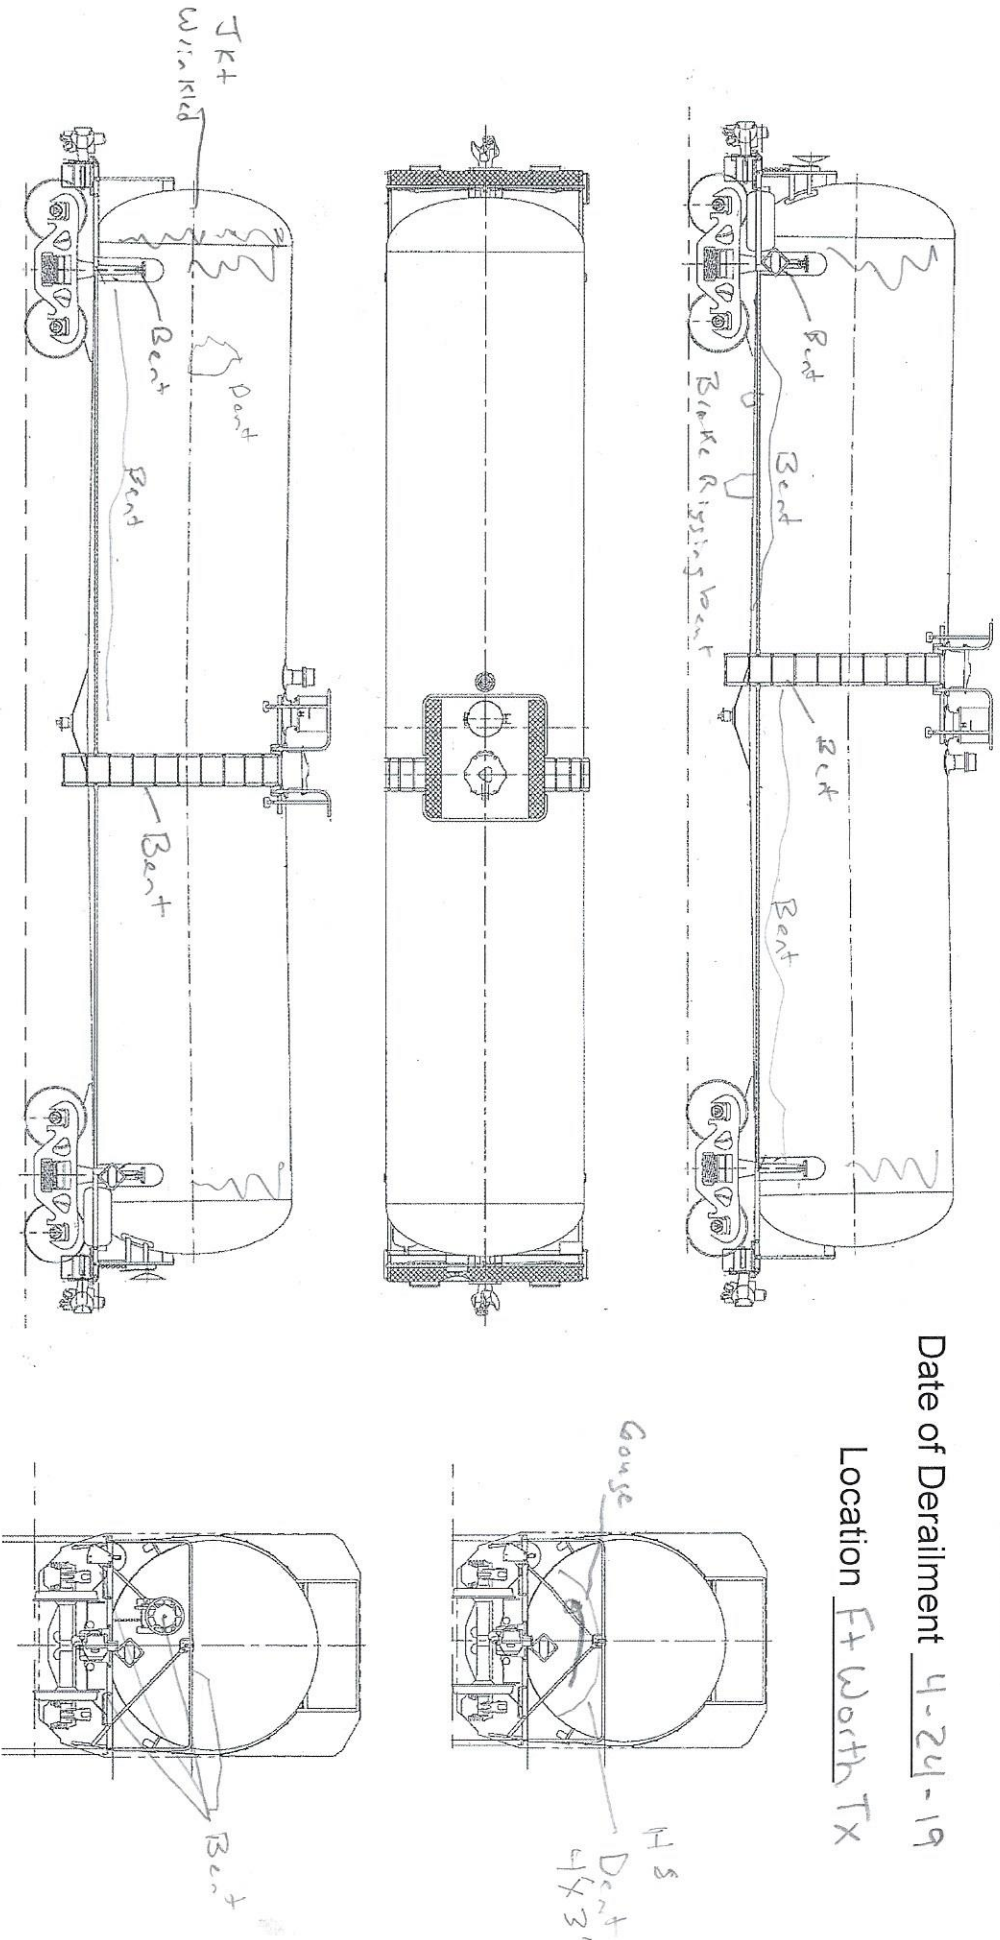
Car Number TLX 197495

Top fittings MW OK MH OK  
Bottom Outlet Leg Sl OK Handle DH Bent Sl ice  
Shell Tear Thermal No Mech No  
Draft Sill A Bent B OK  
Head Shield A Bent B OK  
Skid Condition OK

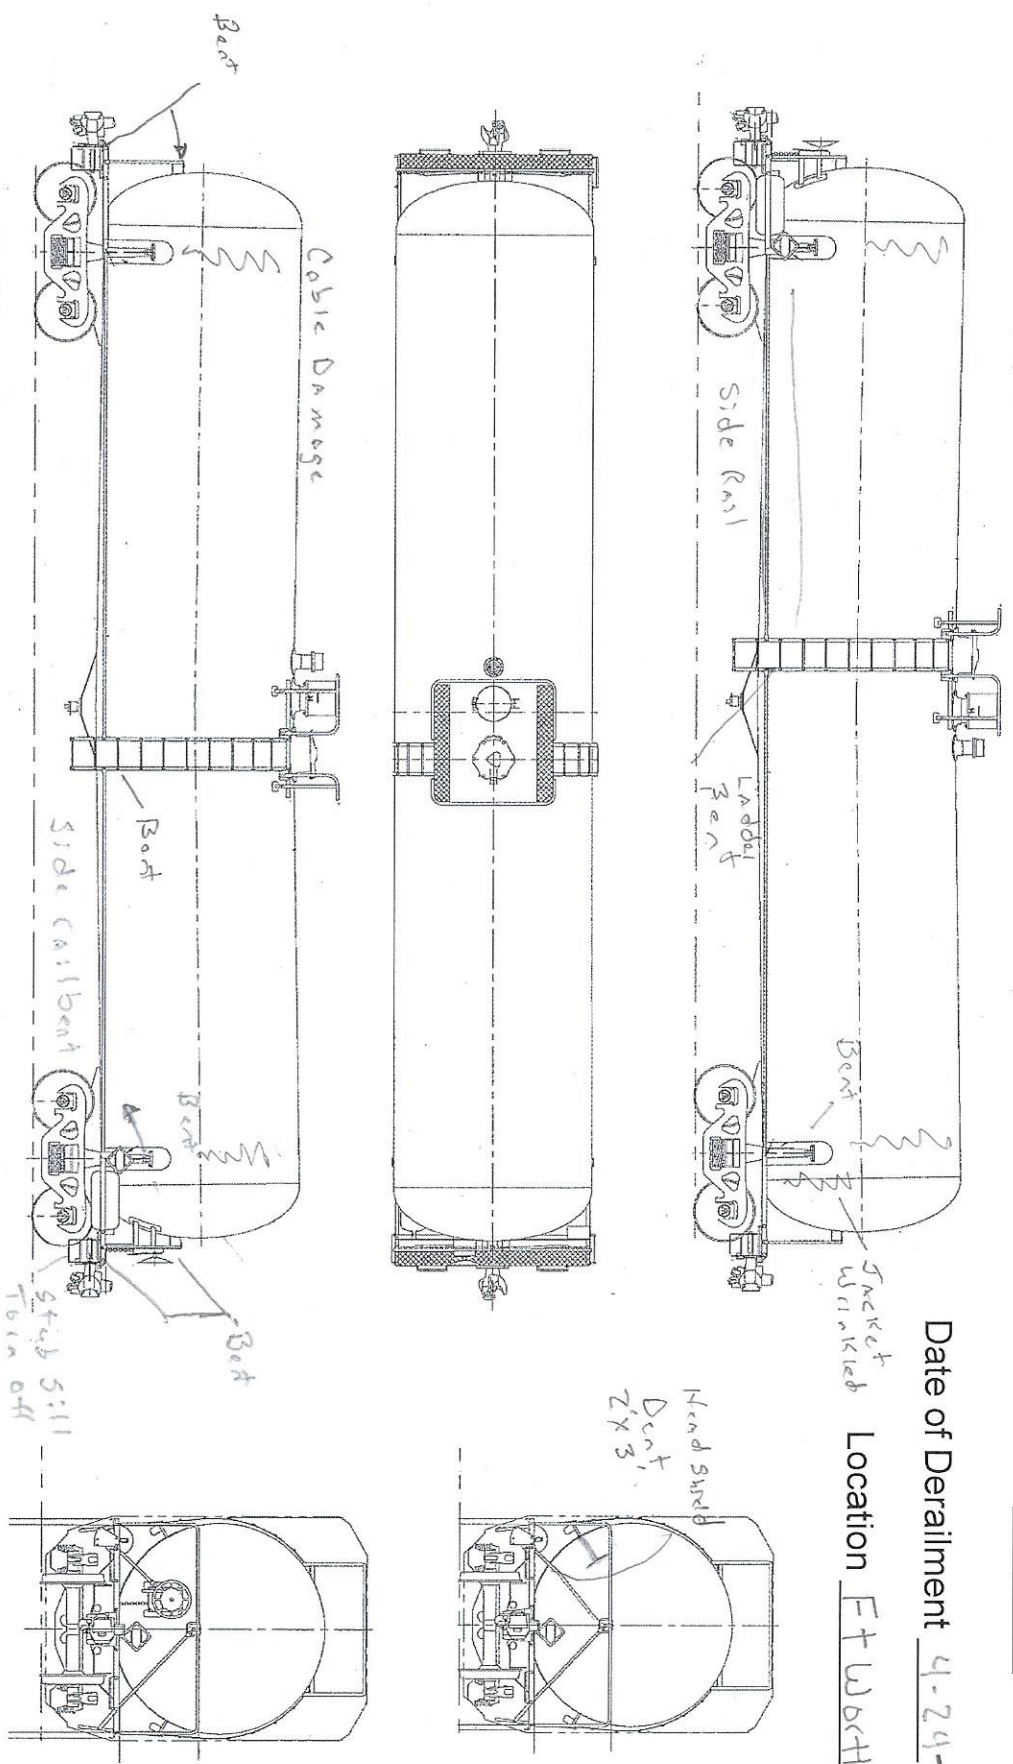
Car Number TKLX 154312

Top fittings MW  OK MH  OK  
 Bottom Outlet Leg S  OK Handle  DH  OK Saleman  
 Shell Tear Thermal No Mech No  
 Draft Sill A Bent? B Tain L side  
 Head Shield A Bent B  
 Skid Condition OK

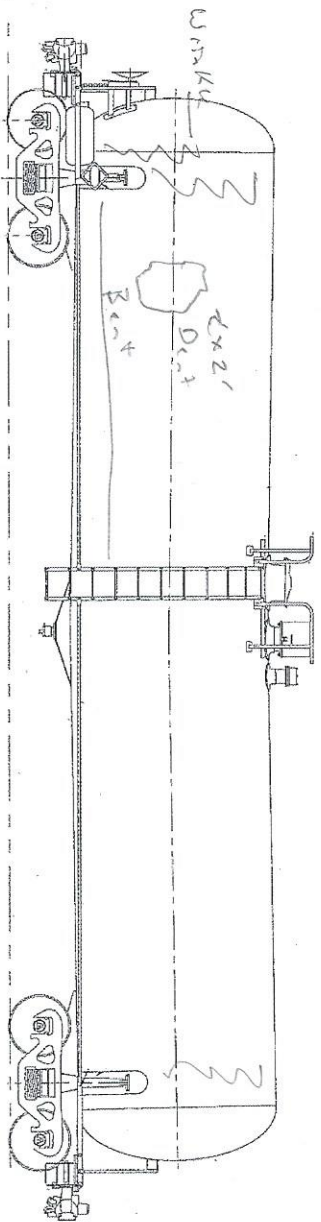
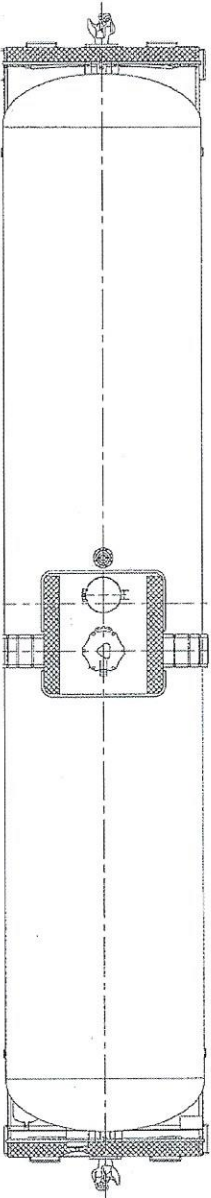
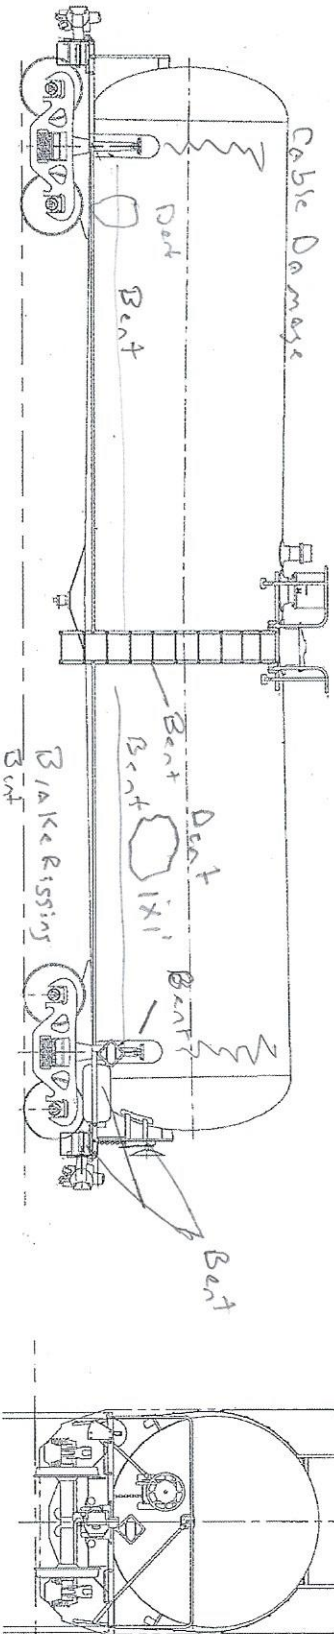
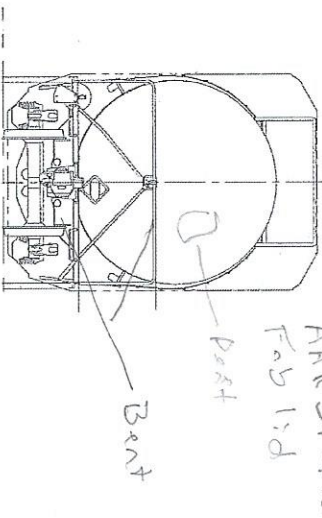
Car Number ILX 363442

Top fittings MW OK MH OK  
 Bottom Outlet Leg S OK Handle DH Bent TQ  
 Shell Tear Thermal ND Mech No  
 Draft Sill A OK B OK  
 Head Shield A OK B OK  
 Skid Condition OK

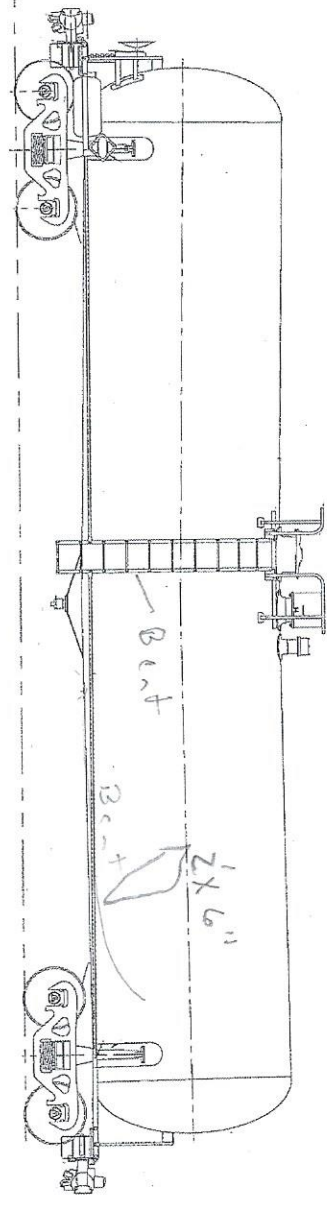
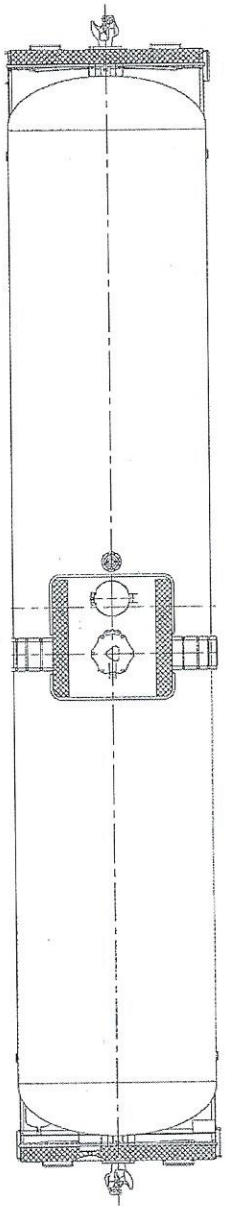
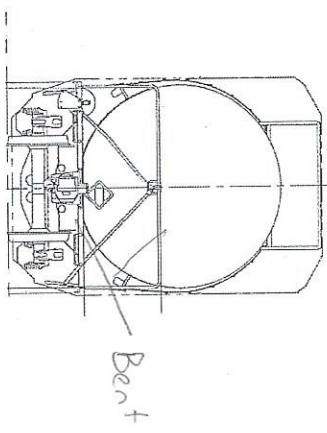
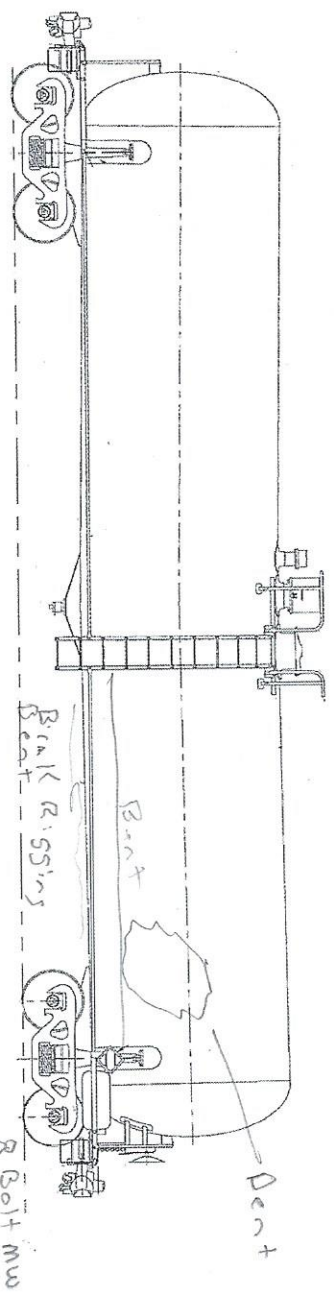
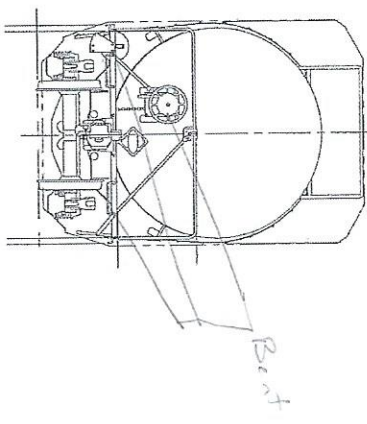
Car Number UTLX 209496

Top fittings MW OK MH OK  
Bottom Outlet Leg Sok Handle DH UTC  
Shell Tear Thermal No Mech No  
Draft Sill A OK B Bent  
Head Shield A OK B OK  
Skid Condition OK

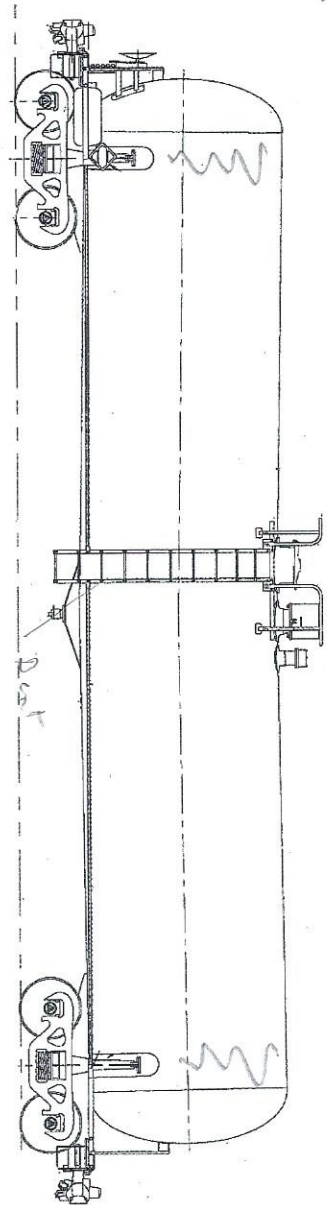
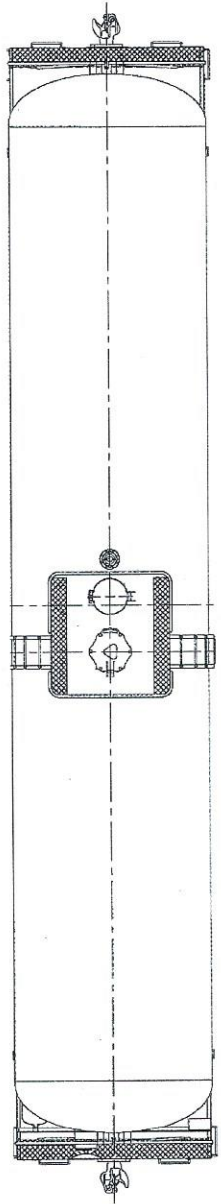
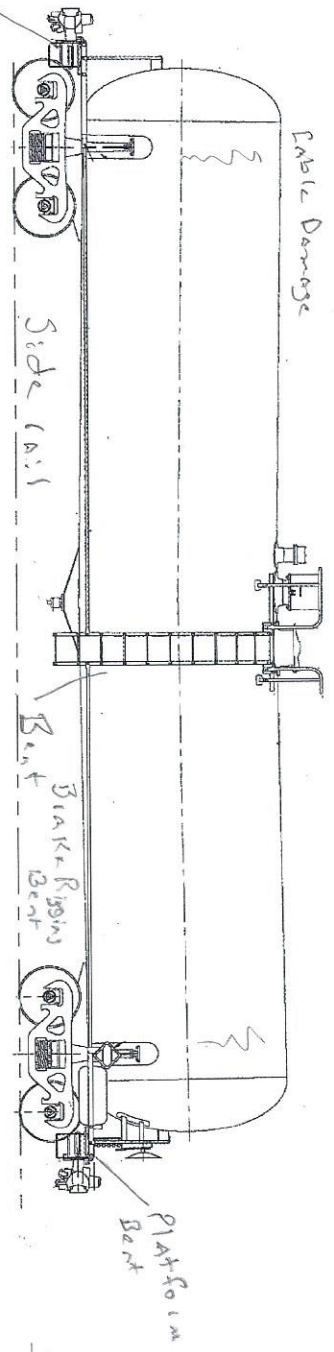
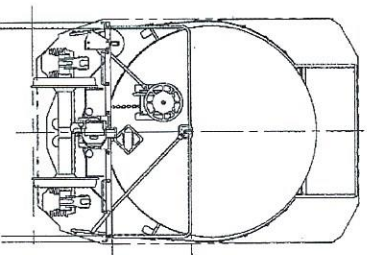
Car Number TLX 191499

Top fittings MW OK MH OK  
 Bottom Outlet Leg S ok Buried Handle DH bent Salco  
 Shell Tear Thermal No Mech No  
 Draft Sill A OK B OK  
 Head Shield A OK B OK  
 Skid Condition OK
