DCA21FA085

OPERATIONAL FACTORS, 777 SIM EVALUATION

777 Simulator and Cockpit Evaluation

October 27, 2022

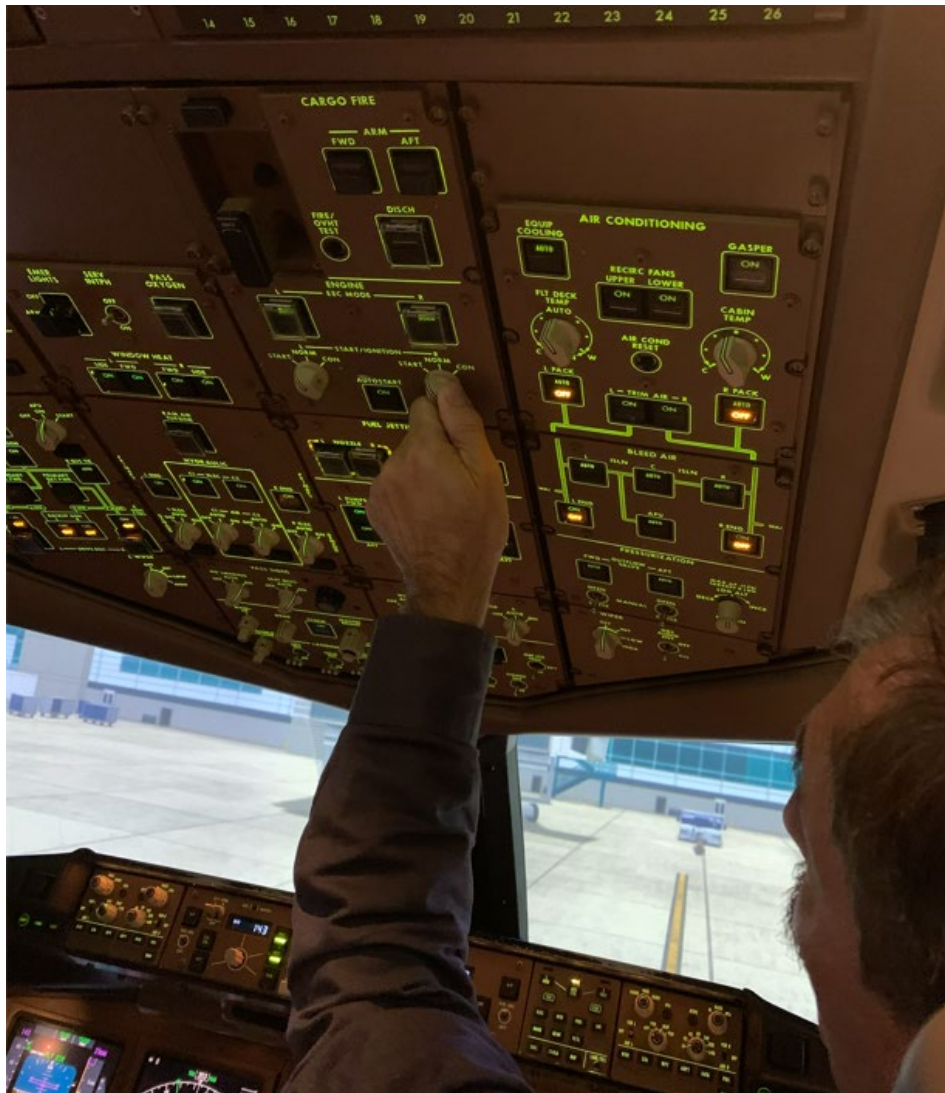
Photo #1. Normal Autostart. (Start, start, Run, run)

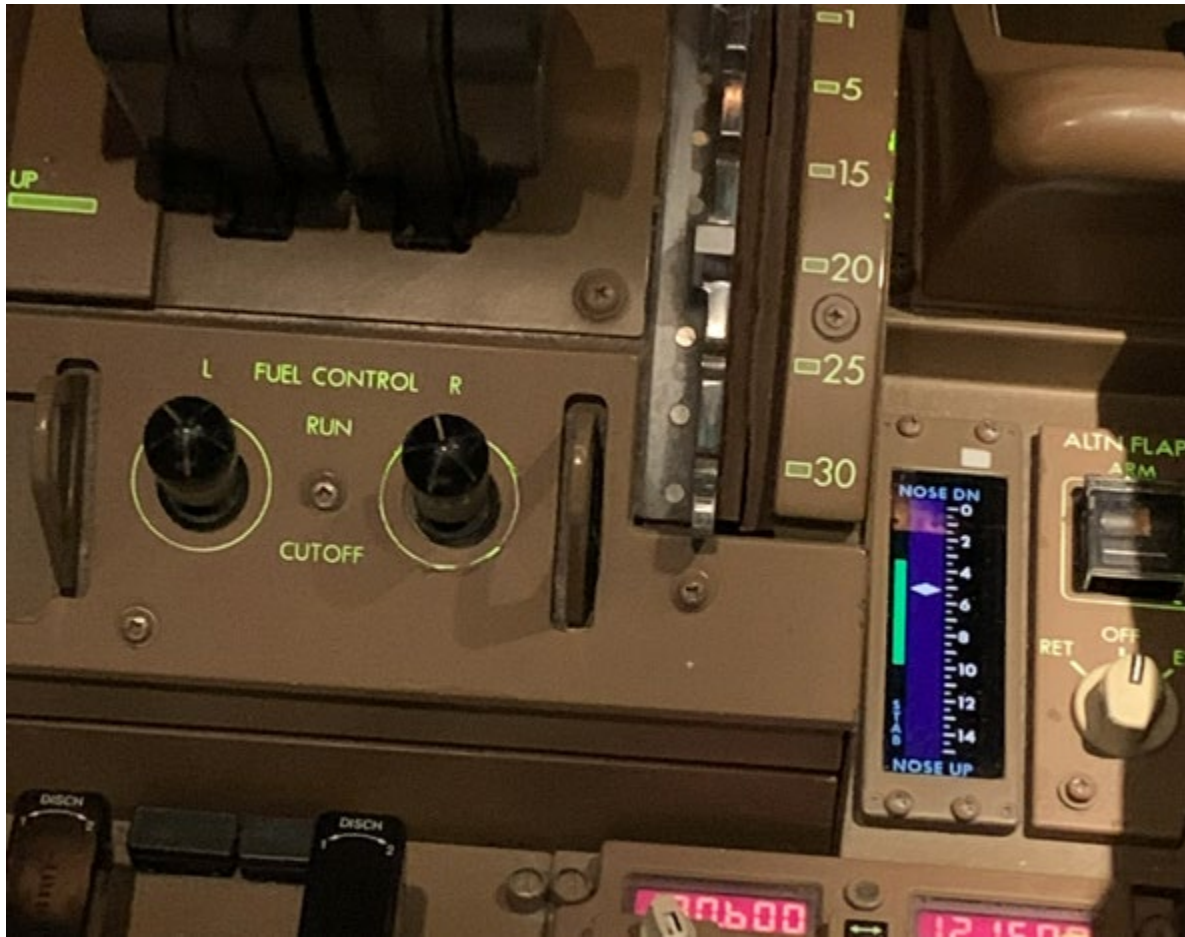
Photo #2. Left and Right Fuel Control switches in the Run, Run position

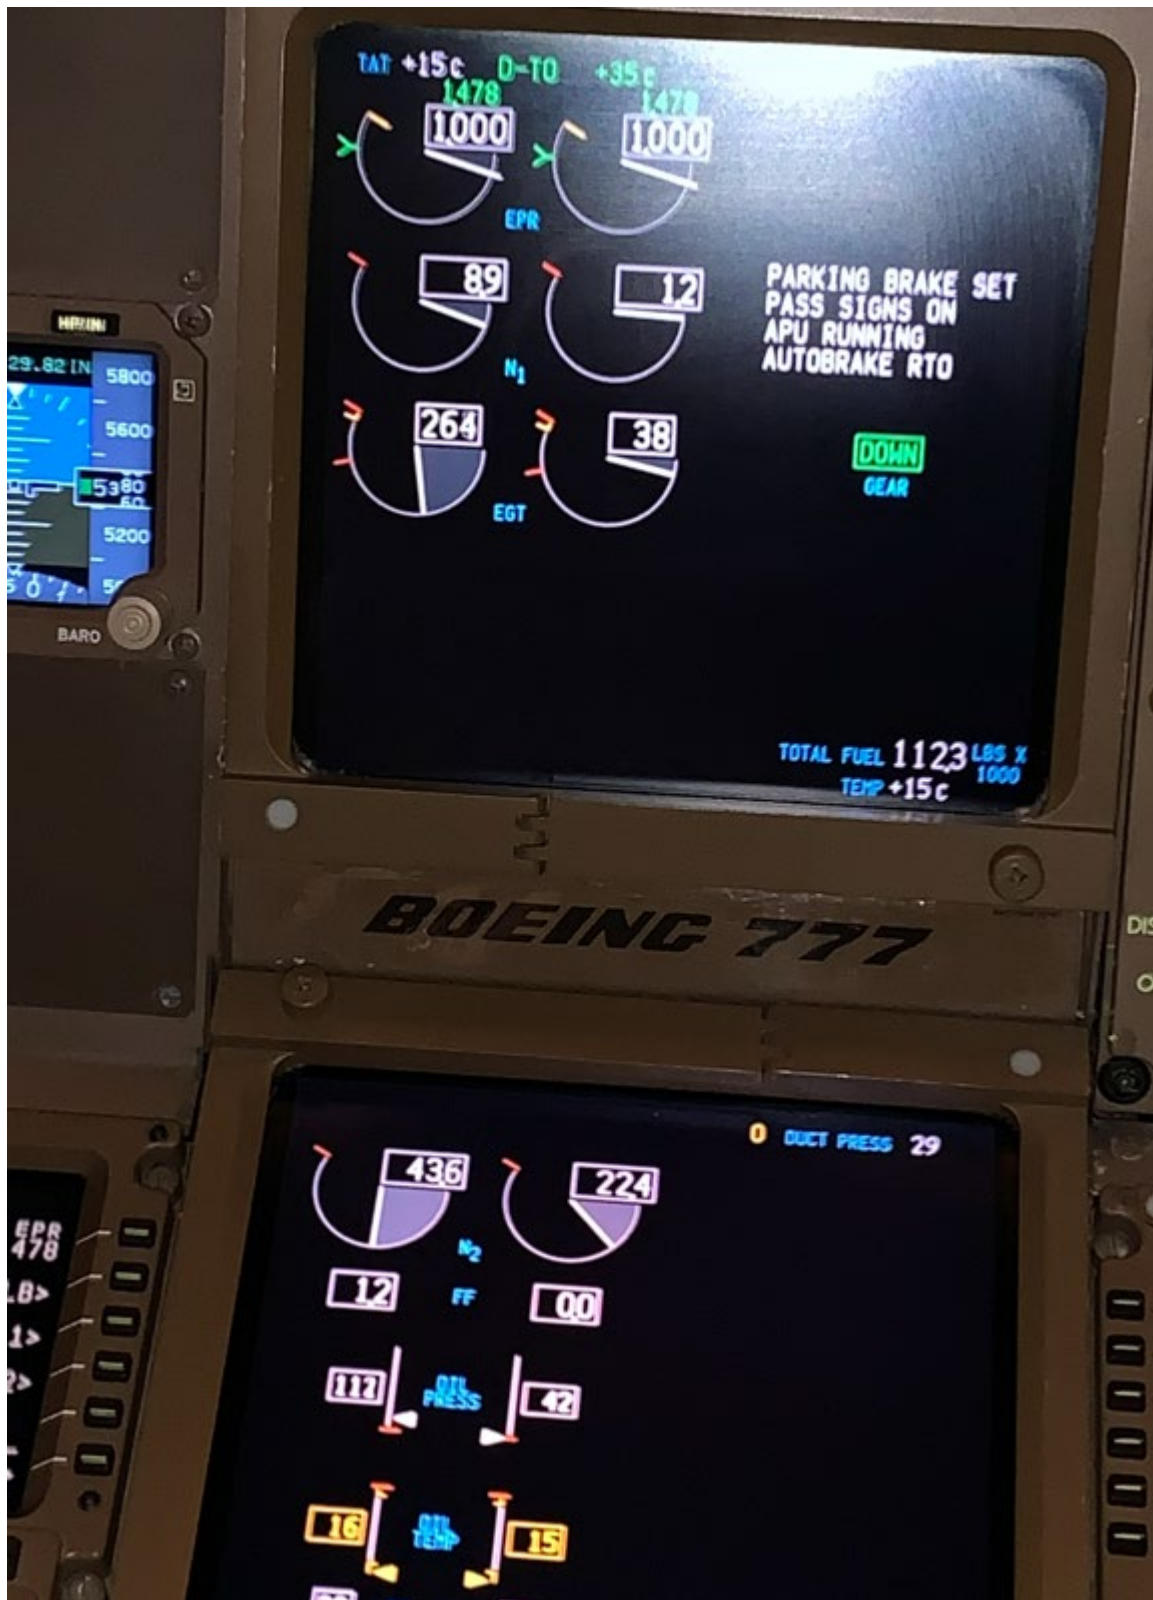
Photo #3 Engine indication of the right engine failing to start with Autostart. No EICAS messages

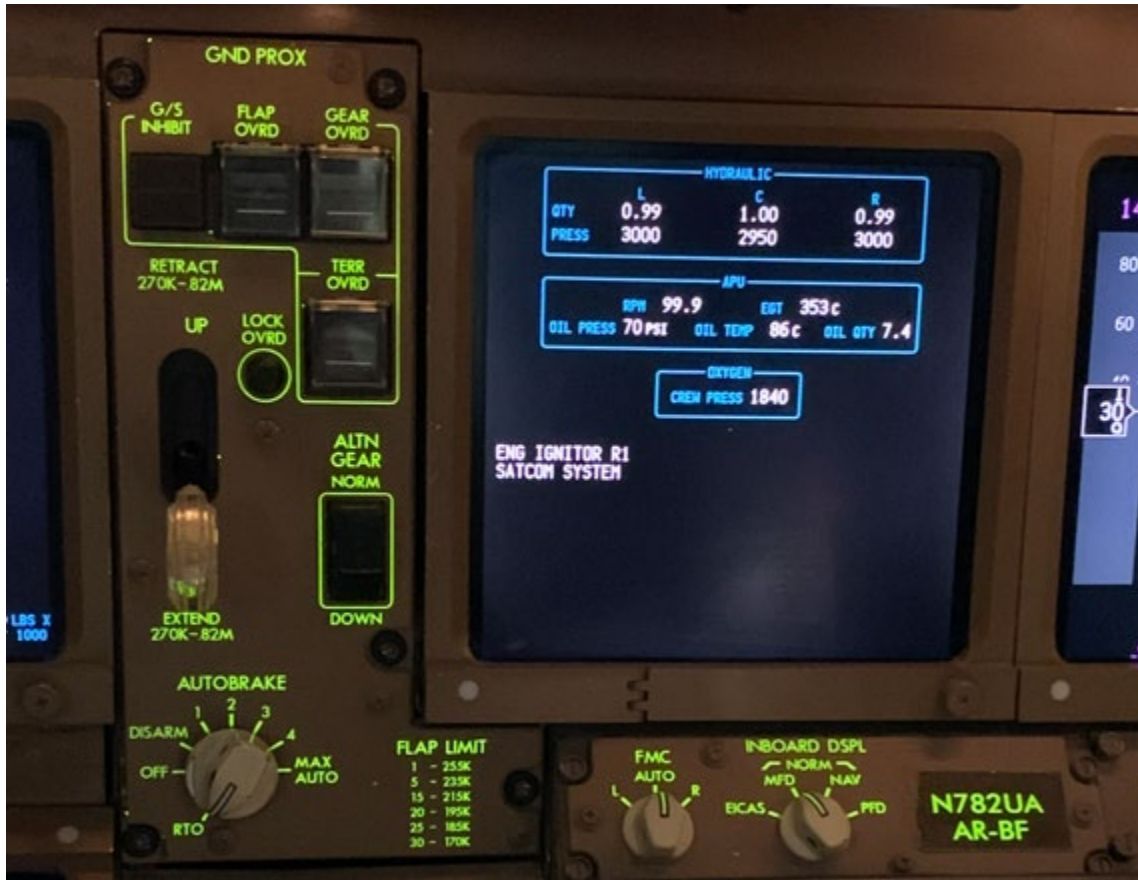
Photo #4; Status page showing a fault with the Right Engine #1 igniter.

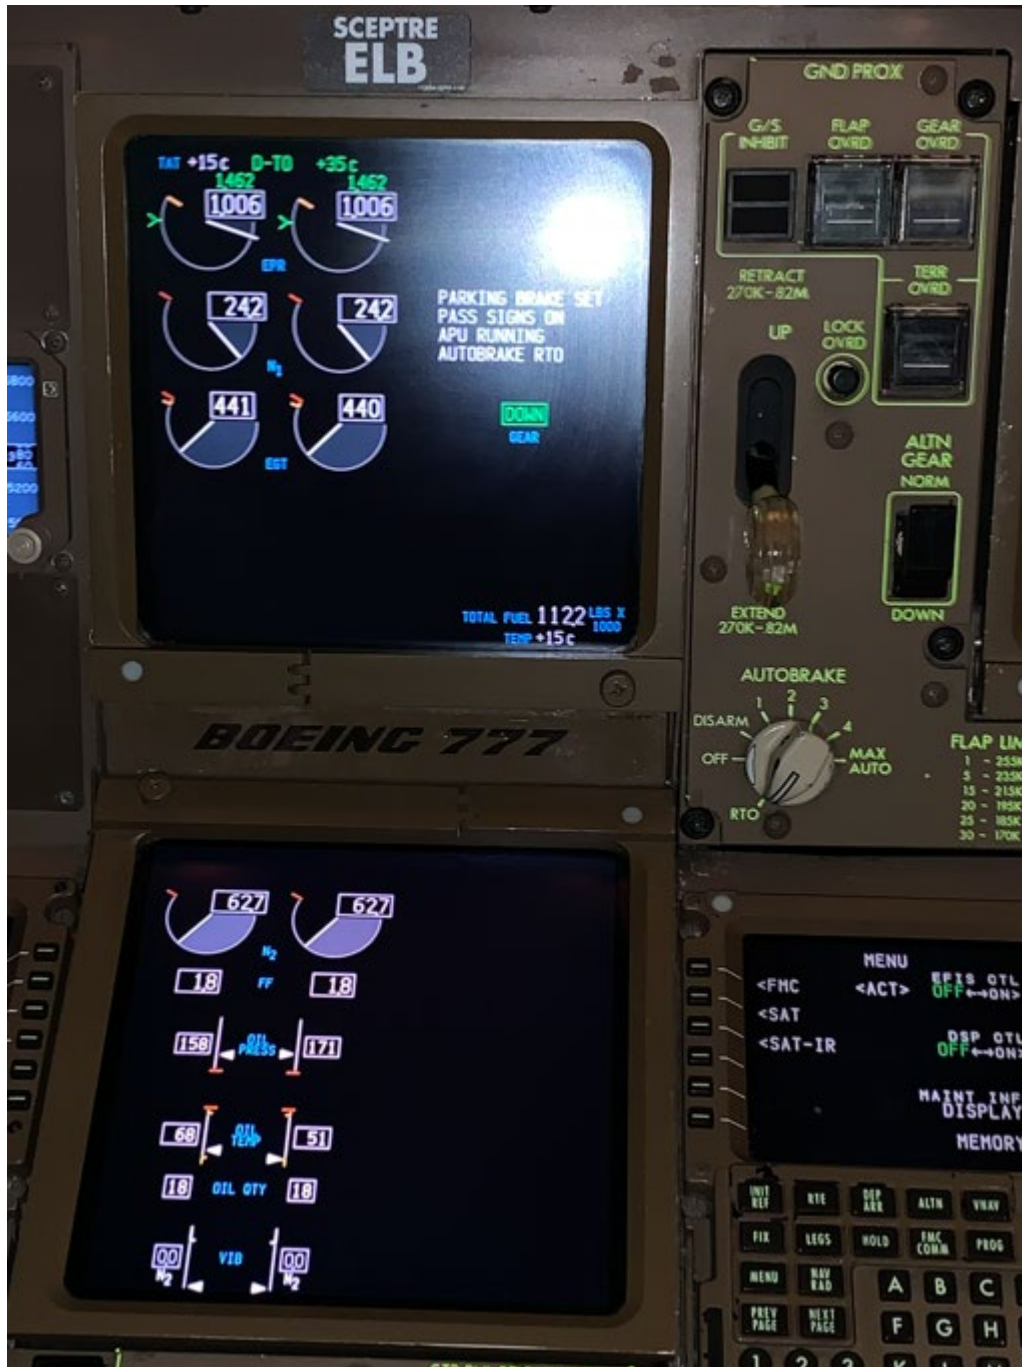
Photo #5: Subsequent start attempt and engine indications

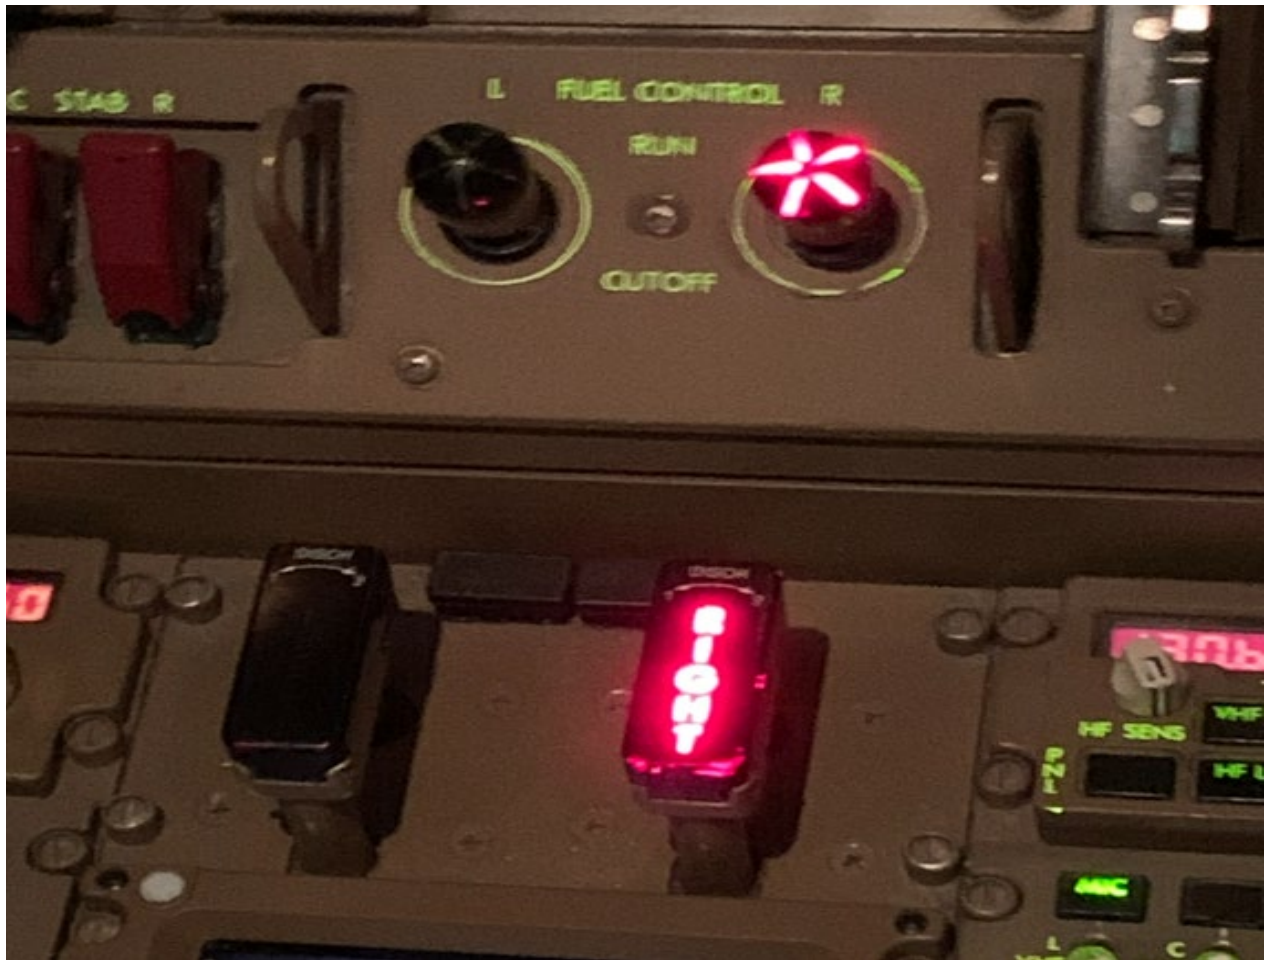
Photo # 6 Right Engine Fire indication

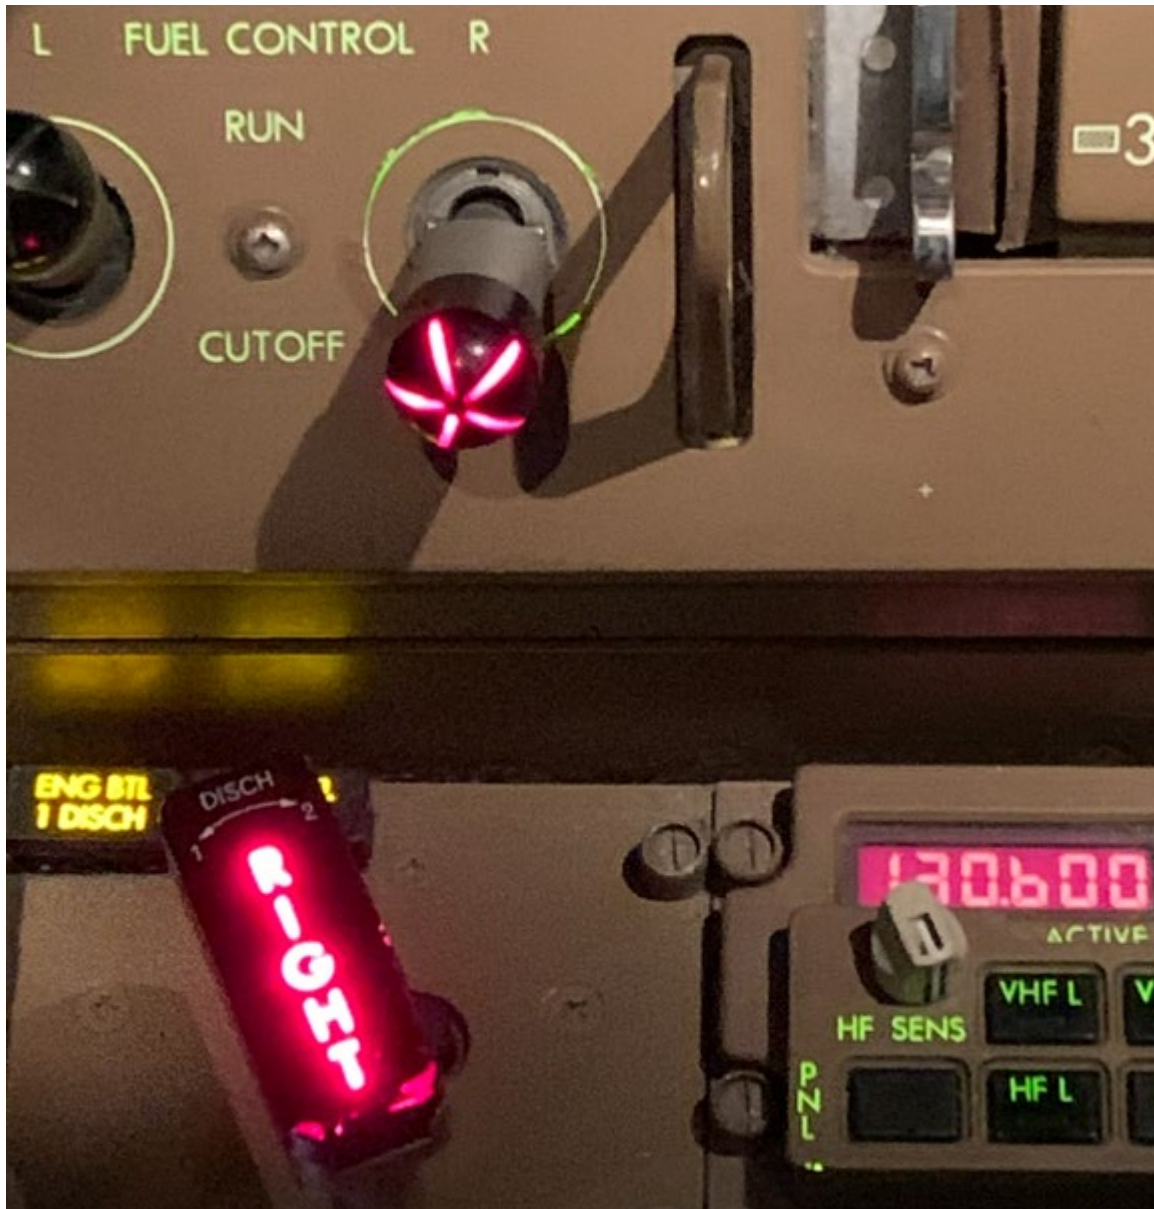
Photo # 7: Right engine fire with the R Fuel Controller shutoff and both fire bottles discharged.

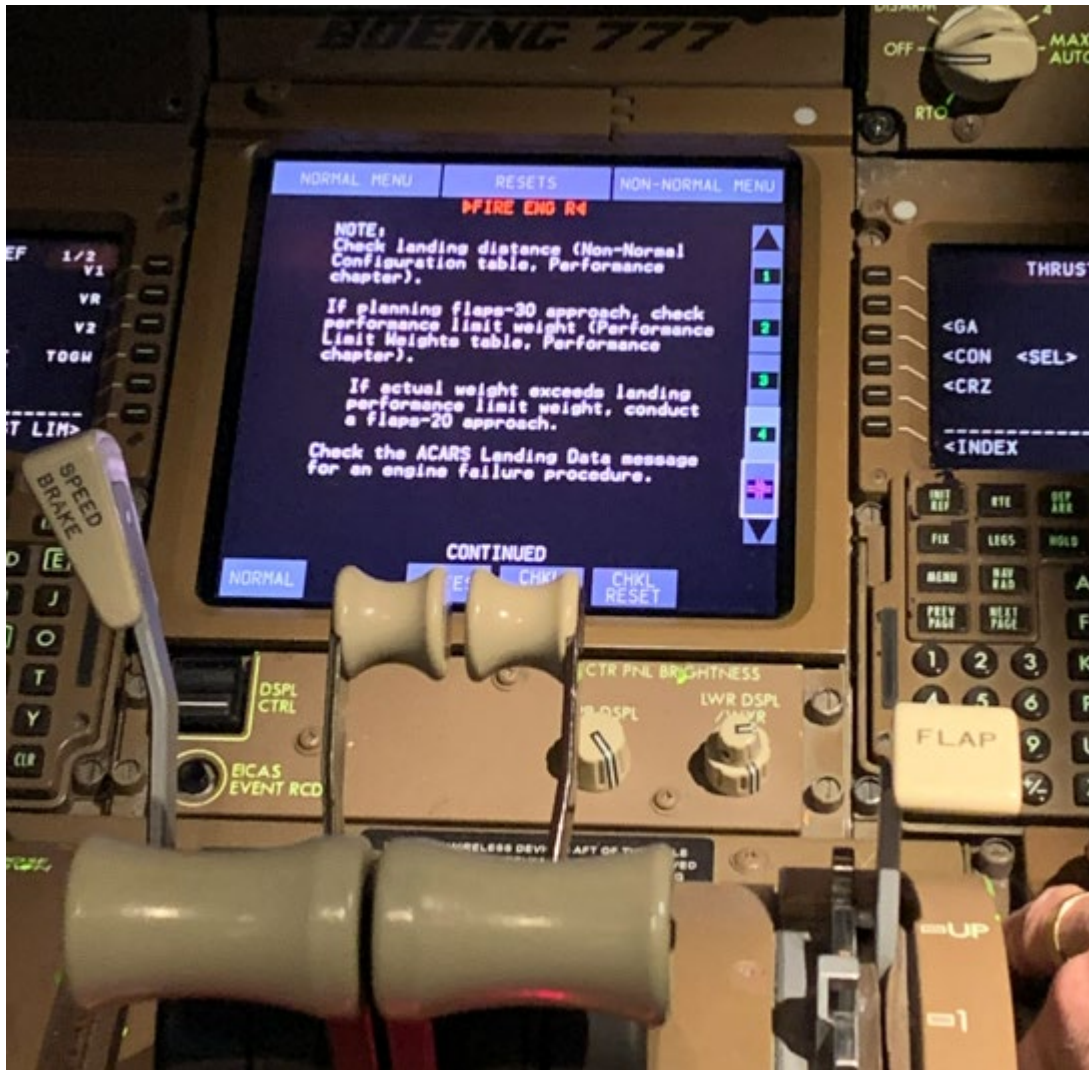
Photo # 8: Page 5 of 6 in the FIRE ENG R checklist.

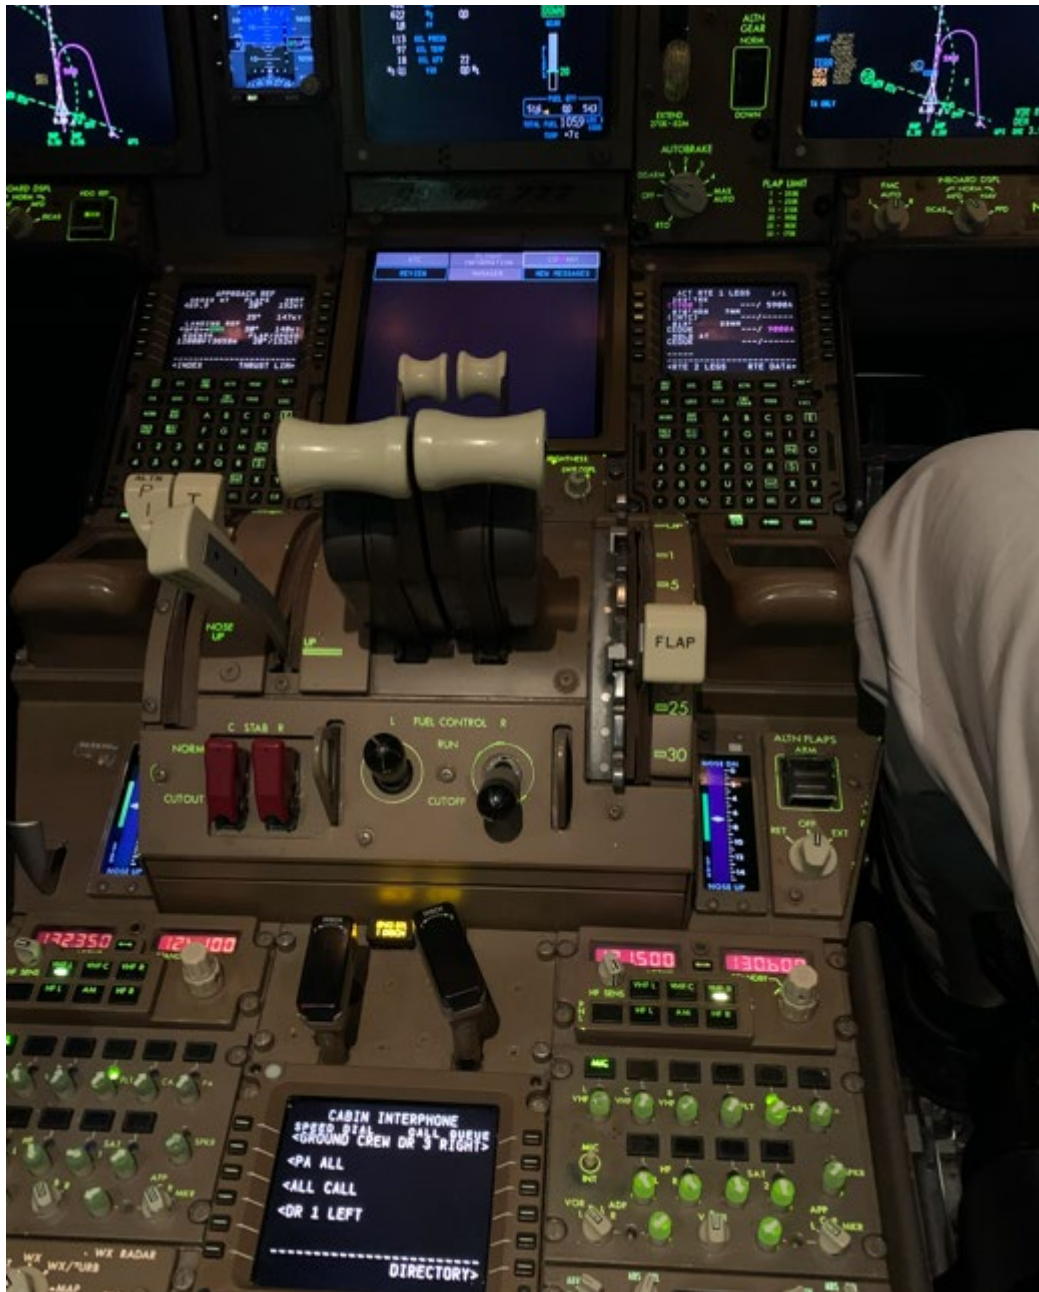
The FIRE ENG R EICAS message and associated Engine Fire indications all disappeared shortly before landing according to the crew interviews.¹⁰ However, the fire was still burning within the engine according to the Fire Chief who was attending to the emergency with the airplane on the ground.

Photo 9: Engine still on fire with no indication to the crew that the detection loops burned through.
