Investigation Report	Doc. No.: IR-E4-19-2021 Rev. No.: 0
	Engine Type: E4	Subject: Accident 40.NC055

Aircraft Registration: **N853L**
 Aircraft S/N: **40.NC055**
 Engine s/n: **E4-A-00588** having **~1337fh**
 Date: **06.06.2021**
 Time: **~10.20**

Aircraft Type: Diamond Aircraft DA 40 NG
 Serial No.: 40.NC055
 Flight hours: >1337 hours (acc. to information provided by operator)

Engine Serial Number: E4-A-00588
 EECU Serial Number: 2786
 EECU HW Revision: AD
 Design data: EECU Software VC33_1_06_24

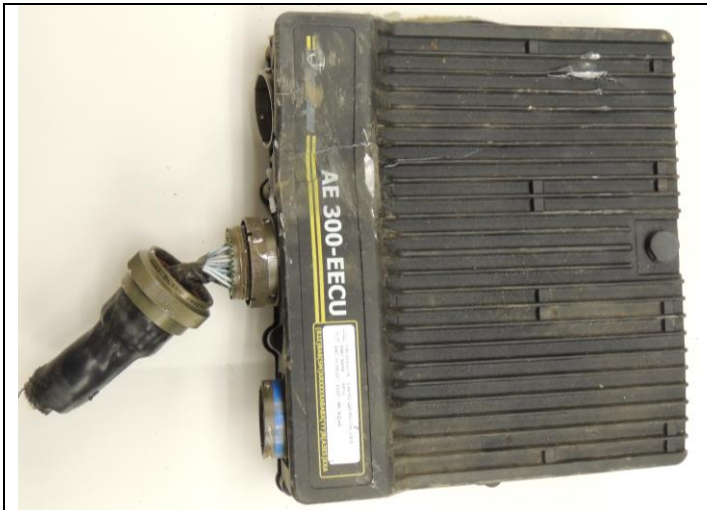
Figure 1 - EECU Upper side

Data from EECU A could not be obtained initially due to the damage caused by the accident.

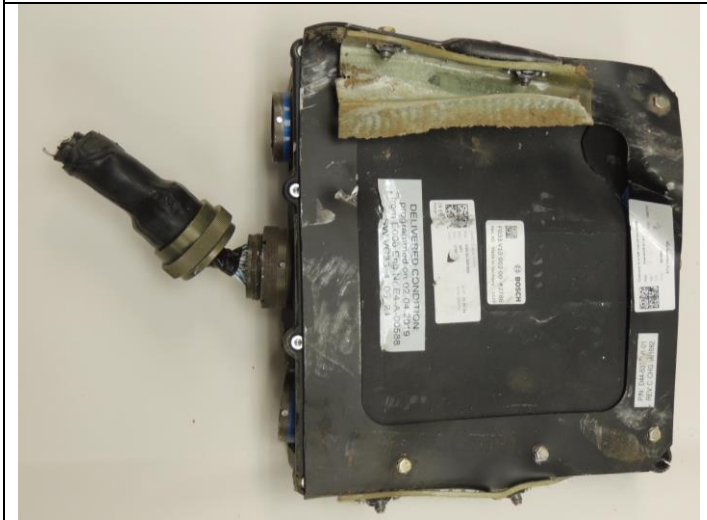
Figure 2 - EECU Bottom side

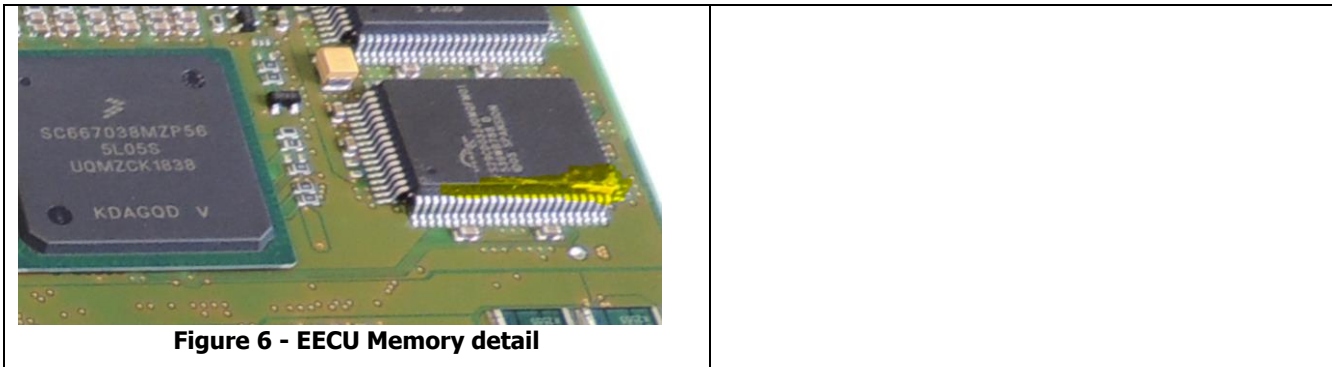
The memory chips of ECU A and ECU B were found in good condition, except for some superficial scratches (refer to Figure 6, yellow highlighted area). These chips will be transferred together to a substitute EECU for readout.

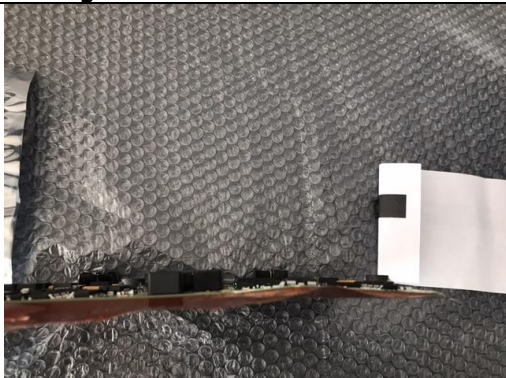
<p>Figure 12 – EECU MB Side view with bending</p>

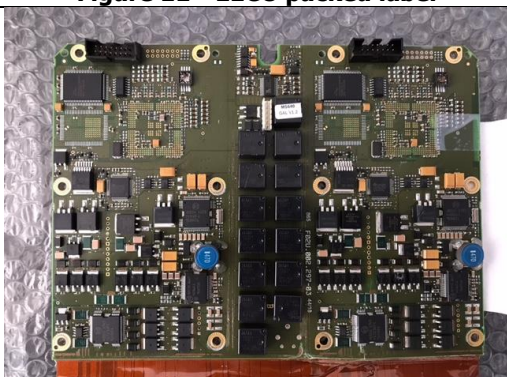
<p>Figure 13 - EECU MB upper Side</p>	<p>Based on the visual inspection, Austro Engine confirms that there is the possibility to recover the data. Mechanical damage had been detected on two sides of the mainboard so that the board is bent, but the location of flash memory and EEPROM do not seem to be affected.</p>

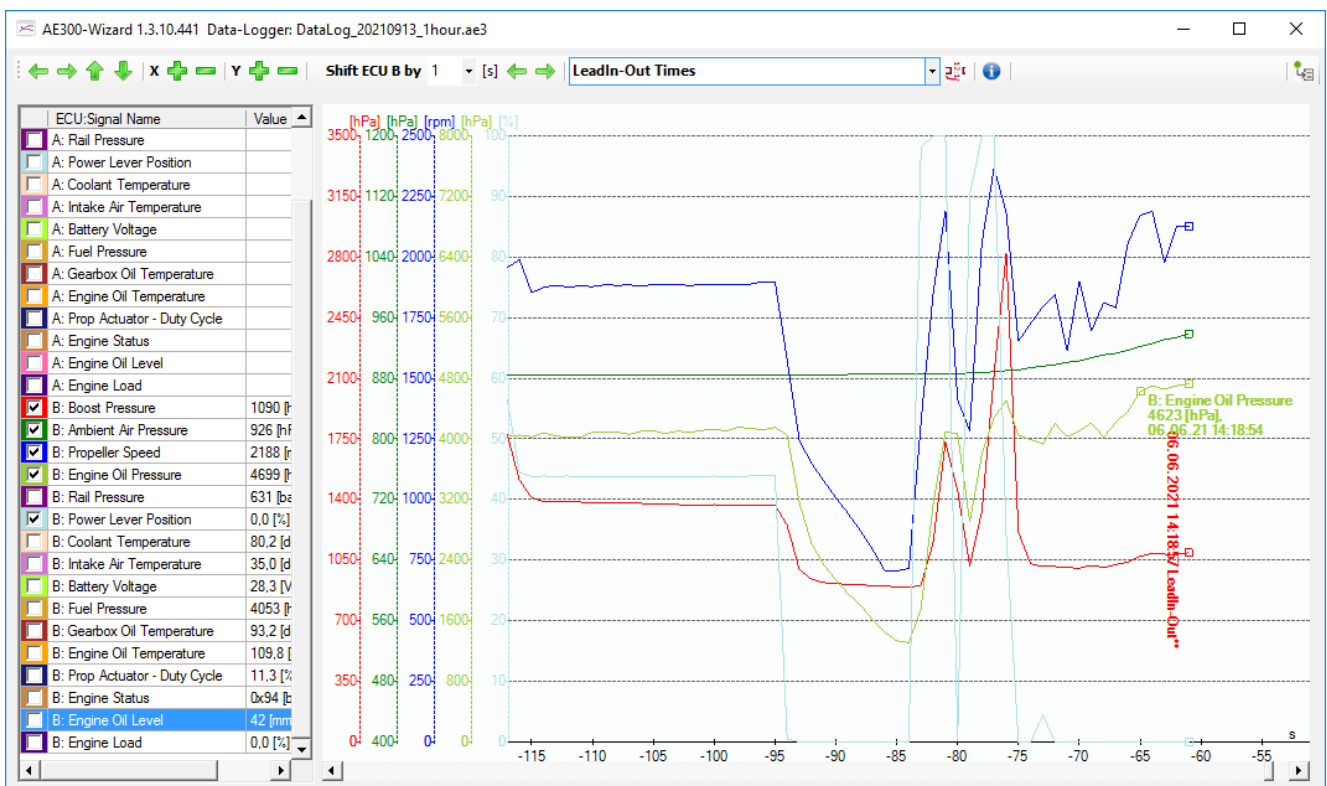
On ECU B, the latest data show that the engine was running properly. All parameters are in the normal range and correspond to the power request (light blue line, power lever position):

Figure 30 – ECU B Engine Operation Data before the event graph

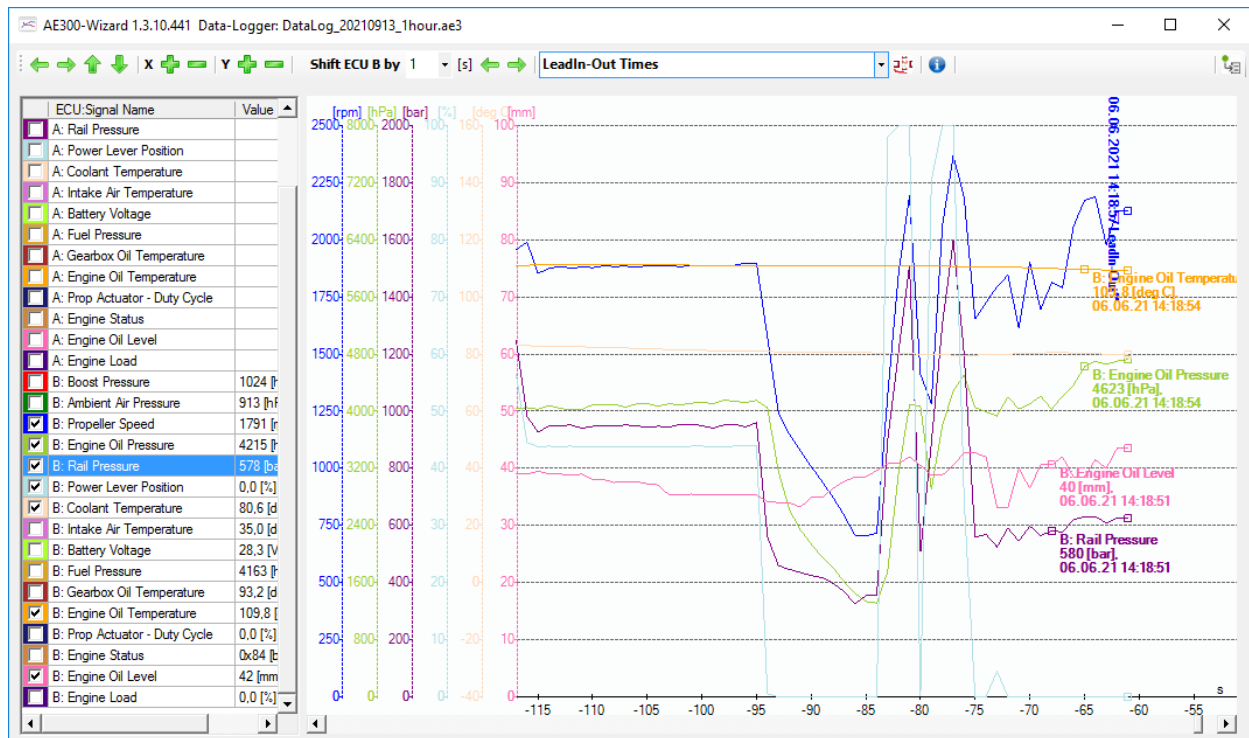
Figure 31 – ECU B Engine Operation Data before the event graph

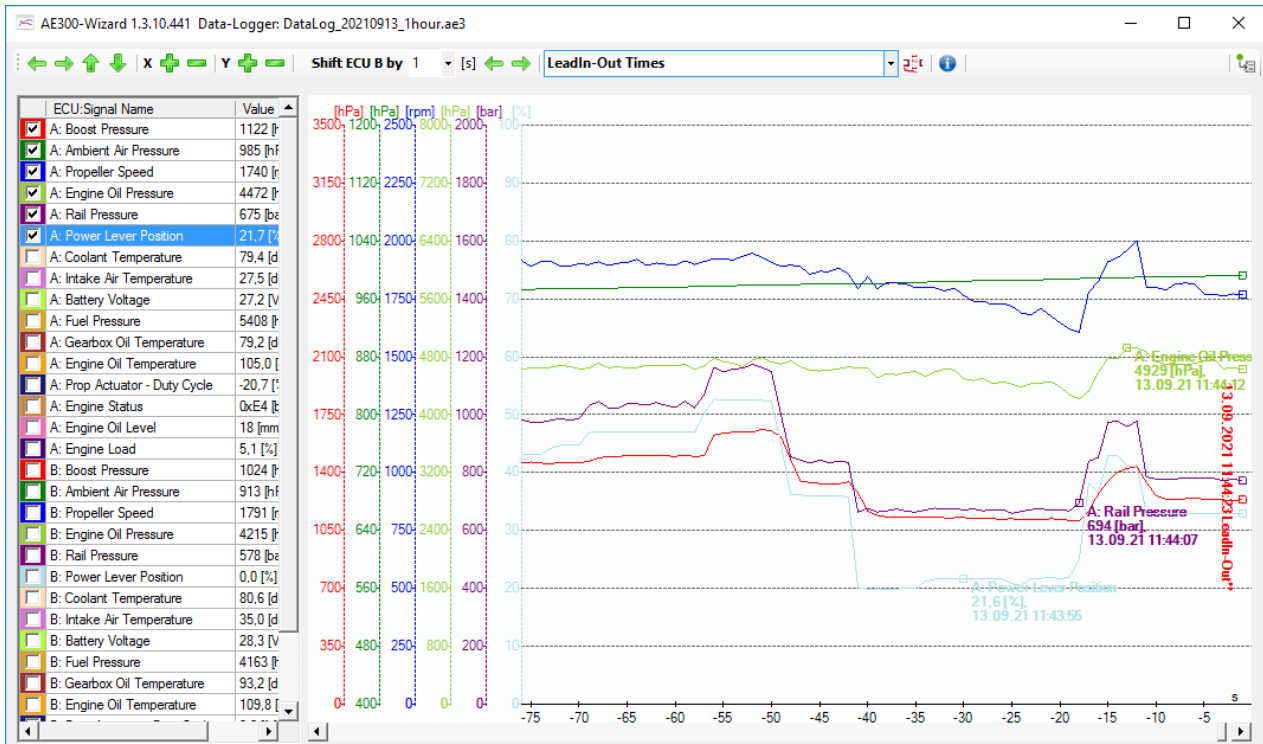
ECU A shows a completely different flight situation at the end of the recording. Even in this situation, all parameters have normal values.

Figure 32 – ECU A Engine Operation Data log graph
