INTERVIEW SUMMARY

Elliott Simpson
Aviation Accident Investigator
Western Pacific Region

Interview Date: November 7, 2019
Person Contacted: Patrick Garcia
NTSB Accident Number: WPR19MA177

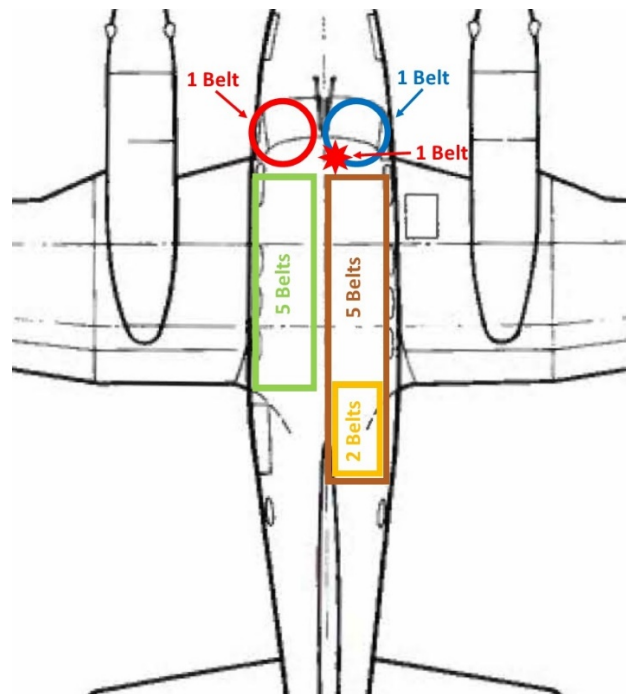
The front left seat (pilot seat), indicated in red, was equipped with a 4-point harness, composed of a latching lap buckle, and slat type shoulder harness.

The front right seat (copilot seat), indicated in blue, had been installed facing aft, and was equipped with a single latching lap buckle, of the same style as the pilot's seat, but without the shoulder harness. The

The left bench seat, indicated in green, extended from the rear of the pilot seat through to the forward end of the main cabin door, and was equipped with 5 buckling seatbelts mounted to the seat rails floor of the airframe, on the window side. One of the belts was longer than the others, and extended just short of the door so that it would not hang out of the door after the jumpers had exited.

The right bench seat, indicated in brown, extended from the back side of the pilot seat through to the aft end of the main cabin door, was equipped with 7 buckling seatbelts mounted to the seat rails on the floor of the airframe, on the window side. Two of the seven belts were located in the aft of the bench, indicated in yellow.

A 15th jumper belt was secured to an eyebolt on the copilot belt left seat rail (indicated by the red star). The eyebolt was also used as a seat rail restriction device, preventing the seat from moving beyond its travel limits. This seatbelt was used to secure jumpers who sat on the floor in the center wing spar section. He could not be sure if this belt was installed at the time of the accident, as OPC did not have enough jumper volume to require a 15th jumper, he believes 14 total occupancy was their capacity (1 pilot, 13 jumpers), but that they often did not achieve that load rate. A center-mounted "pedestal" seat was available for this 15th position, but it was not sent with the airplane to OPC.
