Qualification Inspection & Test

Reporting Mark and Car Number UTLX 209301 Shop Location UTCQ Marion, OH
 Stenciled Specification DOT117R100W Built Date (month / yr) 09/2007
 Car Jacketed Car Non-Jacketed Inspection Date (month / yr) 3/16
 Previous Commodity CRUDE OIL
 (If under corrosive listing, see UTC Bad Actor List)

**TCID
Report of Tank Car Inspection**

**R-1 PREPARATION REPORT
(ALTERATIONS AND CONVERSIONS)**

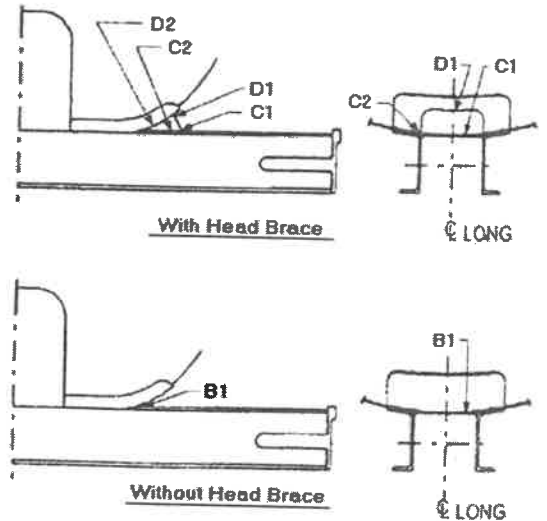
HEAD BRACE AND DRAFT SILL WELD INSPECTION							
Weld Code	Description	Location	Inspection Technique	Number of Cracks	Max Crack Length (0.00)	Crack Orientation Code	How Repaired
B1	Outboard transverse weld (top of sill flange). Full length of weld, inspect from top of sill.	A-End	NA				
		B-End	NA				
C1	Head brace to sill transverse weld. Full length of weld including portion which curves around corner of head brace.	A-End	VT	0			
		B-End	VT	0			
C2	Head brace to sill longitudinal weld. Full length of weld.	A-End Right	VT	0			
		A-End Left	VT	0			
		B-End Right	VT	0			
		B-End Left	VT	0			
D1	Head brace to pad transverse weld. Full length of weld including corners.	A-End	VT	0			
		B-End	VT	0			
D2	Head brace to pad longitudinal weld. Full length of weld.	A-End Right	VT	0			
		A-End Left	VT	0			
		B-End Right	VT	0			
		B-End Left	VT	0

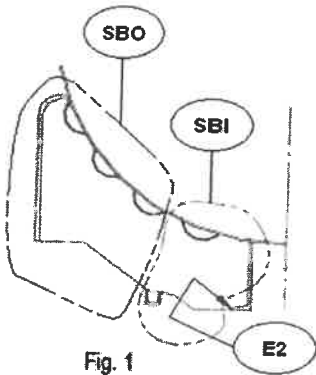
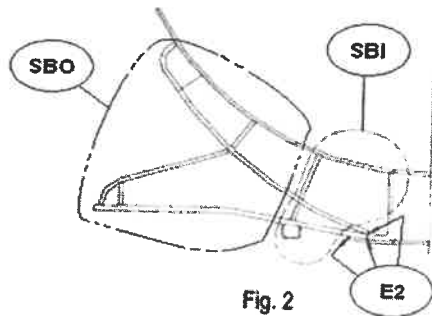
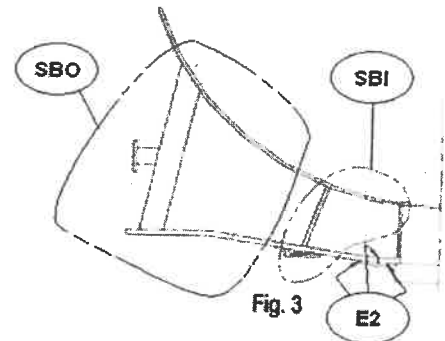
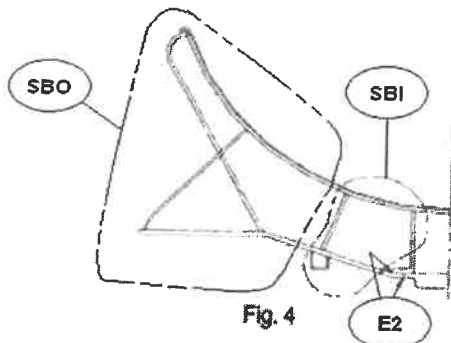
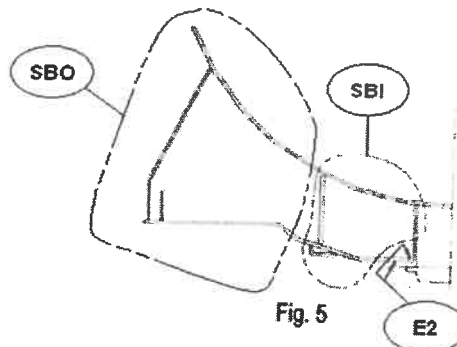
Typical Bolster Designs

Weld Code	Description	Location	Inspection Technique	Number of Cracks	Max Crack Length (0.00)	Crack Orientation Code	How Repaired
SBI	Bolster web, pad and stiffener welds from inboard of body side bearing. Full length of weld.	A-End Right	VT	0			
		A-End Left	VT	0			
		B-End Right	VT	0			
		B-End Left	VT	0			
SBO	Bolster web, pad and stiffener welds from outboard of body side bearing. Full length of weld.	A-End Right	VT	0			
		A-End Left	VT	0			
		B-End Right	VT	0			
		B-End Left	VT	0			
E2	Bolster bottom cover plate to sill flange longitudinal weld. Full length of weld.	A-End Right	VT	0			
		A-End Left	VT	0			
		B-End Right	VT	0			
		B-End Left	VT	0

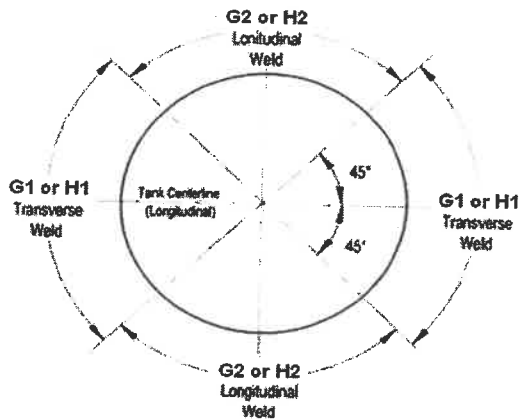
Typical Saddle and Sump Weld Detail

BOV SADDLE WELDS						
Weld Code	Description	Inspection Technique	Number of Cracks	Max Crack Length (0.00)	Crack Orientation Code	How Repaired
G1	Transverse portions of BOV saddle weld. Full length of transverse portions of welds.	VT	0			
		VT	0			
G2	Longitudinal portions of BOV saddle weld. Full length of longitudinal portions of welds.	VT	0			
		VT	0

SUMP WELDS						
Weld Code	Description	Inspection Technique	Number of Cracks	Max Crack Length (0.00)	Crack Orientation Code	How Repaired
H1	Transverse portions of sump weld. Full length of transverse portions of welds.	VT	0			
		VT	0			
H2	Longitudinal portions of sump weld. Full length of longitudinal portions of welds.	VT	0			
		VT	0

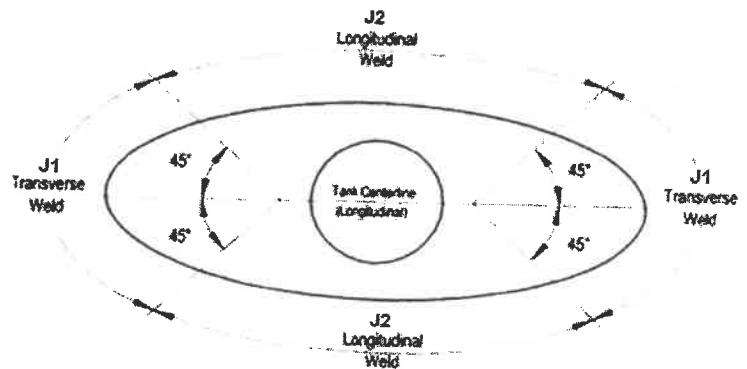
Skid Weld Detail

BOV SKID WELDS						
Weld Code	Description	Inspection Technique	Number of Cracks	Max Crack Length (0.00)	Crack Orientation Code	How Repaired
J1	Transverse portions of BOV skid weld. Full length of transverse welds.	VT	0			
		VT	0			
J2	Termination of BOV skid longitudinal welds.	VT	0			
		VT	0

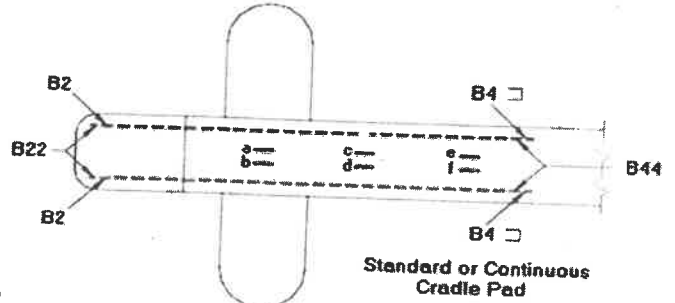
Weld Code	Description	Location	Inspection Technique	Number of Cracks	Max Crack Length (0.00)	Crack Orientation Code	How Repaired
B2	Outboard termination of longitudinal weld (outside of sill). Last 6" of weld.	A-End Right	VT	0			
		A-End Left	VT	0			
		B-End Right	VT	0			
		B-End Left	VT	0			
B4	Inboard termination of longitudinal weld (outside of sill). Last 6" of weld including any portion of weld that wraps around sill and connects with B44.	A-End Right	VT	0			
		A-End Left	VT	0			
		B-End Right	VT	0			
		B-End Left	VT	0			
B22	Outboard termination of longitudinal weld (inside of sill). Last 6" of weld.	A-End Right	VT	0			
		A-End Left	VT	0			
		B-End Right	VT	0			
		B-End Left	VT	0			
B44	Inboard termination of longitudinal weld (inside of sill). Last 6" of weld.	A-End Right	VT	0			
		A-End Left	VT	0			
		B-End Right	VT	0			
		B-End Left	VT	0
