**Bridge Factors Factual Report Attachment 21 – BPA Cracks Report No. 1 - Email from
Mr. Jose Morales of BPA to Mr. Rodrigo Isaza of MCM dated February 13, 2018**

HWY18MH009

**FIU Pedestrian Bridge / BT-904
Crack Inspection Report**

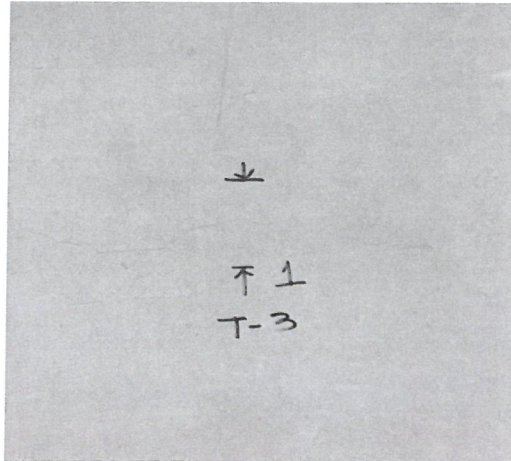
1. Crack T3-1

Location: Truss member No.3, approximately 70 inches measured from the bottom of the member, extended around the cross section.

Classification: Crack type A (<0.007 inches).

Measured: 0.04 inches.

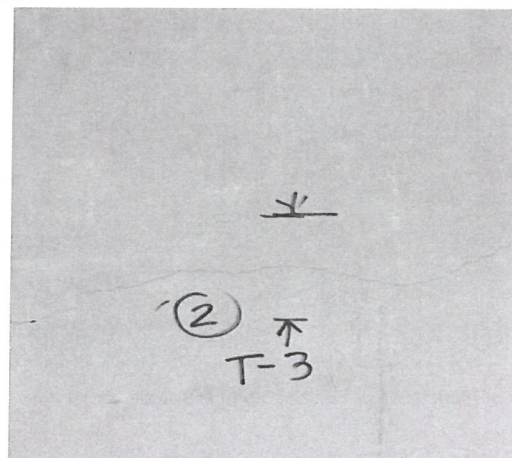
2. Crack T3-2

Location: Truss member No.3, approximately 77 inches measured from the bottom of the member, extended around the cross section.

Classification: Crack type A (<0.007 inches).

Measured: 0.04/006 inches.

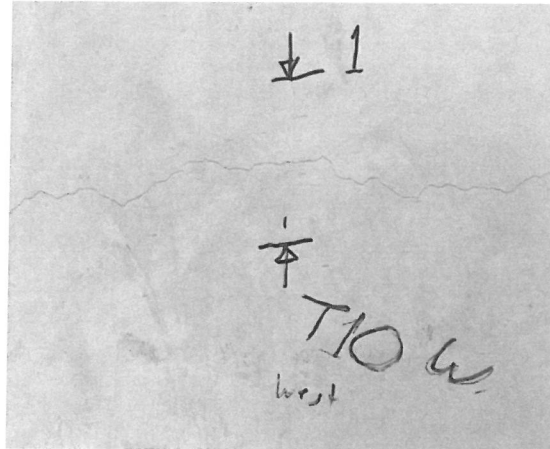
3. Crack T10-1

Location: Truss member No.10, approximately 119 inches measured from the bottom of the member, extended around the cross section.

Classification: Crack type A (<0.007 inches).

Measured: 0.04 inches.

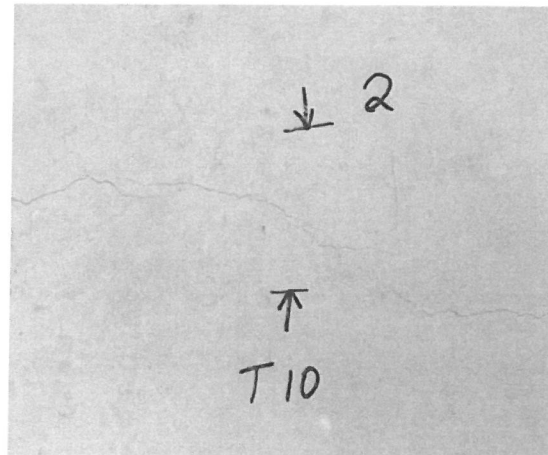
4. Crack T10-2

Location: Truss member No.10, approximately 126 inches measured from the bottom of the member, extended around the cross section.

Classification: Crack type A (<0.007 inches).

Measured: 0.04 inches.

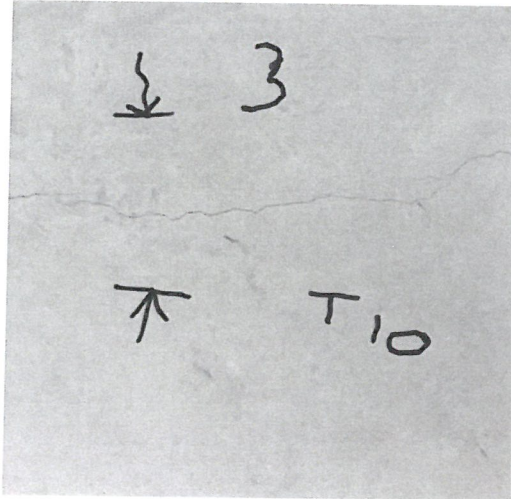
5. Crack T10-3

Location: Truss member No.10, approximately 150 inches measured from the bottom of the member, extended around the cross section.

Classification: Crack type A (<0.007 inches).

Measured: 0.04 inches.

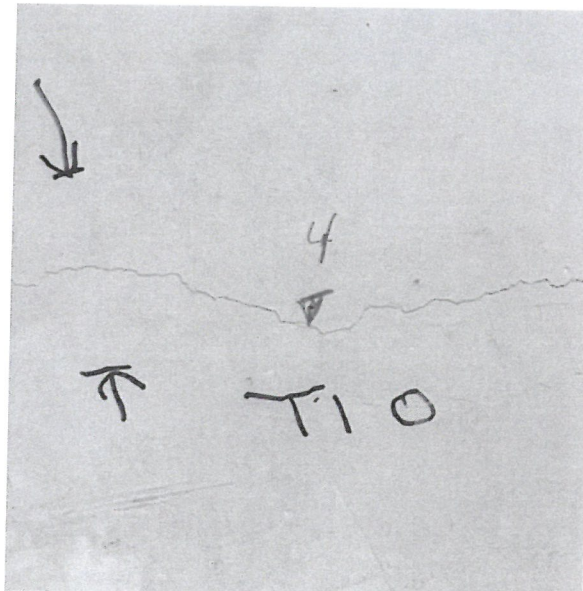
6. Crack T10-4

Location: Truss member No.10, approximately 168 inches measured from the bottom of the member, extended around the cross section.

Classification: Crack type A (<0.007 inches).

Measured: 0.04 inches.
