TANK CORROSION INSPECTION REPORT

Car Reporting Mark and Number UTLX 209301 Location Forth Worth, TX (FRA & NTSB)

UNION TANK CAR COMPANY
TANK CAR UTT REPORT

STANDARD ULTRASONIC THICKNESS PATTERN

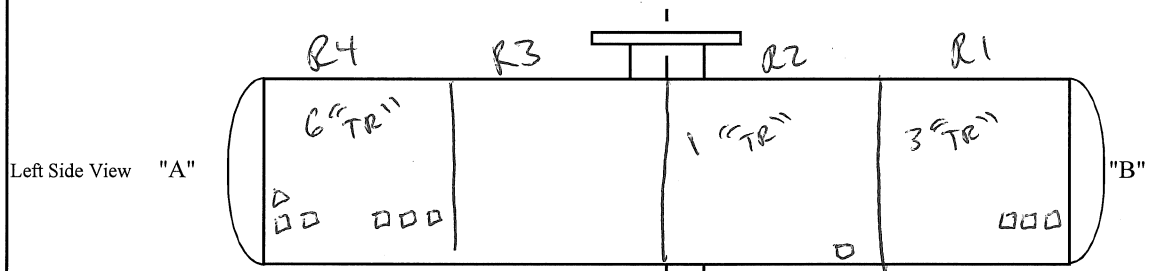
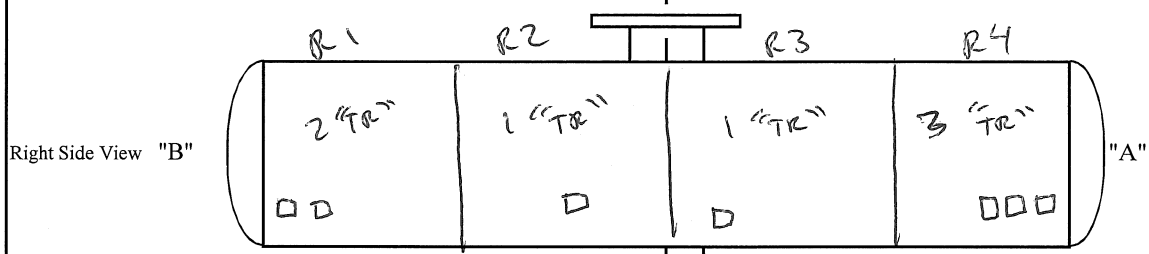
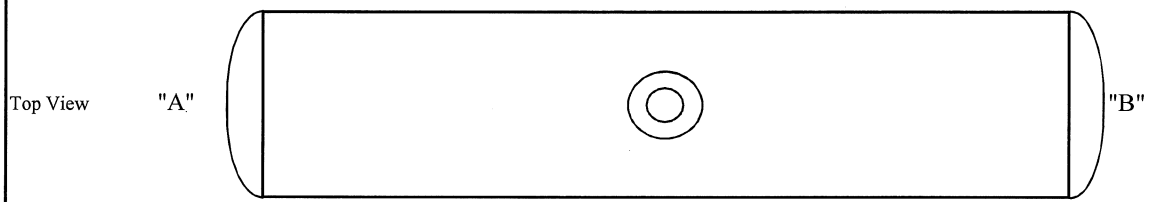
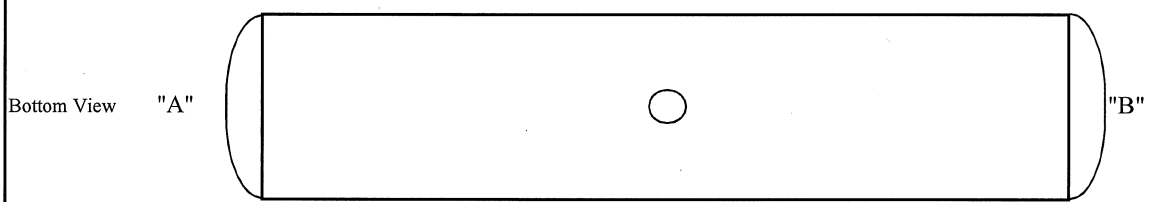
General Corrosion from 4-5 & 7-8 o'clock positions
from head to head. Spot checks made with
UTT after grinding

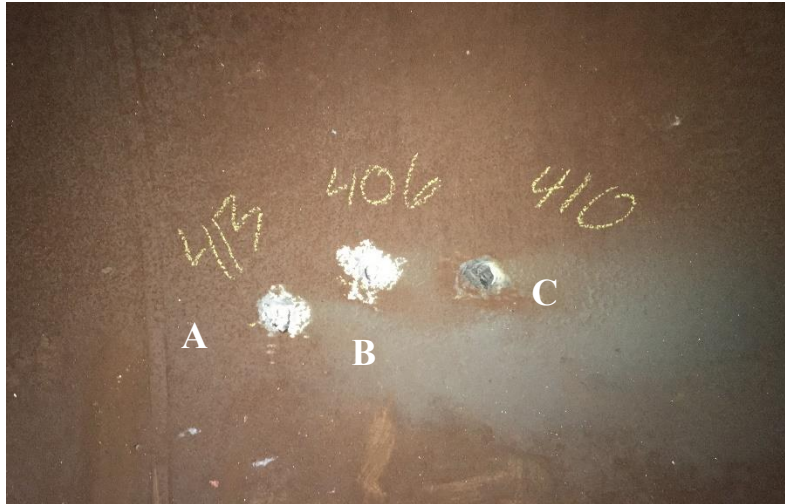
Figure 1. Ring 1 left side UTLX 209301

Location from A-side Seam 1	UT (inches)
A	7"; 29" above BCL	0.413
B	12"; 32" above BCL	0.406
C	18"; 30" above BCL	0.410

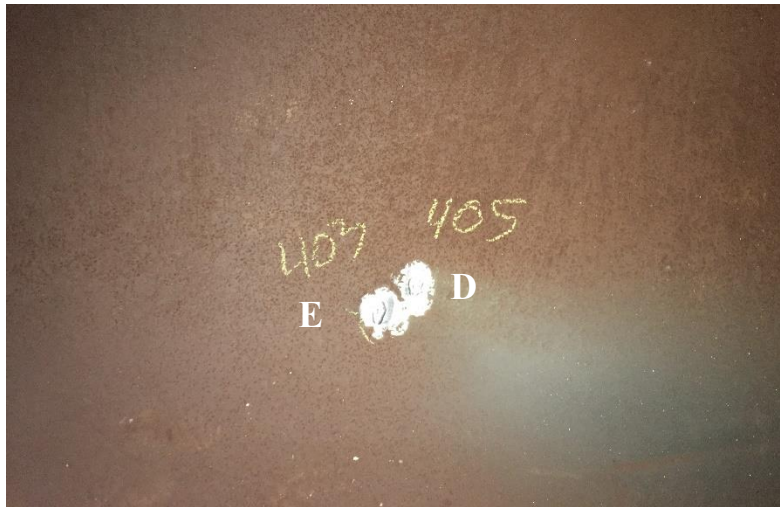
Figure 2. Ring 1 right side UTLX 209301

Location from A-side Seam 1	UT (inches)
D	28"; 41" above BCL	0.405
E	30"; 39" above BCL	0.403

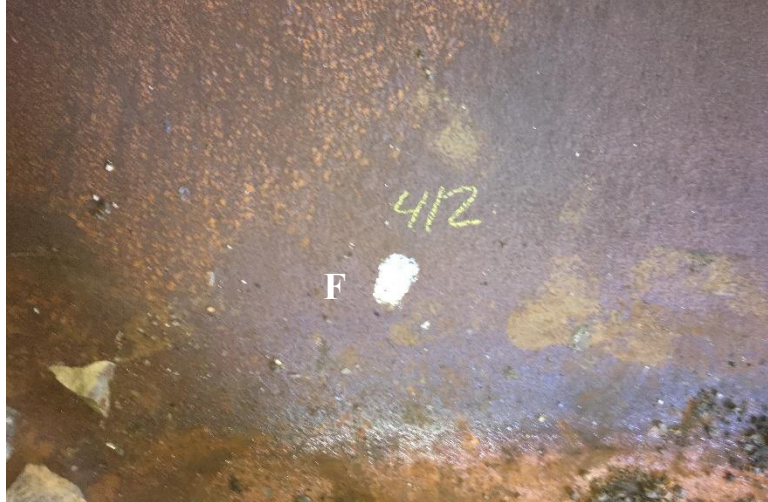
Figure 3. Ring 2 left side UTLX 209301

Location from A-side Seam 2	UT (inches)
F	28"; 16" above BCL	0.412

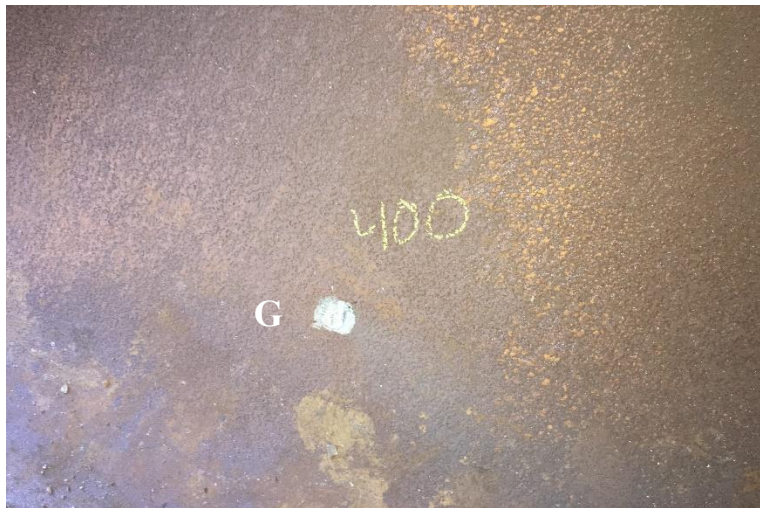
Figure 4. Ring 2, right side UTLX 209301

Location from A-side Seam 2	UT (inches)
G	41"; 30" above BCL	0.400

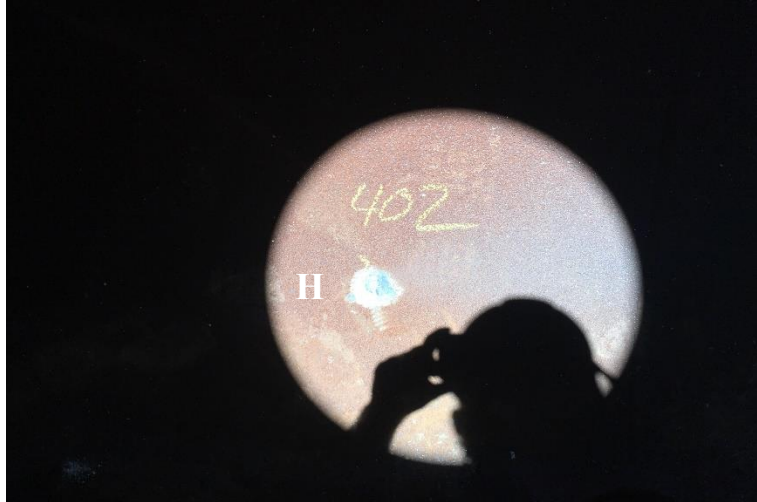
Figure 5. Ring 3, right side UTLX 209301

Location from A-side Seam 3	UT (inches)
H	15"; 15" above BCL	0.402

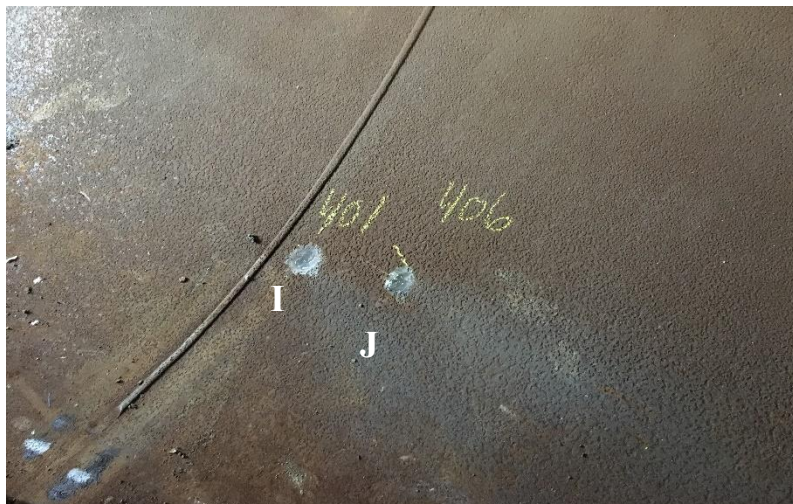
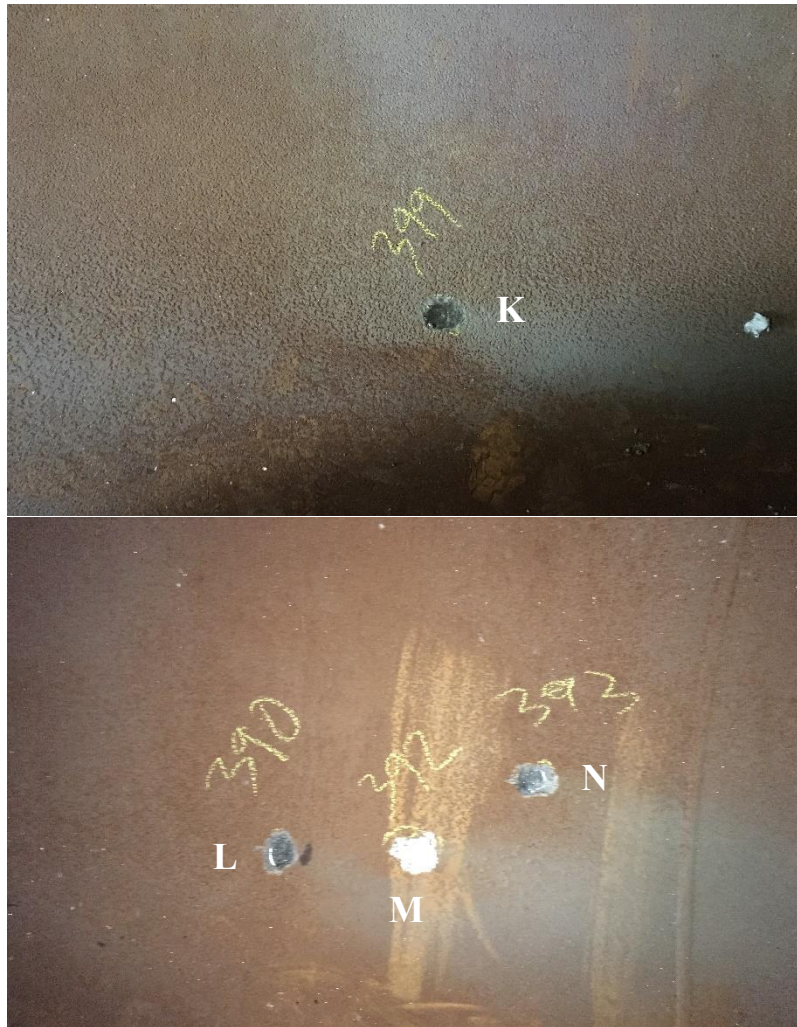
Figure 6, 7 & 8. Ring 4, left side UTLX 209301

Location from A-side Seam 4	UT (inches)
I	3"; 23" above BCL	0.401
J	11"; 25" above BCL	0.406
K	57"; 27" above BCL	0.399
L	24"; 37" above BCL (ref. from B-side Seam 5)	0.390
M	16"; 38" above BCL (ref. from B-side Seam 5)	0.392
N	9"; 45" above BCL (ref. from B-side Seam 5)	0.393

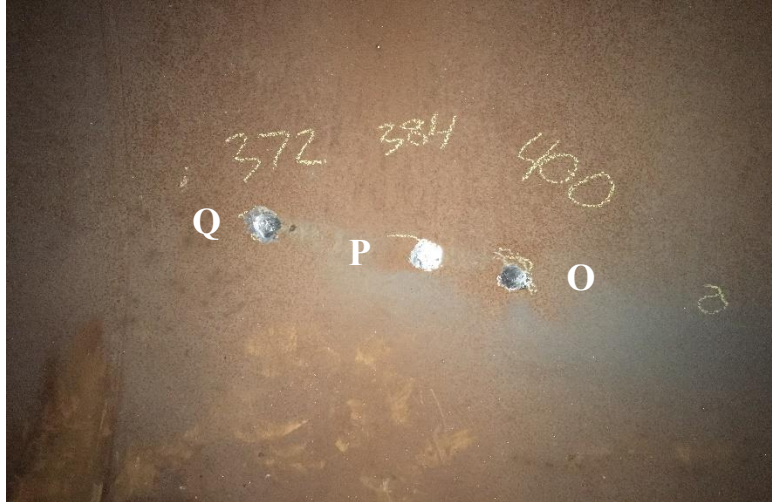
Figure 9. Ring 4, right side UTLX 209301

Location from B-side Seam 5	UT (inches)
O	27"; 32" above BCL	0.400
P	21"; 34" above BCL	0.384
Q	10"; 37" above BCL	0.372

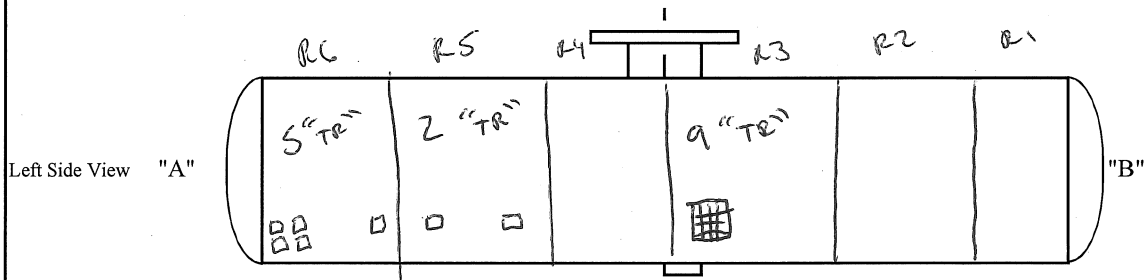
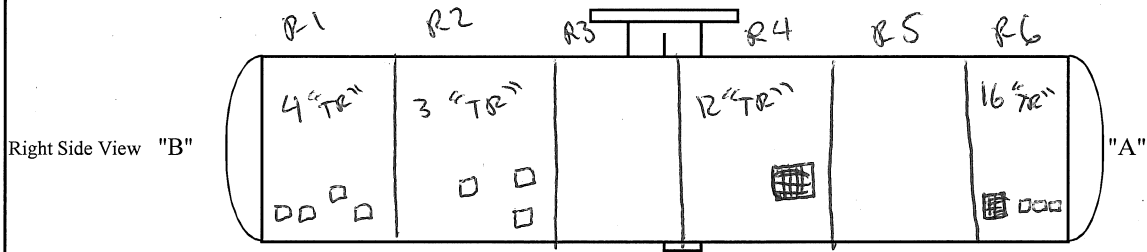
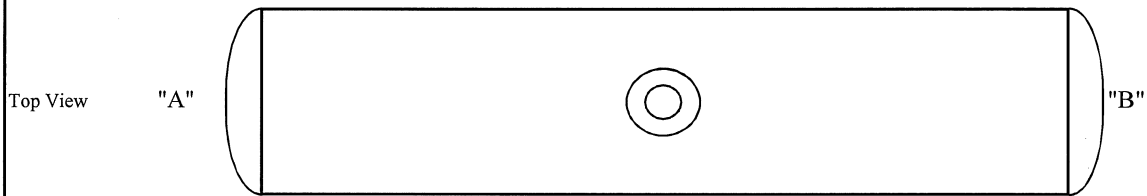
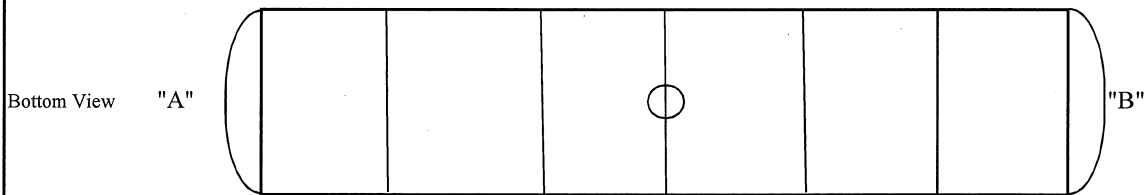
General corrosion from 4-5 & 7-8 o'clock positions
from head to head. Spot checks made with
UTT after grinding.

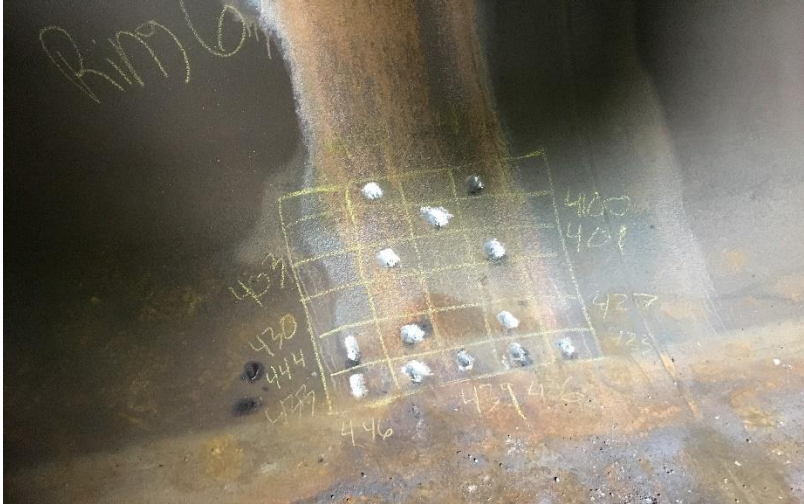
Figure 1. Ring 6, right side UTLX 209403

1. Ring 6, right side. Grid pattern 26” Longitudinal, 24” transverse. The lowest end was 24” above bottom center line, the right side was 8” toward A-end from Seam 6.

0.415		0.411	
		0.400		
	0.403		0.401	
0.444	0.430		0.427	
0.446	0.433	0.439	0.436	0.433

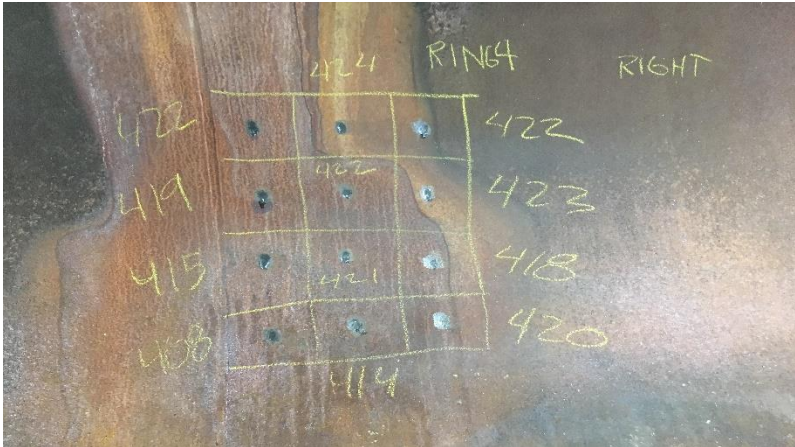
Figure 2. Ring 4, right side UTLX 209403

2. Ring 4, right side. Grid pattern 24” longitudinal, 32” transverse. The lowest end was 26” above bottom center line, the left side bordered Seam 5.

0.422	0.424	0.422
0.419	0.422	0.423
0.415	0.421	0.418
0.408	0.414	0.420

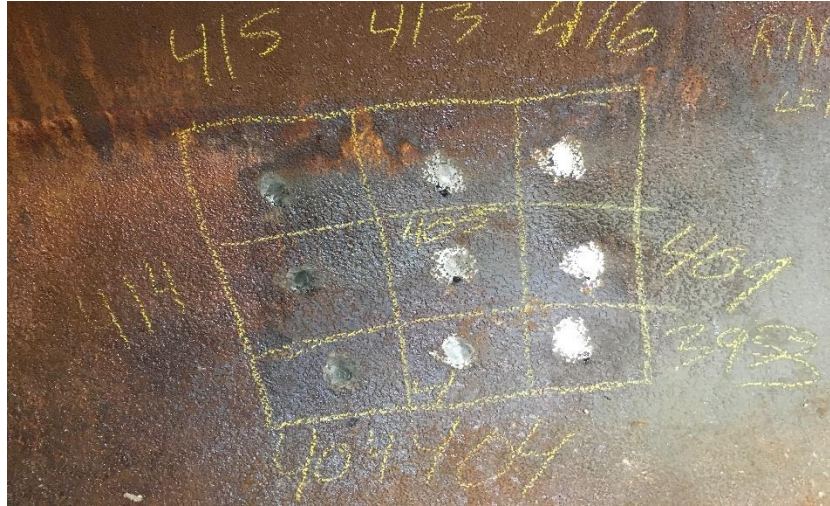
Figure 3. Ring 3, left side UTLX 209403

3. Ring 3, left side. Grid pattern 24” longitudinal, 28” transverse. The lowest end was 30” above bottom center line, the right side was 31” toward the B-end from Seam 4.

0.415	0.413	0.416
0.414	0.405	0.409
0.404	0.404	0.393

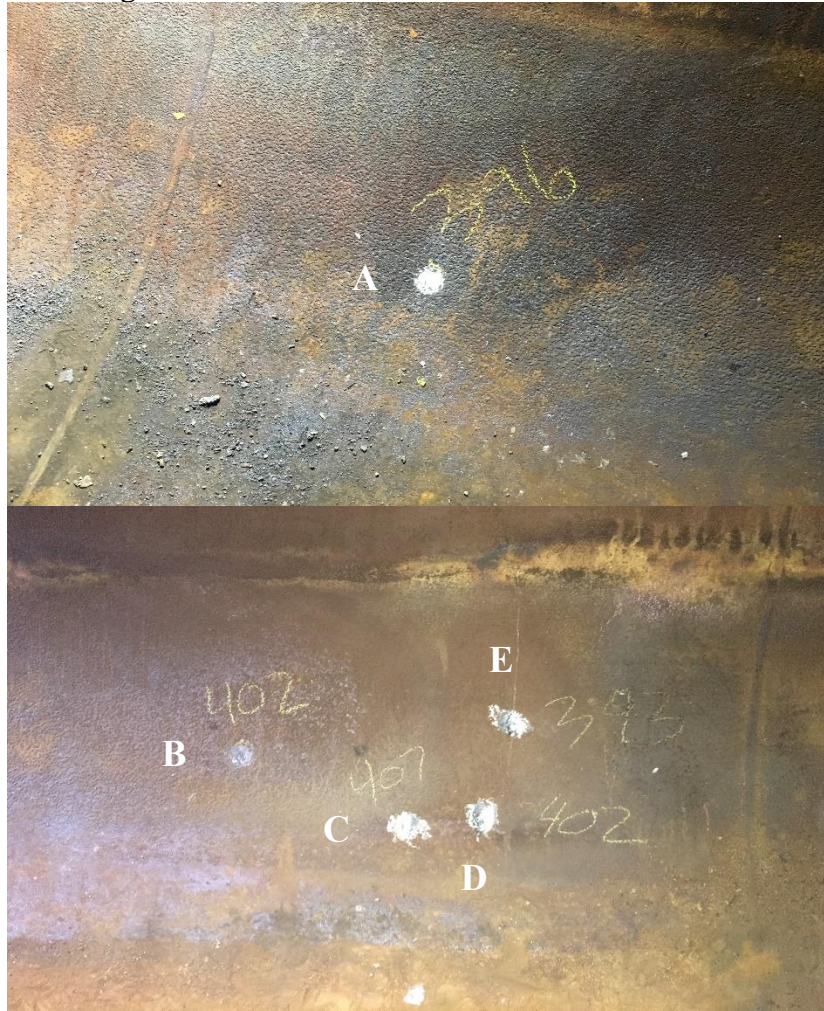
Figure 4 & 5. Ring 6, left side UTLX 209403

Location from A-side Seam 6	UT (inches)
A	18"; 24" above BCL	0.396
B	58"; 42" above BCL	0.402
C	72"; 33" above BCL	0.407
D	78"; 33" above BCL	0.402
E	80"; 44" above BCL	0.393

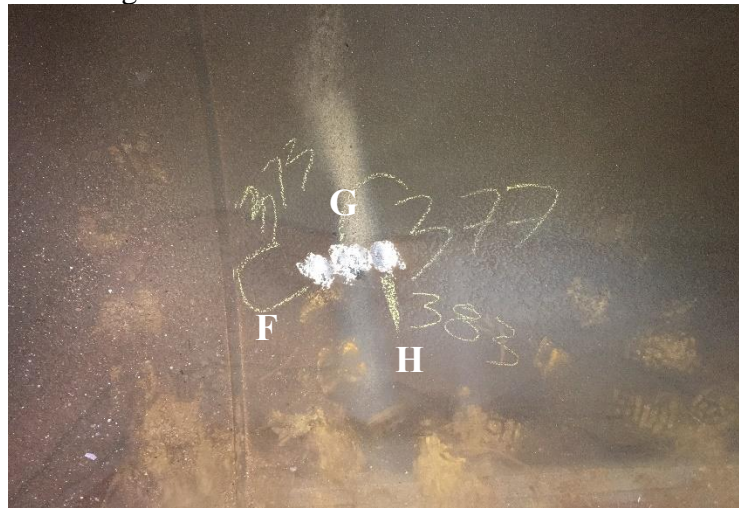
Figure 6. Ring 6, right side UTLX 209403

Location from B-side Seam 7	UT (inches)
F	7"; 34" above BCL	0.373
G	10"; 34" above BCL	0.377
H	12"; 34" above BCL	0.383

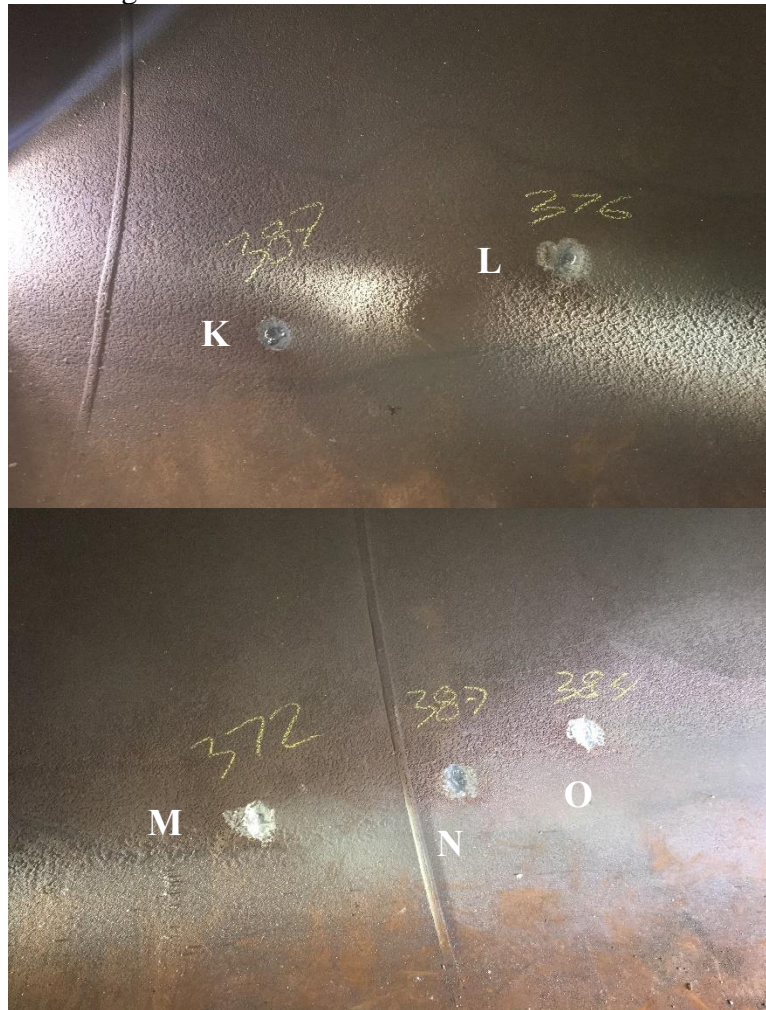
Figure 7 & 8. Ring 2, right side UTLX 209403

Location from B-side Seam 3	UT (inches)
K	13"; 22" above BCL	0.387
L	33"; 27" above BCL	0.376
M	13"; 26" above BCL (ref. from A-side Seam 2)	0.372

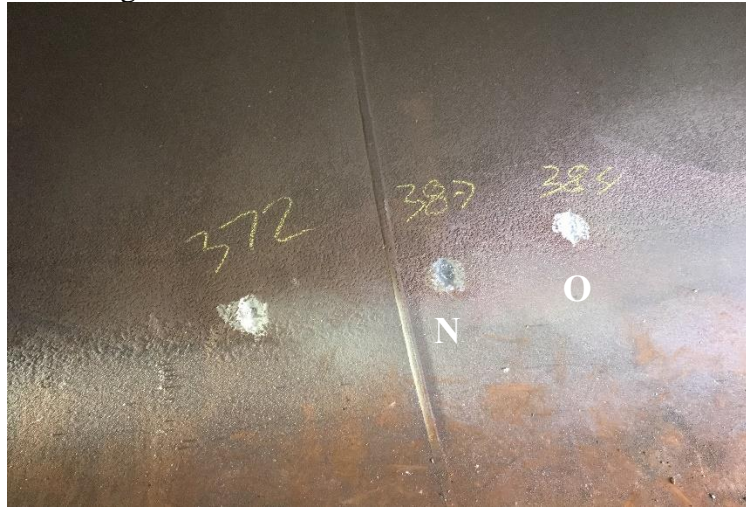
Figure 8. Ring 1, right side UTLX 209403

Location from B-side Seam 2	UT (inches)
N	4"; 28" above BCL	0.387
O	17"; 31" above BCL	0.384
P	24"; 24" above BCL (ref. from A-side Seam 1)	0.398
Q	21"; 24" above BCL (ref. from A-side Seam 1)	0.404
