**Bridge Factors Factual Report Attachment 22 – BPA Cracks Report No. 2 - Email from
Mr. Jose Morales of BPA to Mr. Rodrigo Isaza of MCM dated February 28, 2018**

HWY18MH009

From: Jose Morales
Sent: Wednesday, February 28, 2018 3:32 PM
To: Rodrigo Isaza [REDACTED]
Cc: [REDACTED]; Ernie Hernandez [REDACTED]; Pedro Cortes; Rafael Urdaneta; [REDACTED]; Carlos Chapman; Maria Christina Acosta
Subject: Main Span 1 - Cracks Inspection on Truss Members after formwork / scaffolding removal
Attachments: CRACKS REPORT AFTER SHORING REMOVAL.pdf

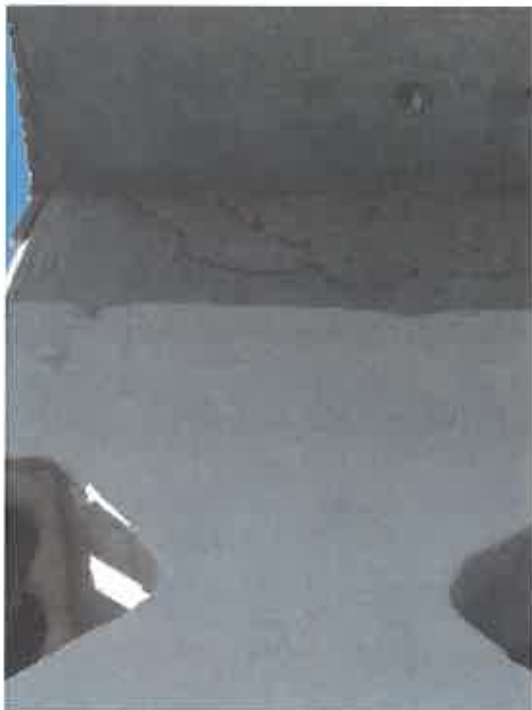
PHOTO # 1

- Photo number 1 appears to be a delamination of the concrete surface of member number 1 near the canopy of Span 1. FIGG does not have a structural concern about this type of imperfection in the finish of the member. MCM will have to repair this imperfection after Span 1 is moved to its final position.

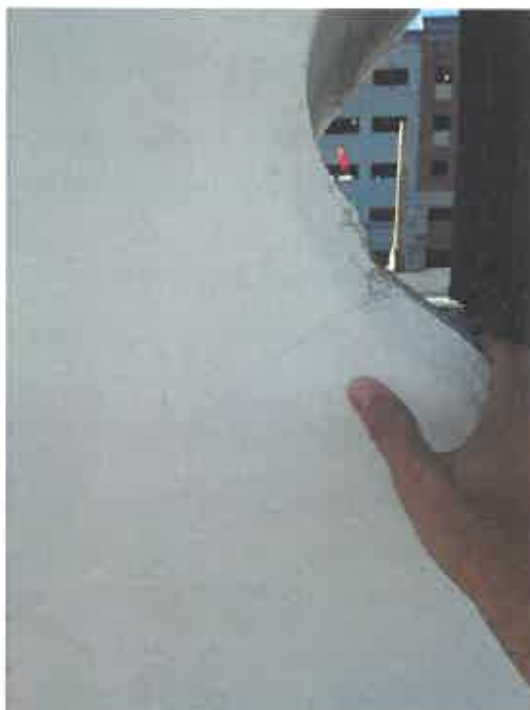
PHOTO # 2

- Photo number 2 shows two very small cracks adjacent to the temporary top hinge in vertical member 1. FIGG is not concerned about these very small cracks in this region. Cracks near the temporary hinge were expected.

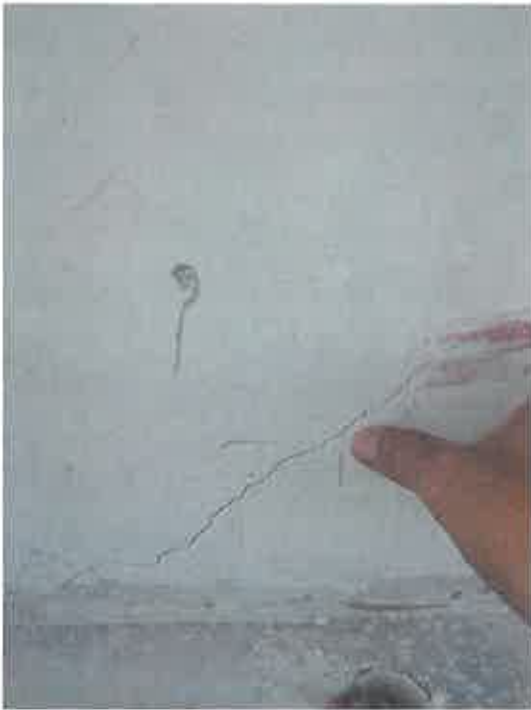
PHOTO # 3

- The elevation of Span 1 shows that photo 3 was taken from the underside of diaphragm number 1. However, the photo appears to be taken at the deck level and its orientation seems to be parallel to the longitudinal axis of member number 2. FIGG is not concern about this type of crack which seem to be very small and confined to the reinforced concrete chamfer region.

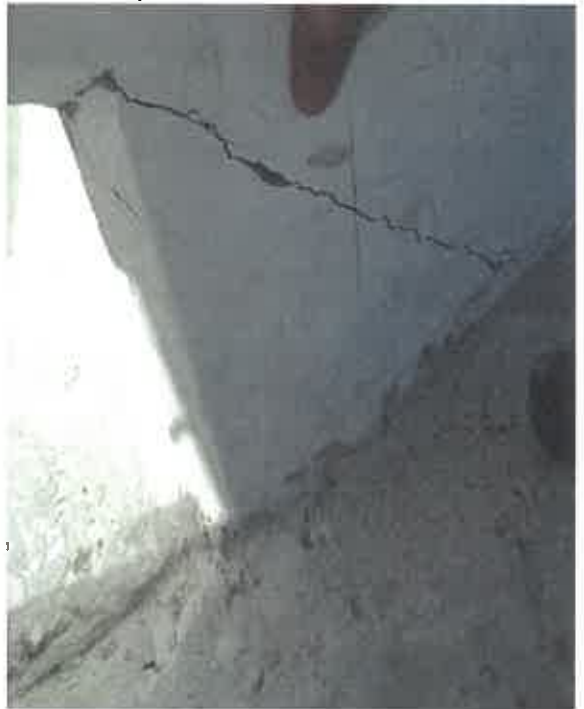
PHOTO # 4

- The cracks that are shown on photos 4, 5 and 6 appear to be in the reinforced concrete chamfer region of member 11. The elevation view locates these cracks on the downstation side of diaphragm number 2. It appears that the arrow that shows the general location of the crack was misplaced in the elevation view. These cracks developed at the boundary between the diagonal compression member and its reinforced concrete bottom chamfer. It is anticipated that MCM will seal these cracks in accordance with FDOT Standard Specifications.

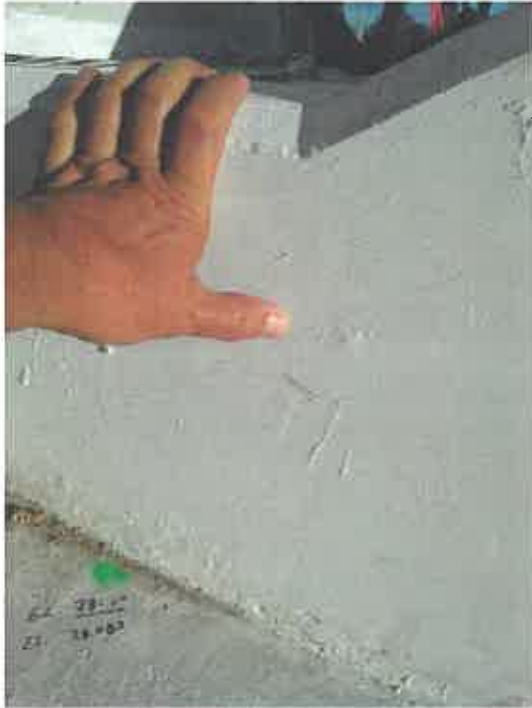
PHOTO # 5

Forward to the EOR for their information. We will monitor these or any other developing cracks on the bridge, but we would like to the EOR to provide a response and determine if these were expected during the bridge stressing. The one due the size that we believe needs special attention is the crack shown in photos 5,6 &7.

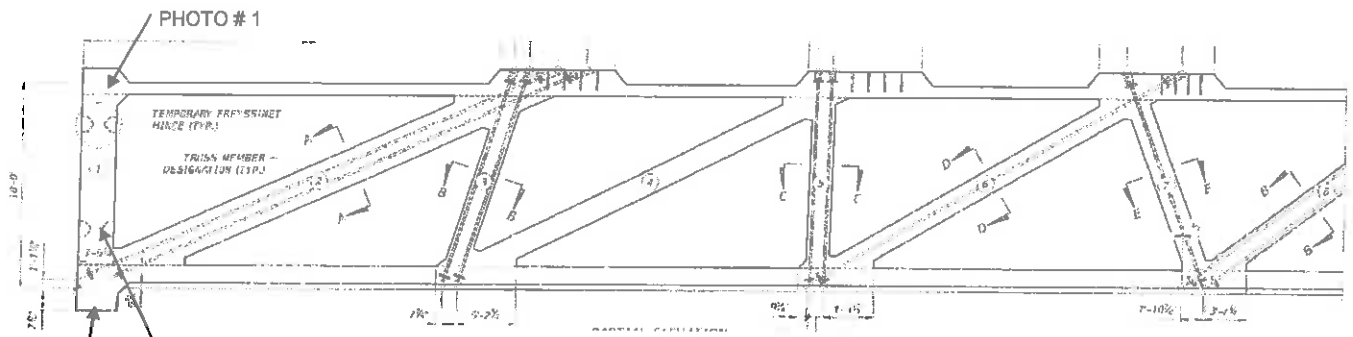
CRACKS LOCATION

- CEI Report only contains three (3) pages of photos and one (1) page that shows the elevation view of Span 1 titled Cracks Location. The general locations of the cracks are depicted on this elevation view. Using the information provided by CEI, it is not clear from which side of the span the photos were taken since there is not a description of the location for each photo. Therefore, FIGG requests a more descriptive report of the crack locations and width.
