**Bridge Factors Factual Report Attachment 24 – Email from Mr. Rodrigo Isaza of MCM to
Mr. Dwight Dempsey of FIGG dated March 12, 2018**

Miami, FL

HWY18MH009

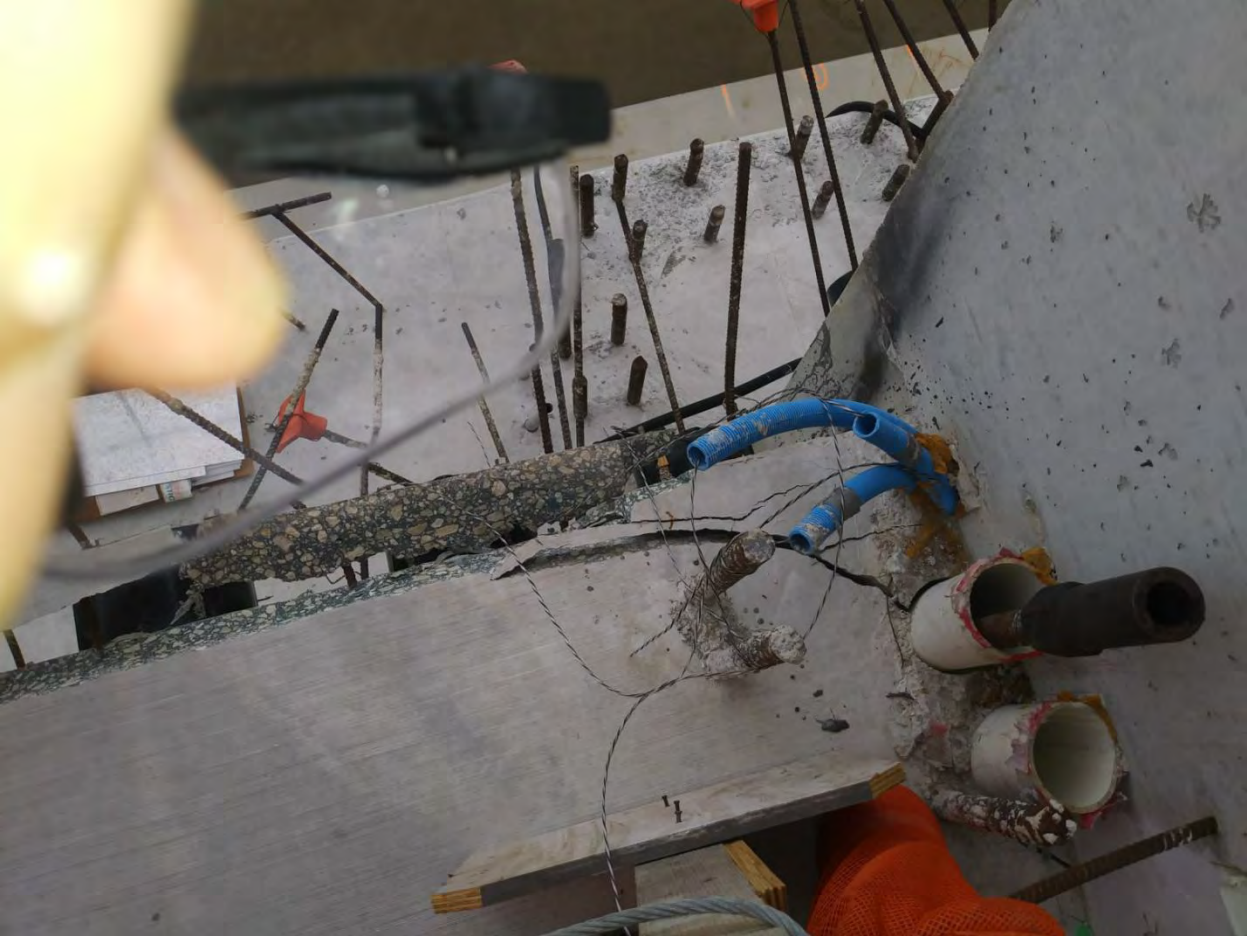
PHOTO 1: Diaphragm 2, Westside top view, crack

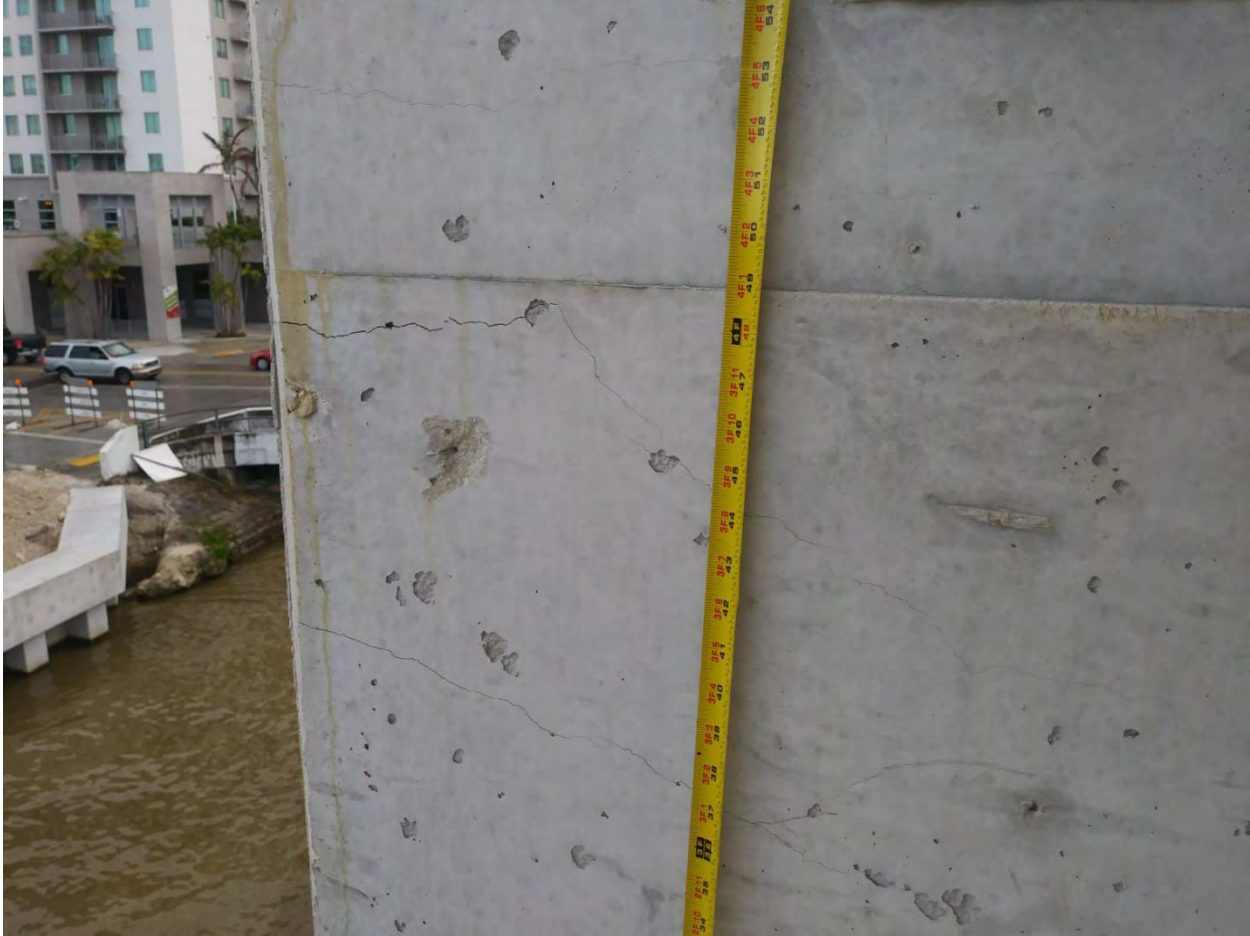
PHOTO 2: Truss 12, Westside hair cracks

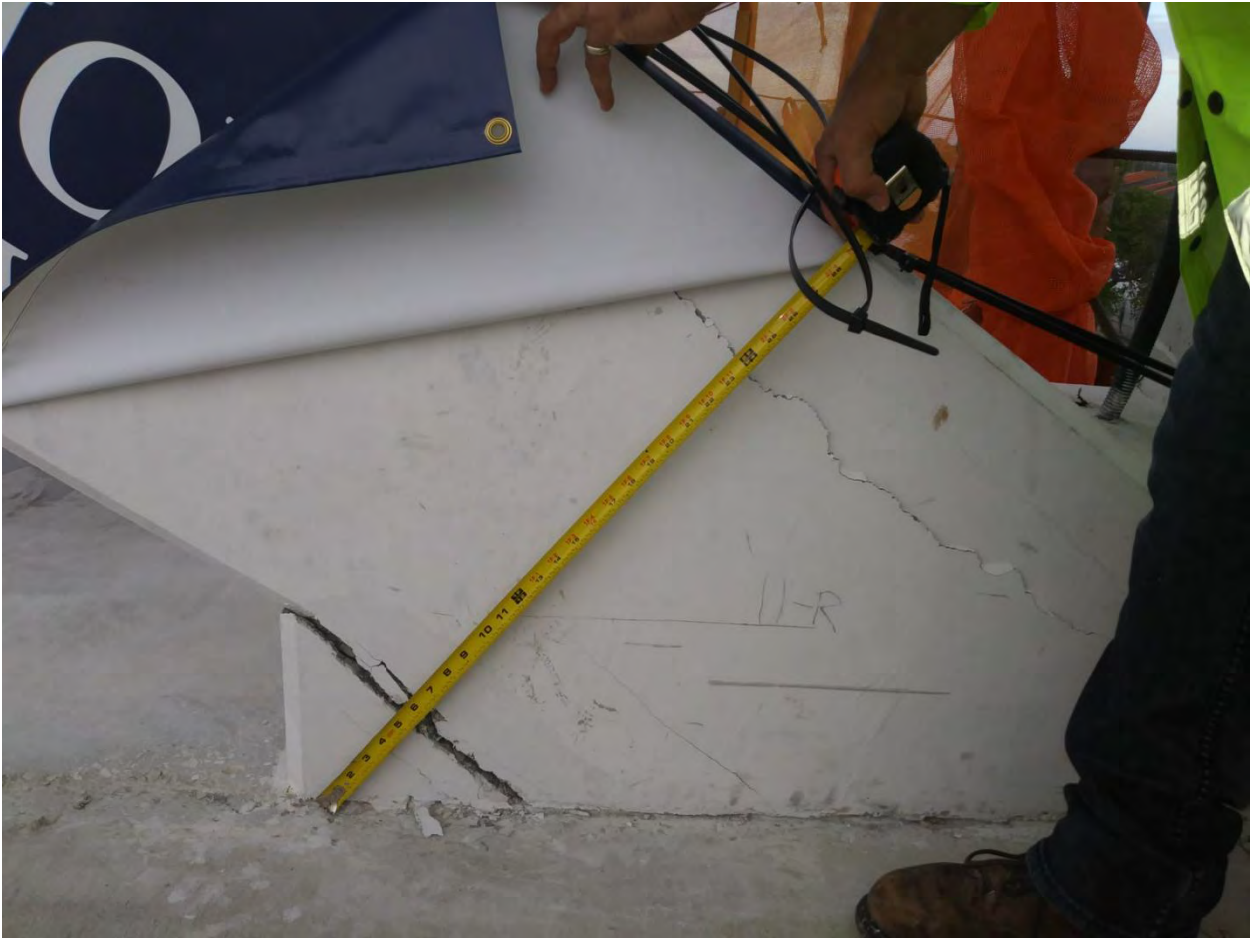
PHOTO 3: Truss 11, Eastside cracks

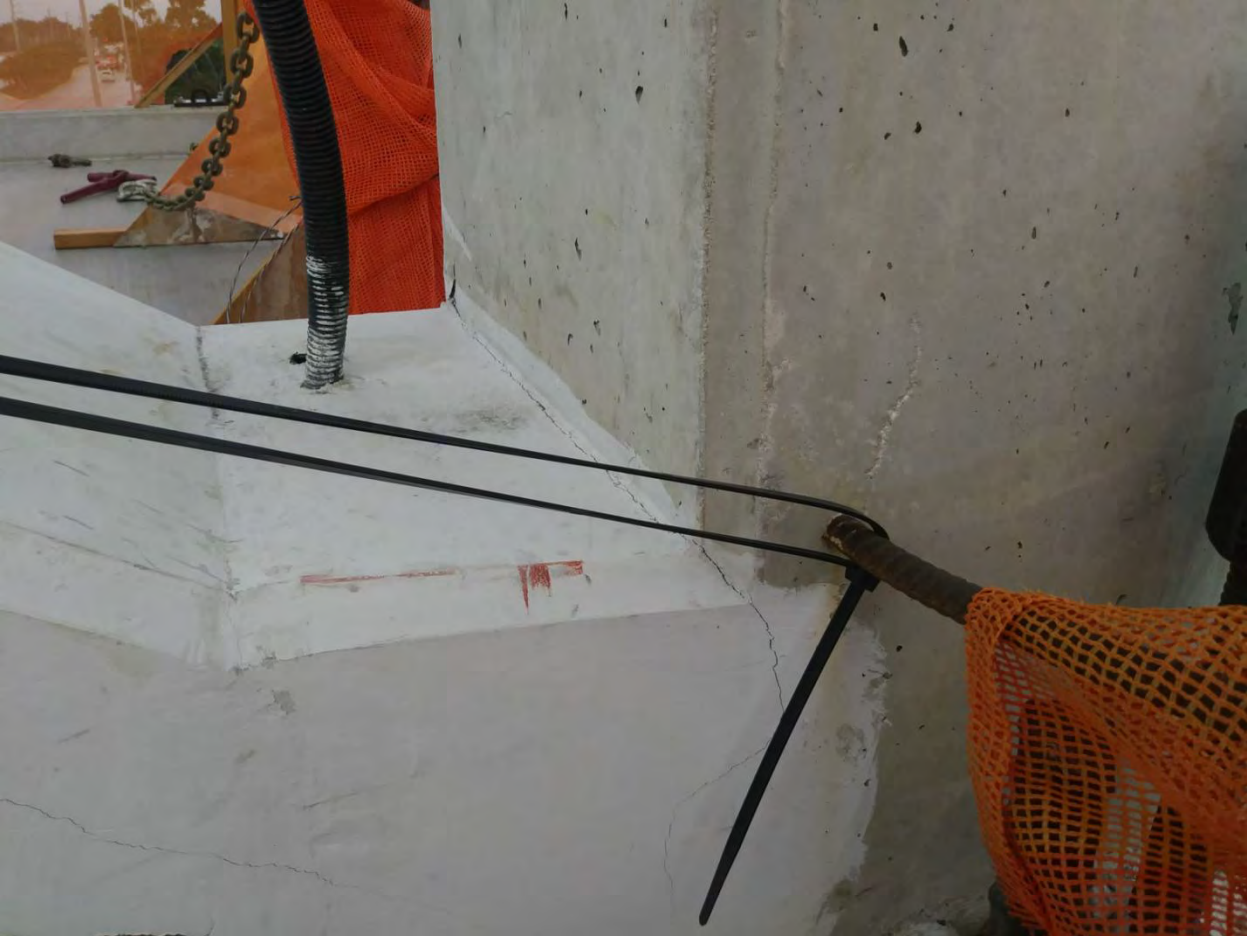
PHOTO 4: Truss 11/12 crack

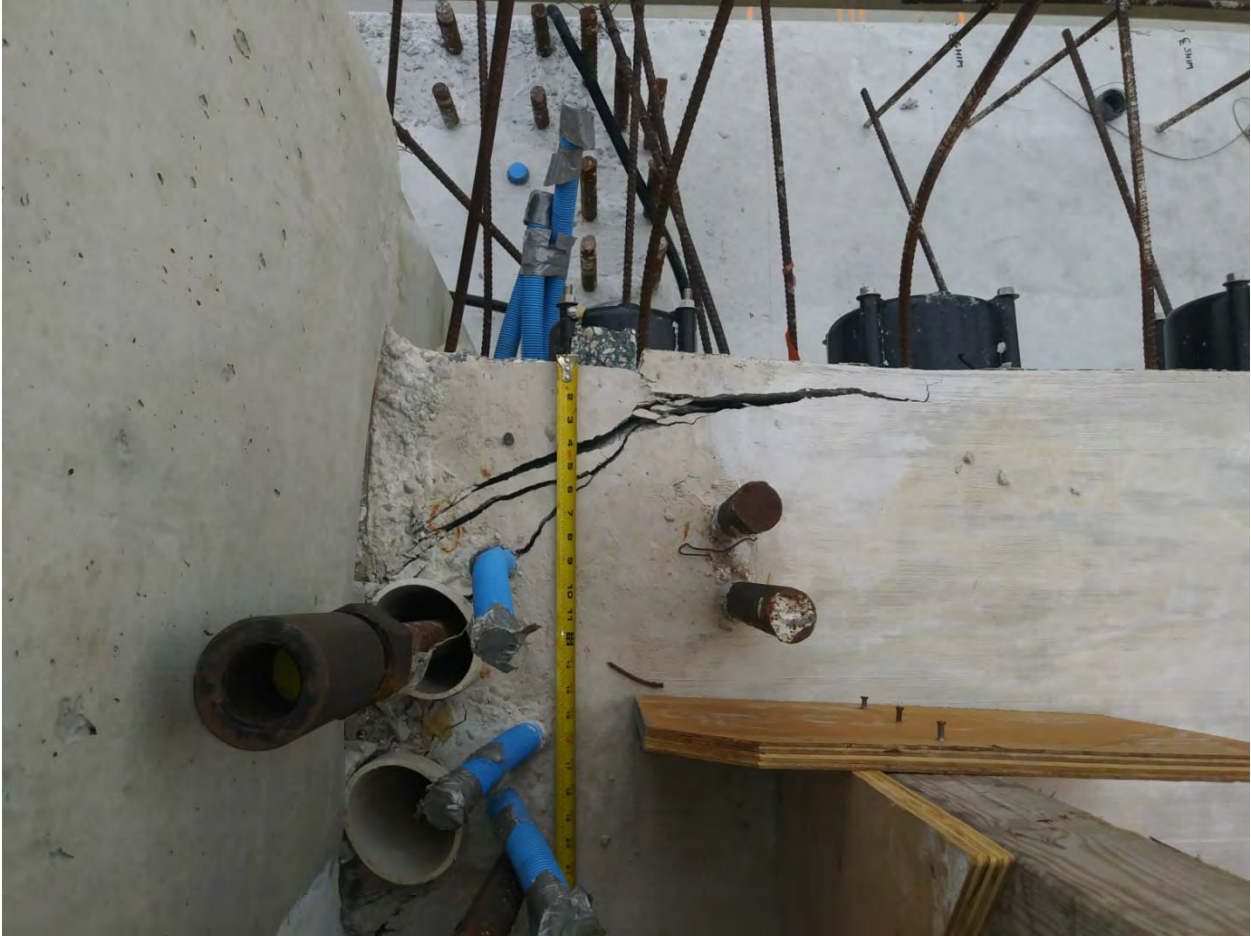
PHOTO 5: Diaphragm 2, Eastside top view crack

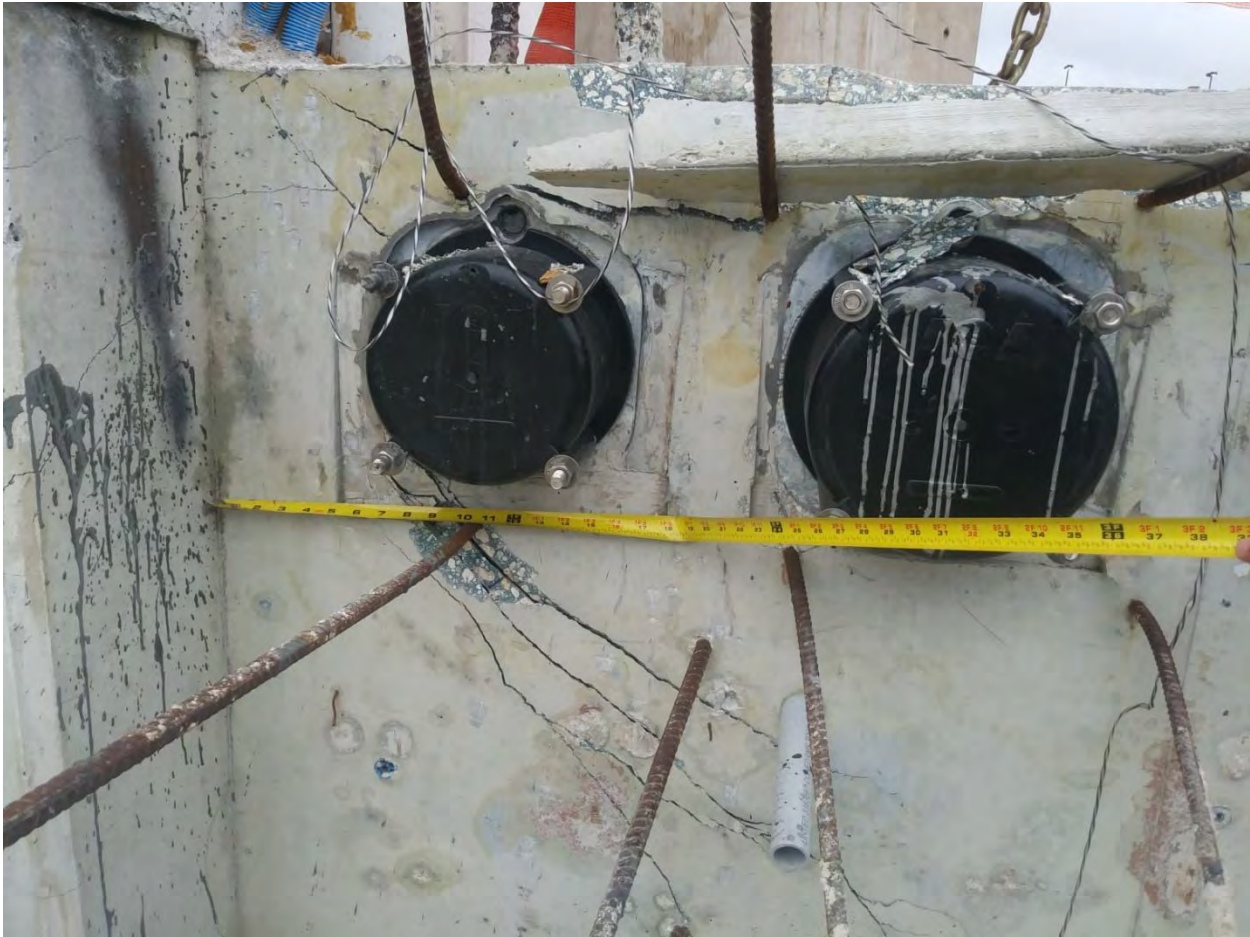
PHOTO 6: Diaphragm 2, Westside North view cracks

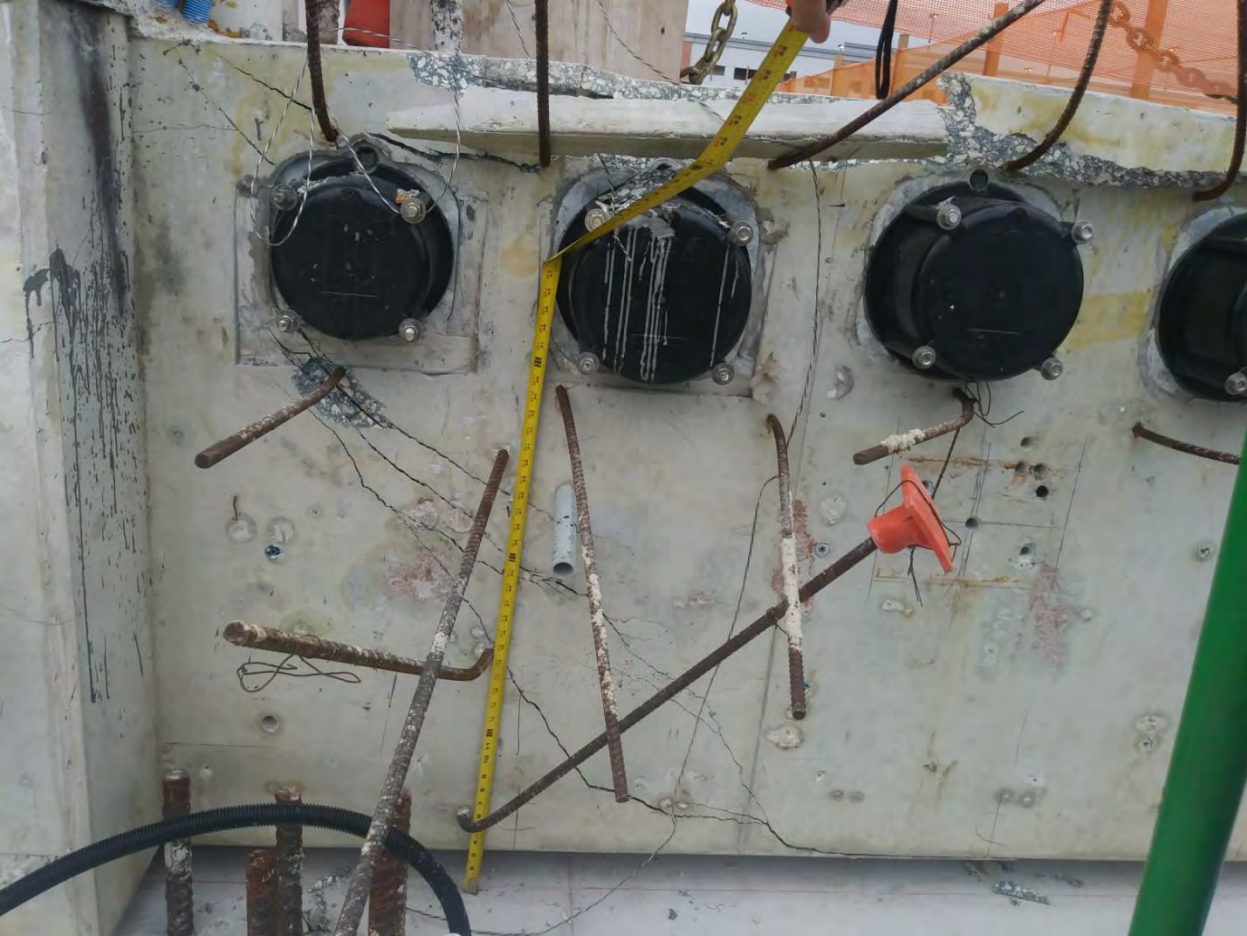
PHOTO 7: Diaphragm 2, Westside North view cracks

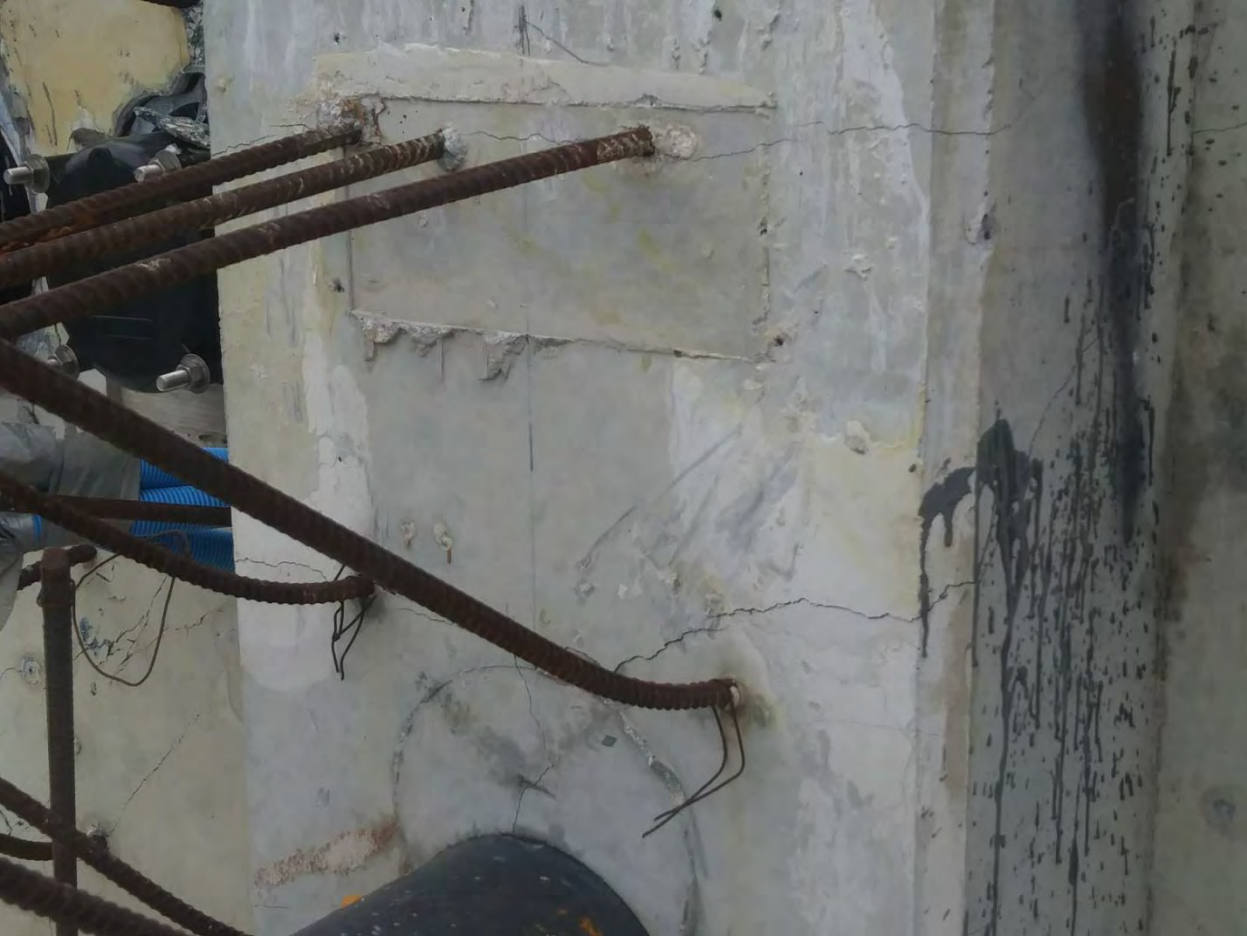
PHOTO 8: Truss 12, North view cracks

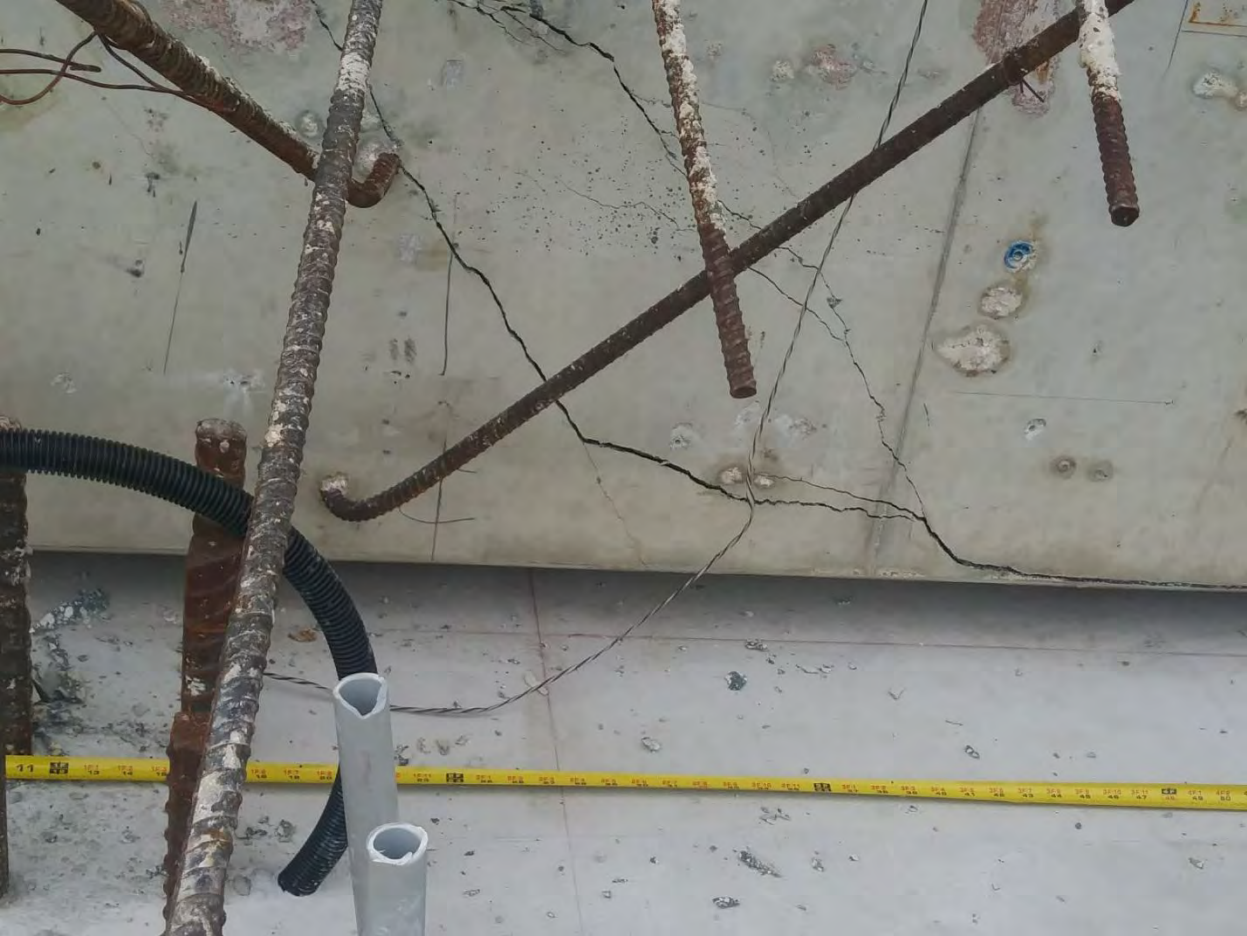
PHOTO 9: Diaphragm 2, Westside North view cracks

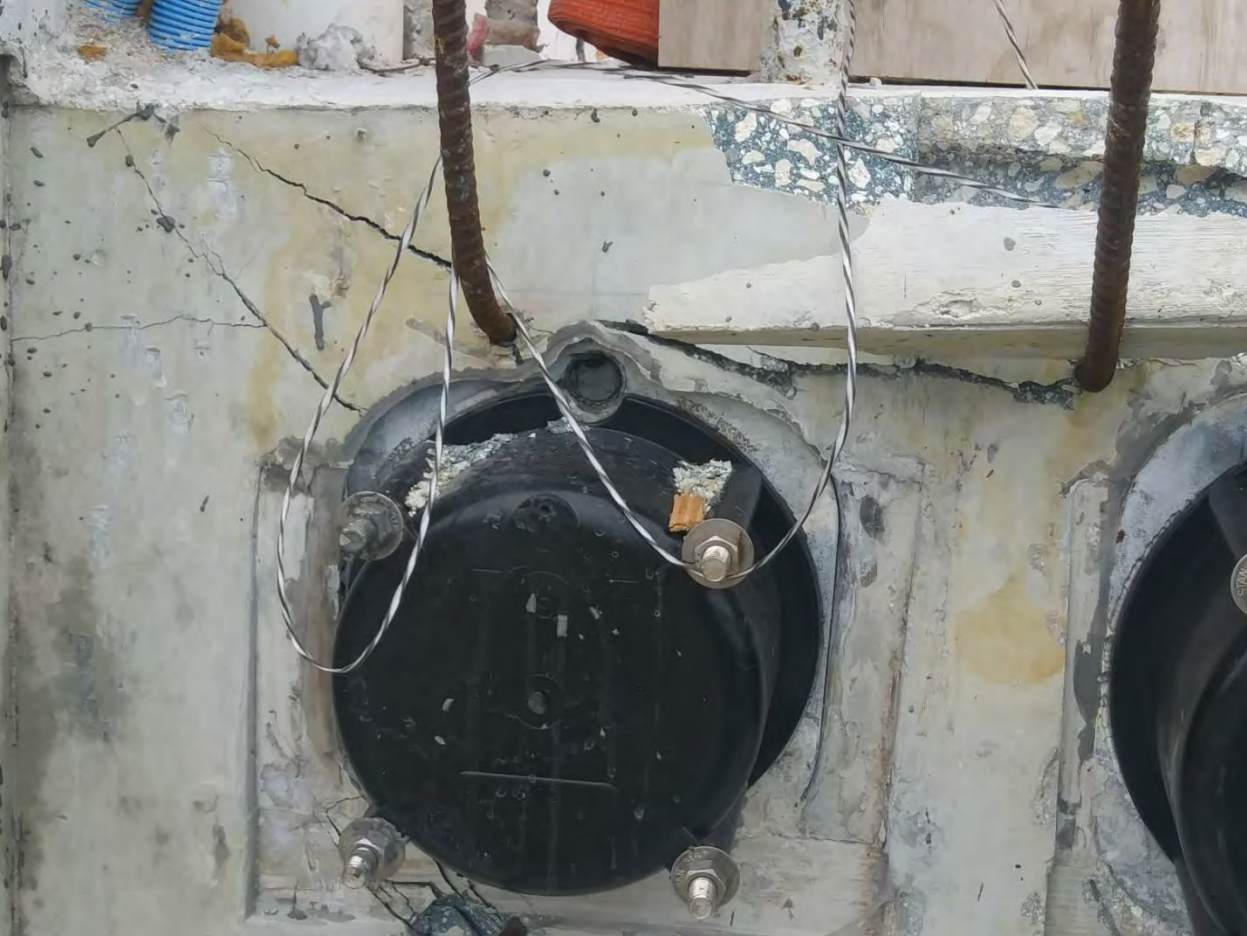
PHOTO 10: Diaphragm 2, Westside North view cracks

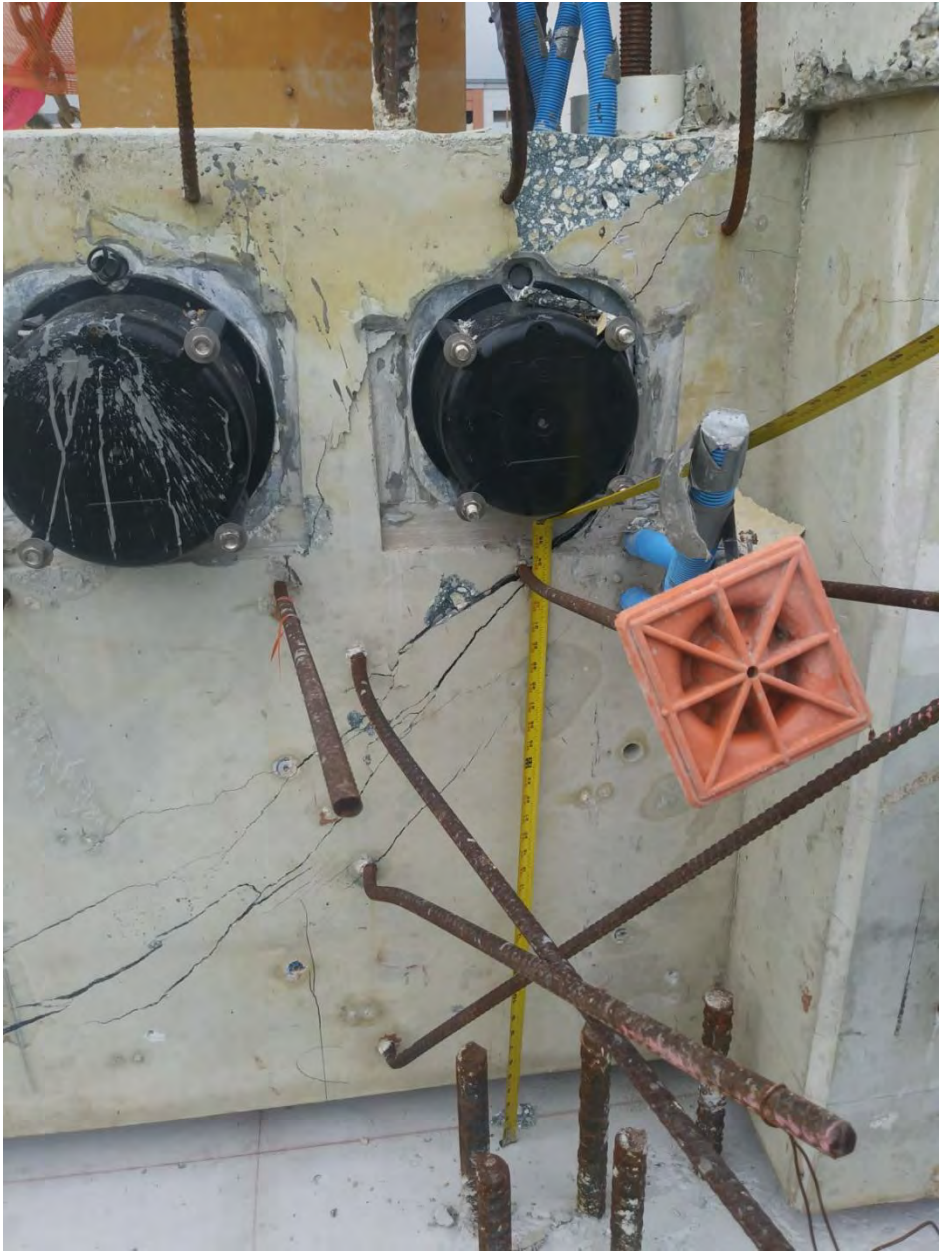
PHOTO 11: Diaphragm 2, Eastside North view cracks

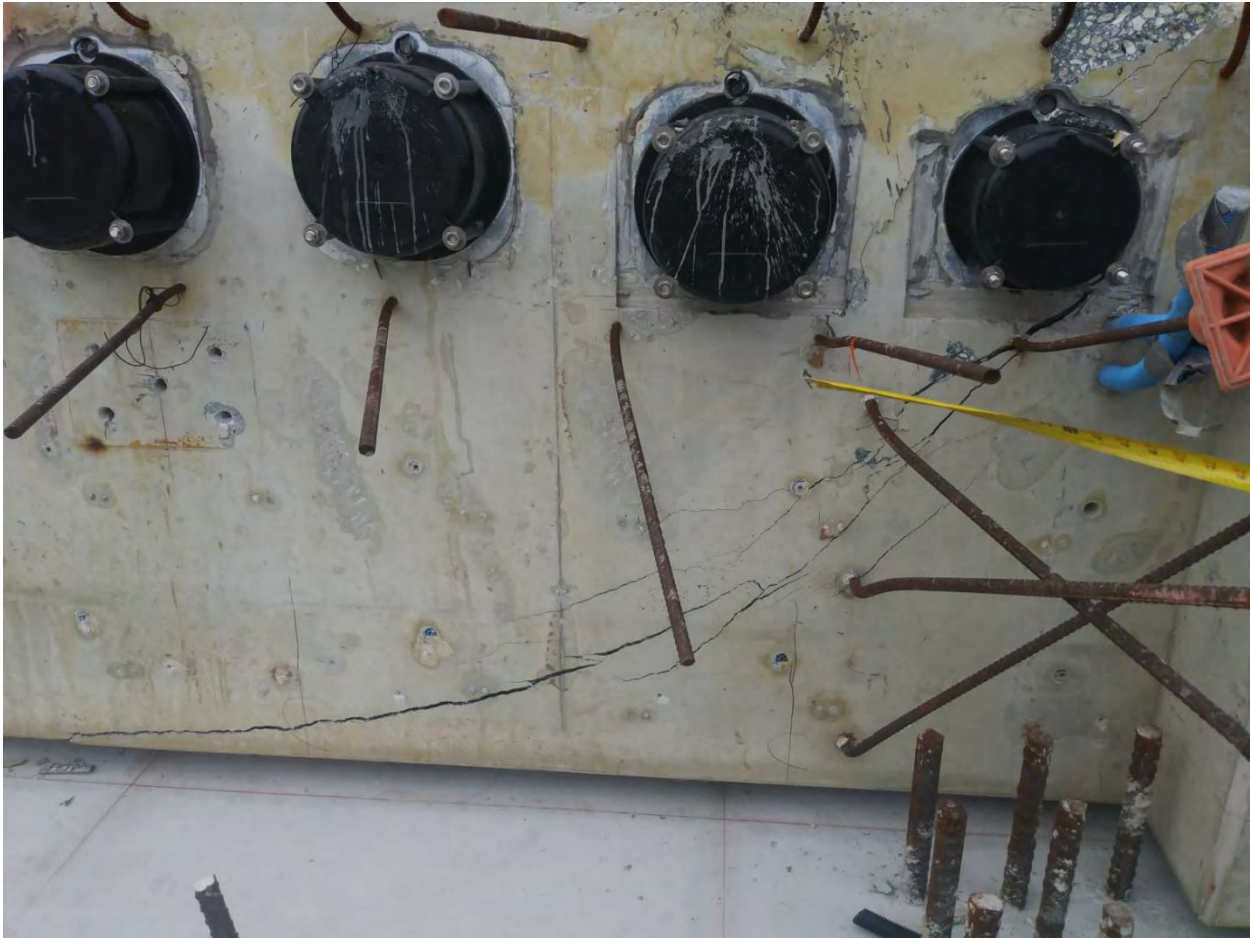
PHOTO 12: Diaphragm 2, Eastside North view cracks

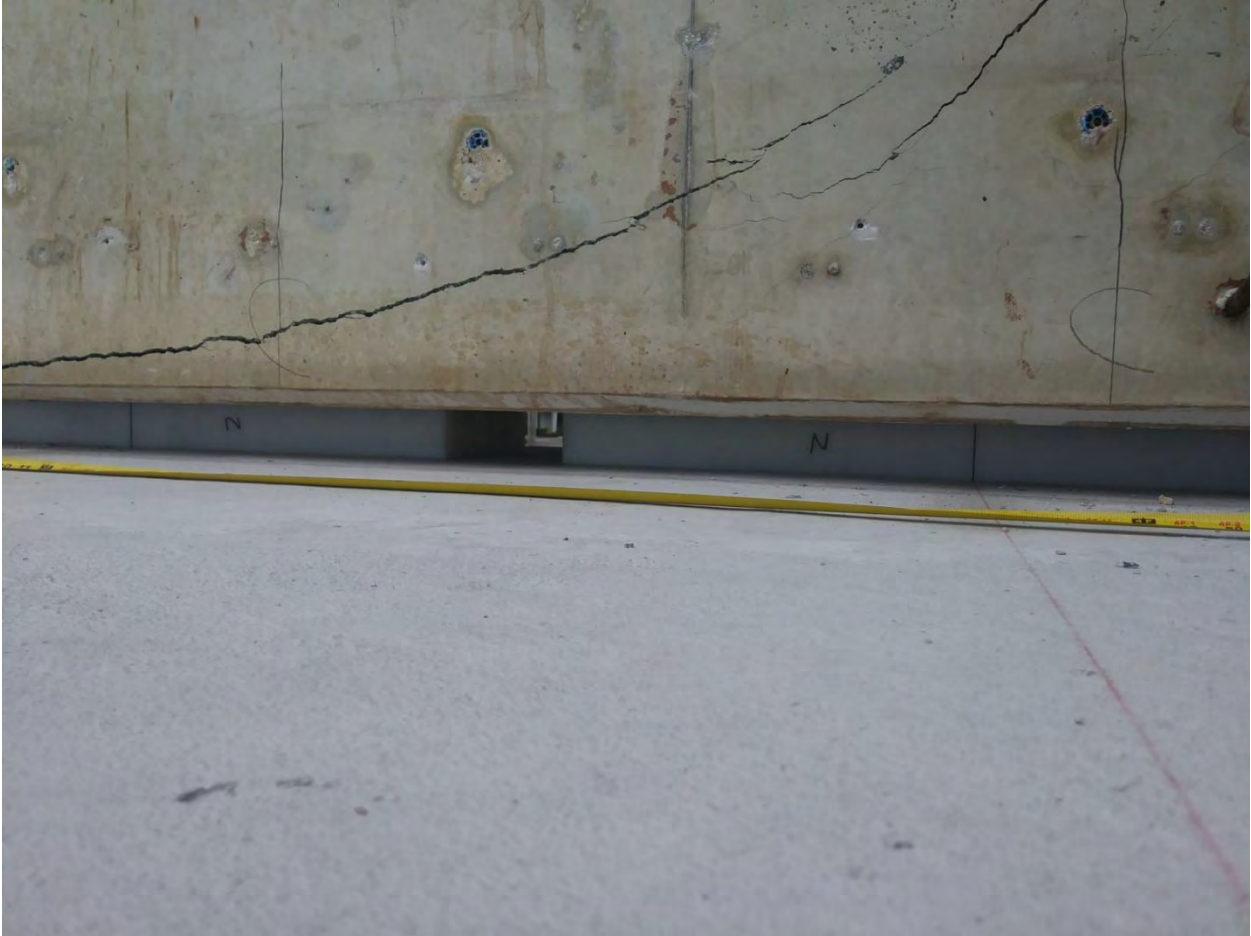
PHOTO 13: Diaphragm 2, Eastside North view cracks

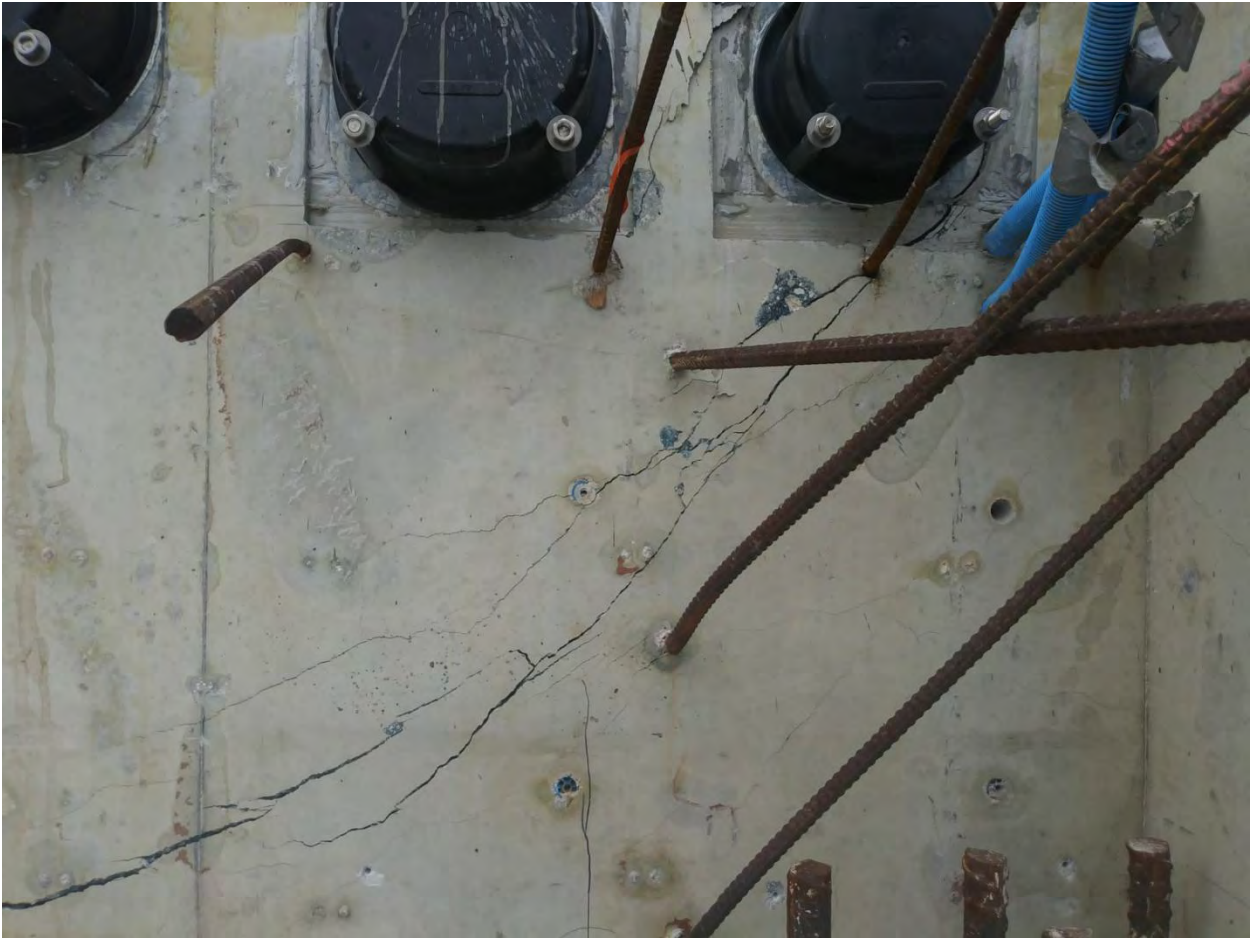
PHOTO 14: Diaphragm 2, Eastside North view cracks

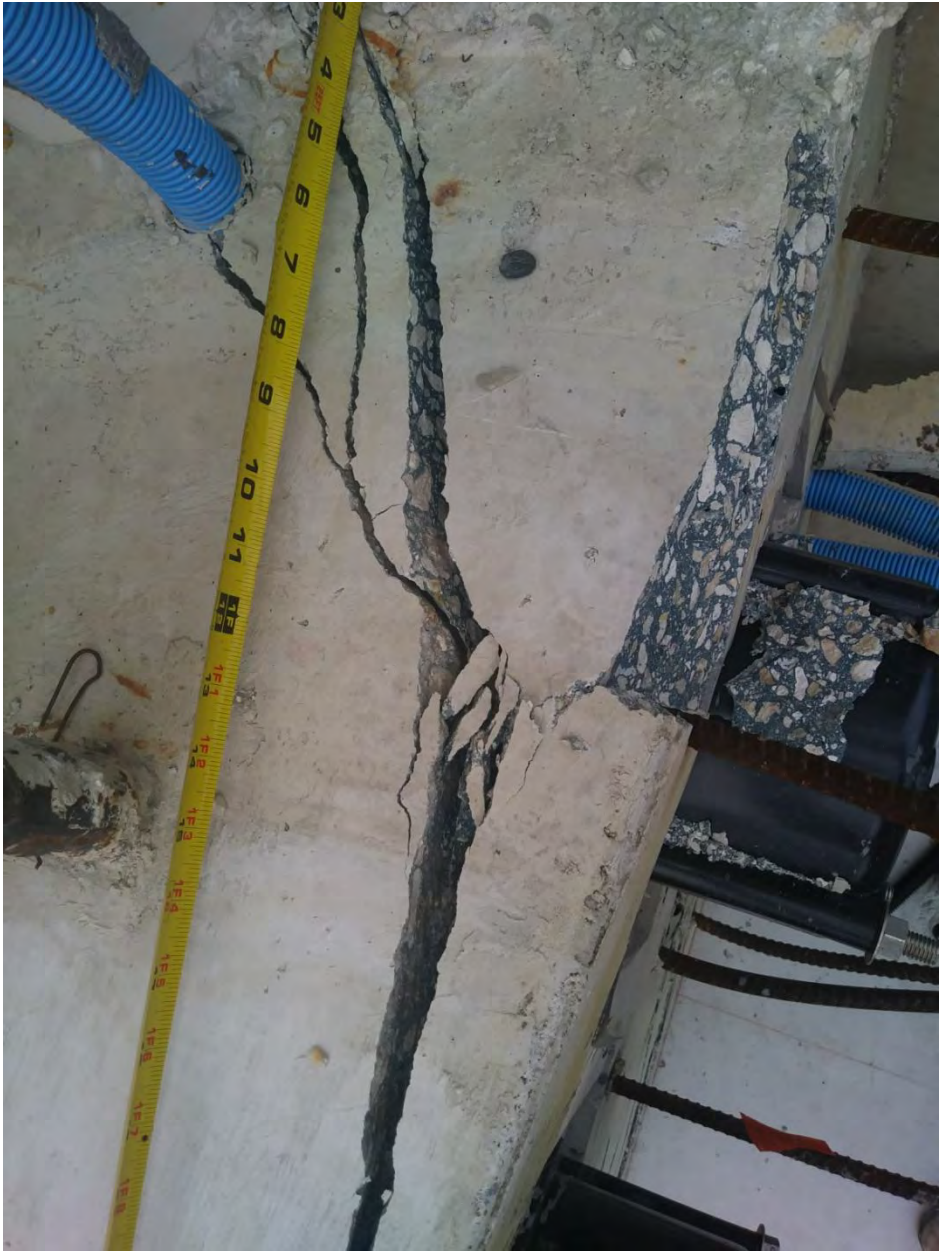
PHOTO 15: Diaphragm 2, Eastside Top view cracks

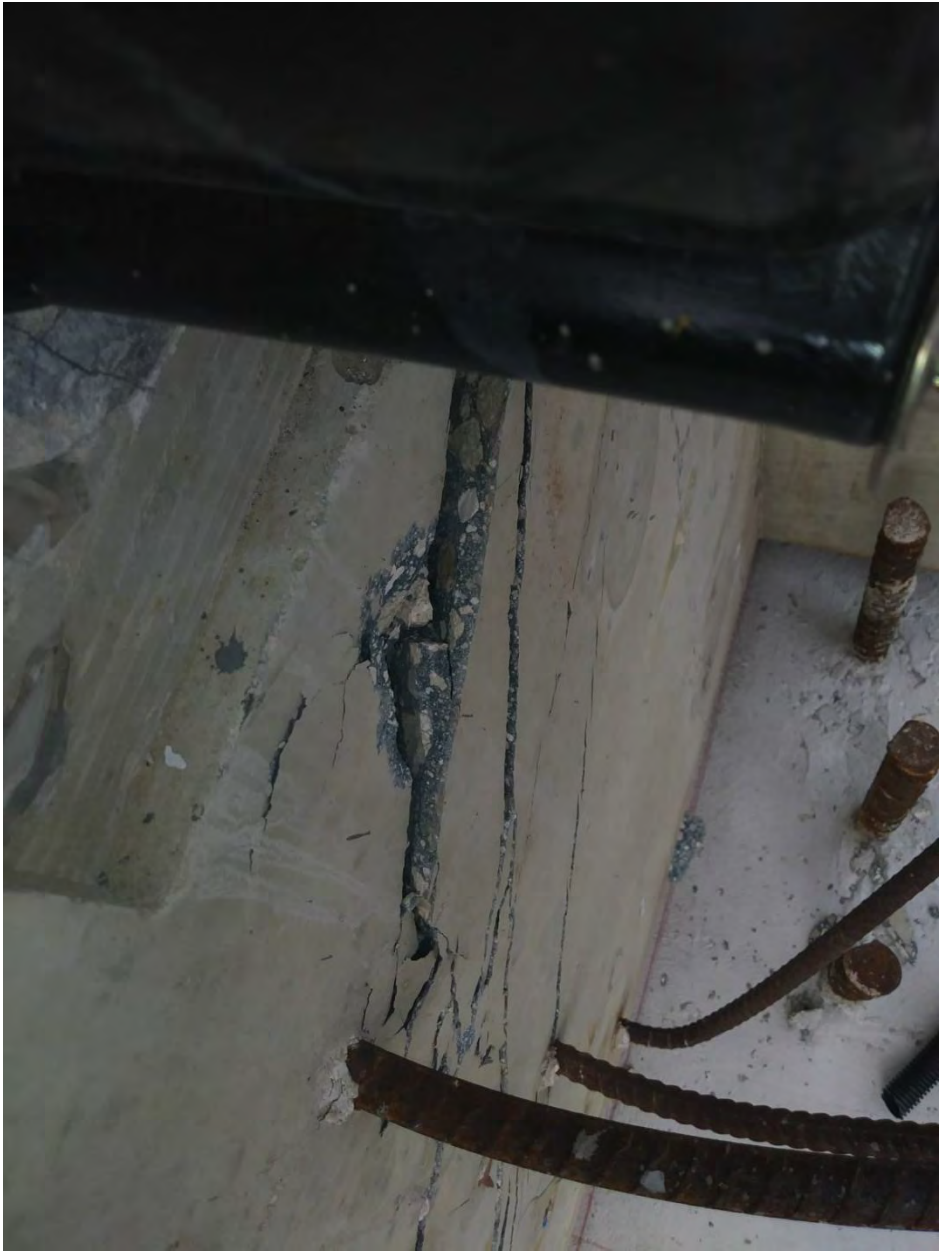
PHOTO 16: Diaphragm 2, Eastside Top/side view cracks
