**Bridge Factors Factual Report Attachment 26 – BPA Cracks Report No. 3 - Email from
Mr. Jose Morales of BPA to Mr. Rodrigo Isaza of MCM dated March 13, 2018**

HWY18MH009

Report # 3

From: Jose Morales
Sent: Tuesday, March 13, 2018 10:59 AM
To: Rodrigo Isaza
Cc: Rafael Urdaneta; Maria Christina Acosta; Carlos Chapman; Ernie Hernandez; Pedro Cortes
Subject: RE: FIU-UCPP - Stage 3 - Erection of Main Span

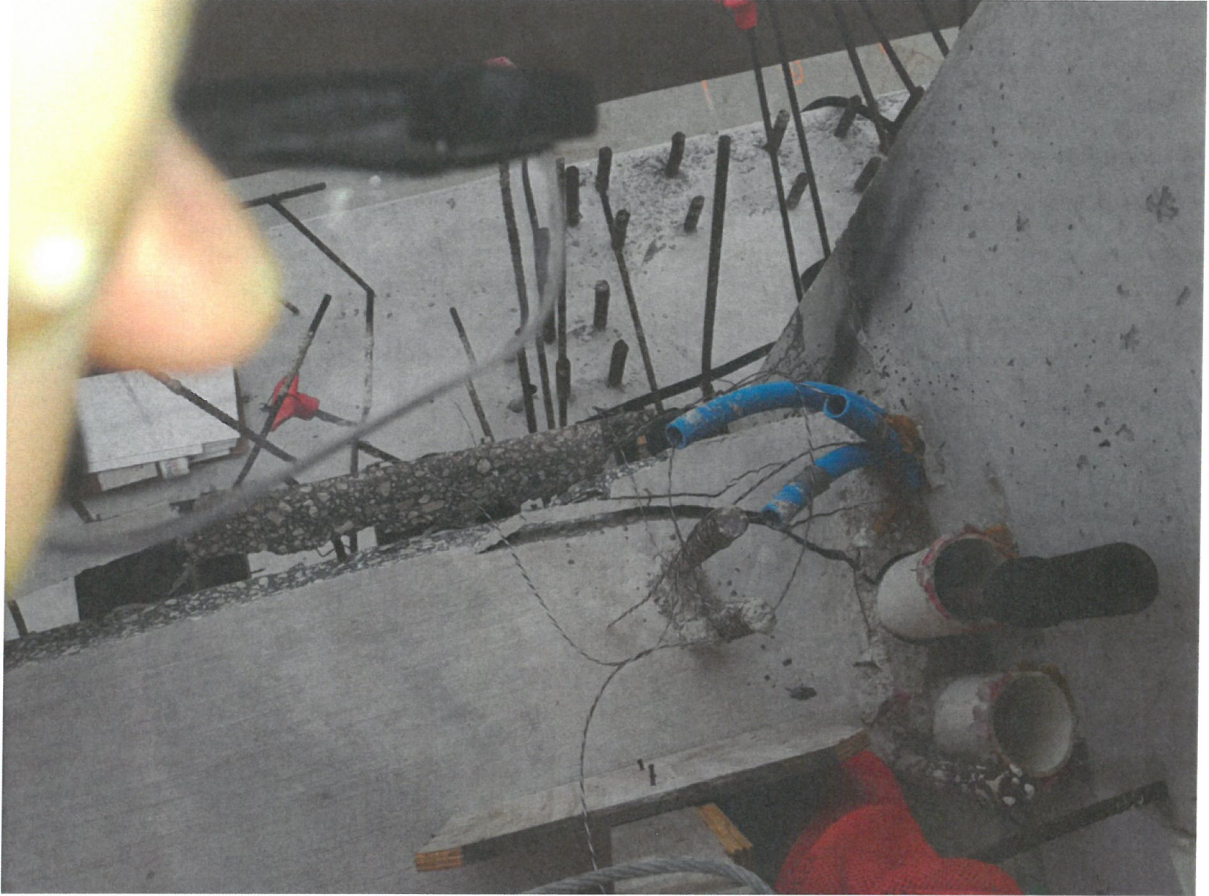
PHOTO 1: Diaphragm 2, Westside top view, crack

As discussed earlier, I recommend we monitor and document the growth of these cracks to determine if these are active and developing further or dormant.

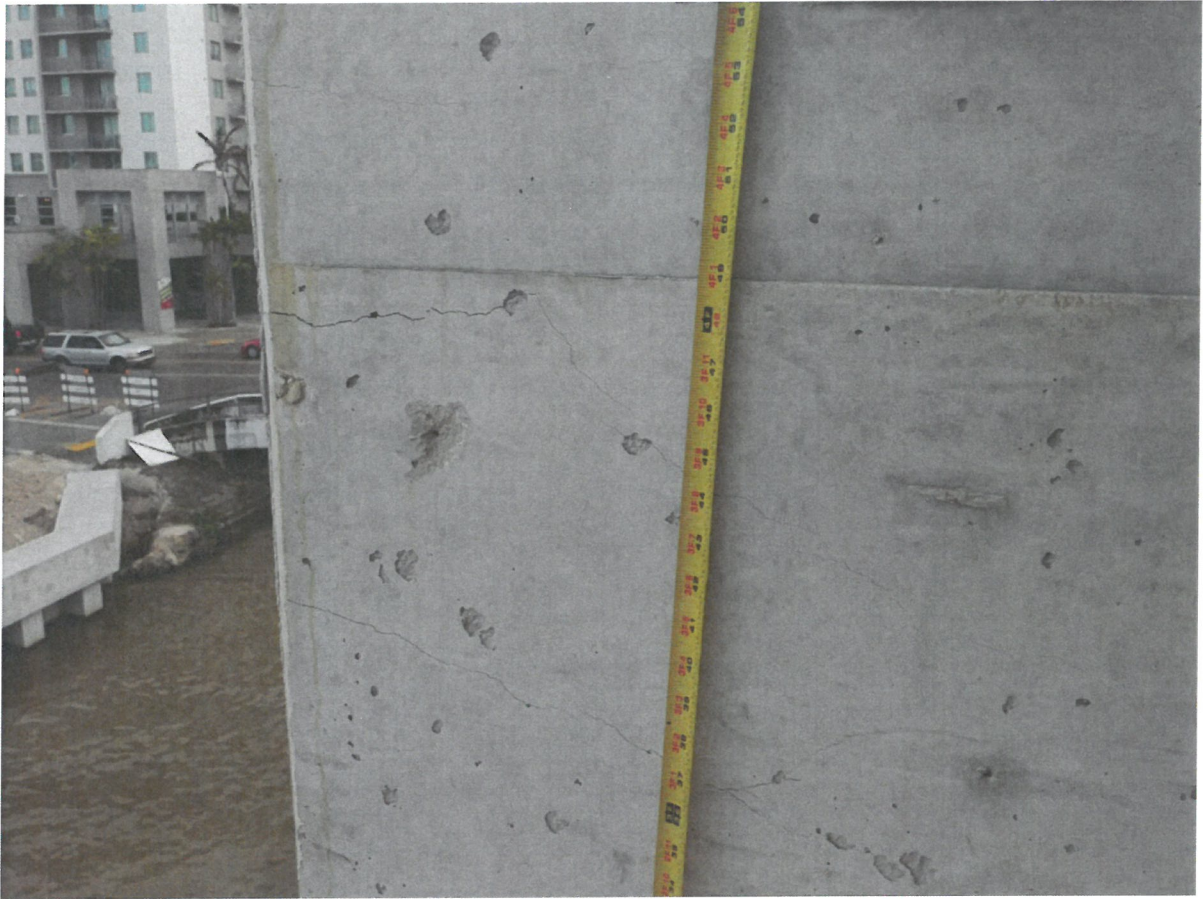
PHOTO 2: Truss 12, Westside hair cracks

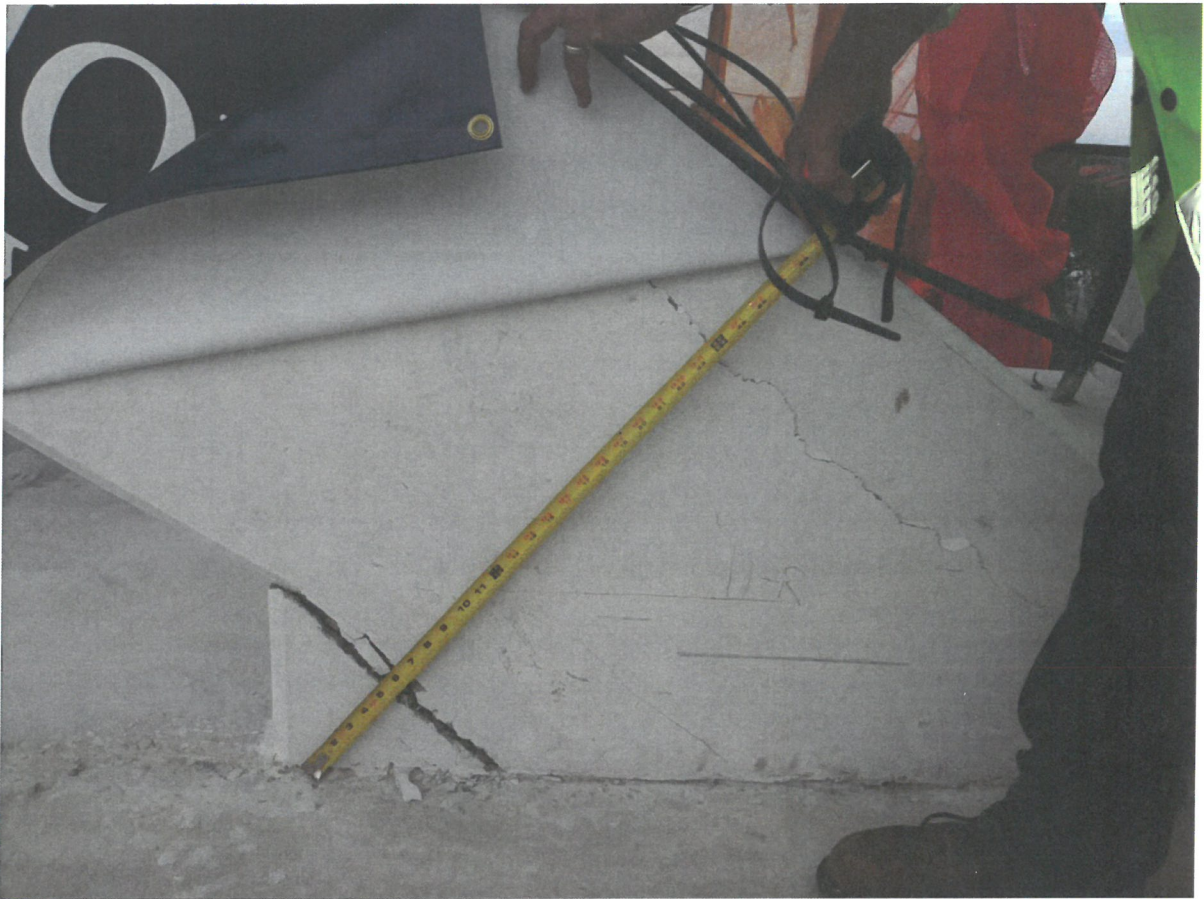
PHOTO 3: Truss 11, Eastside cracks

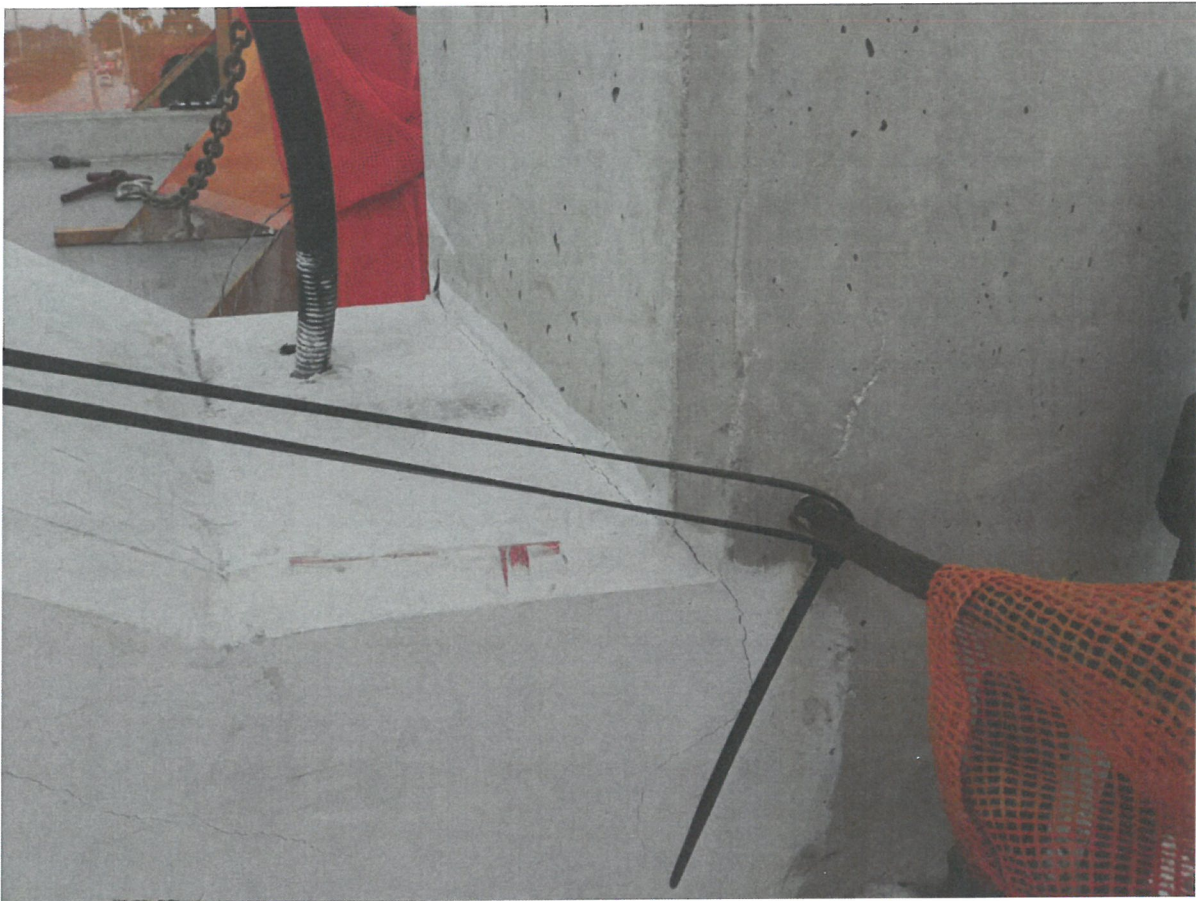
PHOTO 4: Truss 11/12 crack

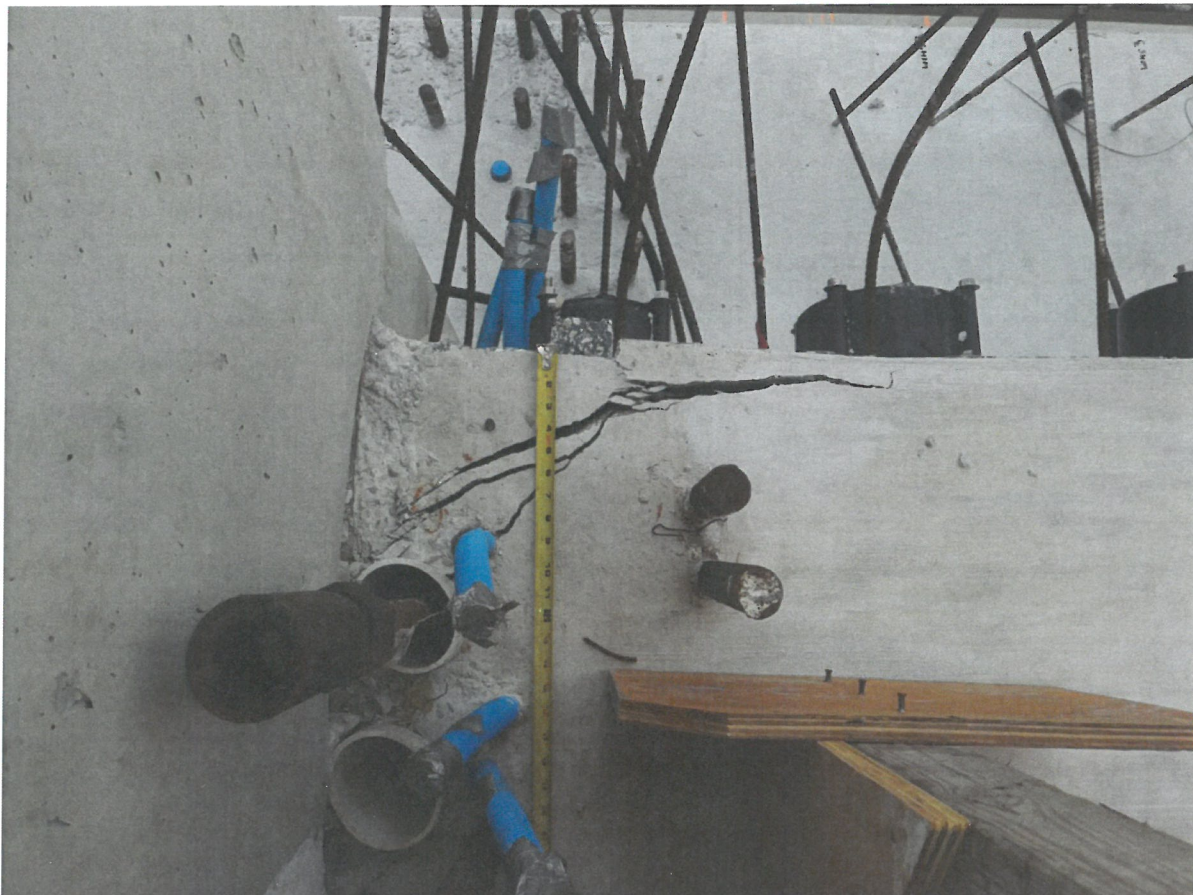
PHOTO 5: Diaphragm 2, Eastside top view crack

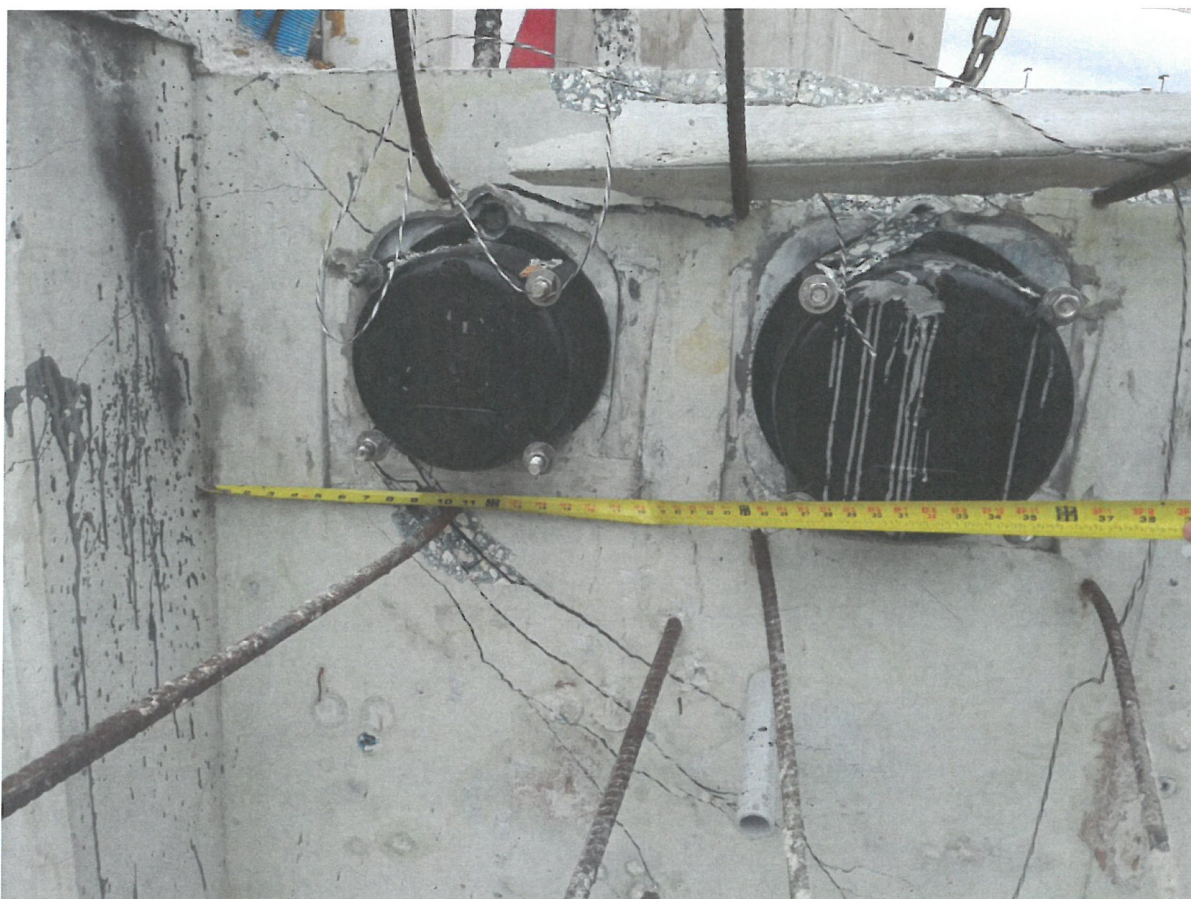
PHOTO 6: Diaphragm 2, Westside North view cracks

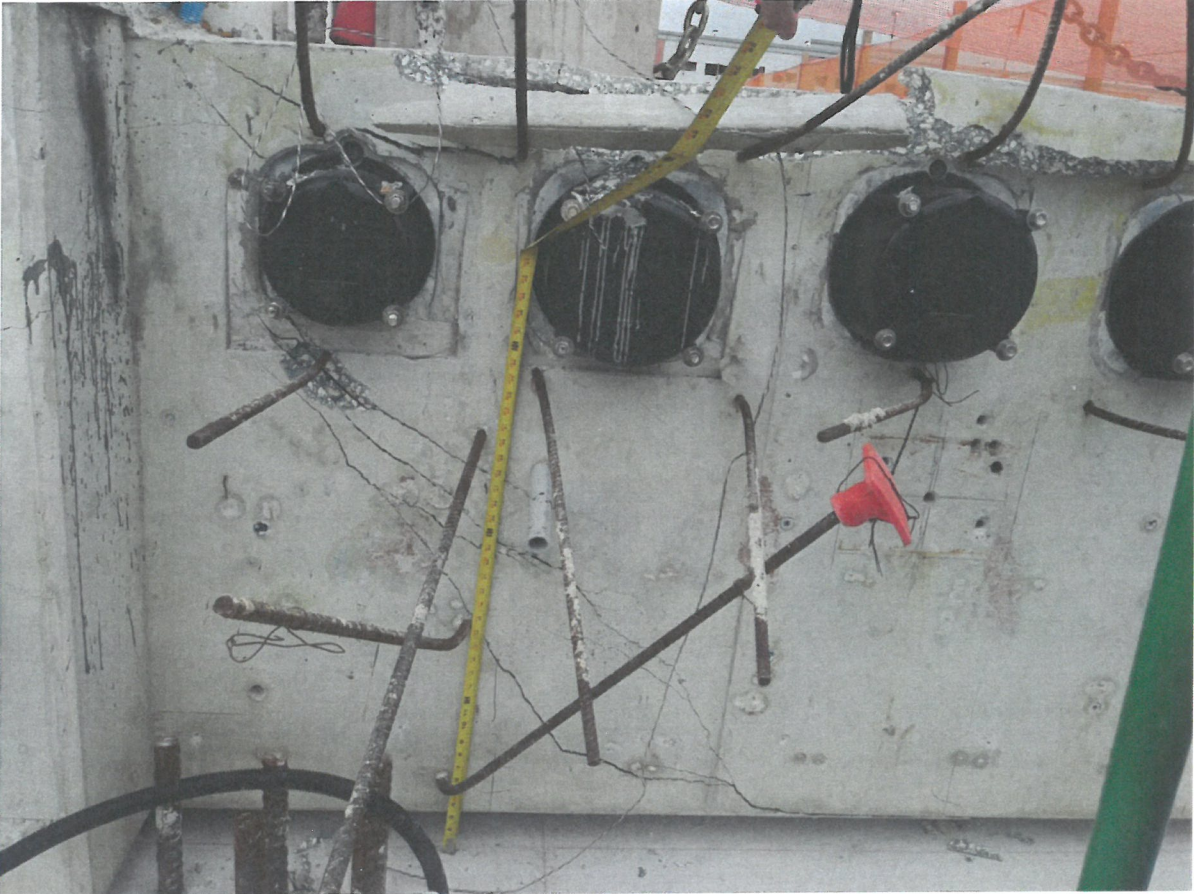
PHOTO 7: Diaphragm 2, Westside North view cracks

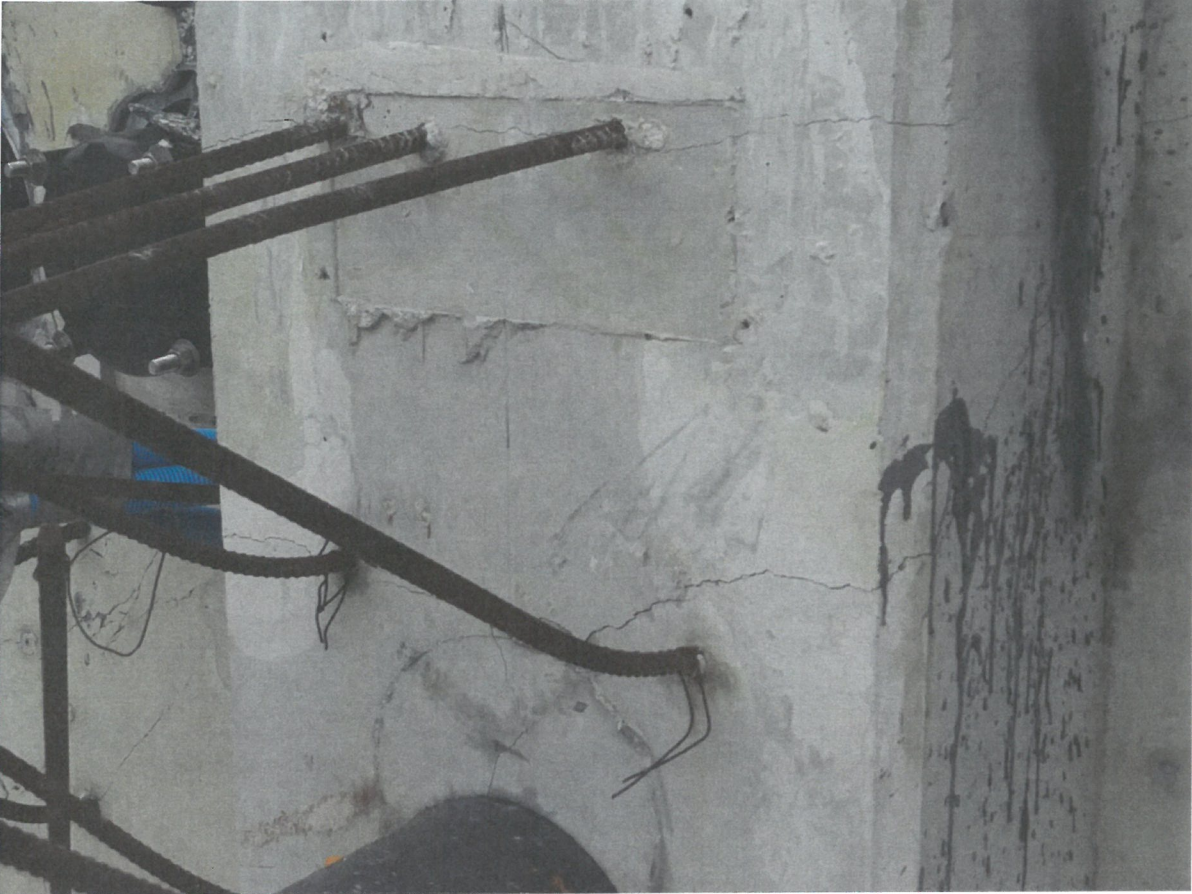
PHOTO 8: Truss 12, North view cracks

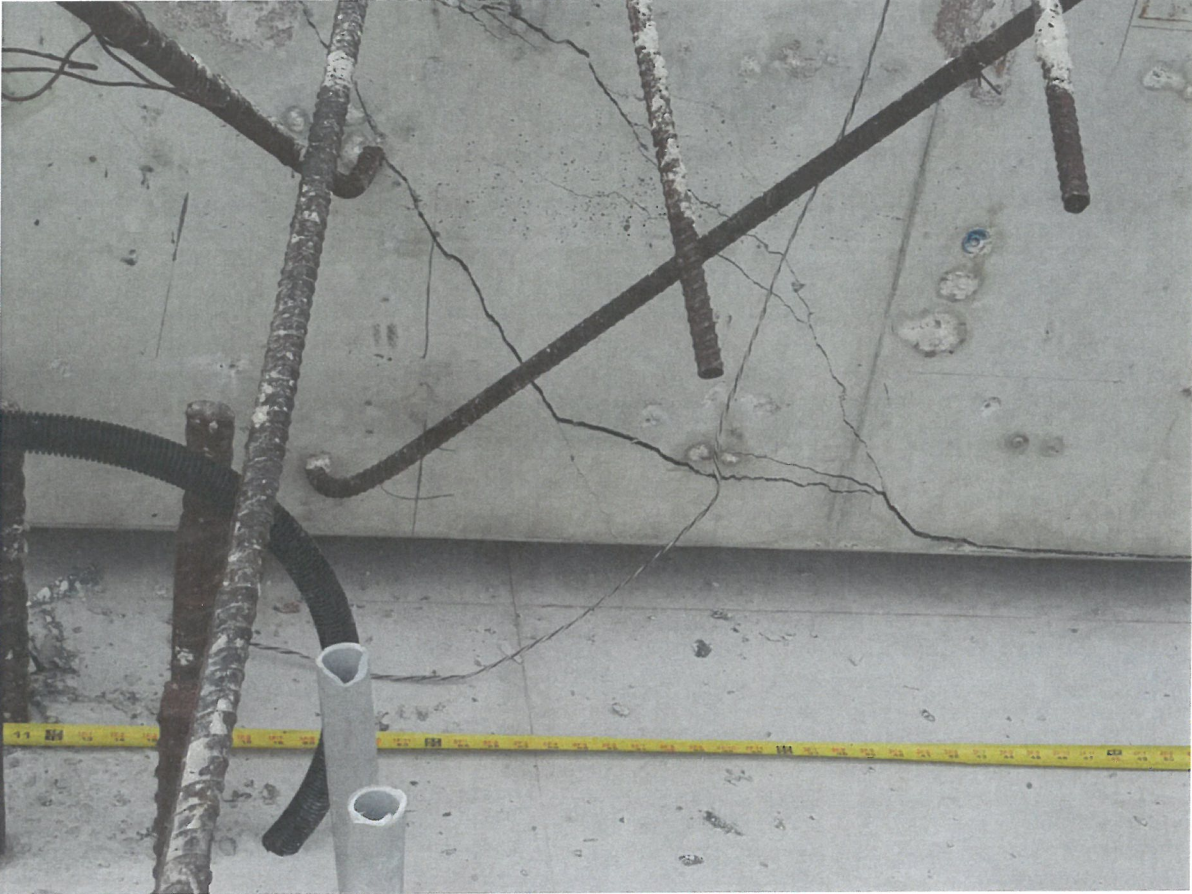
PHOTO 9: Diaphragm 2, Westside North view cracks

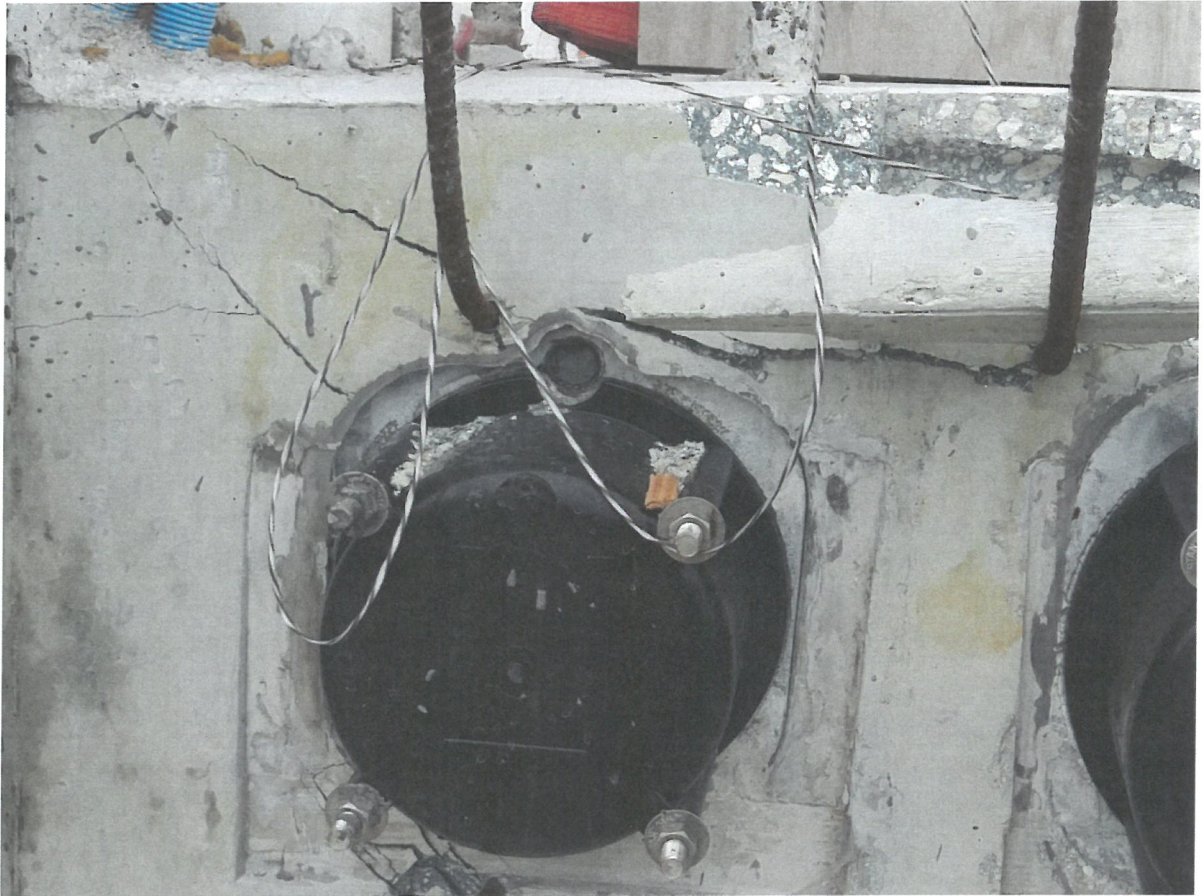
PHOTO 10: Diaphragm 2, Westside North view cracks

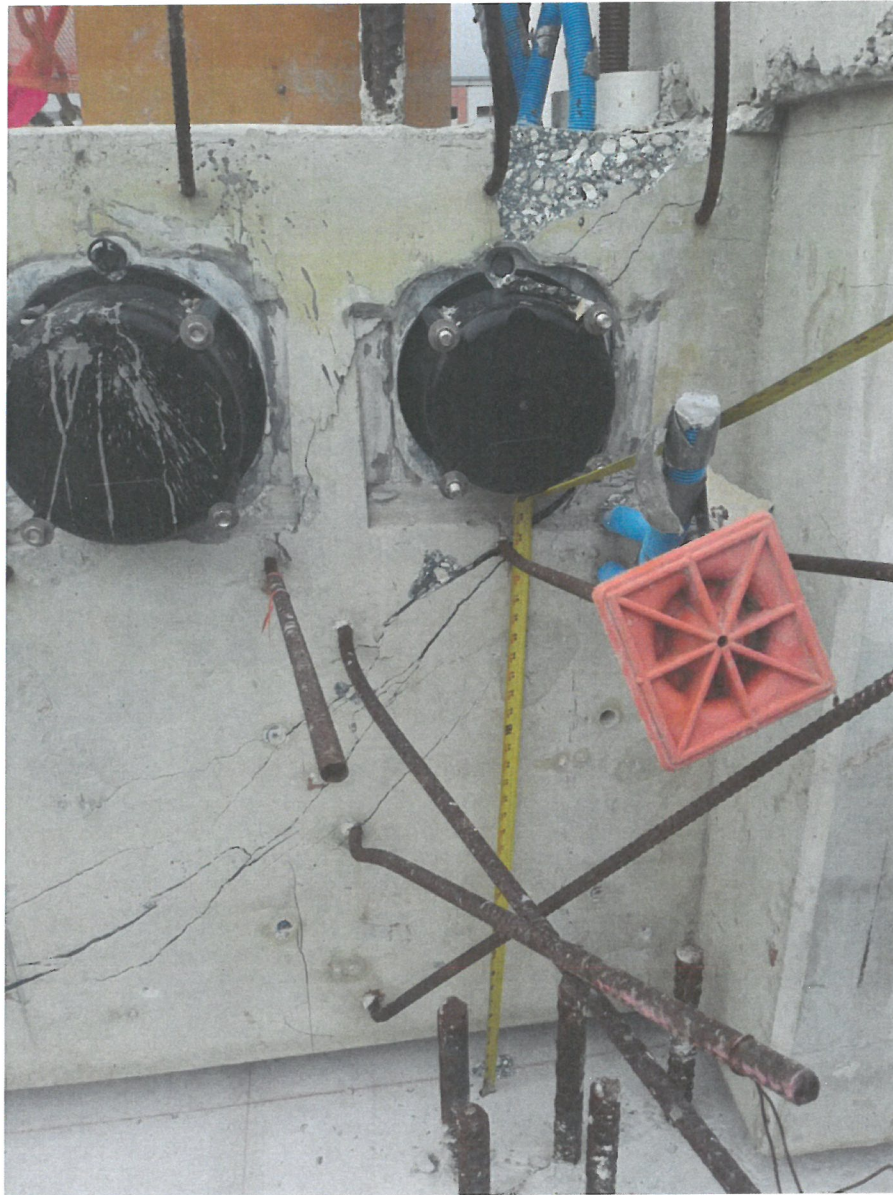
PHOTO 11: Diaphragm 2, Eastside North view cracks

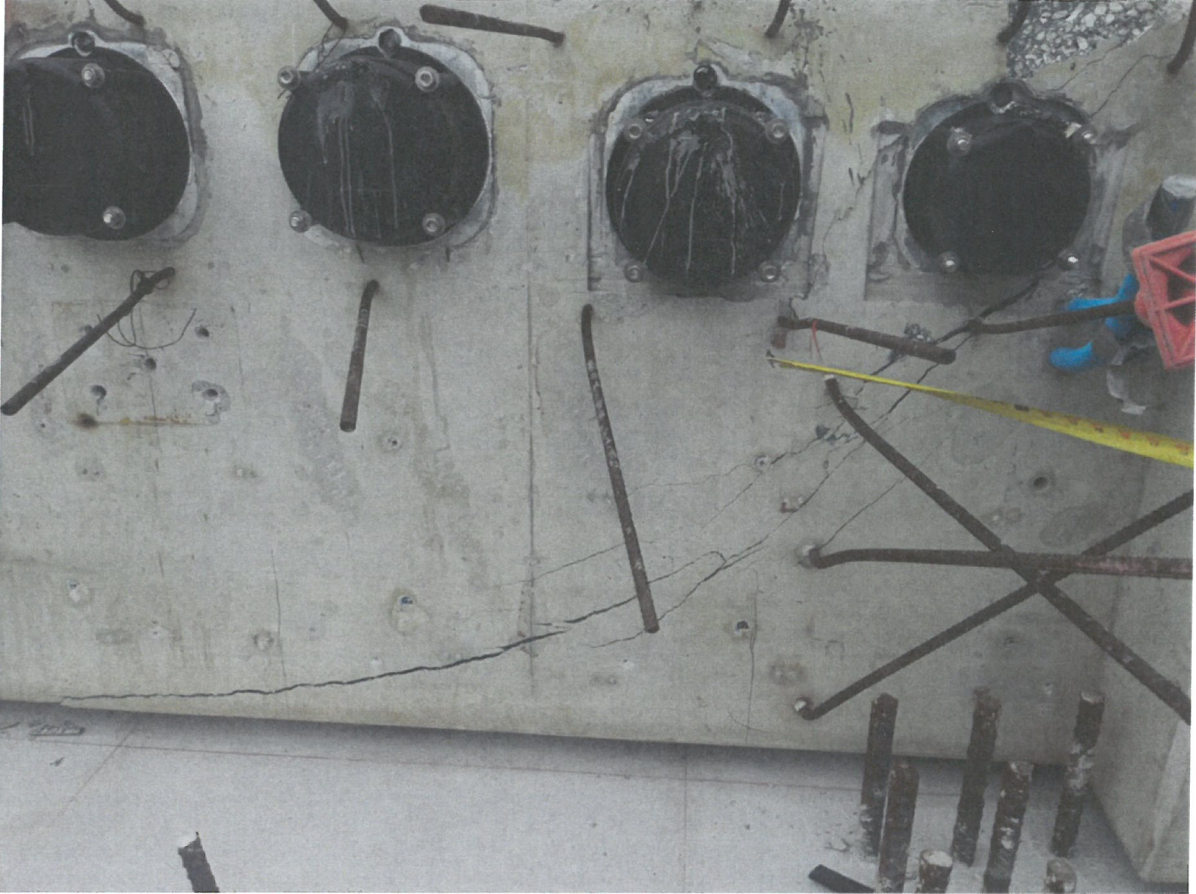
PHOTO 12: Diaphragm 2, Eastside North view cracks

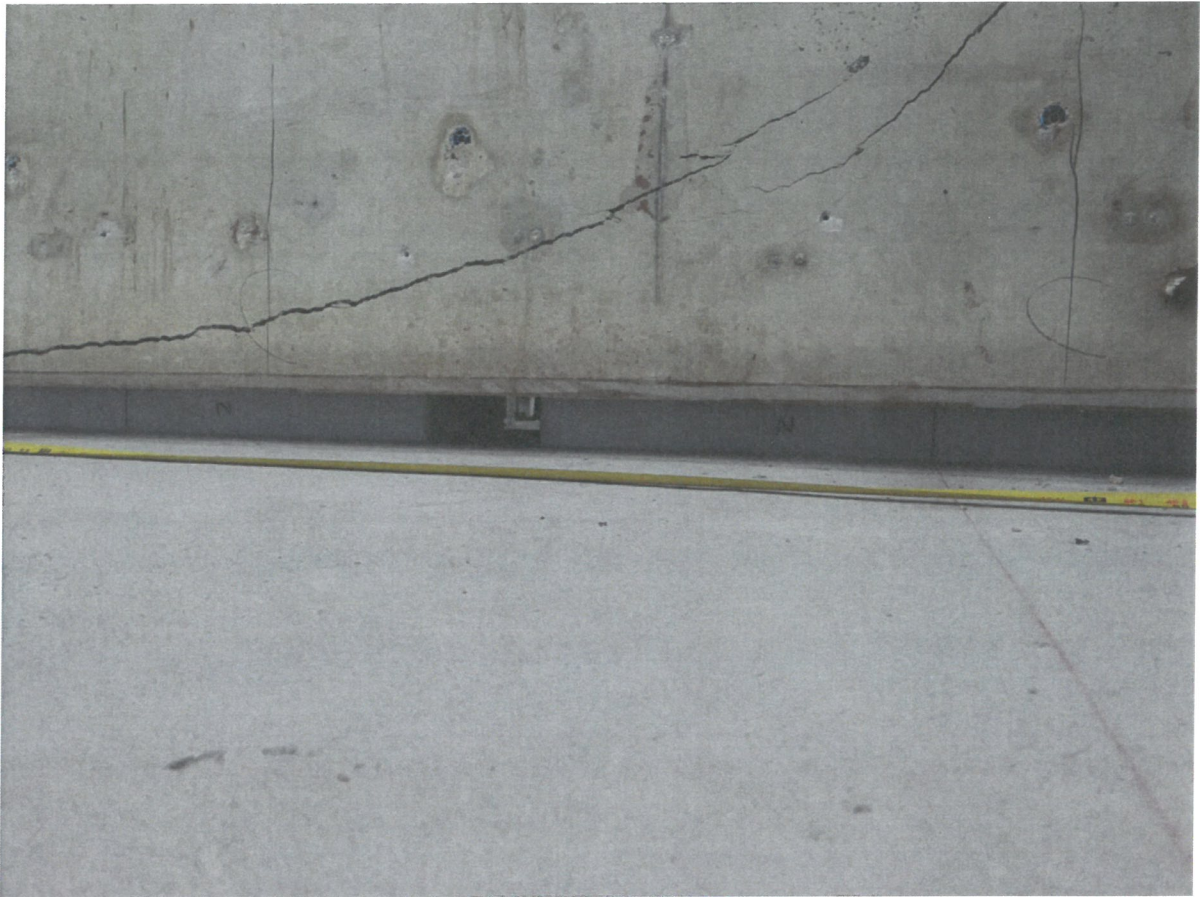
PHOTO 13: Diaphragm 2, Eastside North view cracks

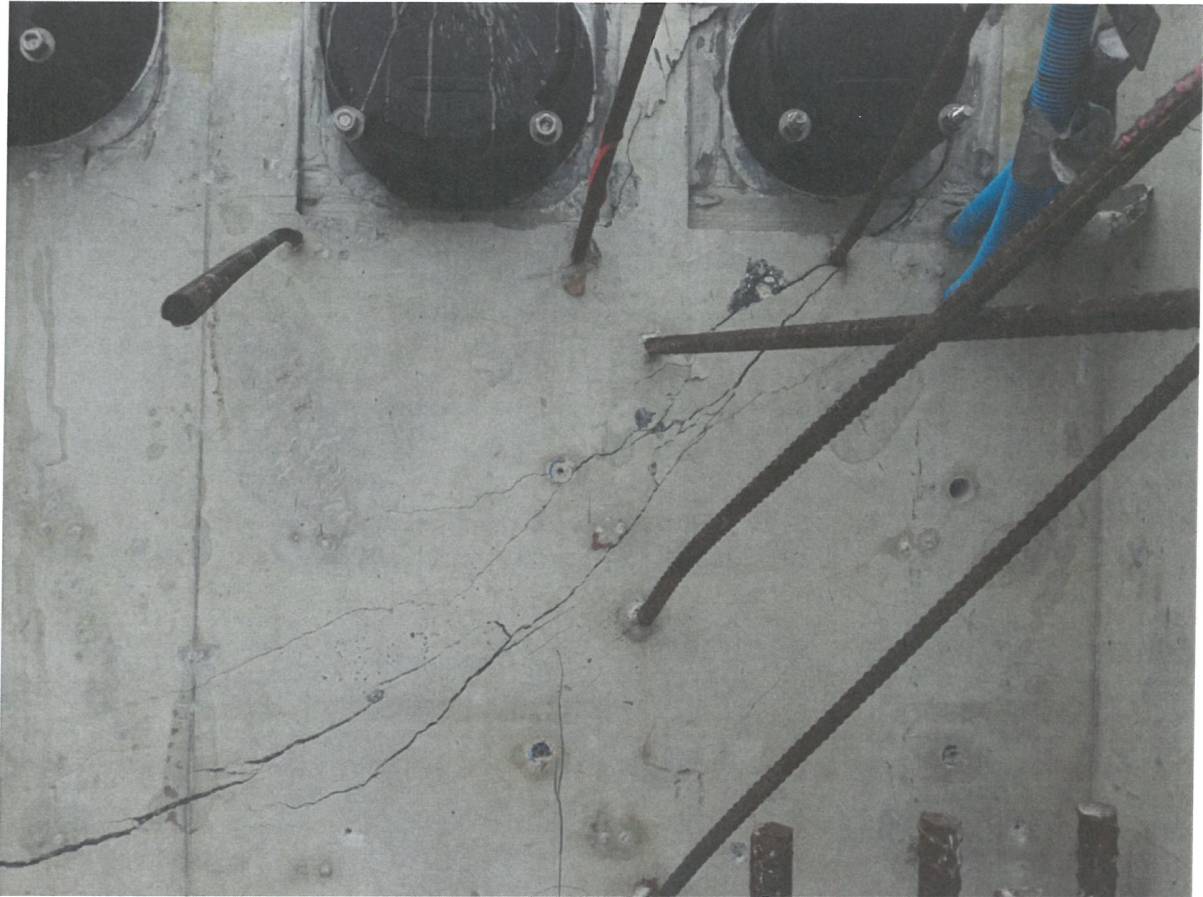
PHOTO 14: Diaphragm 2, Eastside North view cracks

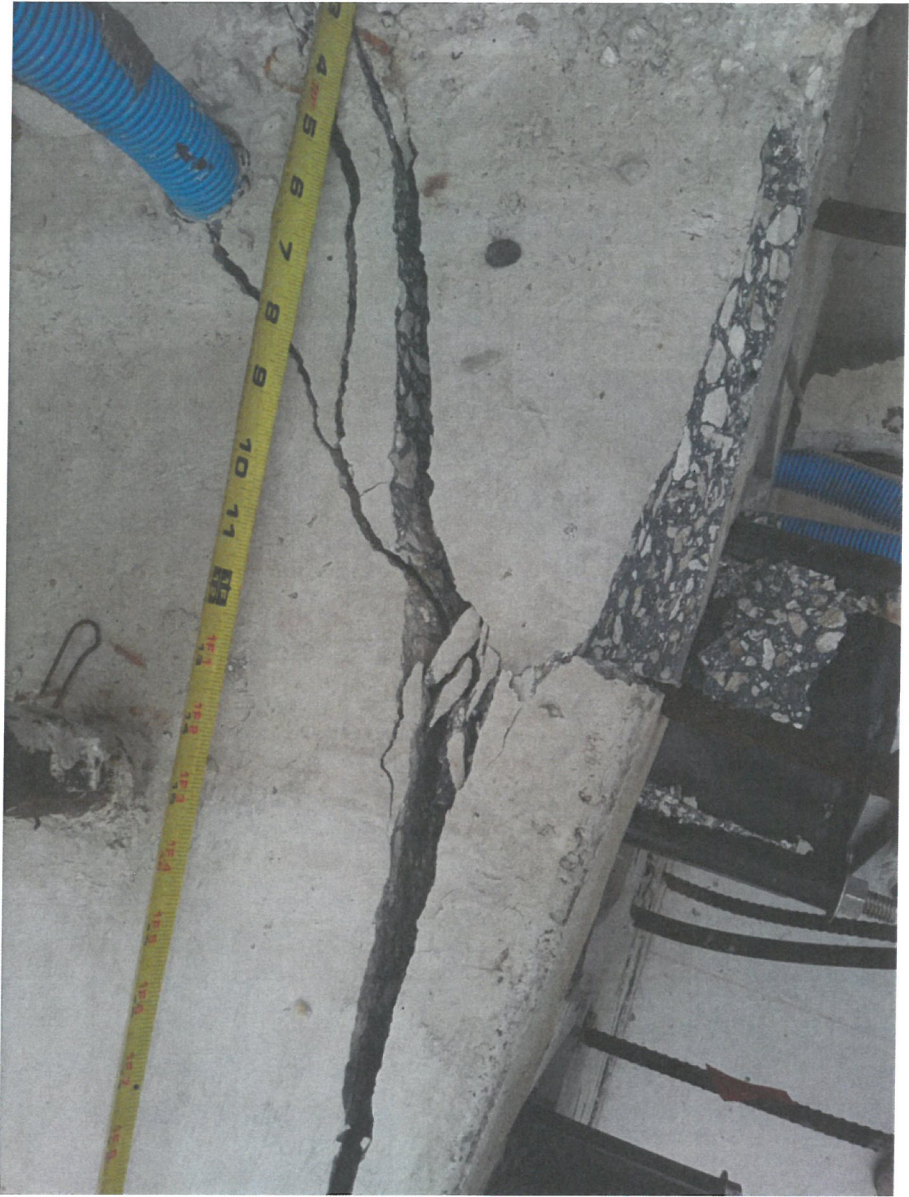
PHOTO 15: Diaphragm 2, Eastside Top view cracks

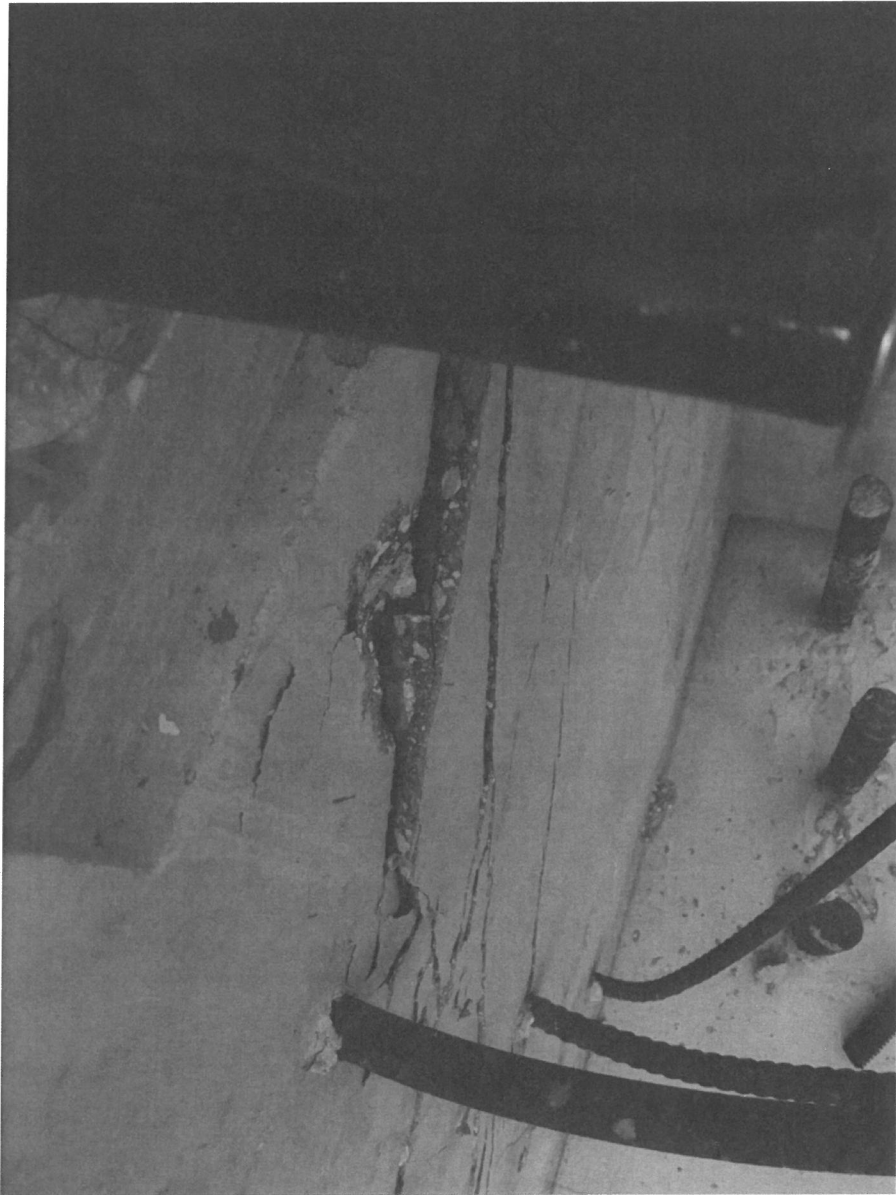
PHOTO 16: Diaphragm 2, Eastside Top/side view cracks
