Attachment 32:

Party photographs – showing evidence of observed sink hole opposite 1642 Park Avenue; subsequent excavations and locations of material facts.

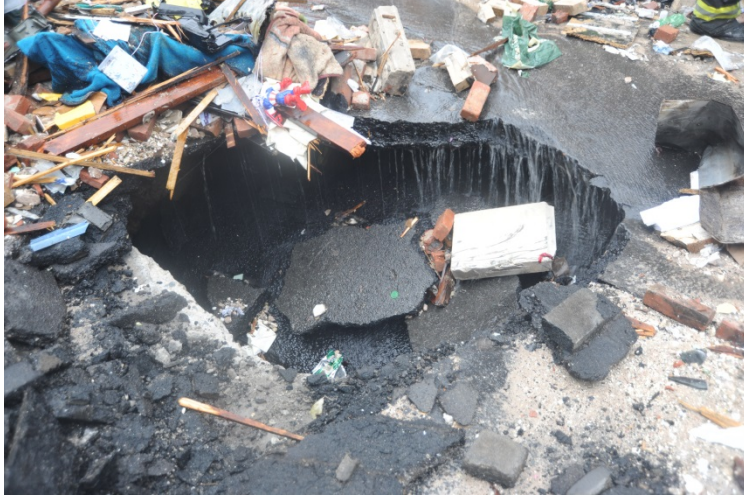
Figure 1: Sink-hole observed at the location of the 12-inch water main break, 8-inch HDPE gas main opposite 1642 Park Avenue during emergency response excavation. Source: FDNY

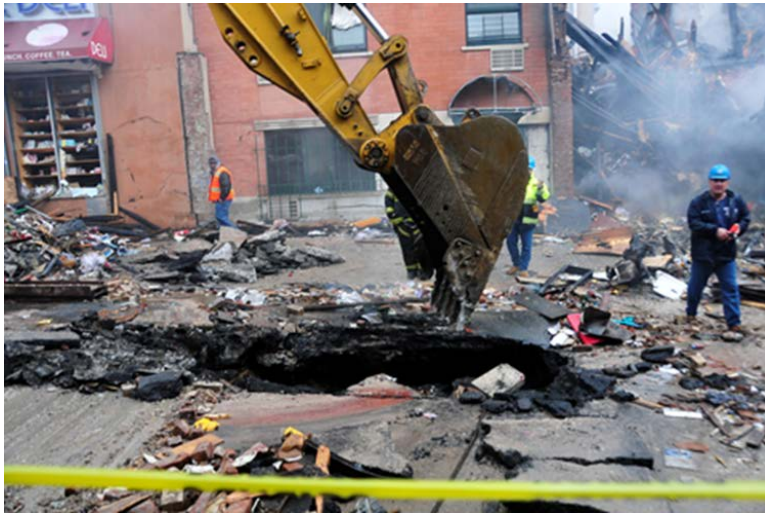
Figure 2: Excavator removing asphalt over 8-inch HDPE gas main, 2-inch HDPE gas service tee to 1642 Park Avenue and 12-inch cast iron water main during emergency response excavation. Source: Con Edison

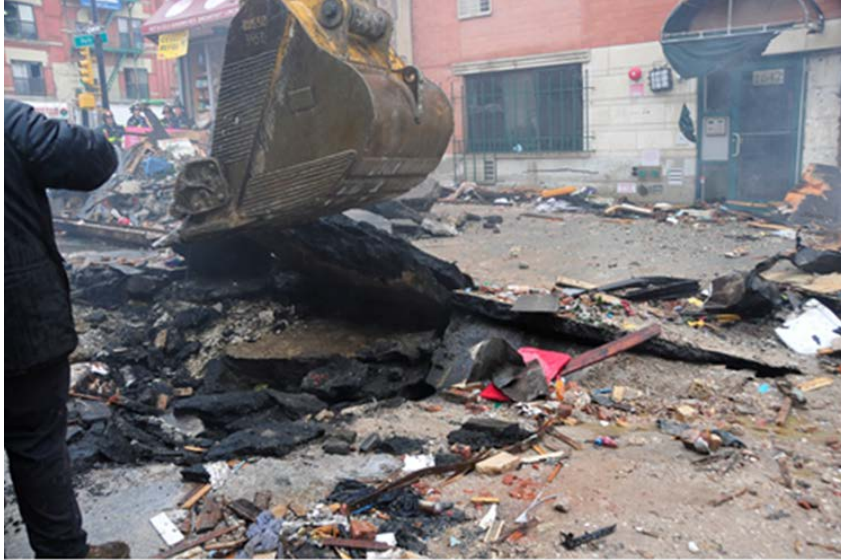
Figure 3: Excavator removing asphalt over 8-inch HDPE gas main, 2-inch HDPE gas service tee to 1642 Park Avenue and 12-inch cast iron water main during emergency response excavation.
Source: Con Edison

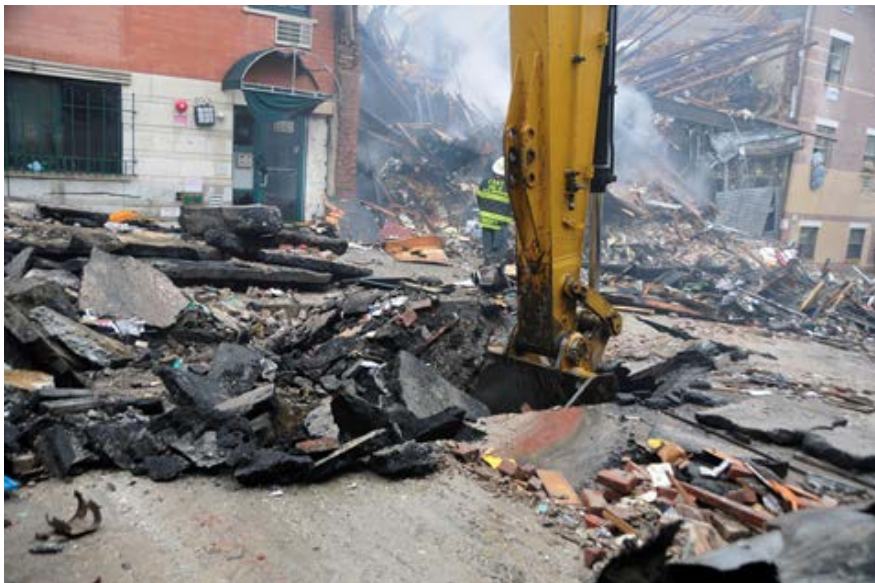
Figure 4: Excavator bucket clearing pieces of roadway pavement (asphalt and concrete) from cavity at 8-inch HDPE gas main, 2-inch HDPE gas service tee to 1642 Park Avenue and 12-inch cast iron water main location during emergency response excavation. Source: Con Edison

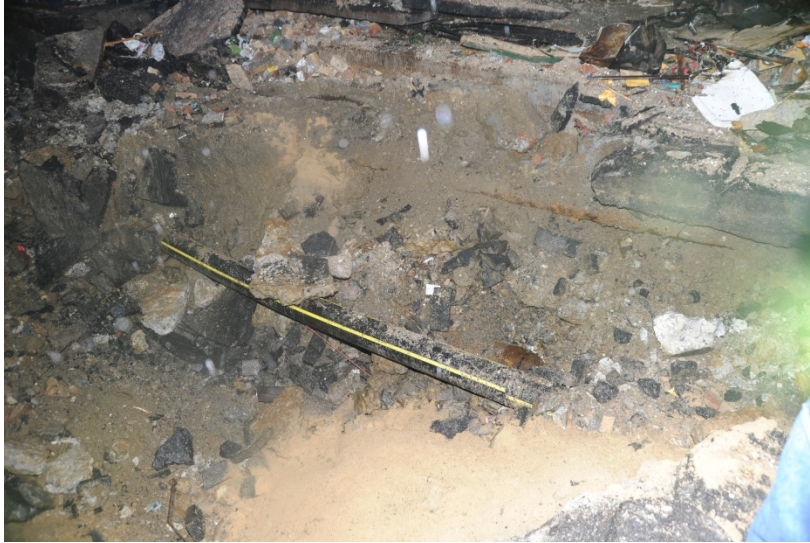
Figure 5: Excavation shows both 12-inch water main break location and 8-inch HDPE going south to 1642 Park Avenue Service tee about 9 feet from water main crack during emergency response excavation. Source: FDNY

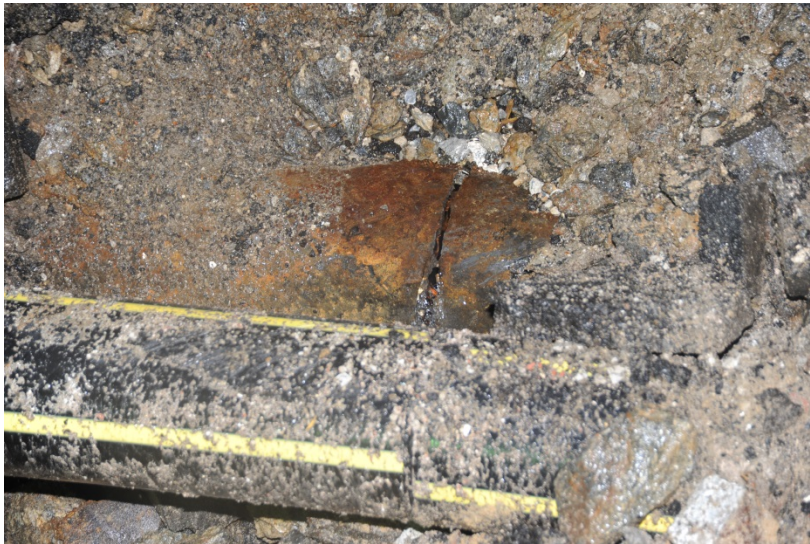
Figure 6: Excavation shows both 12-inch water main break location and 8-inch HDPE during emergency response excavation. Source: FDNY

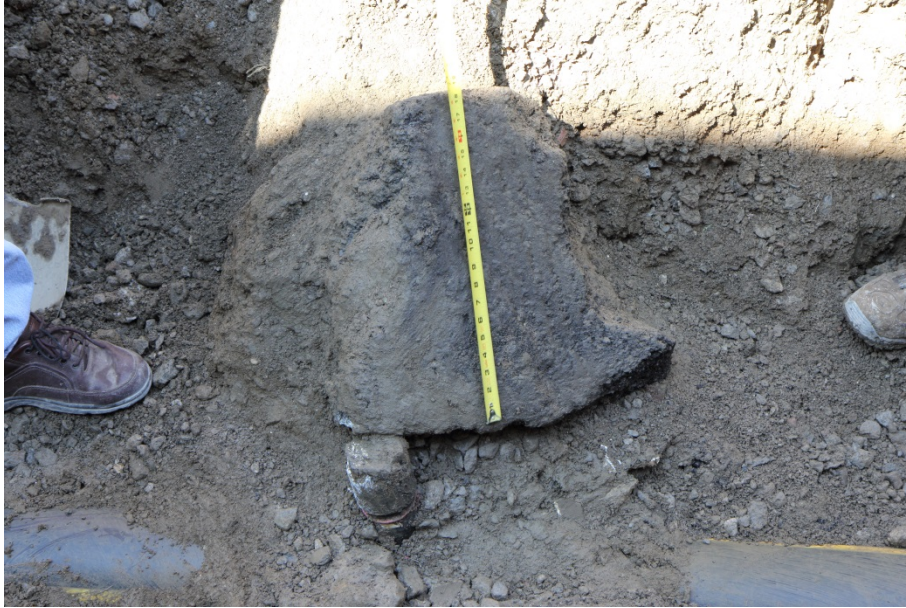
Figure 7: Re-excavation at 1642 Park Avenue shows asphalt piece on top of service saddle tee cap that measured about 19 inches high during field investigation. Source: NYPSC.

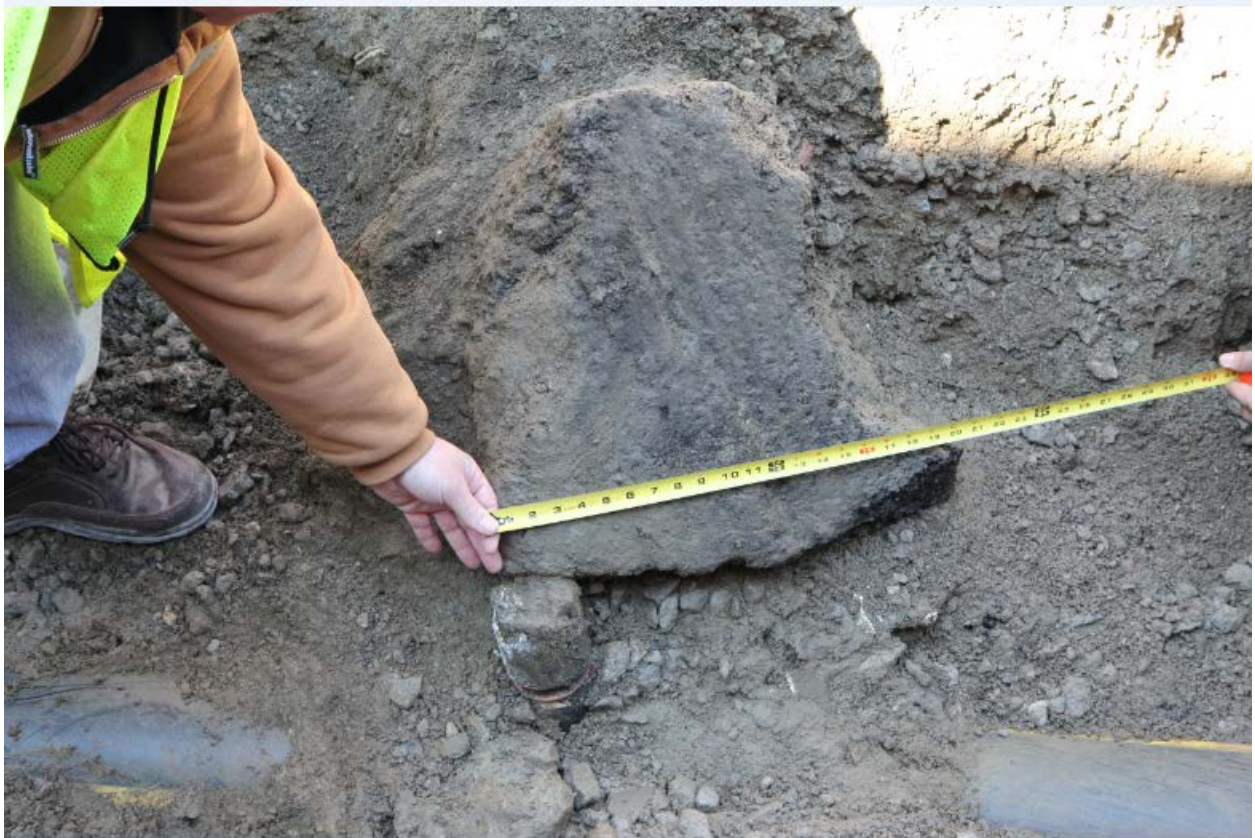
Figure 8: Re-excavation at 1642 Park Avenue show asphalt piece on top of service saddle tee cap that measured about 14-20 inches wide during field investigation. Source: NYPSC
