Attachment 35

NYCDEP Exploratory excavations on Park Avenue

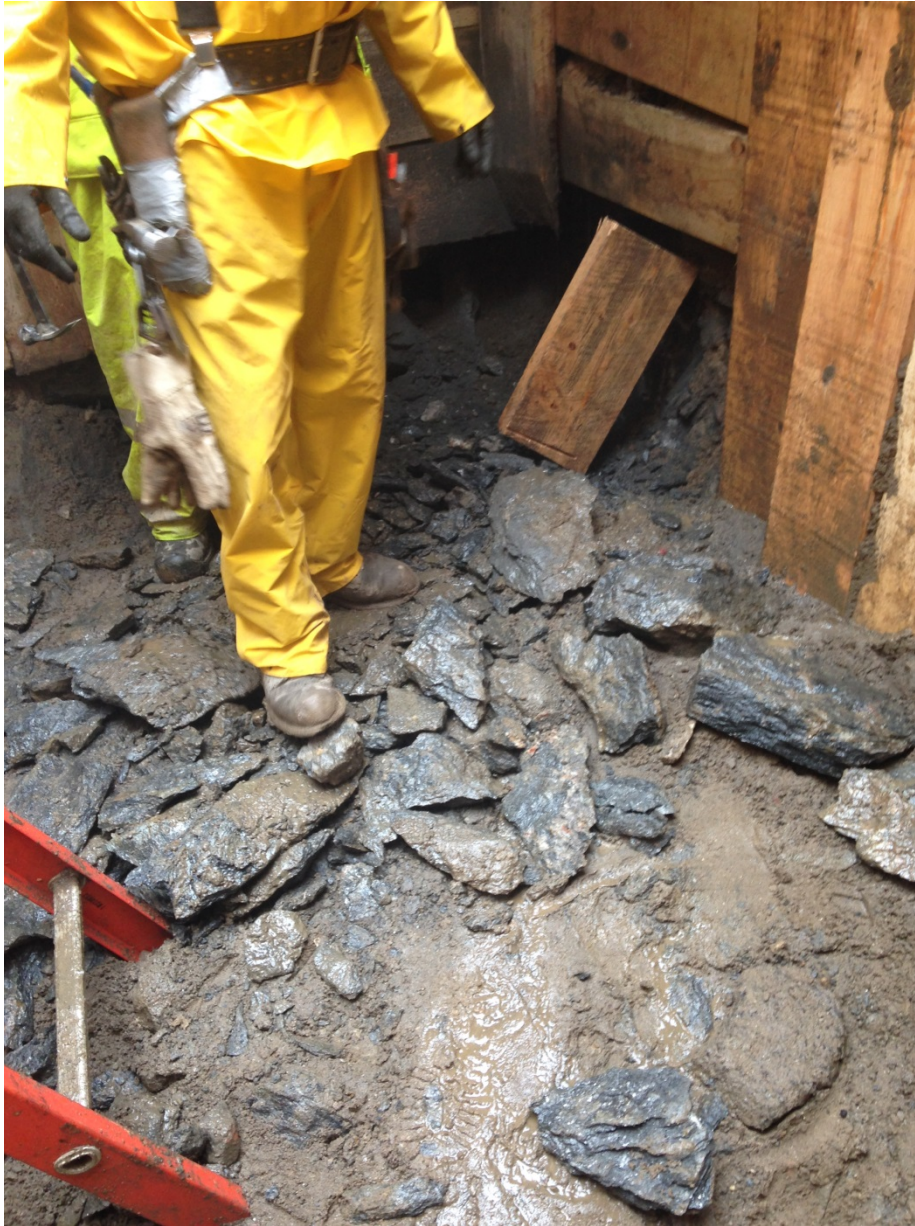
Figure 1: Excavation for the sewer connection at 1642 Park Avenue revealed presence of boulders in the backfill materials. Source: NYCDEP

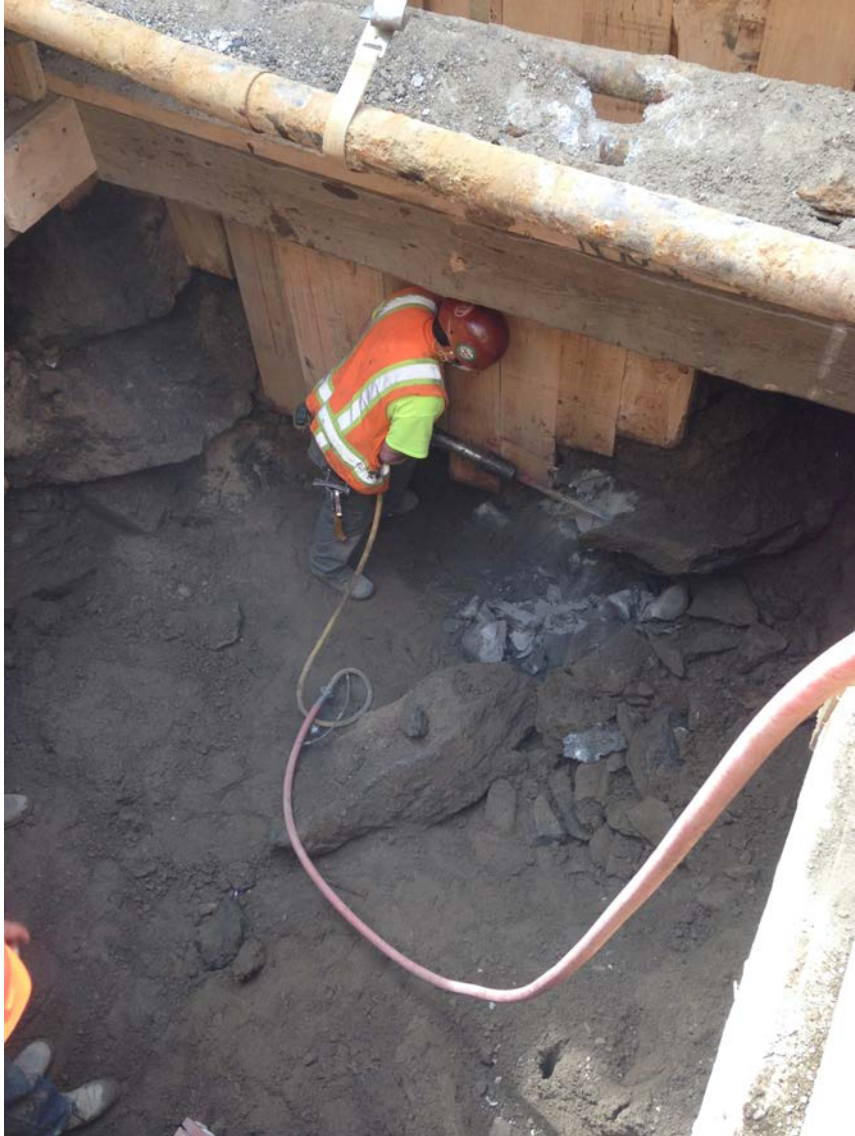
Figure 2: Excavation for the sewer connection at 1642 Park Avenue continued to show boulders in backfill materials being split with drill. Sources NYCDEP.

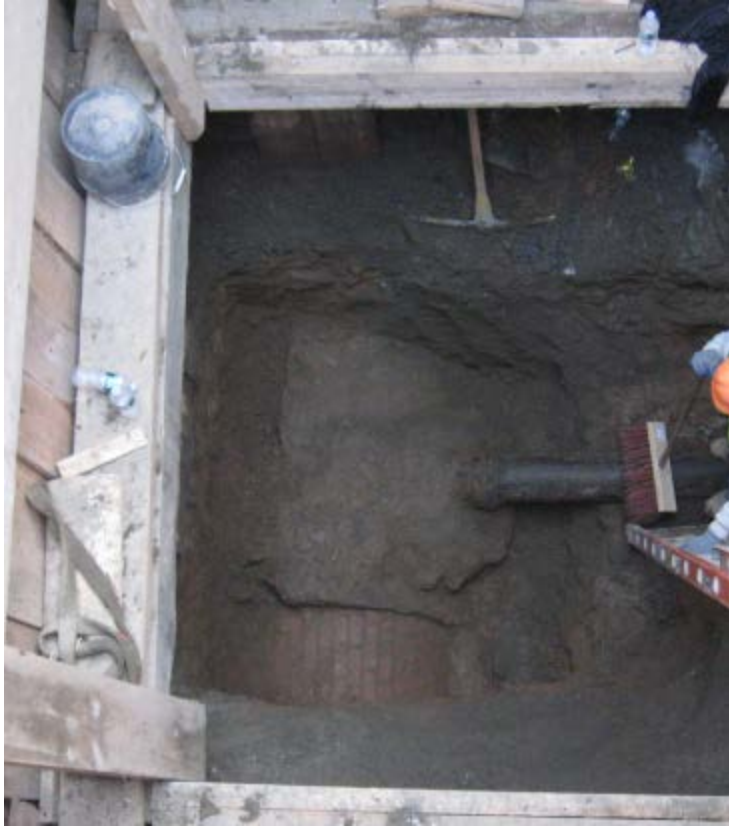
Figure 3: Direct Connection of 1642 Park Avenue lateral into the combined Sewer Main without “a riser”. Source: NYCDEP

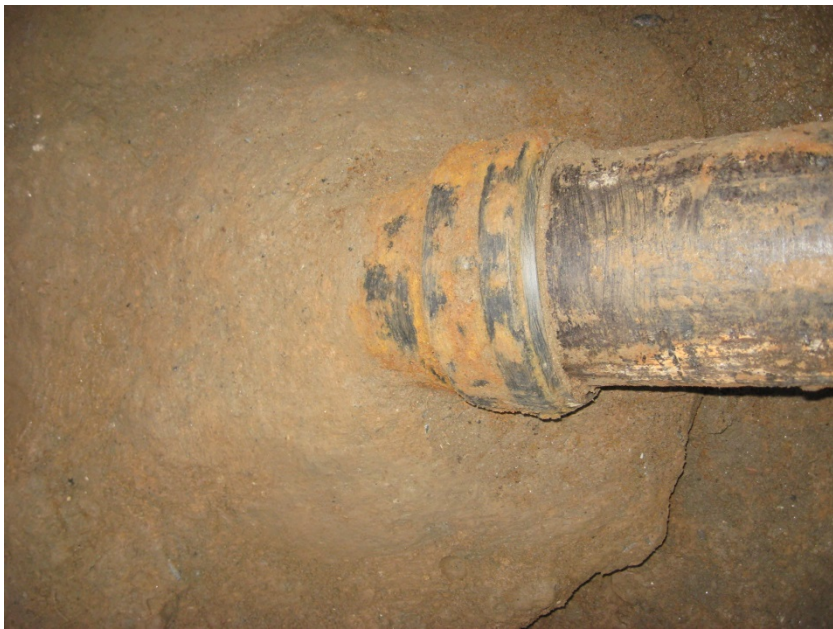
Figure 4: Close north side view of direct connection of 1642 Park Avenue Sewer lateral into the combined Sewer Main without “a riser”. Source: NYCDEP

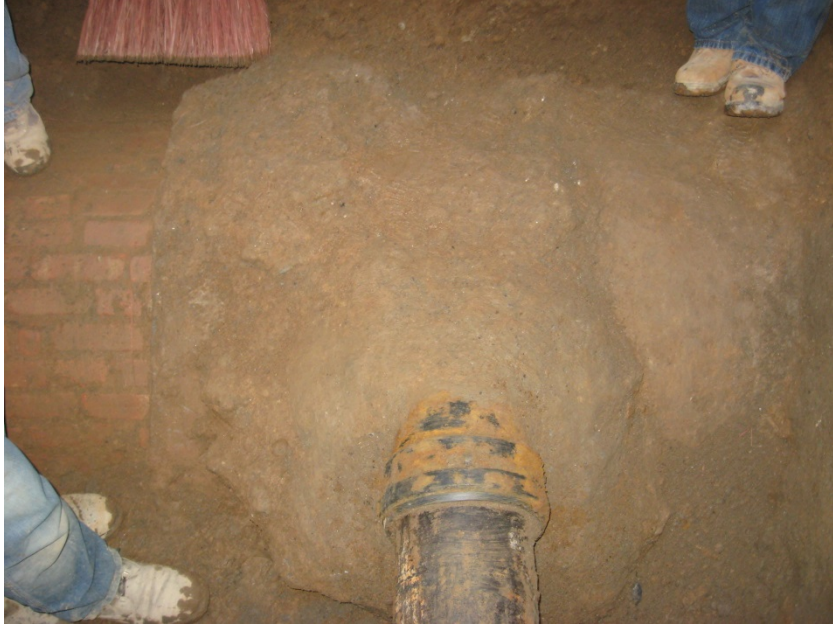
Figure 5: Close top view of direct connection of 1642 Park Avenue Sewer lateral into the combined Sewer Main without “a riser”. Source: NYCDEP
