Federal Railroad Administration
Tank Car Damage Assessment Form

| Reporting Marks | UTLX 643949 | | Car Location City/State | HYNDMAN, PA | |

Car Damage Report

Car Number UTLX 643949

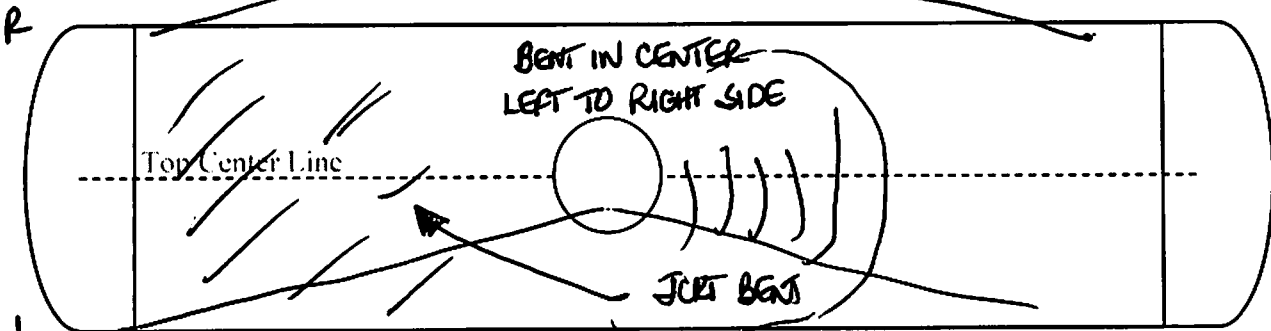
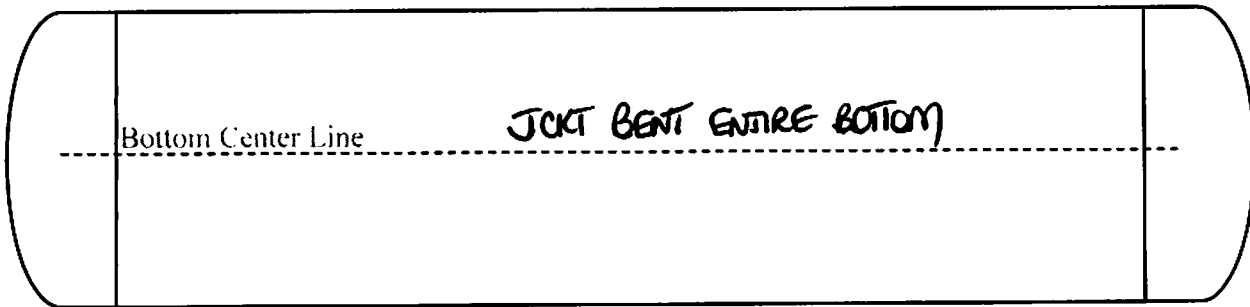
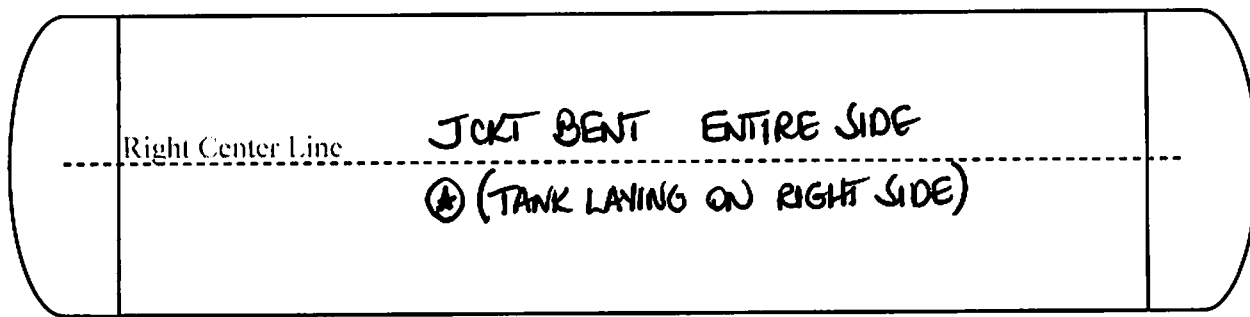
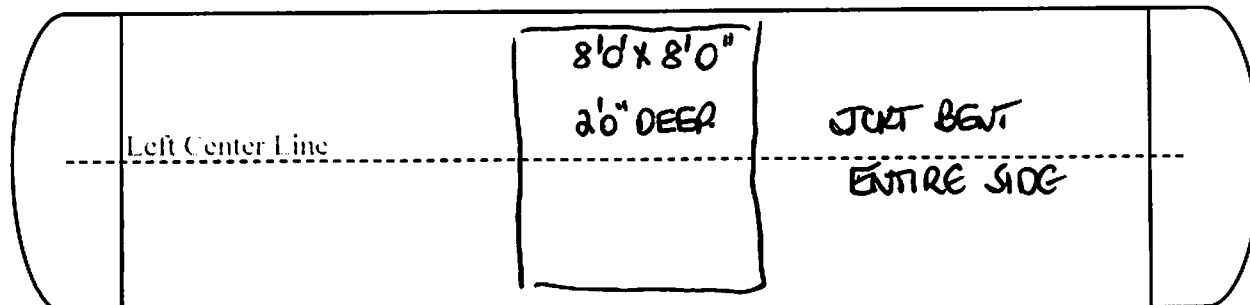
NOTE: BON IN PLACE (OPEN & LEAKING)
NOZZLE/CAP TORN OFF

A END DRAFT SILL TWISTED & BROKEN COUPLER MISSING.
 B END DRAFT SILL IN PLACE COUPLER BROKEN

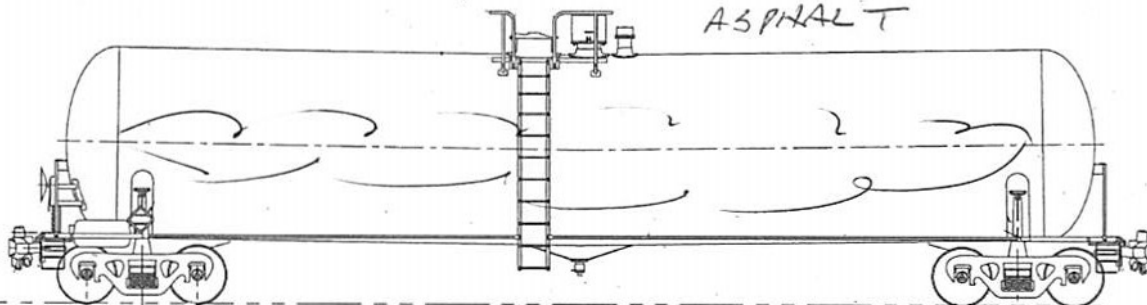
LARGE DENT ON TANK 96" Long 96" W.

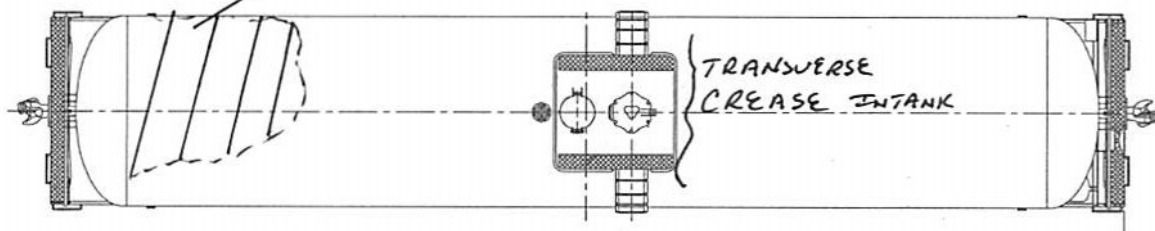
DENT 4' x 3'

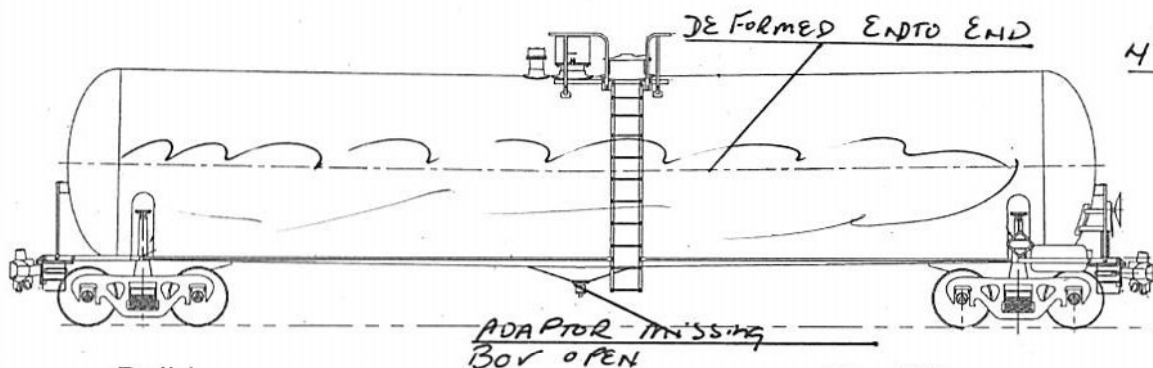
4' x 6' DENT

6' x 7' DENT
