DCA21FA174

POWERPLANTS

Specialist's Factual Report - Attachment 5
No. 1 Engine Fuel System, Disassembly Examinations

October 5, 2022

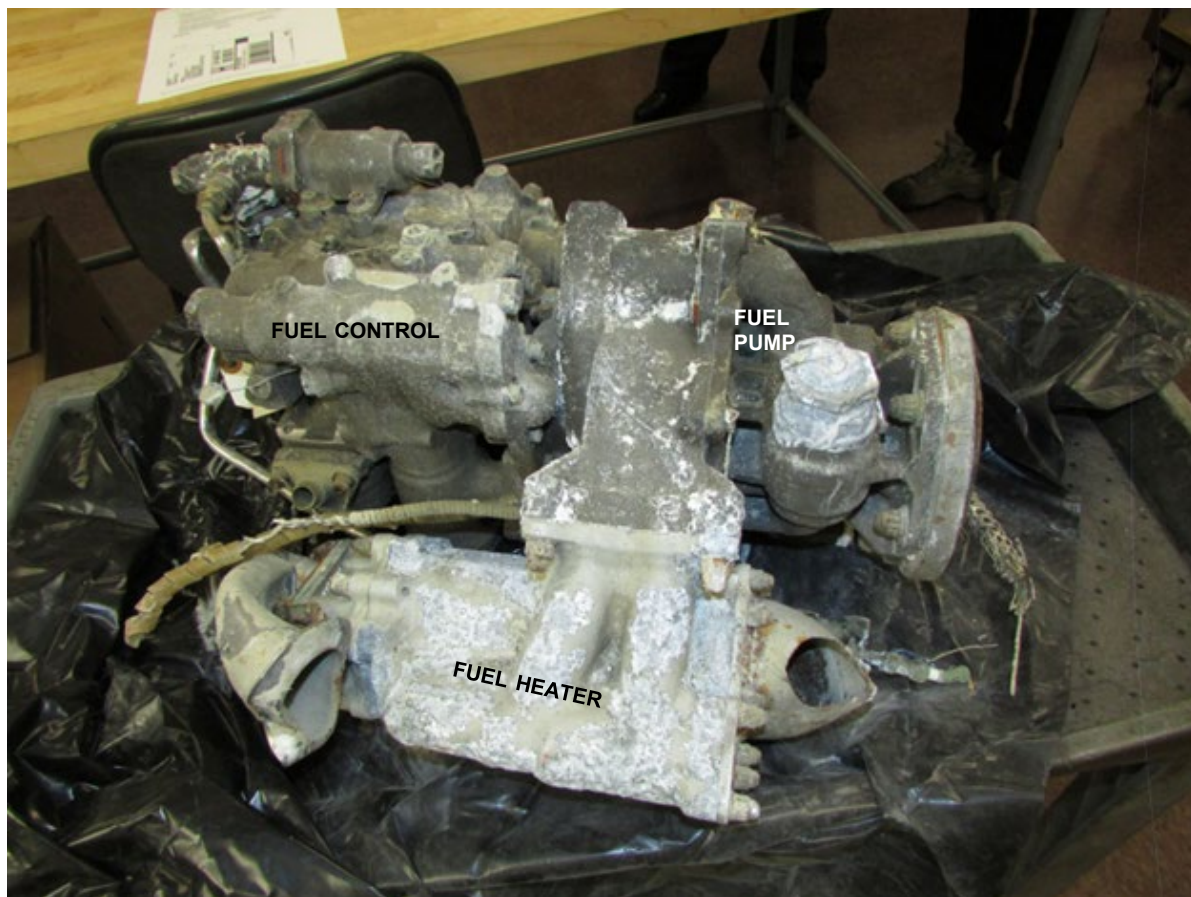
The assembly was immersed in ocean water for approximately 4 months. See Figure 1.

Figure 1 No. 1 engine fuel component assembly

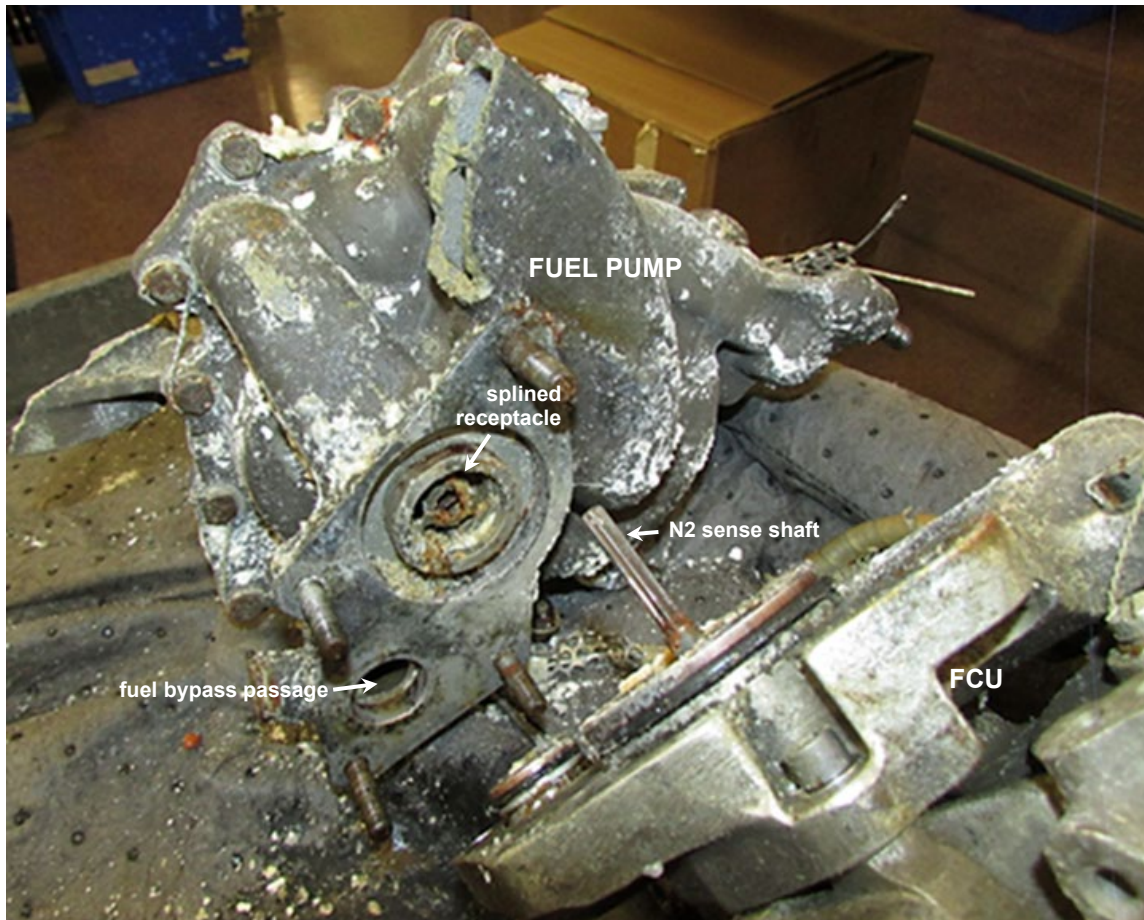
Figure 2 Fuel pump separation from FCU

The cast aluminum alloy housing and cover exhibited a white powdery coating that was easily removed. No surface corrosion was noted on the housing/cover surfaces where the deposit were removed. The steel components exhibited heavy corrosion consistent with saltwater immersion. The MGB drive pad mounting adapter and attachment clamp were attached to the drive side of the pump. The fuel heater was still attached. A segment of fire loop was attached by clamp. The filter bowl was fractured from the pump gear housing; the filter bowl and the associated components were missing. The bypass valve housing was fractured, and the bypass valve was missing. The gearbox end of the driveshaft was fractured at a 45 degree angle in the necked-down area and was missing.

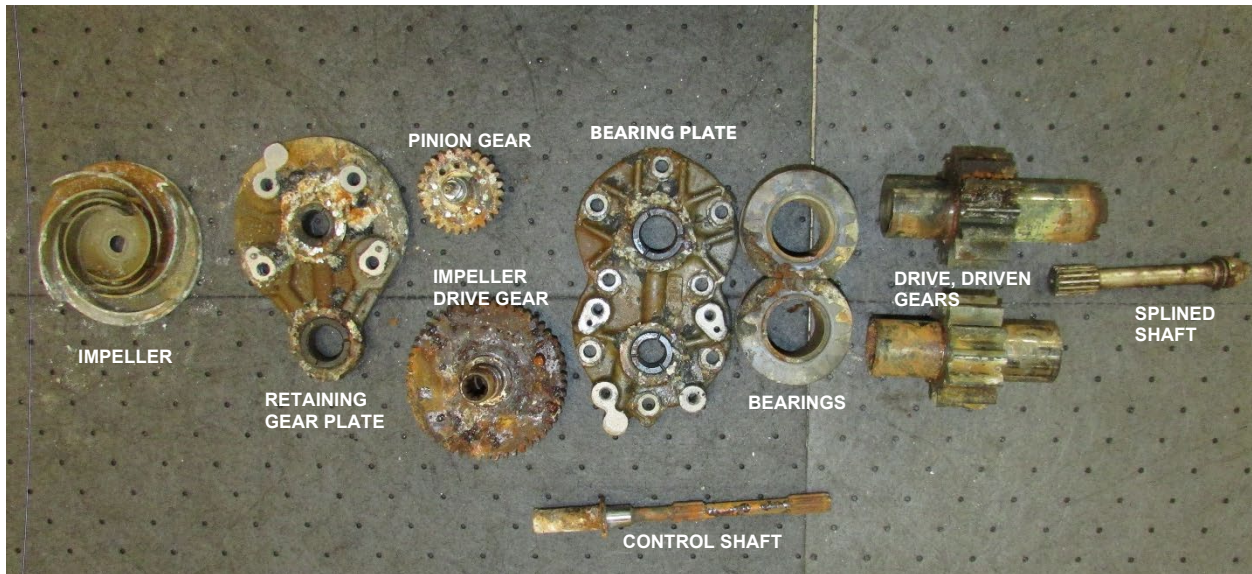
The internal steel components of the fuel pump were heavily corroded; however, the fuel pump was disassembled without difficulty. The pump gear train was intact from the main drive shaft fracture to the N2 sense shaft drive spline, including the pump impeller. All fasteners were found present and secured. Assembly fitting fluid was observed. See Figure 3.

Figure 3 Fuel pump drive components

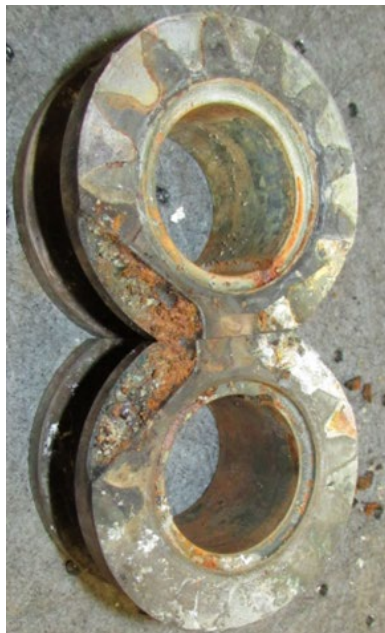
Both the main drive gear and the main driven gear, including their internal splines, were in good condition. The drive and driven pumping teeth were intact. No milling or cavitation erosion was found on the gear stage fixed and floating bushing thrust faces. The bushing journals showed no abnormal wear. No damage was noted to the bearings and bearing bores. The main stage gear housing bores exhibited no rotational scoring. No cavitation erosion was found at the inlet or discharge windows. See Figures 4 and 5.

Figure 4 Drive bearings

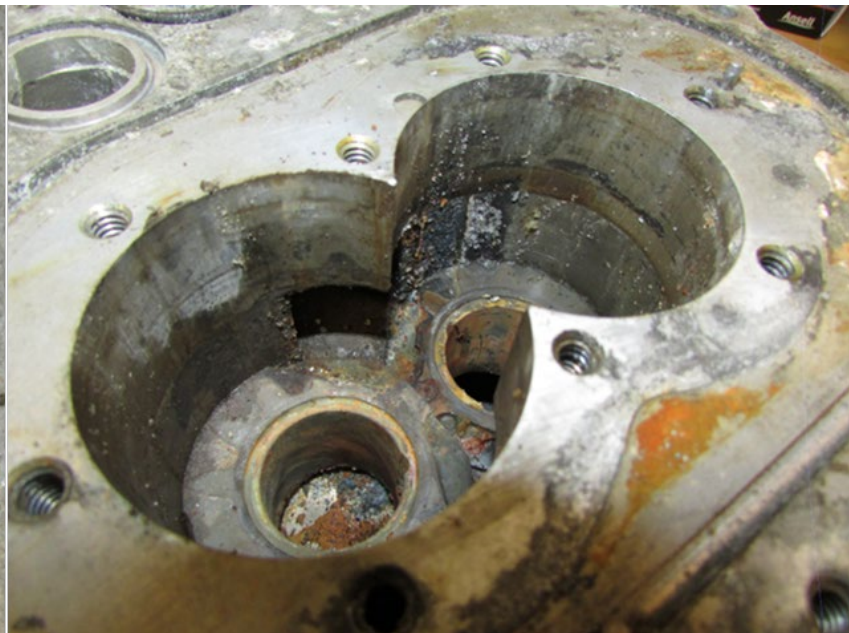
Figure 5 Gear housing bores

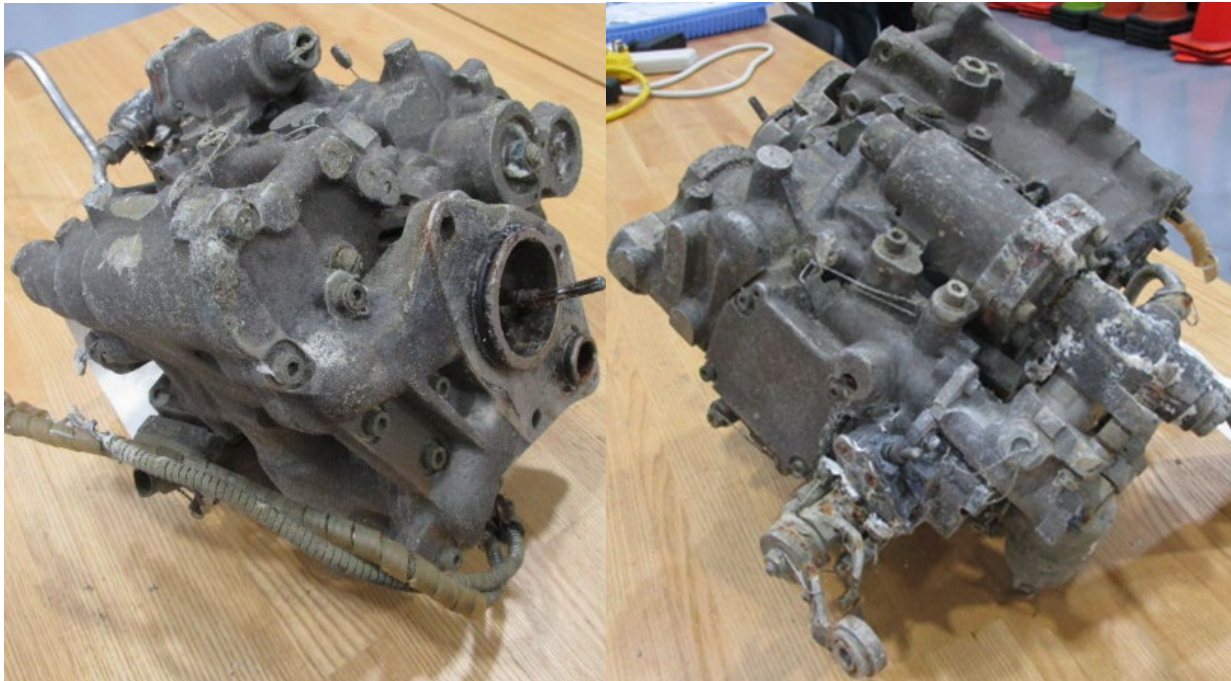
Examination of the FCU noted that the steel components were rusted. A white powdery substance coated the cast aluminum alloy housing and cover. The substance was easily removed, and no surface corrosion was noted underneath. The power and run/shutoff levers were bent, and the power lever was fractured. Portions of the trimmer housing and the idle and MIL trim adjustment mechanisms were fractured off. The driveshaft and collar (N2 sense shaft) was bent but intact. The shutoff valve signal pressure tube was distorted. The metered flow outlet tube was fractured adjacent to the flange. The throttle valve transfer tube & restrictor plug was fractured off. See Figure 6.

Figure 6 FCU as received, two views

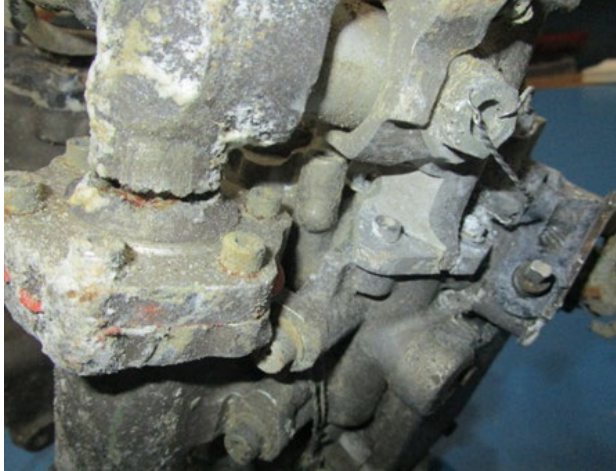
The compressor inlet temperature (CIT) sensor head was missing. The bolted flange at the control end of one of the CIT tubes was fractured off and the two attachment bolts were sheared. The hydraulic housing was scraped along its engine-facing surface in the area of the pressure regulating valve. The compressor discharge pressure (CDP) bellows cover plug & bleed head was corroded, and the head was missing. The CDP limiter housing was fractured 360° above the flange. See Figure 7. The flexure (bellows) cover was in place but was fractured and separated at the flange attachments. See Figure 8.

Figure 7 Fractured CDP limiter housing

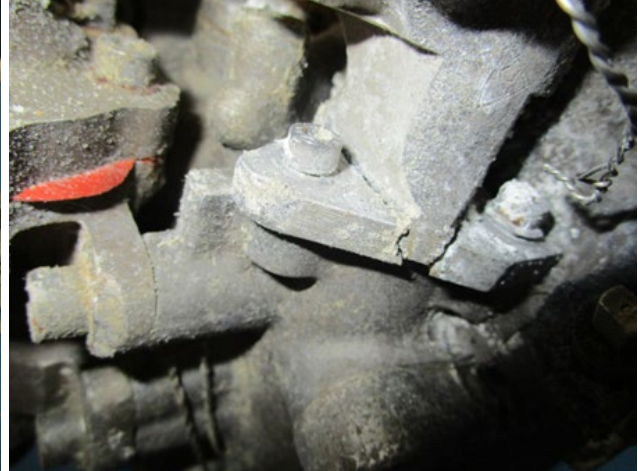
Figure 8 Motor bellows cover flange fractures

It was not possible to pressure check the motor bellows as installed due to the cracked housing. Instead, a hose was attached at the end of the motor bellows and 25 psig of shop air was applied. The pressure was deadheaded for two minutes, with no leakage noted.

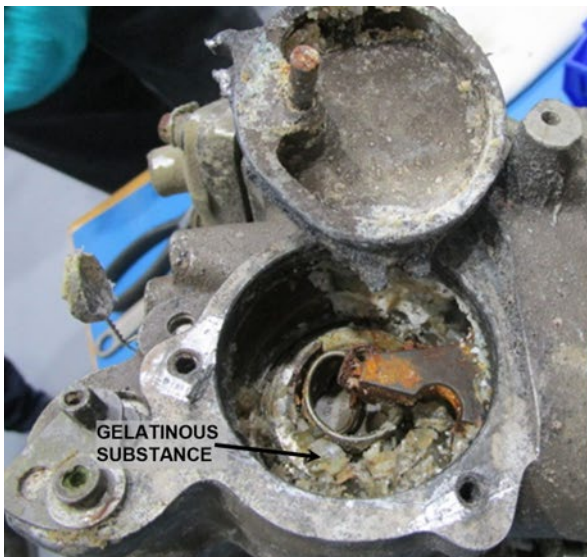
The throttle valve cover was removed, exposing the multiplying bracket assembly and helical compression spring. The throttle valve cover material was deteriorated consistent with corrosion damage; this material crumbled during removal. A gelatinous substance was present in the bore.⁴ Corrosion was noted on the multiplying lever and the valve piston, and on the extension spring. See Figures 9 and 10.

Figure 9 FCU throttle valve bore showing multiplying lever and extension spring

⁴ This substance was found throughout the control. It had a strong fuel odor. It was whitish-gray in color and crystalline in appearance and had a slippery, waxy texture that easily broke into smaller chunks and became a paste when rubbed.

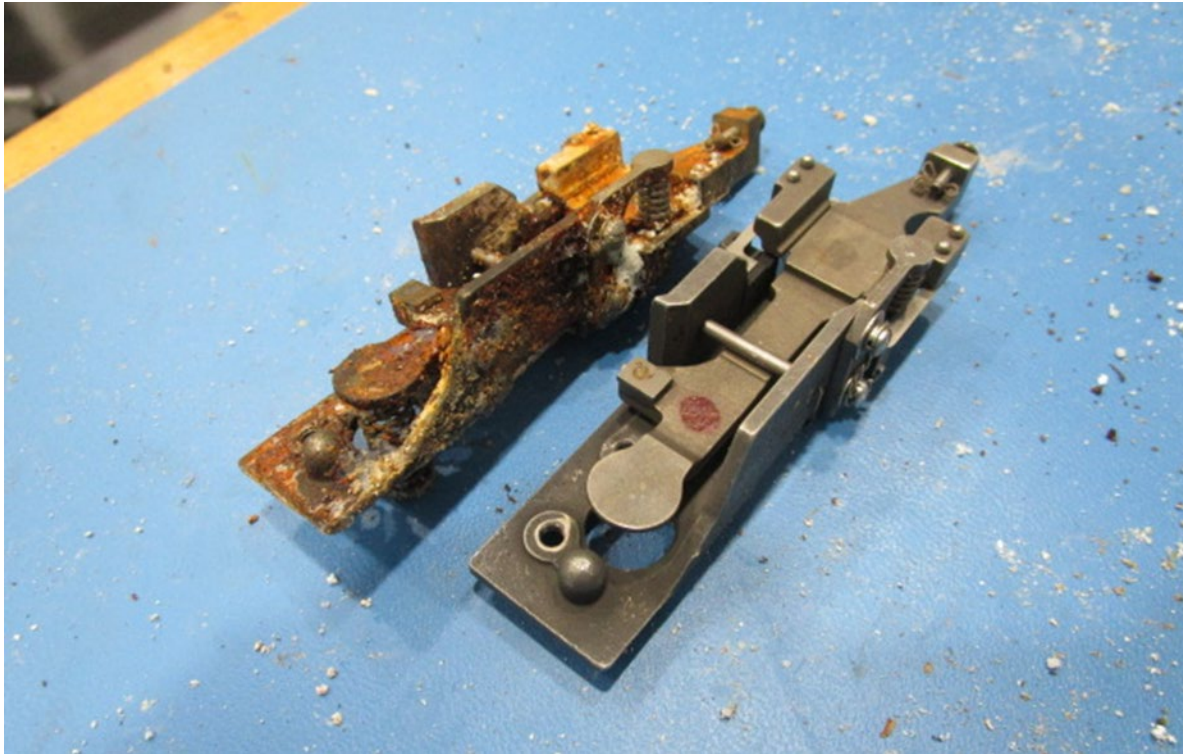
The multiplying lever and springs were heavily corroded but were intact. The lever moved smoothly with light pressure as assembled. The resistance was consistent compared to the exemplar FCU. After removal from the housing, the multiplying lever assembly function was compared with an exemplar assembly. The functioning was the same. See Figure 11.

Figure 11 Multiplying lever assembly with exemplar

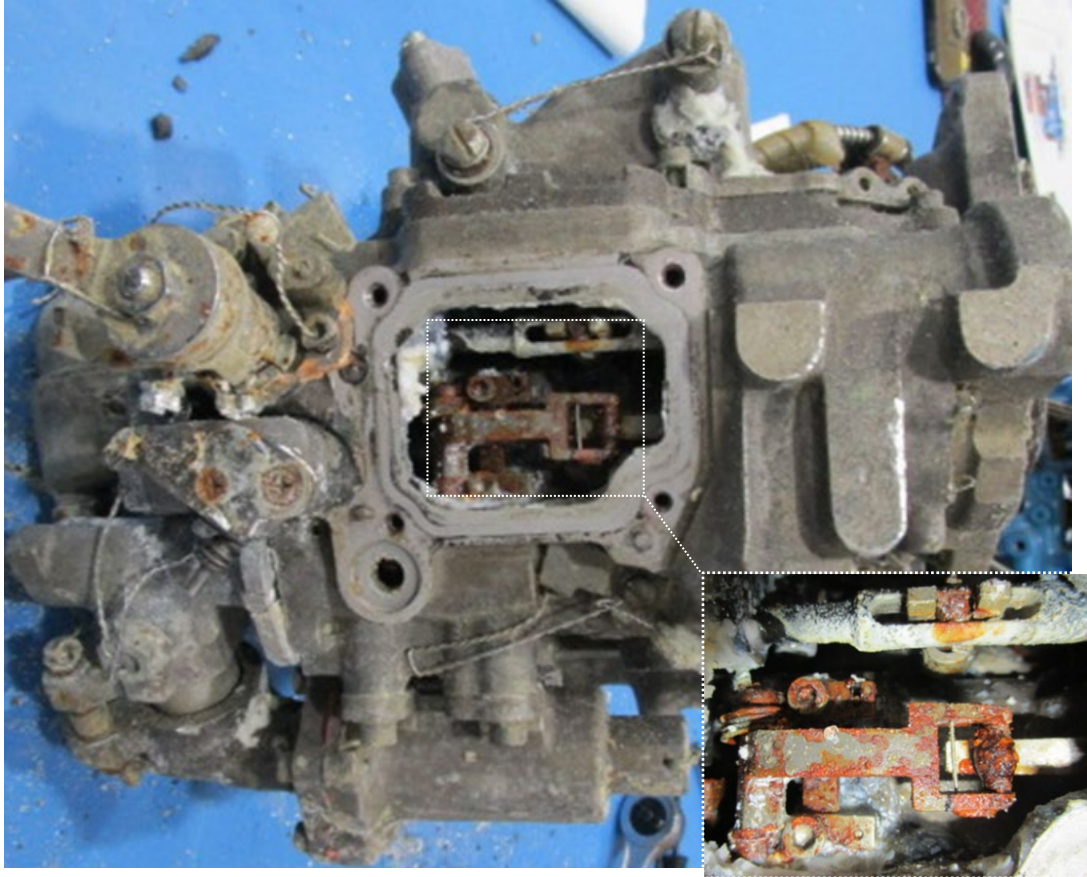
Figure 12 Reset bracket & speed setting lever in linkage housing cavity

The reset lever moved when pulled back but did not reset when released. The compressor inlet temperature (CIT) servo piston was viewable; no damage was noted.

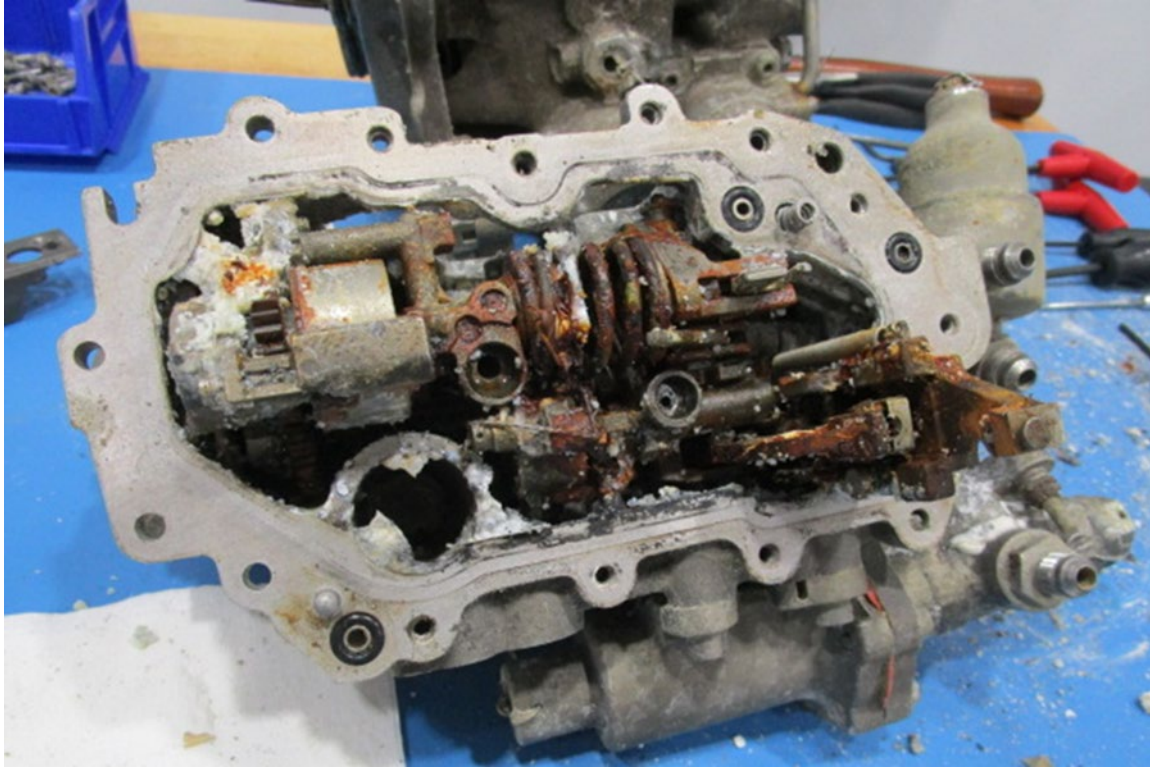
The linkage housing was separated from the hydraulic housing. The mating O-ring was in good condition. Both leaf springs were intact. More of the gelatinous substance was found inside the linkage housing cavity. See Figure 13.

Figure 13 Linkage housing components exposed (gelatinous substance removed)

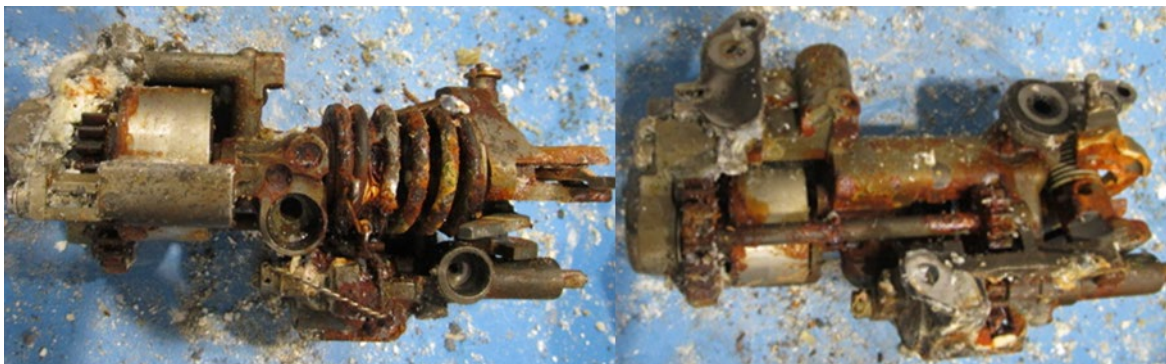
The pilot valve housing group was removed from the linkage housing. The flyweight head assembly, the throttle valve pilot valve, and the pilot valve were heavily corroded/rusted. The viewable springs and linkages were intact. The springs were operable. The drive line and gear teeth were intact but the gear train was seized in place with corrosion. The pilot valve housing group was not disassembled. See Figure 14.

Figure 14 Pilot valve and housing group, two views

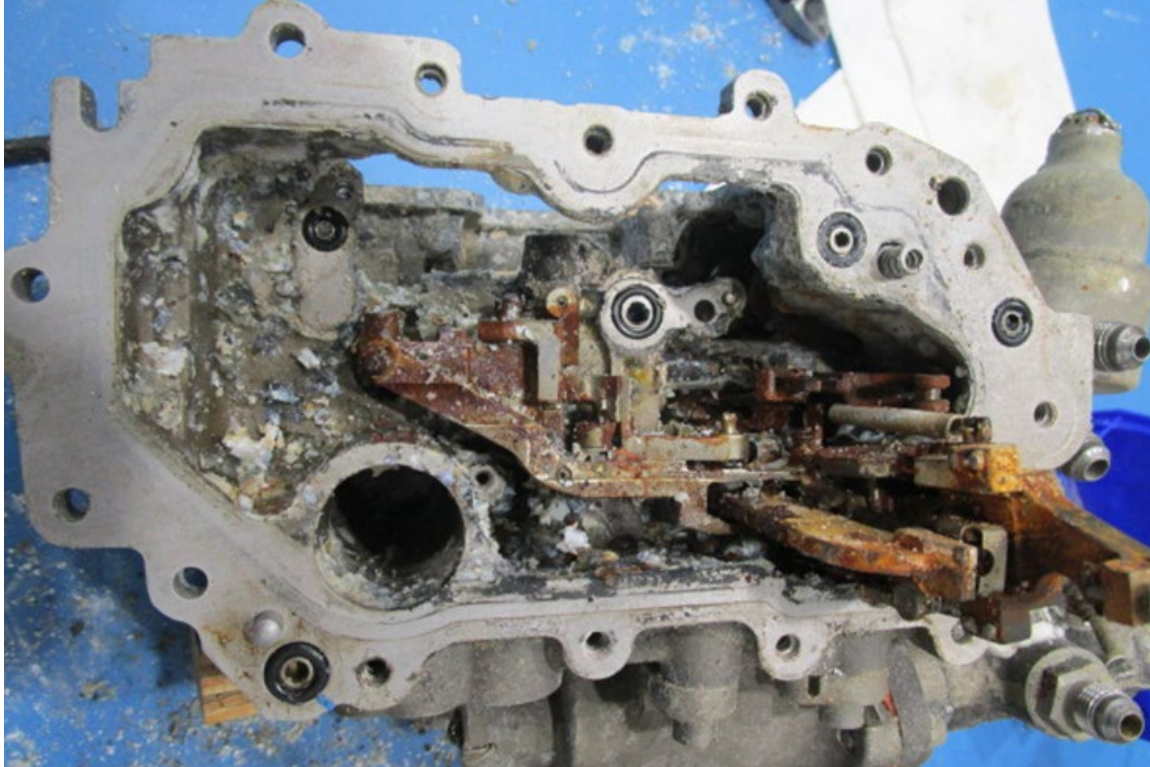
The limiting linkage group assembly was corroded. See Figure 15.

Figure 15 Limited linkage group in linkage housing

The linkage pivoted normally on its pin. Once the linkage assembly was removed all of the pieces moved smoothly. All the parts including the springs were intact. The push bar rollers appeared full diameter, and rotated with light finger pressure.
