Federal Railroad Administration
Tank Car Damage Assessment Form

Reporting Marks	SUJX 299124		Car Location City/State	HYNDMAN, PA	
Date inspected	8/5/17	Railroad	CSX	DOT Specification	DOT-111A100W-1
Last Contained	SULFUR 2448		Was product released?		
(Jacket thickness)	Jacket YES	Non-jacketed	Does car contain product		
Car builder	TRINITY	Stub Sill Design		Built Date	
Capacity (GAL)	13902		LD Limit (LB)

Car Damage Report

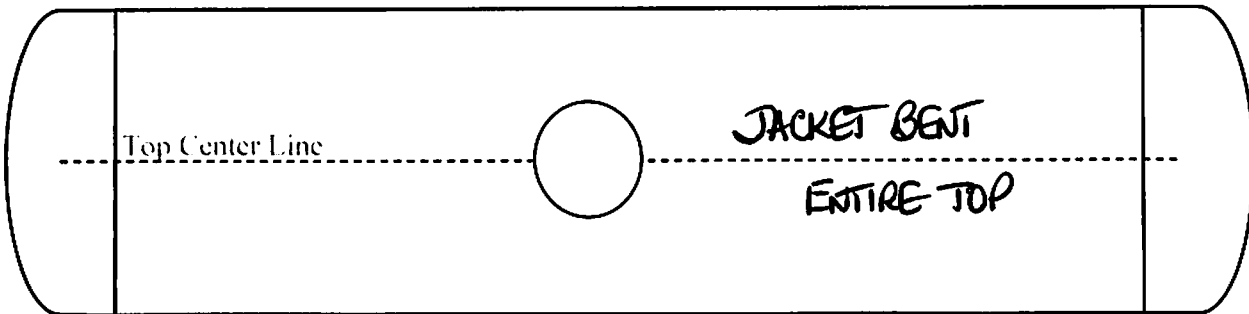
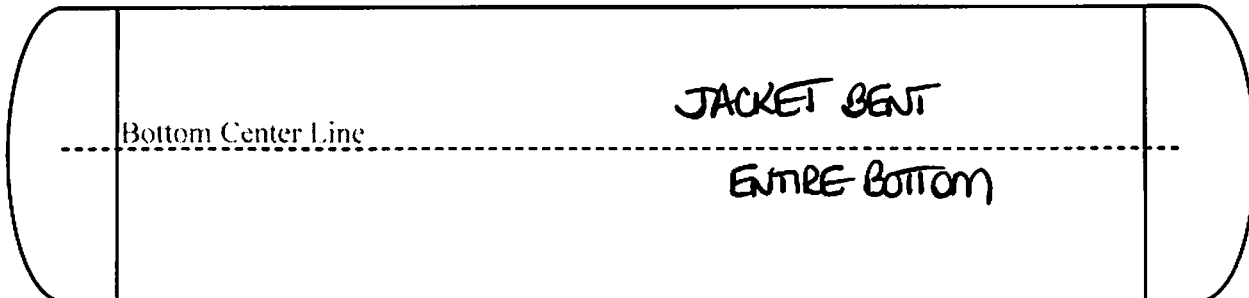
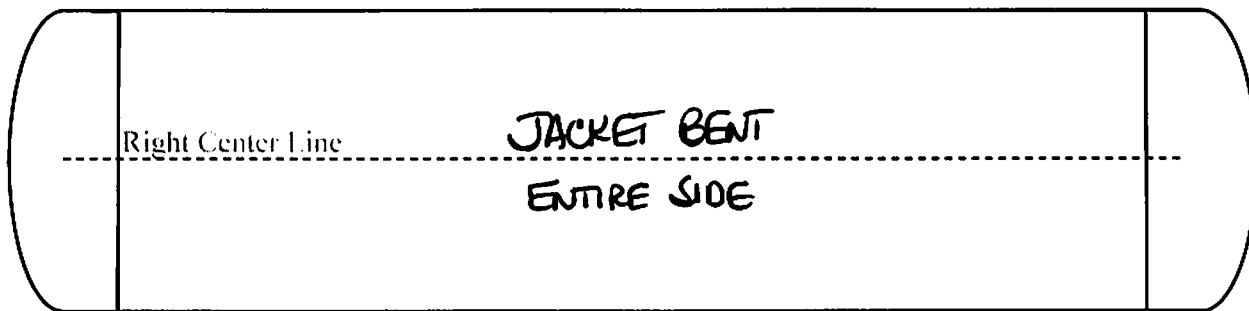
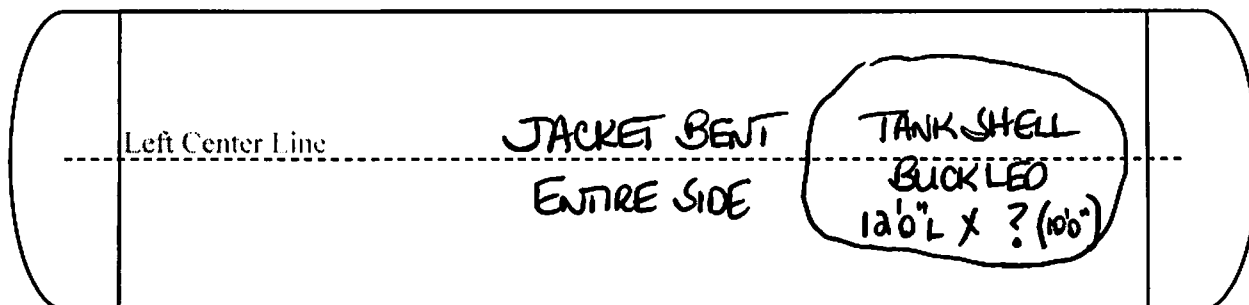
BEND

NOTE: ALL 4 BODY BOLSTERS BENT

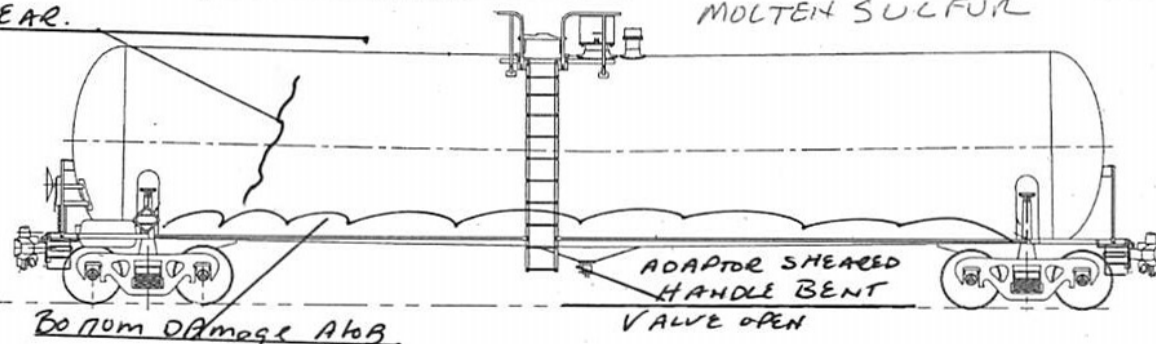
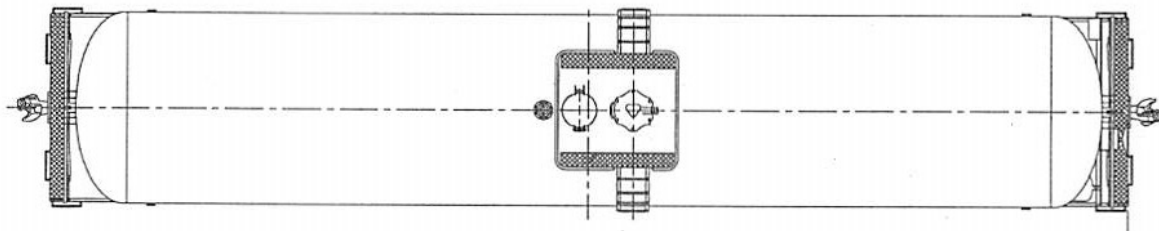
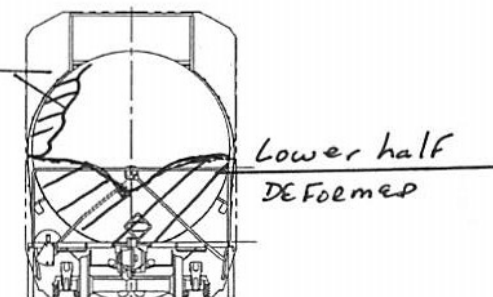
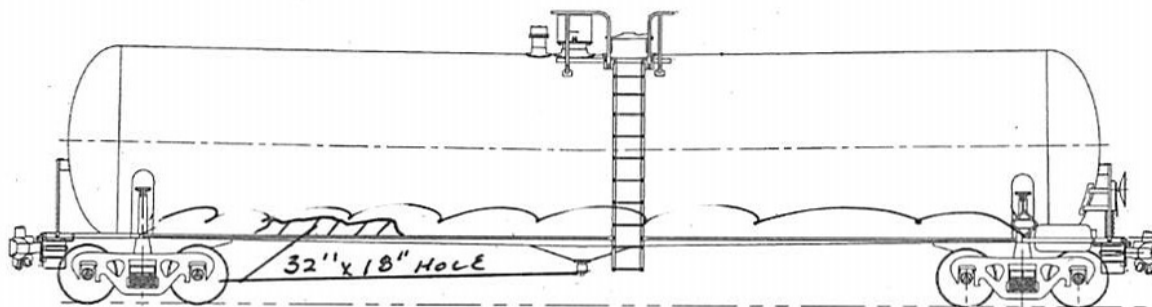
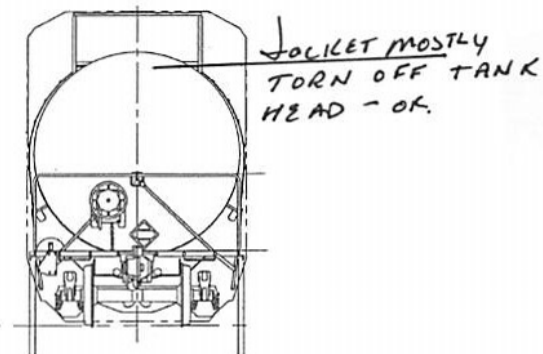
Car Number ITDX 5082
7' TEAR.

Top fittings manway bolt (U) damaged - VENT DAMAGED
Bottom Outlet OPEN - HANDLE BENT
Punctures NO
Draft sill A & B OK
