ERA24FA110

Group Chair's Factual Report - Attachment 6

GE Presentation Material - CL5584 Annex 13 investigation ERA24FA110 Summary

# CL5584 Annex 13 investigation ERA24FA110

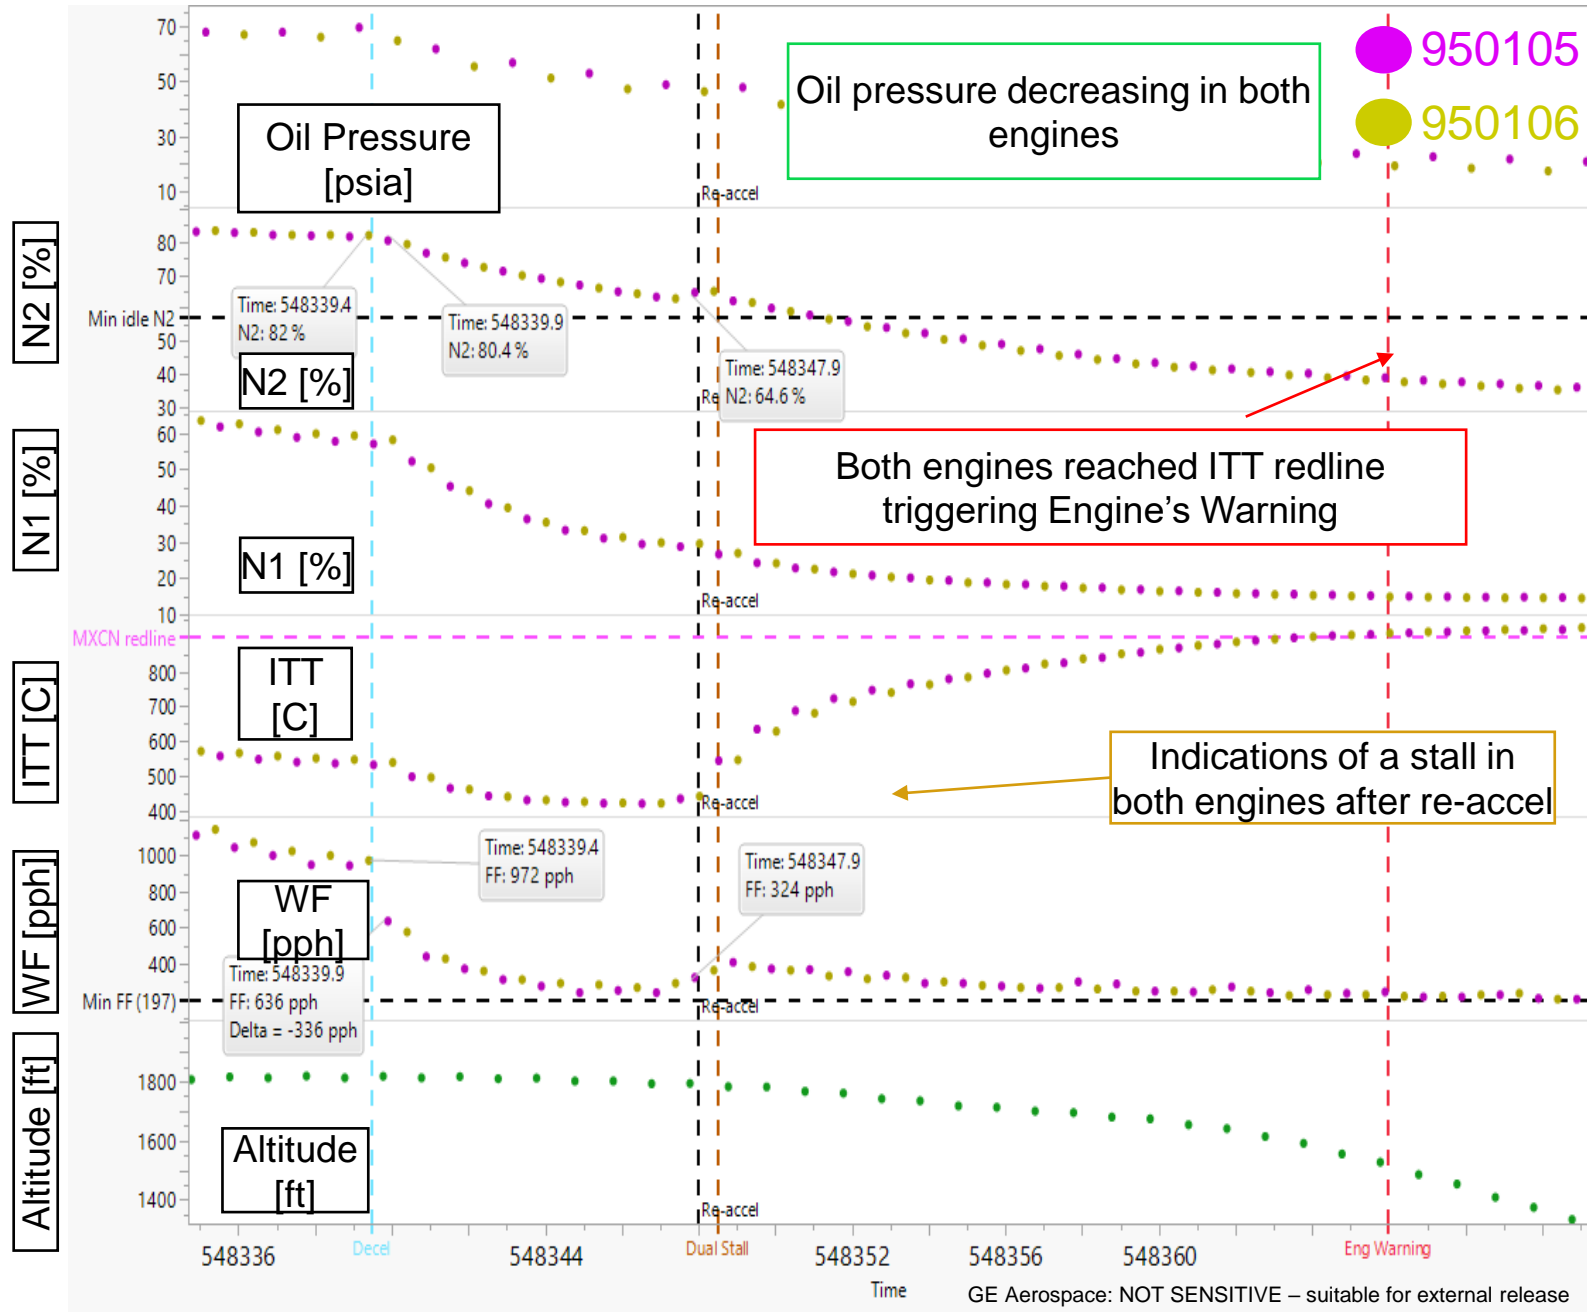
# CL5584 Feb 09 FDR data analysis

**Conditions during stall/roll sub-idle:**  
 Mach = 0.24  
 Altitude = 1794 ft

**Conditions during decel:**  
 Mach = 0.26  
 Altitude = 1813 ft

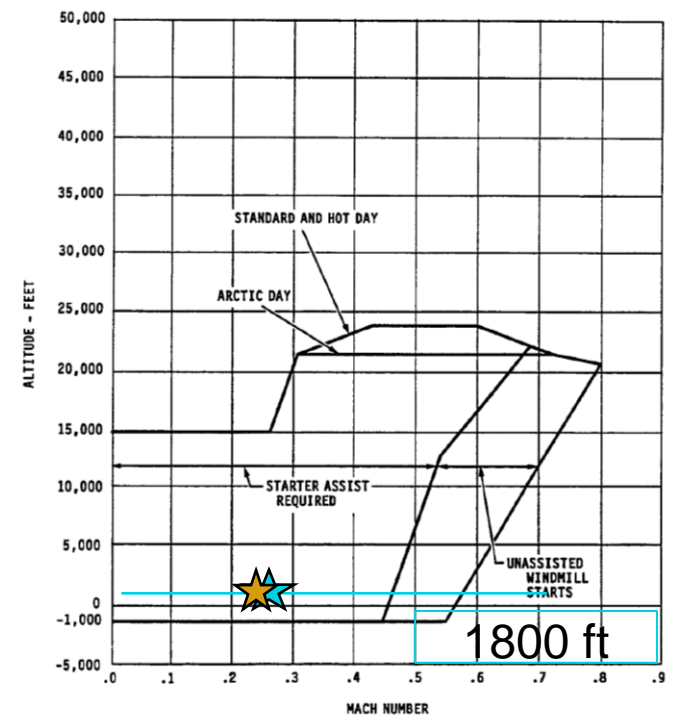
CF34-3 Air Starter Limits

**Rolling sub-idle occurred at conditions where starter assist was required**

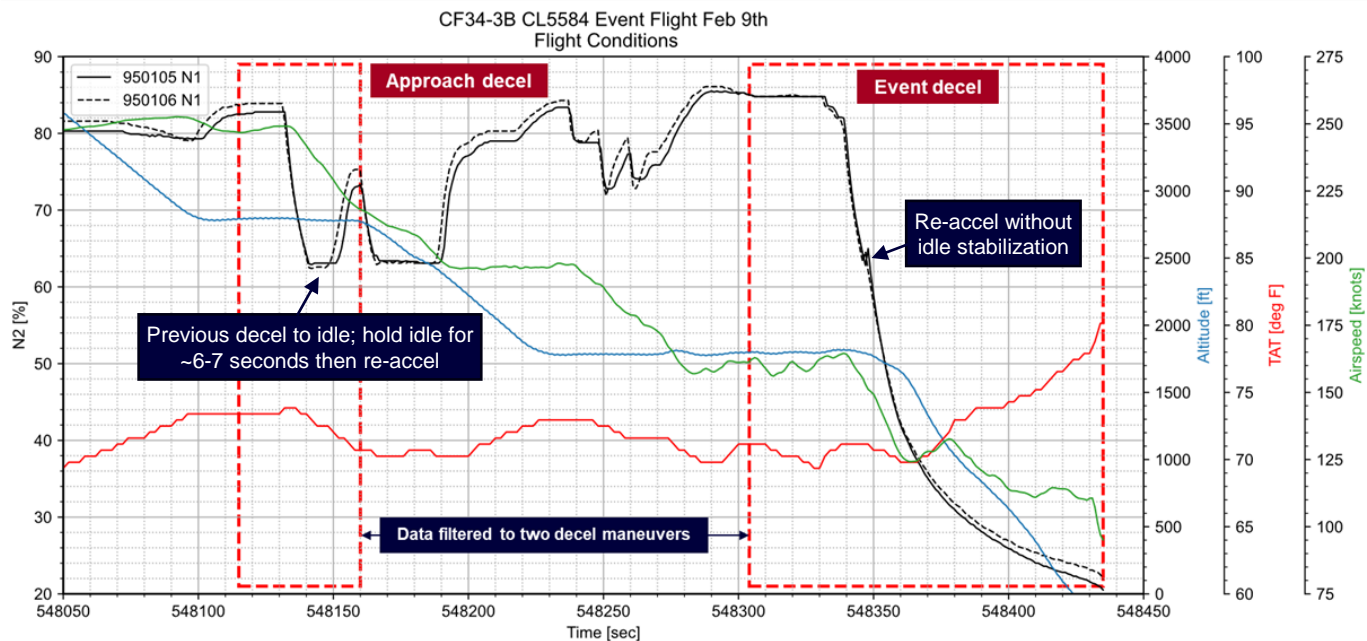
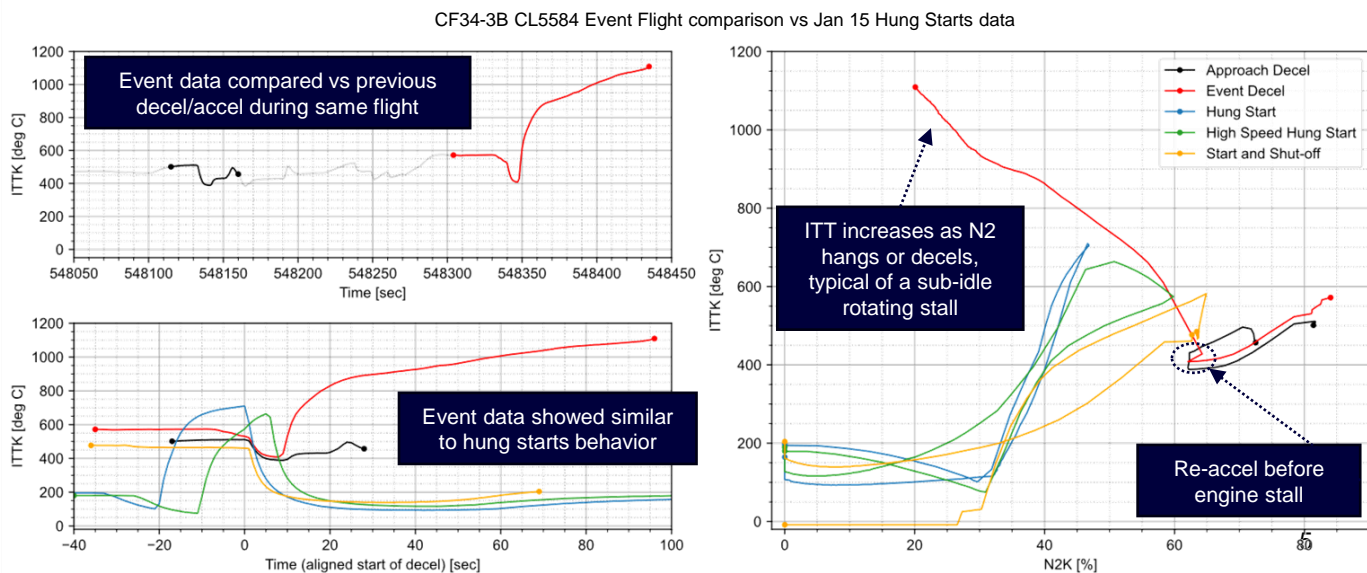
During the event when N2 reaches idle speed, a simultaneous dual engine re-accel is observed followed by a decel and roll sub-idle. The event roll sub-idle characteristic is similar to unsuccessful starts observed during January 15<sup>th</sup> while troubleshooting starting issues and is consistent with a compressor stall after starter disengagement. Analysis for Feb 9<sup>th</sup> event data indicates that both engines experienced simultaneously a compressor surge resulting in an unrecoverable rotating stall, with an estimated Ps3 drop of ~20% at surge.

The event data indicates no flameout, fuel cut, or combustor blowout, and both engines followed the characteristic of a compressor surge followed by a rotating stall after the re-accel - similar to the Jan 15<sup>th</sup> starting issues.

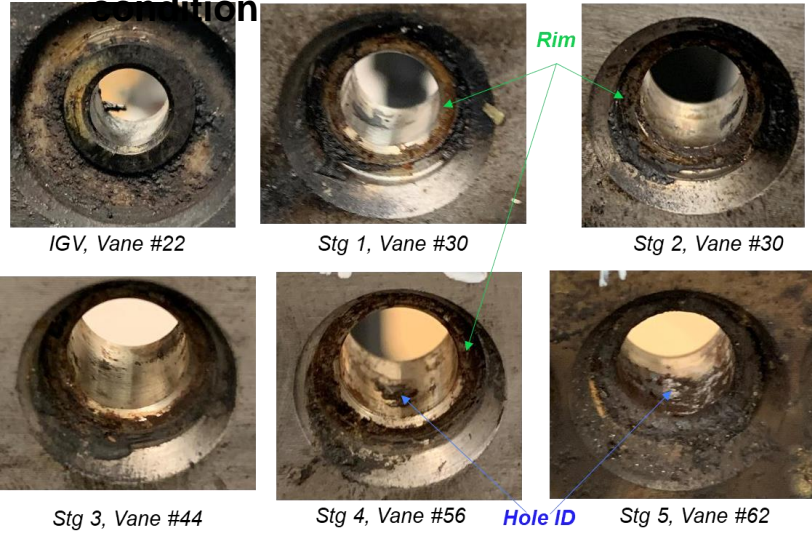
## HPC case bore holes surface condition

- All bore hole stages show evidence of corrosion at rim, where bushing is located.
- Majority of Stg 5 bore holes show higher amount of corrosion at rim and ID locations

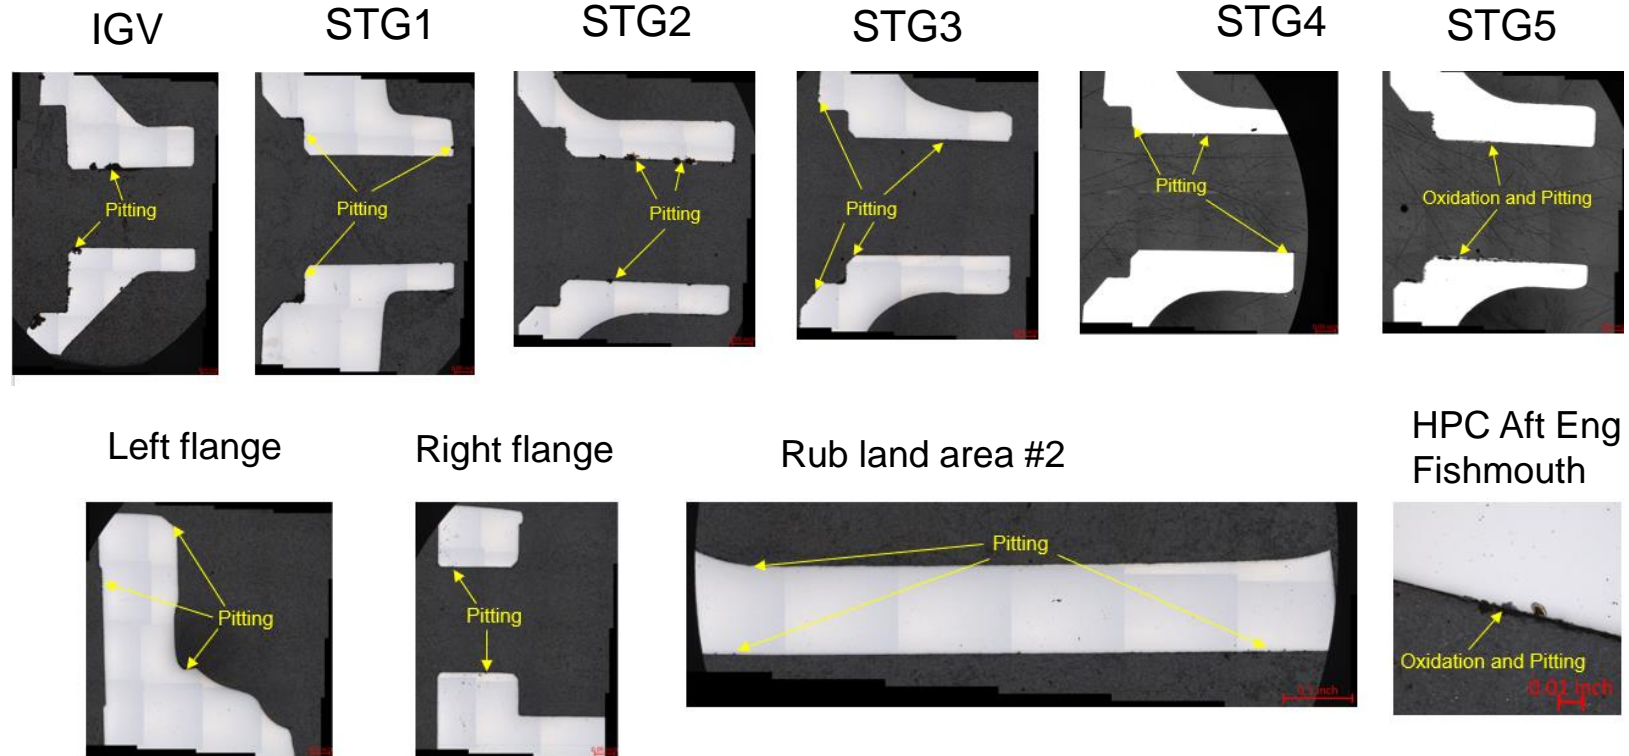
## HPC VG bore holes cross sections

Consistent pitting corrosion identified in both HPC cases. Stg 5 shows additionally an oxide layer as compared to prior stages; oxide layer is also observed on Aft End Fishmouth cavity section to a lesser degree. Thicker oxide layer in stage 5 can be attributed to operation temperature >500F and Cr depletion due to corrosion mechanism (passivation loss).

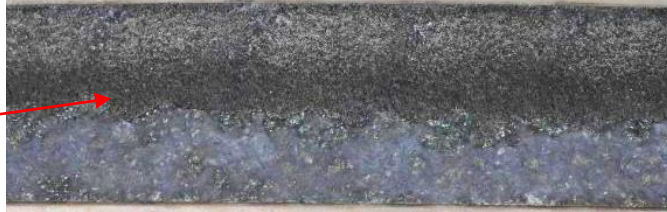
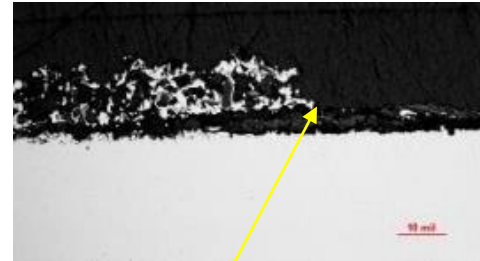
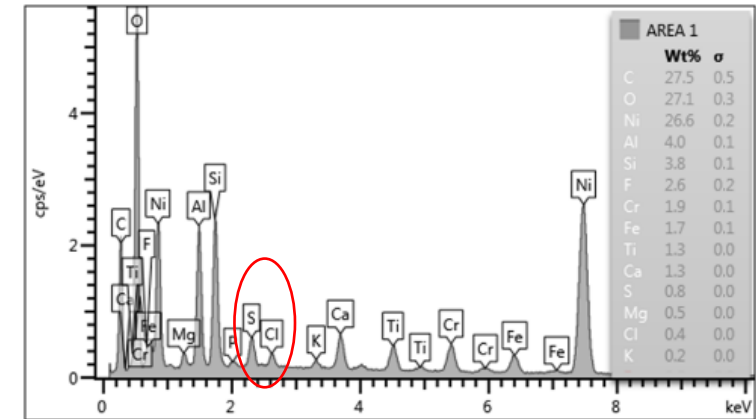
HPC Spool Stg 5 – ESN 950105

Delaminated coating due to oxidation/corrosion of bond coat

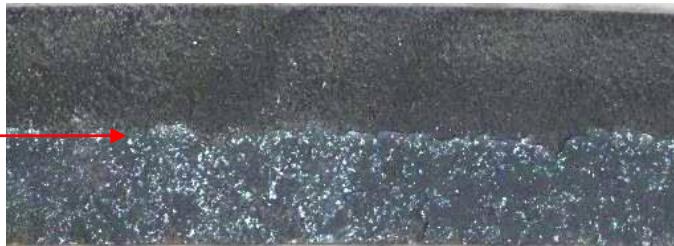
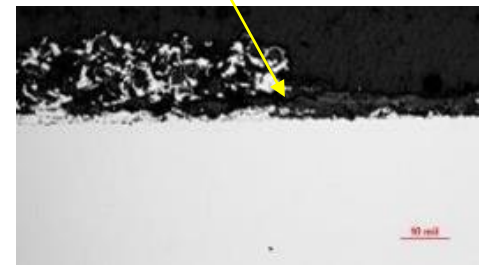
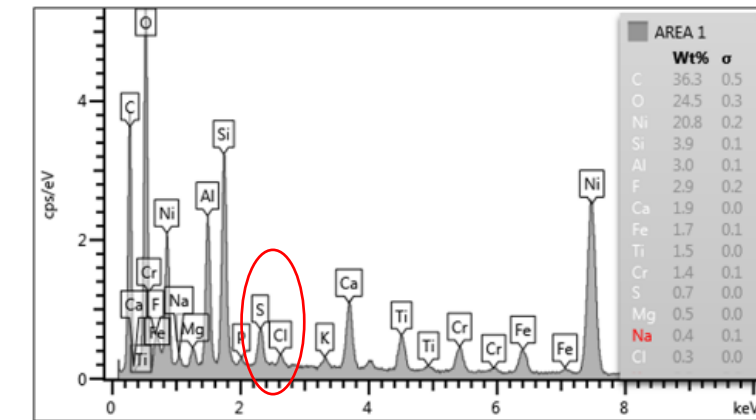
HPC Spool Stg 5 – ESN 950106

Delamination of Ni-Cr-Al bentonite coating attributed to corrosion of bond coat due to Cl and S presence as identified in EDS, along with Nickel oxide formation between the bond and topcoat. Cl and S presence along with other elements such as Na, Mg and K are generally associated to engines exposed to saline environment. Fluorine traces identified may come from fire extinguishing agents used during event.

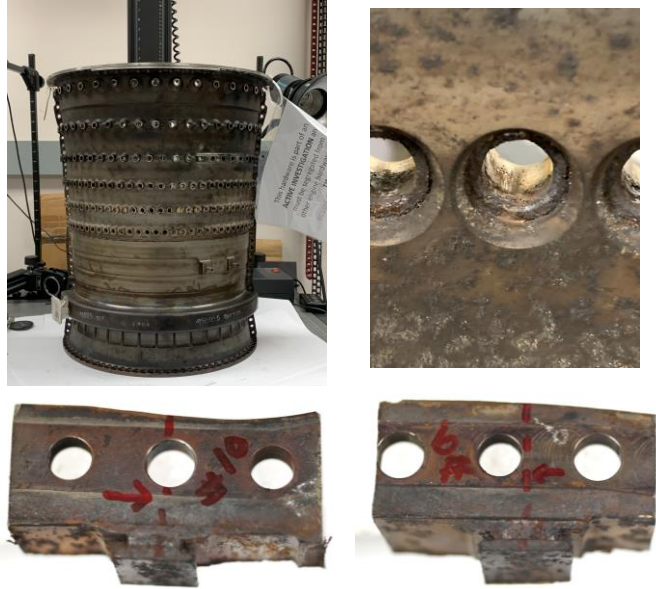
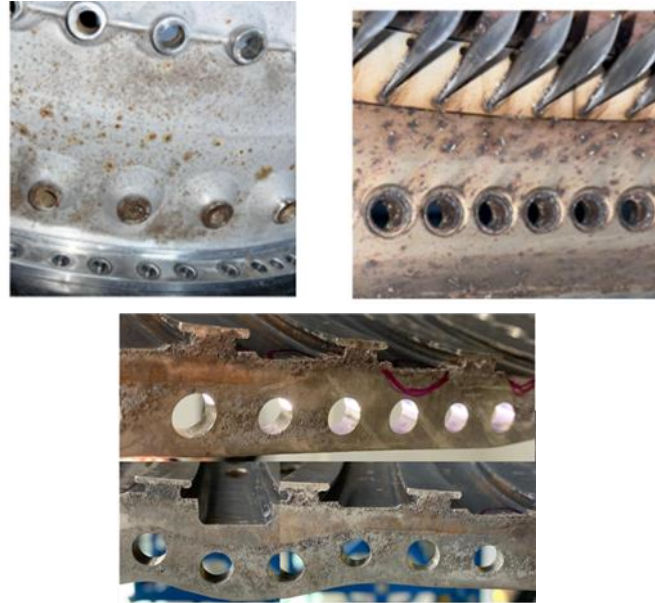
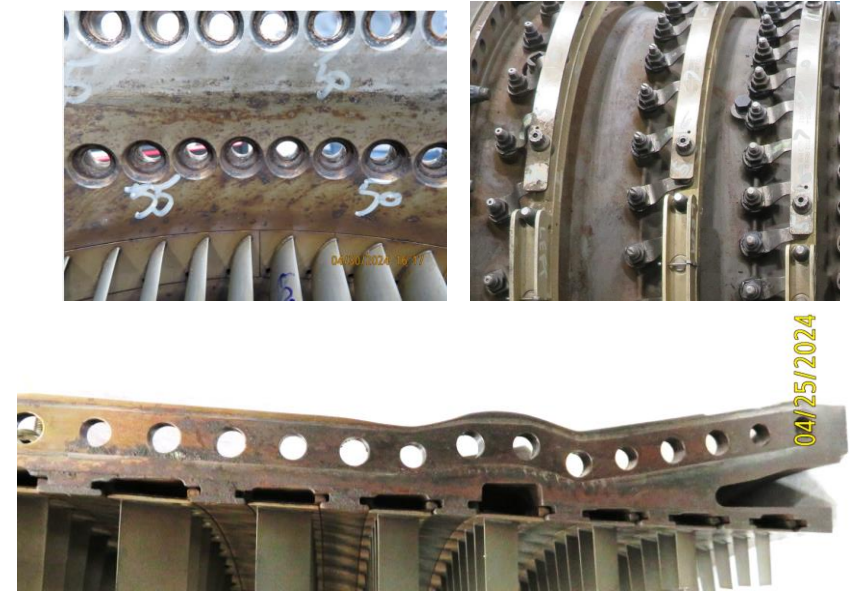
Comparison among different HPC cases presenting corrosion. Typically pitting is found along all HPC case being more predominant in later stages (corrosion + oxidation associated). Reports from debris gathered from other non-event engines showed Cl and S presence along with Na, Ca, K and Mg elements. These elements are generally associated to engines exposed to saline environment.

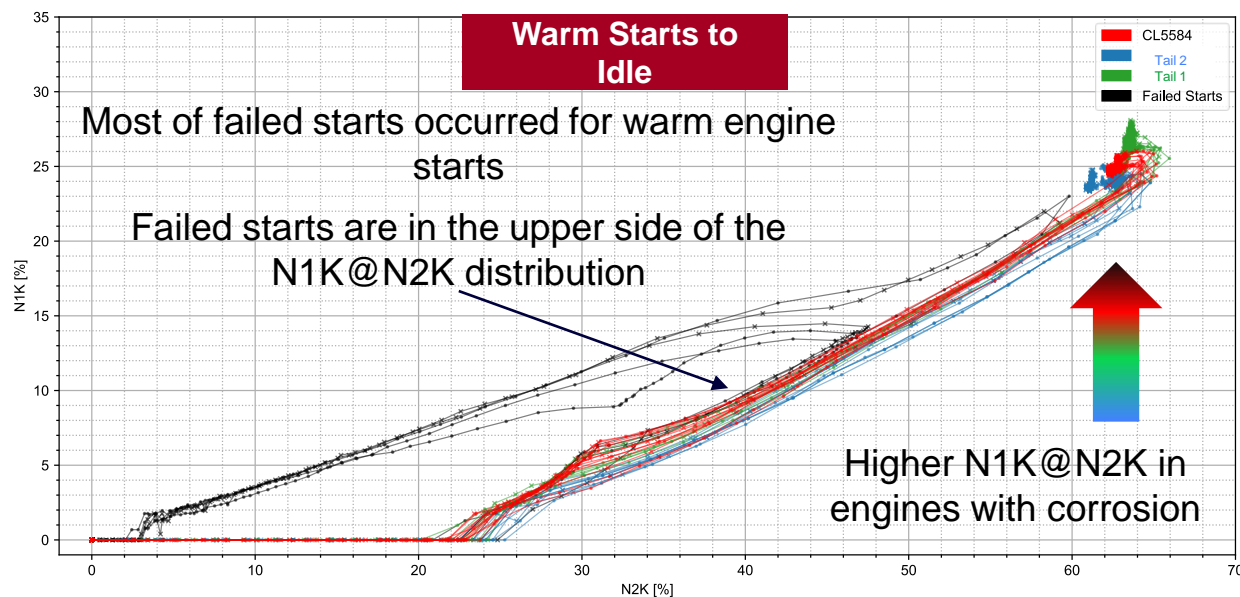
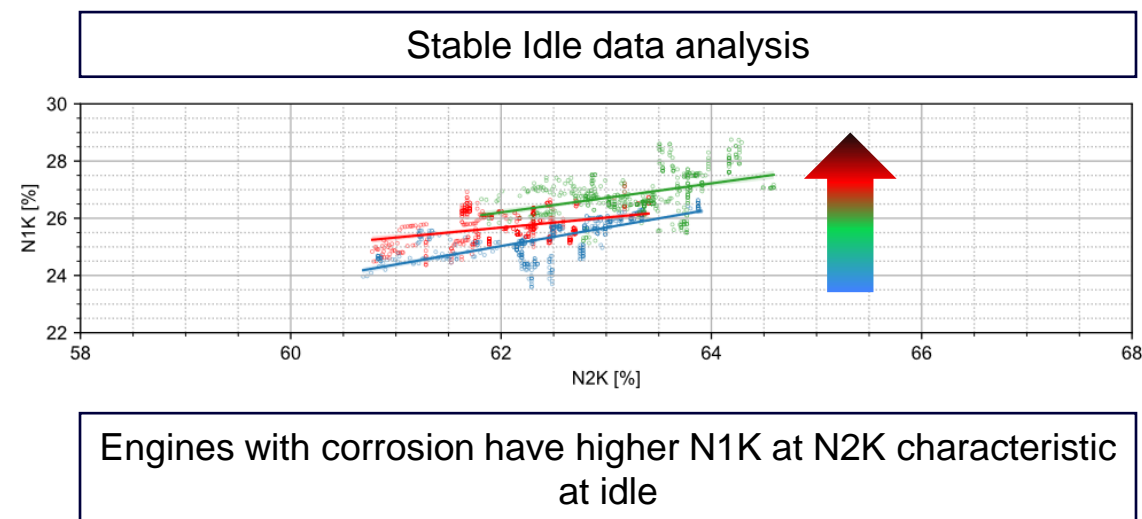
Trends show higher fan speed at same core speed for engines with corrosion vs engines without corrosion during startup and Idle, no effect observed at high power operation

Higher fan speed at core speed during starts for engines with corrosion consistent with more open VGs

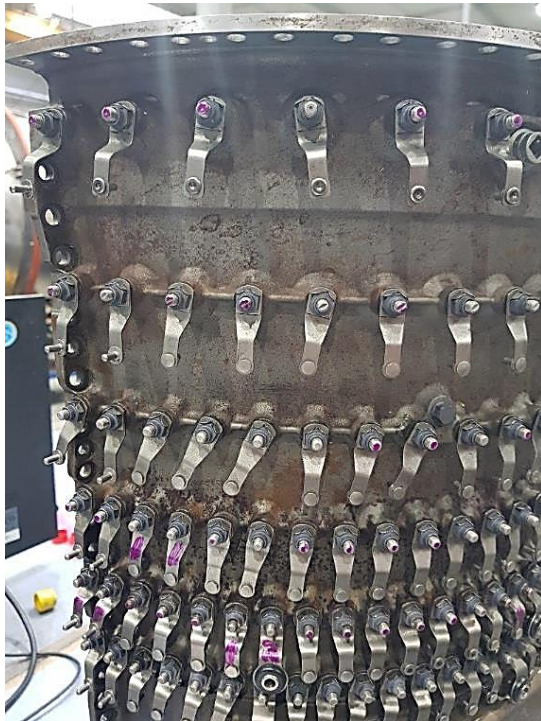
HPC case with corrosion
