DCA21FA174

Specialist's Factual Report - Attachment 7
Pratt & Whitney DCA21FA174 Metallurgical Investigation Report, July 29, 2022

Final Report for DCA21FA174

Subject: Metallurgical Investigation of High Pressure Turbine (HPT) Blades from an accident on July 2, 2021 in Honolulu, Hawaii involving a Boeing 737-200 aircraft, N810TA, operated by Rhodes Aviation Inc., dba Transair Flight 810.

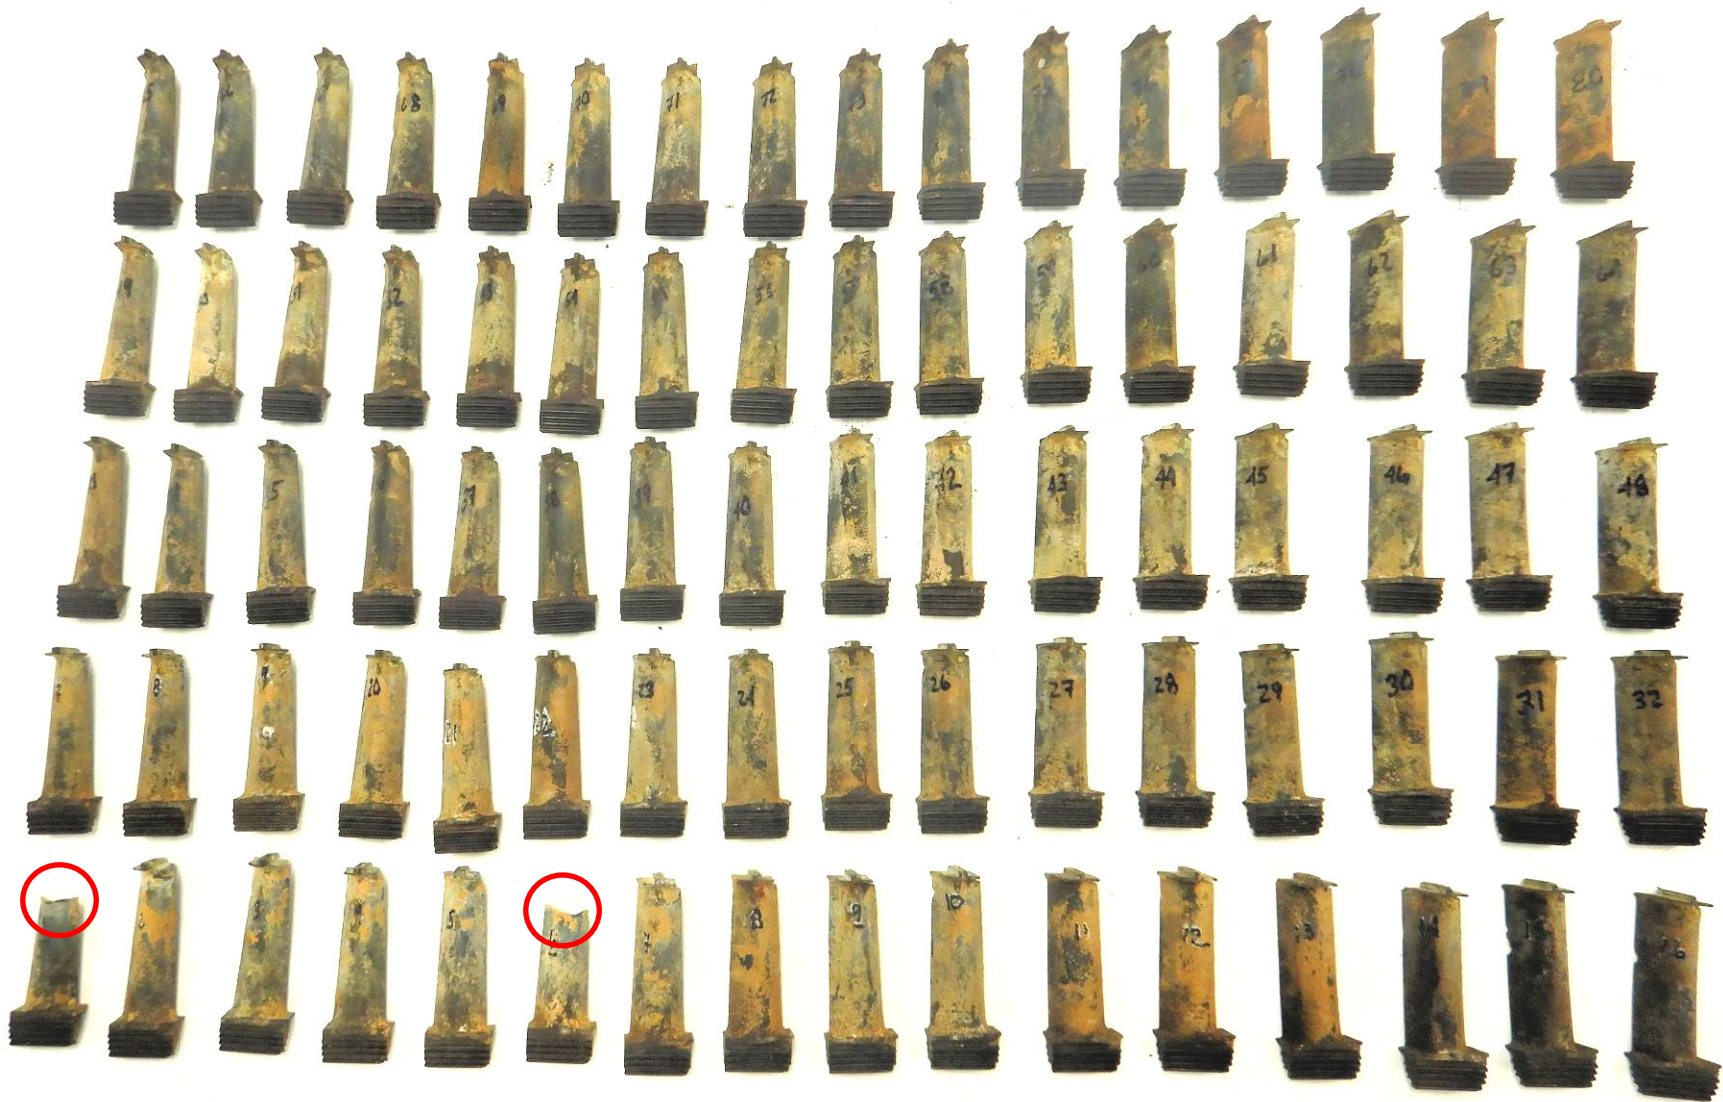
Two blades, numbered 1 and 6, were fractured through the airfoil between 65% and 75% airfoil span. The liberated portions of the blades were not recovered and not available for investigation (**Figures 1 & 2**). During part layout, some debris fell off of the parts onto the white background paper. Four adhesive SEM examination stubs were prepared with a random variety of this debris. All four stubs were examined using a scanning electron microscope (SEM) and energy dispersive spectrometry (EDS). Analysis of multiple regions of these stubs found a variety of compositions. A typical region that exhibited predominantly potassium, calcium, iron rich compositions is presented in **Figure 3**.

Figure 1: Blade set viewed from convex (suction) side of airfoils. The two indicated blades, #1 and #6, were fractured between 65 and 75 percent span.

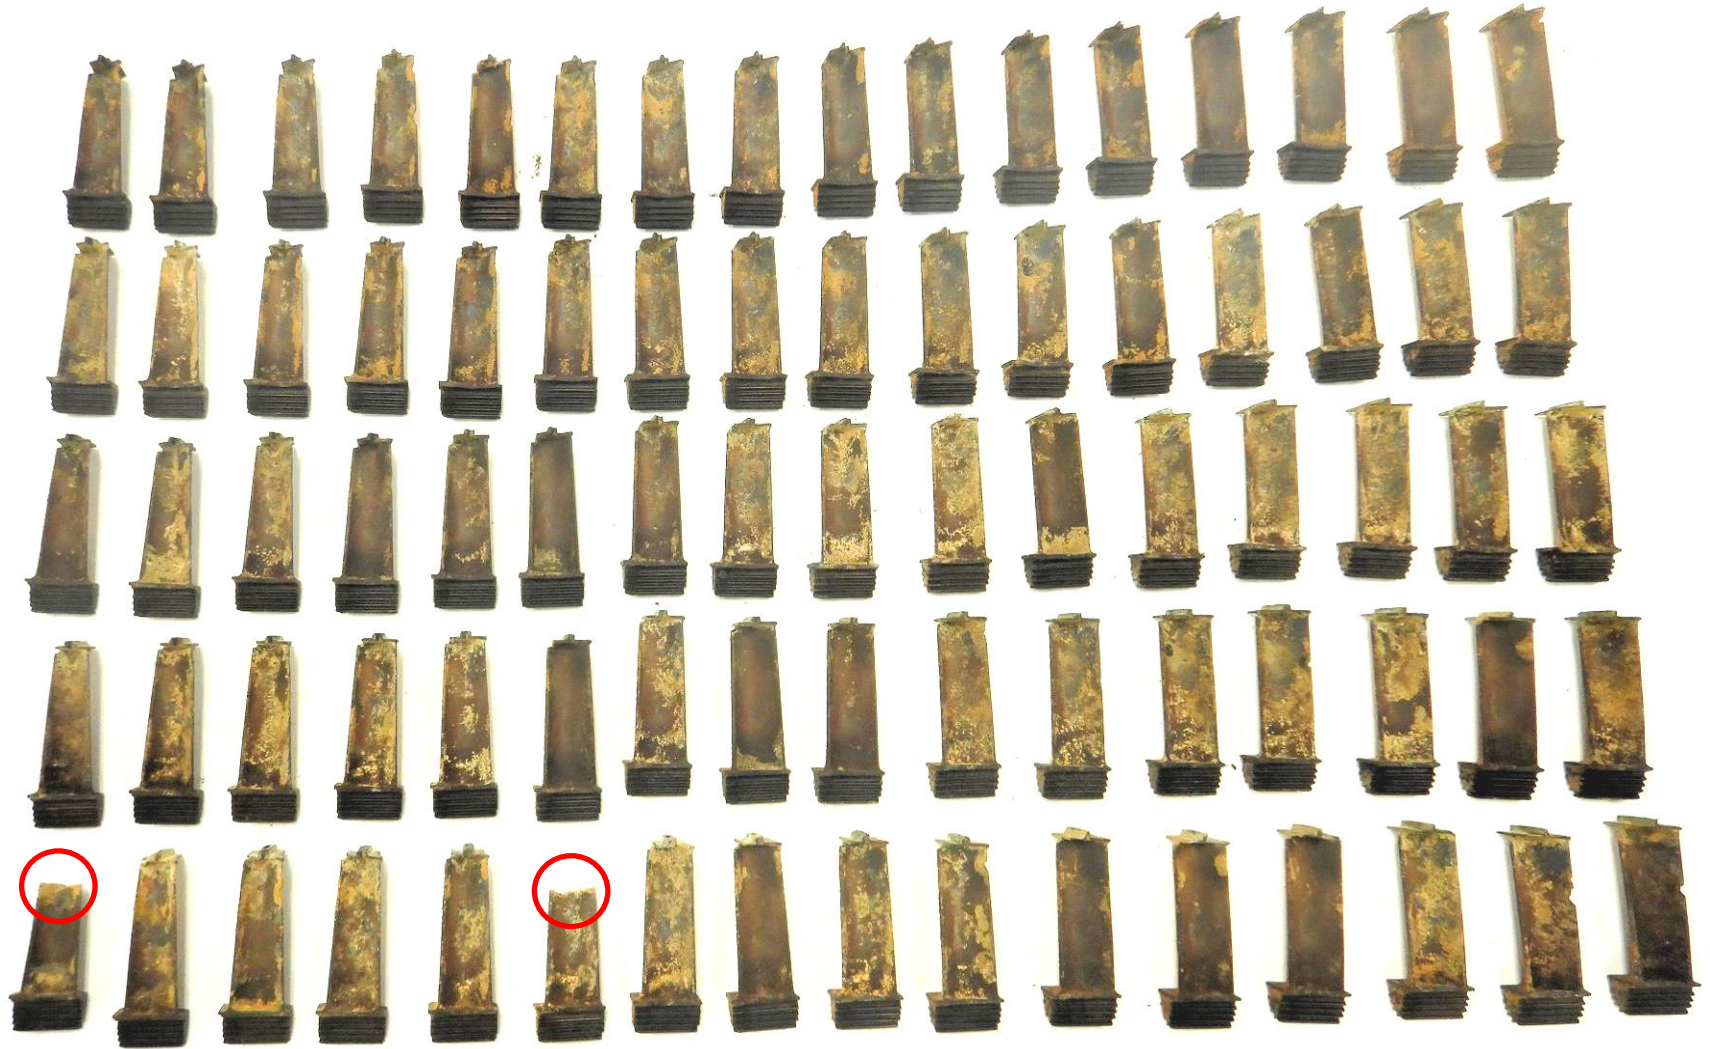
Figure 2: Blade set viewed from concave (pressure) side of airfoils. Two blades, #1 and #6, were fractured.

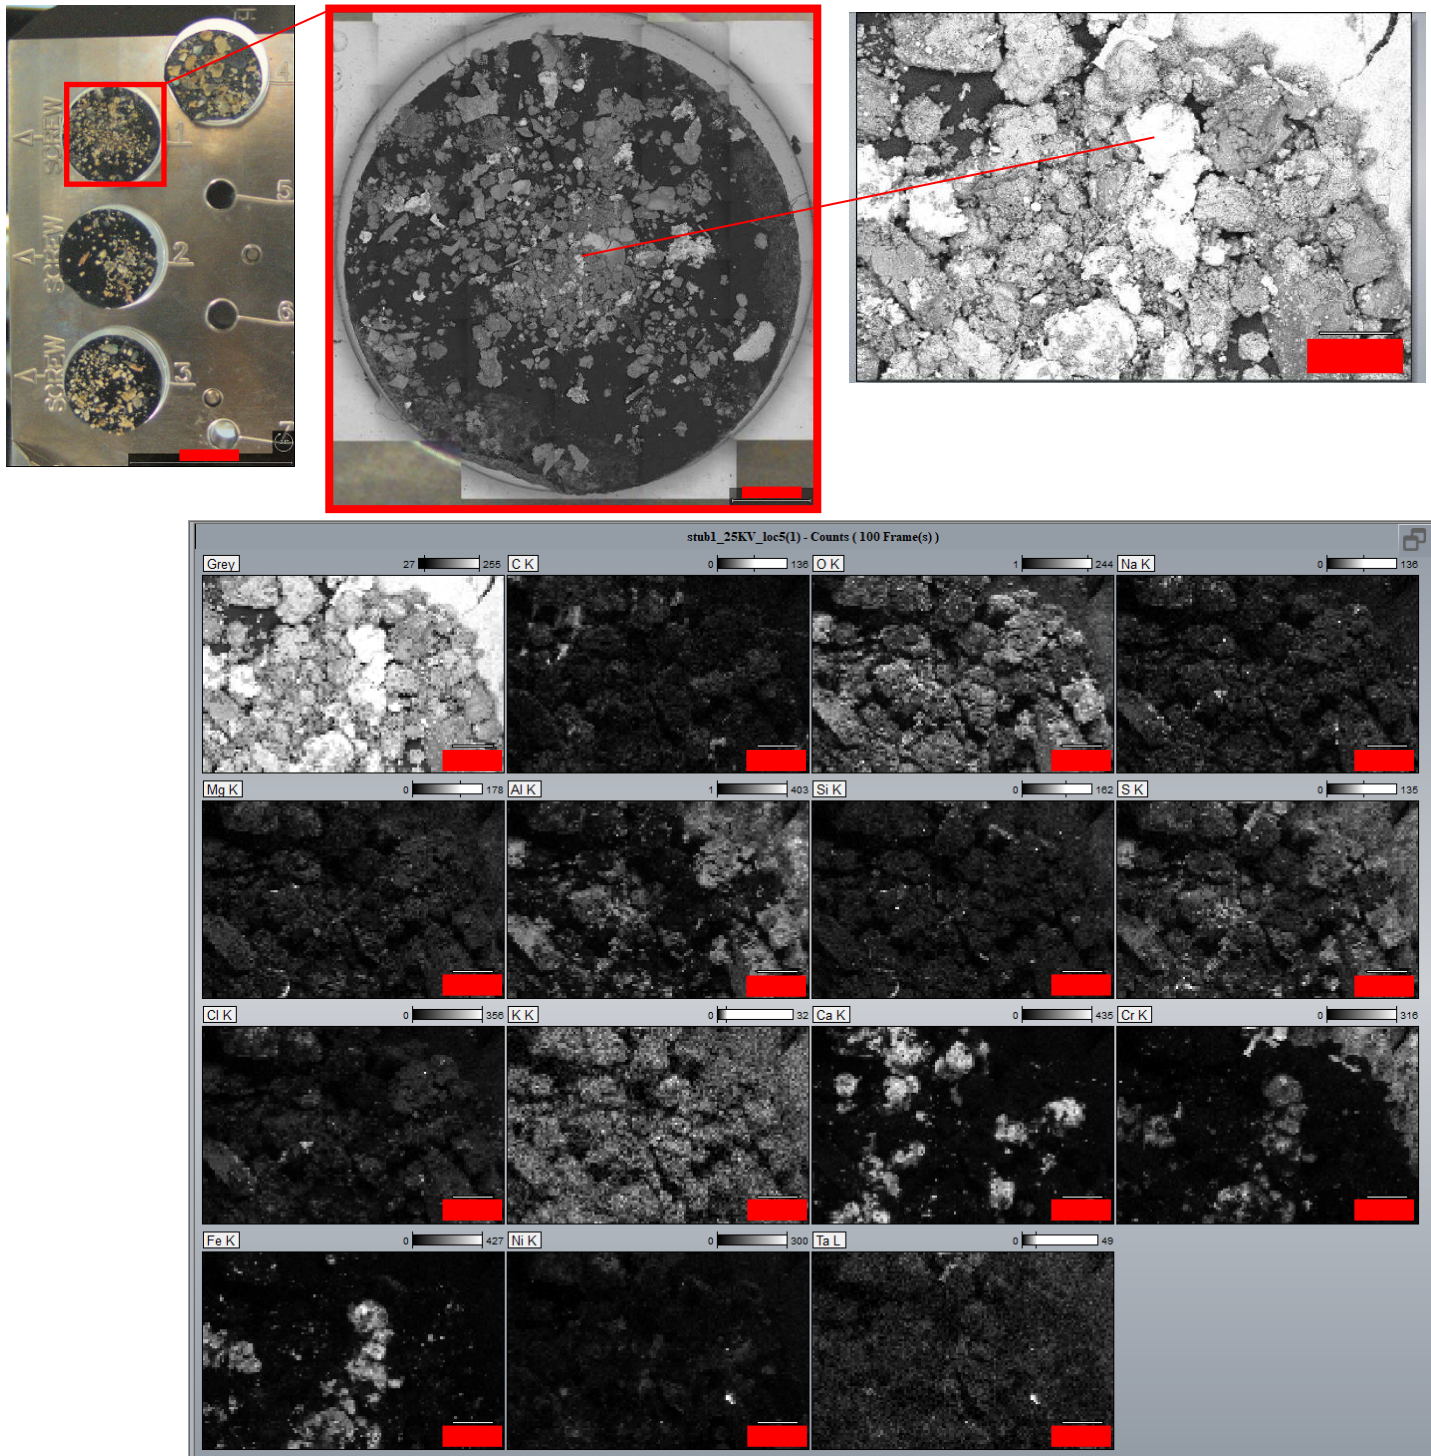
It was observed that all of the blades in the set had surface deposits. As some of the deposits covered some of the blade 1 and blade 6 fracture surfaces, it was clear that they occurred post event and as a result of submersion. It was speculated that this was some type of coral or barnacle growth. For the purpose of this investigation, accurate identification of this growth was deemed irrelevant. These deposited organisms will be referred to as barnacles for the remainder of this report, although no biologist was consulted to establish this fact.

Figure 3: Elemental mapping of a typical region containing multiple particles of debris that fell off of the parts during layout found predominantly potassium, calcium, iron rich compositions.

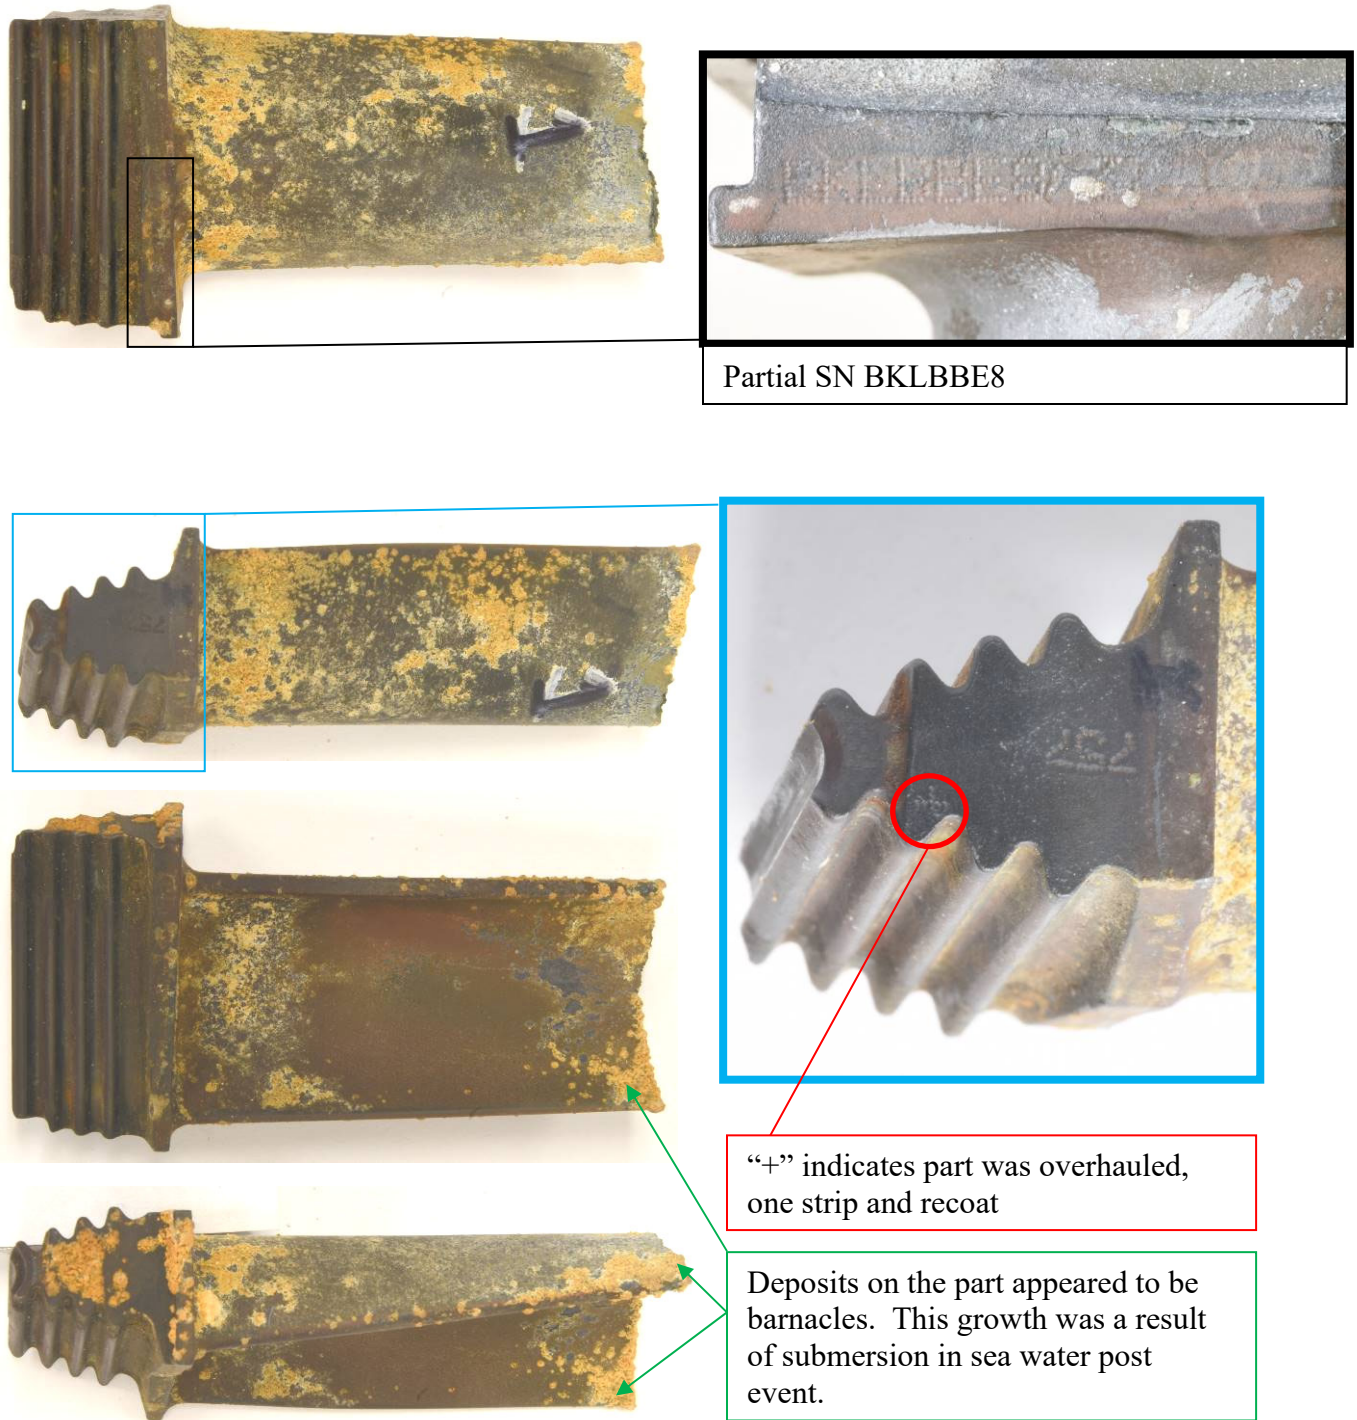
Close up views of blade 1, including concave (CC) side, convex (CV) side, aft side / trailing edge (TE), and forward side / leading edge (LE), are presented in **Figure 4**. The forward root face exhibited the original manufacturer part number, 840001, which was crossed out. A “+” sign was present on the aft root face, indicating a strip and recoat repair of the protective

aluminide coating was performed. A new part number, 840001-003, was engraved on the CC side of the blade platform. A partial serial number was engraved on the CV side of the blade platform, “BKLBBE8,” but it was not possible to resolve the terminal 3 digits. The part markings present indicate that the blade had a strip and recoat repair and was reworked to become a -003, but it was not possible to determine when or where these processes occurred.

Figure 4: Closer views of fractured blade 1, which was confirmed to be refurbished. Views from top down are CV, TE, CC, and LE, respectively.

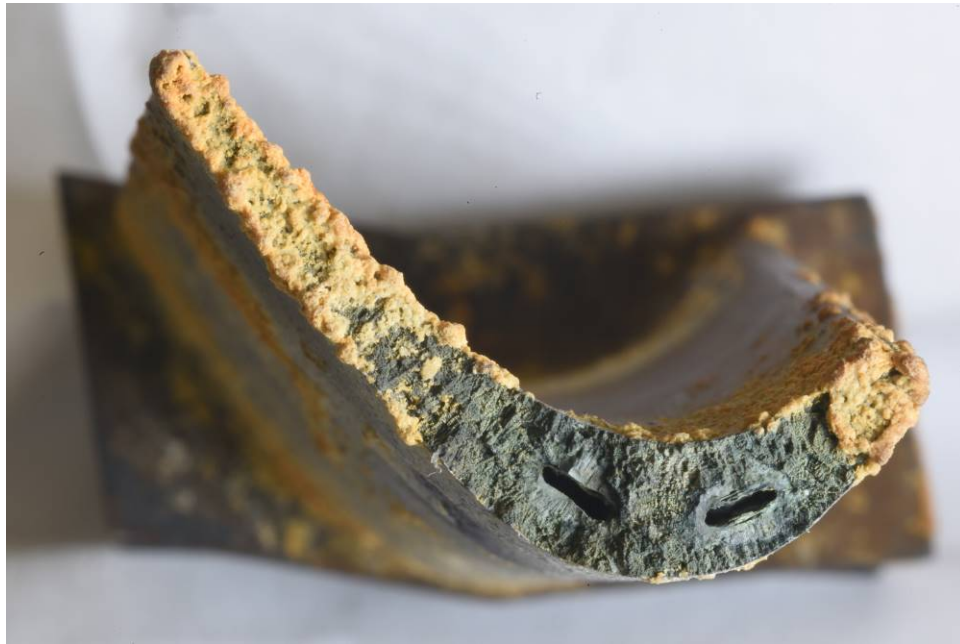
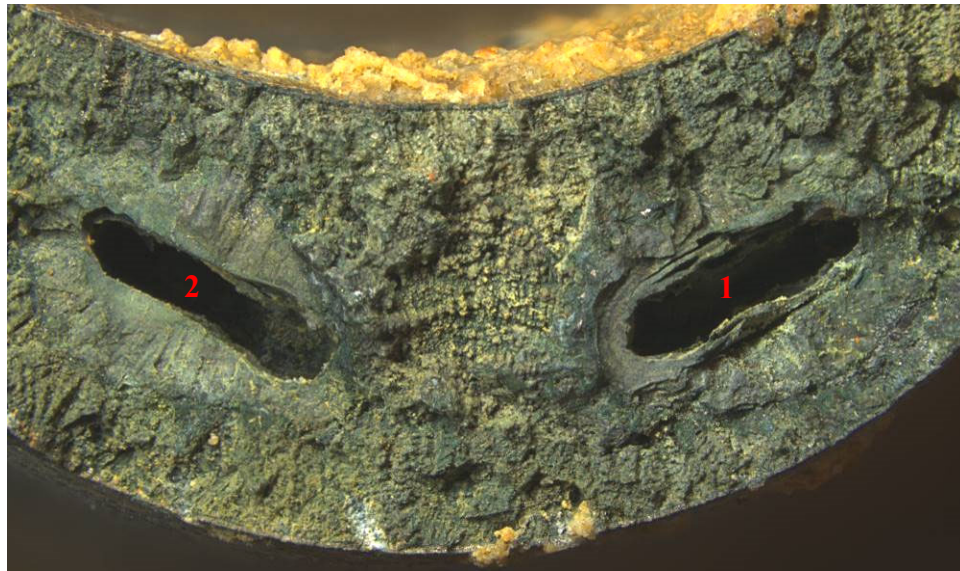
The fracture surface of blade 1 is shown at increasing magnification in **Figure 5**. Approximately half of the fracture surface was covered with barnacles, however, it was clear that the underlying regions were rough textured. Most of the fracture surface that was not obscured by barnacles was rough-textured and oxidized, which was the result of inter-granular crack propagation and fracture. Under most engine operating conditions, intergranular fracture of this blade alloy is associated with either overstress or stress-rupture crack propagation. Flatter regions of fracture were also present, surrounding the two lightening holes within the airfoil. These holes begin at the outermost span of the blade on the outer diameter end face and run inward until they dead end within the airfoil. These holes were numbered 1 and 2 for reference purposes, with hole 1 being forward and hole 2 being aft. While flat fracture regions can be a result of fatigue progression, which is often transgranular at engine operating conditions, it should be noted that no clamshell-shaped arrest lines were observed. These arrest lines are commonly observed optically at low magnification, even on oxidized fracture surfaces.

Figure 5: Optical images of the fracture surface of blade 1. Regions of the surface not covered with ocean deposits were predominantly rough textured (intergranular), with the exception of the regions around the holes, which were mostly flat. The holes were labeled 1 and 2 from front to back for ease of reference.

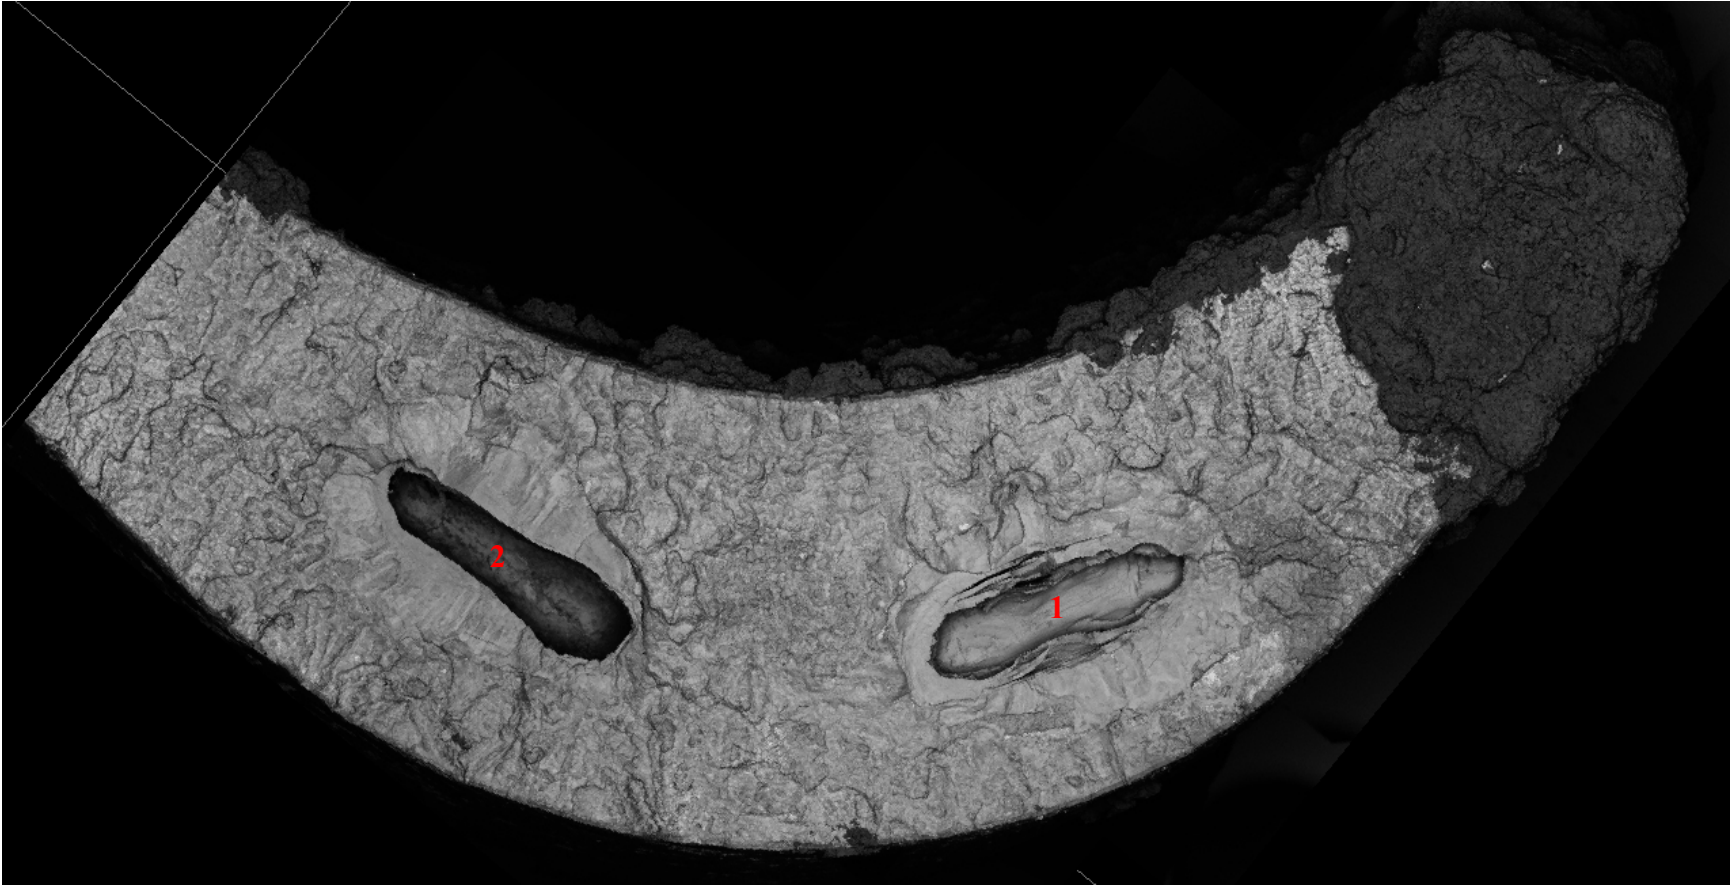
Figure 6: SEM backscatter electron (BSE) montage of blade 1 fracture surface. Note, some stitching errors may be present. Re-oriented images at higher magnification follow.

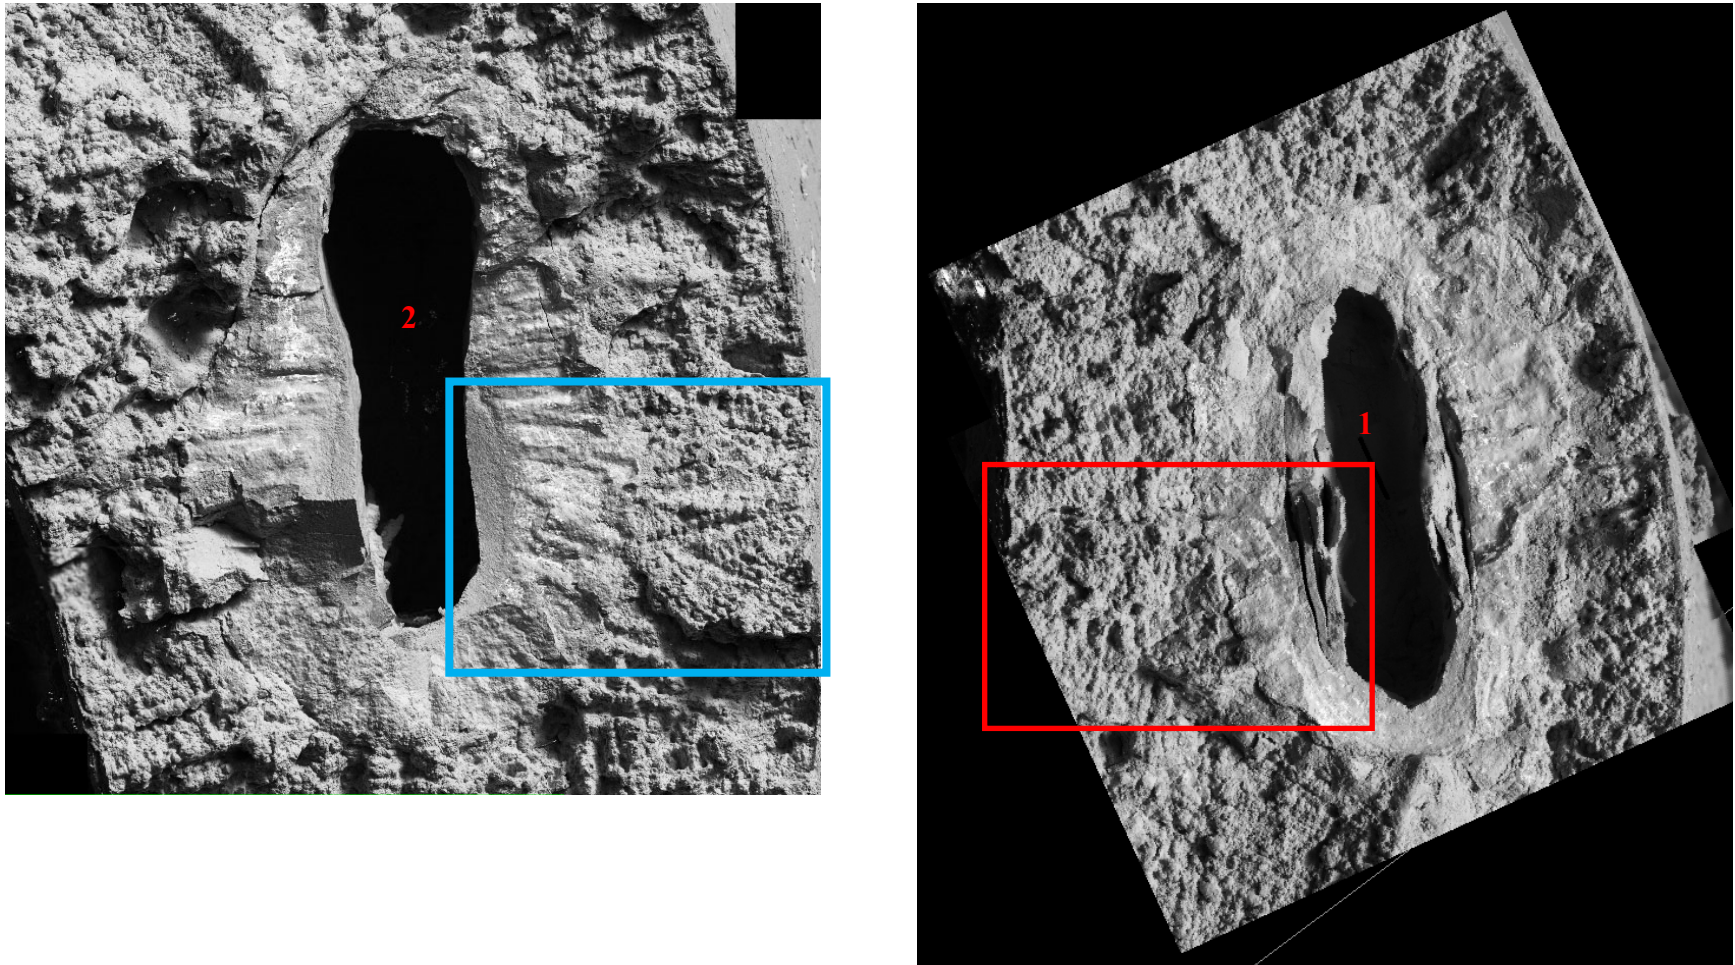
Figure 7: Everhart-Thornley detector (ETD) BSE montages of blade 1 fracture surface at holes 1 and 2. Texture around the holes was relatively flat, while texture elsewhere was intergranular. Close-up images of the regions enclosed in red and blue rectangles follow.

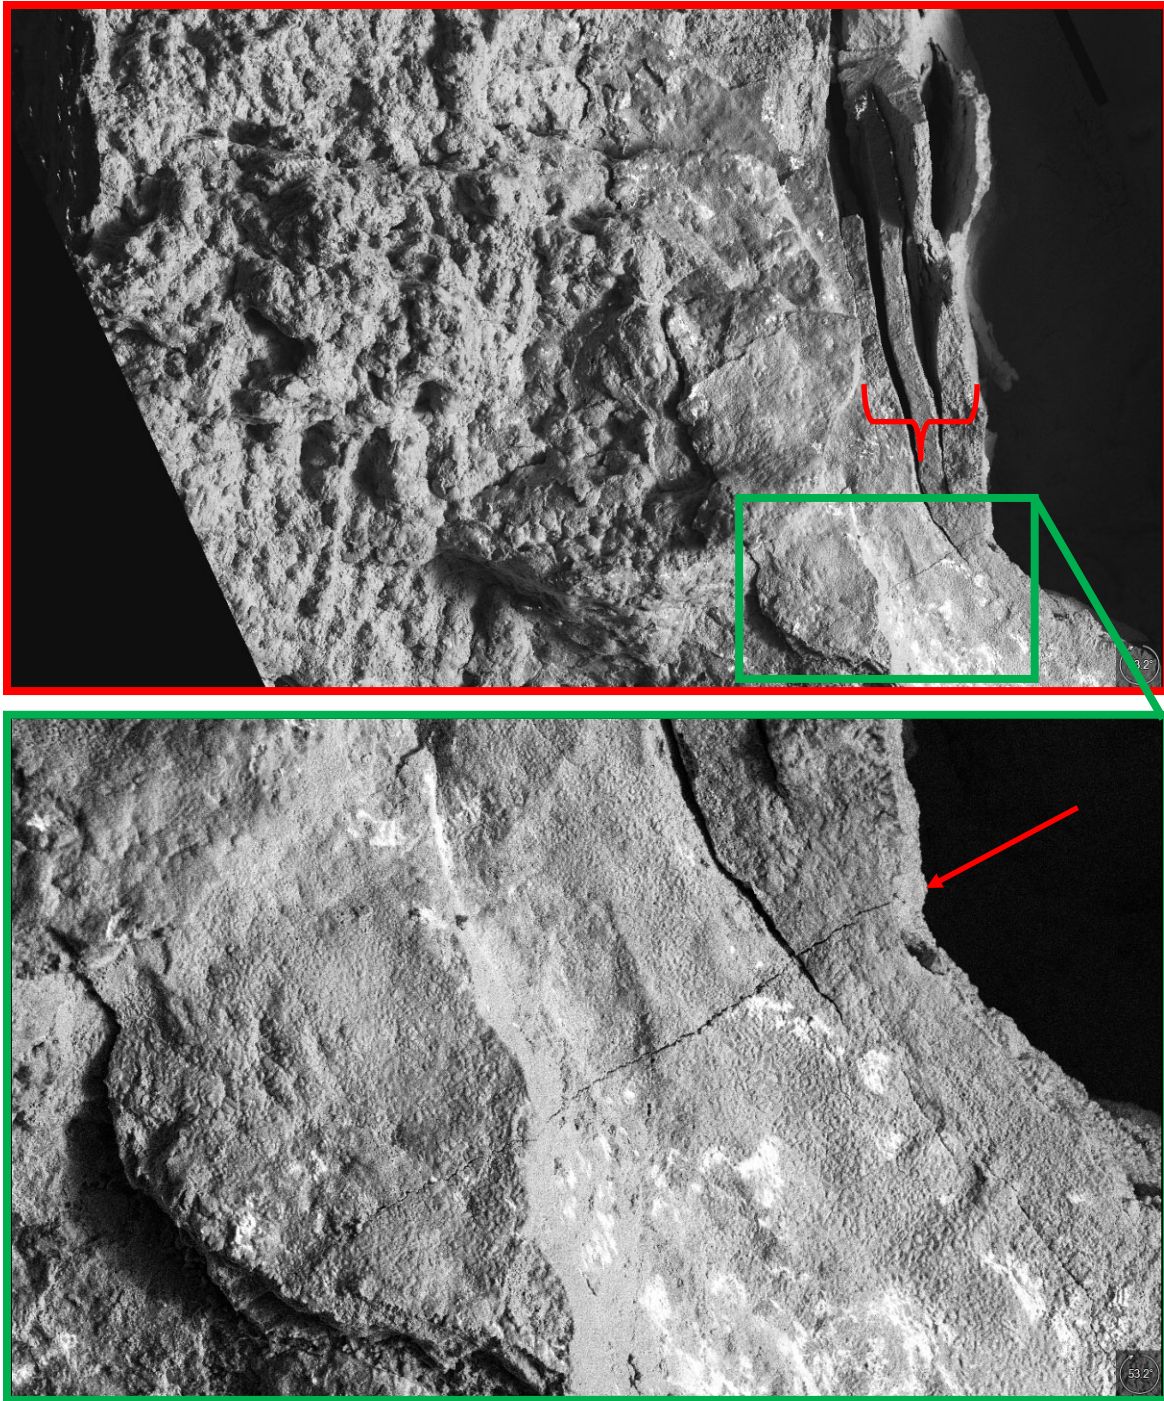
Figure 8: ETD BSE images of blade 1 fracture surface (refer to Fig. 6, red rectangle). Upper image reveals stratified layers at hole surface, as indicated with a red brace. The lower image shows the relatively flat texture at the hole, as well as an out of plane crack (red arrow). No fatigue markers or river lines were apparent.

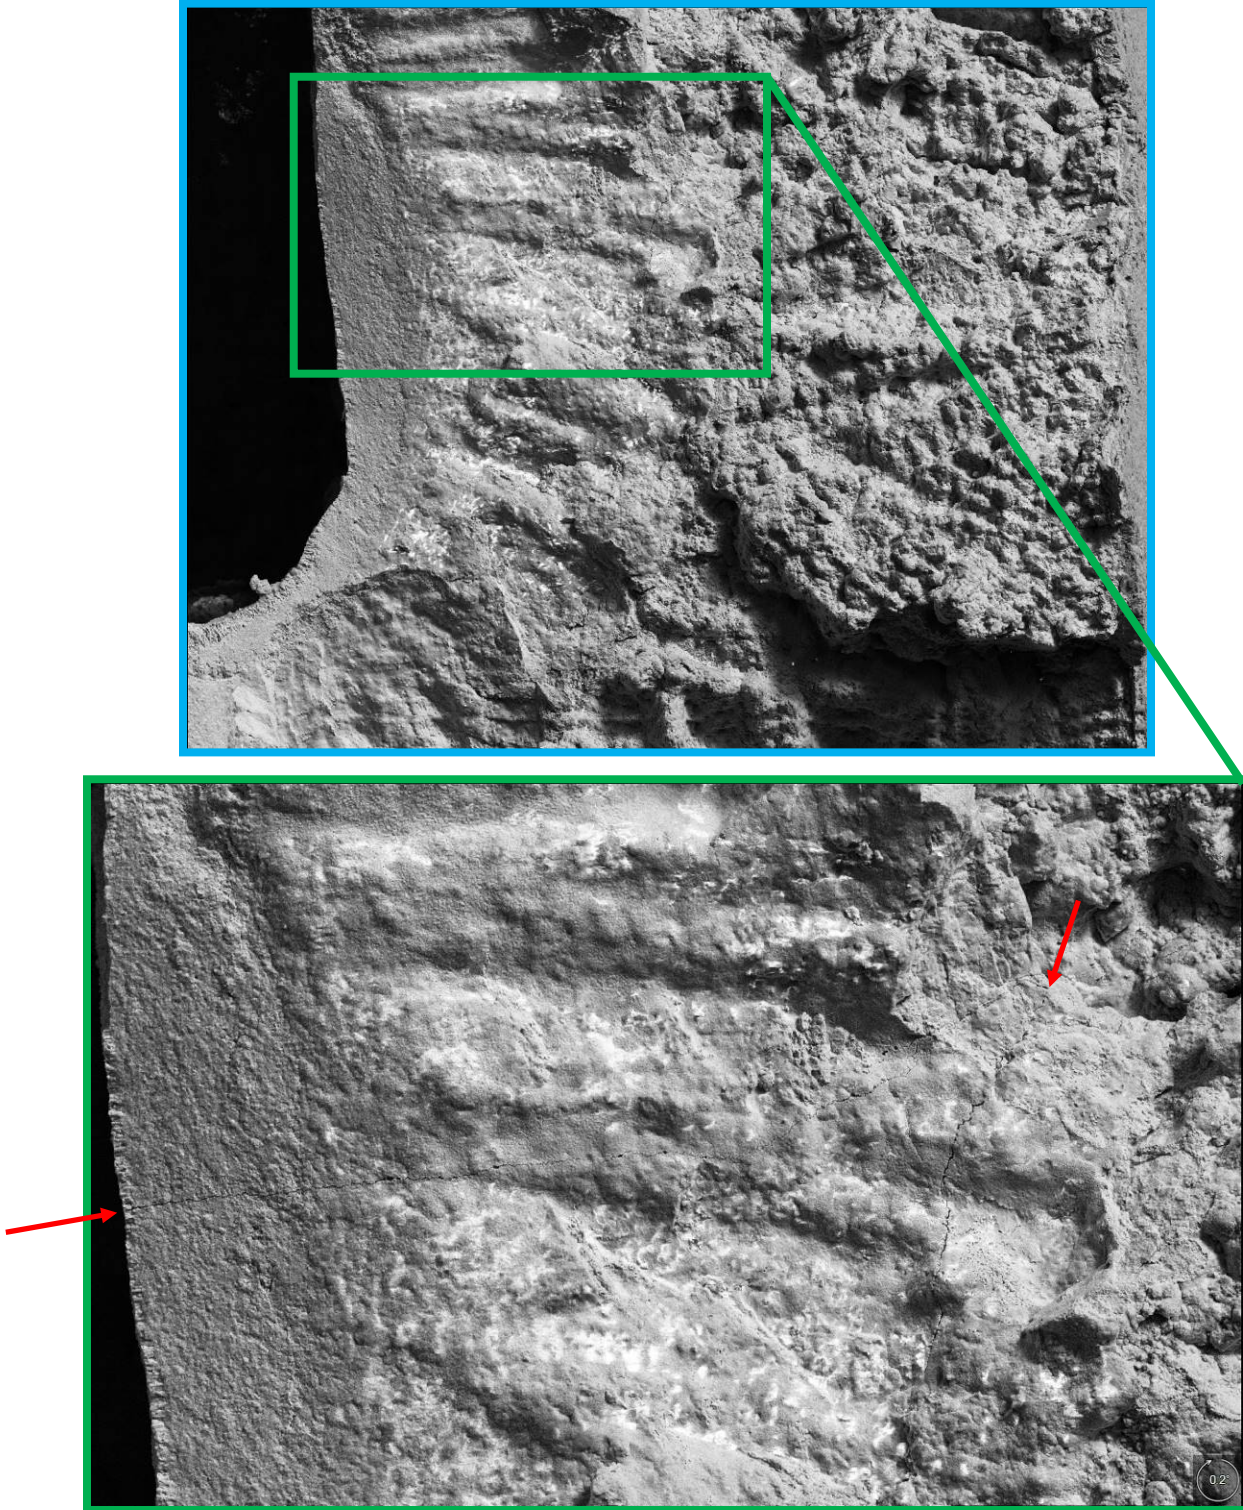
Figure 9: ETD BSE images of blade 1 fracture surface (refer to Fig. 6, blue rectangle). Upper image shows both smooth and intergranular fracture. The lower image shows the relatively flat texture at the hole, as well as two out of plane cracks (red arrows). No fatigue markers or river lines were apparent.

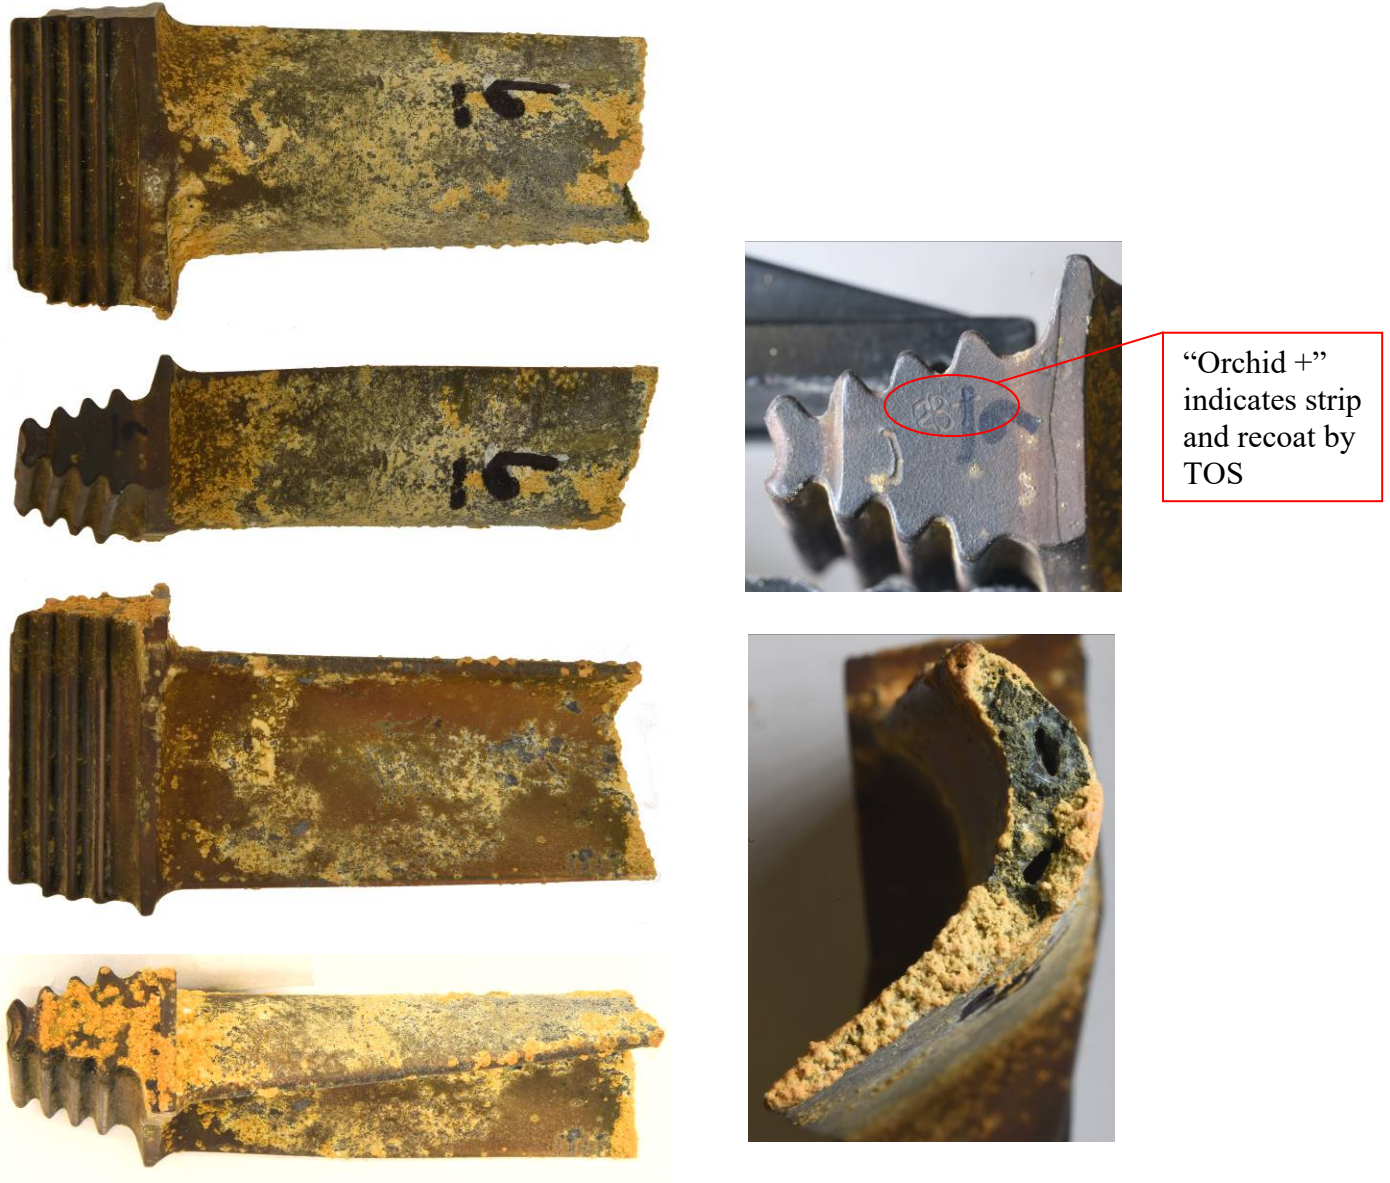
Multiple views of fractured blade 6 are presented in **Figure 10**. Views from the CV, TE, CC, and LE are included. The aft side of the root face exhibited a “+ orchid” aftermarket repair marking, which indicates that the blade’s aluminide coating was stripped and recoated by Turbine Overhaul Services PTE LTD (TOS). The blade was also re-identified from 840001 to

840001-003, but in a different manner than Blade 1 was re-identified, suggesting that they were processed at different times and or locations. For blade 6, the -003 was simply engraved above the original part number. No evidence of a serial number was observed. The fracture surface of blade 6 was obscured by barnacles more than was blade 1's but was generally similar, with smooth regions around the holes and rough intergranular regions elsewhere.

Figure 10: Closer views of fractured blade 6, which was confirmed to be refurbished. Views from top down are CV, TE, CC, and LE, respectively. The fracture surface of blade 6 was obscured by barnacles more than was blade 1's, but was generally similar with smooth regions around the holes and rough intergranular regions elsewhere.

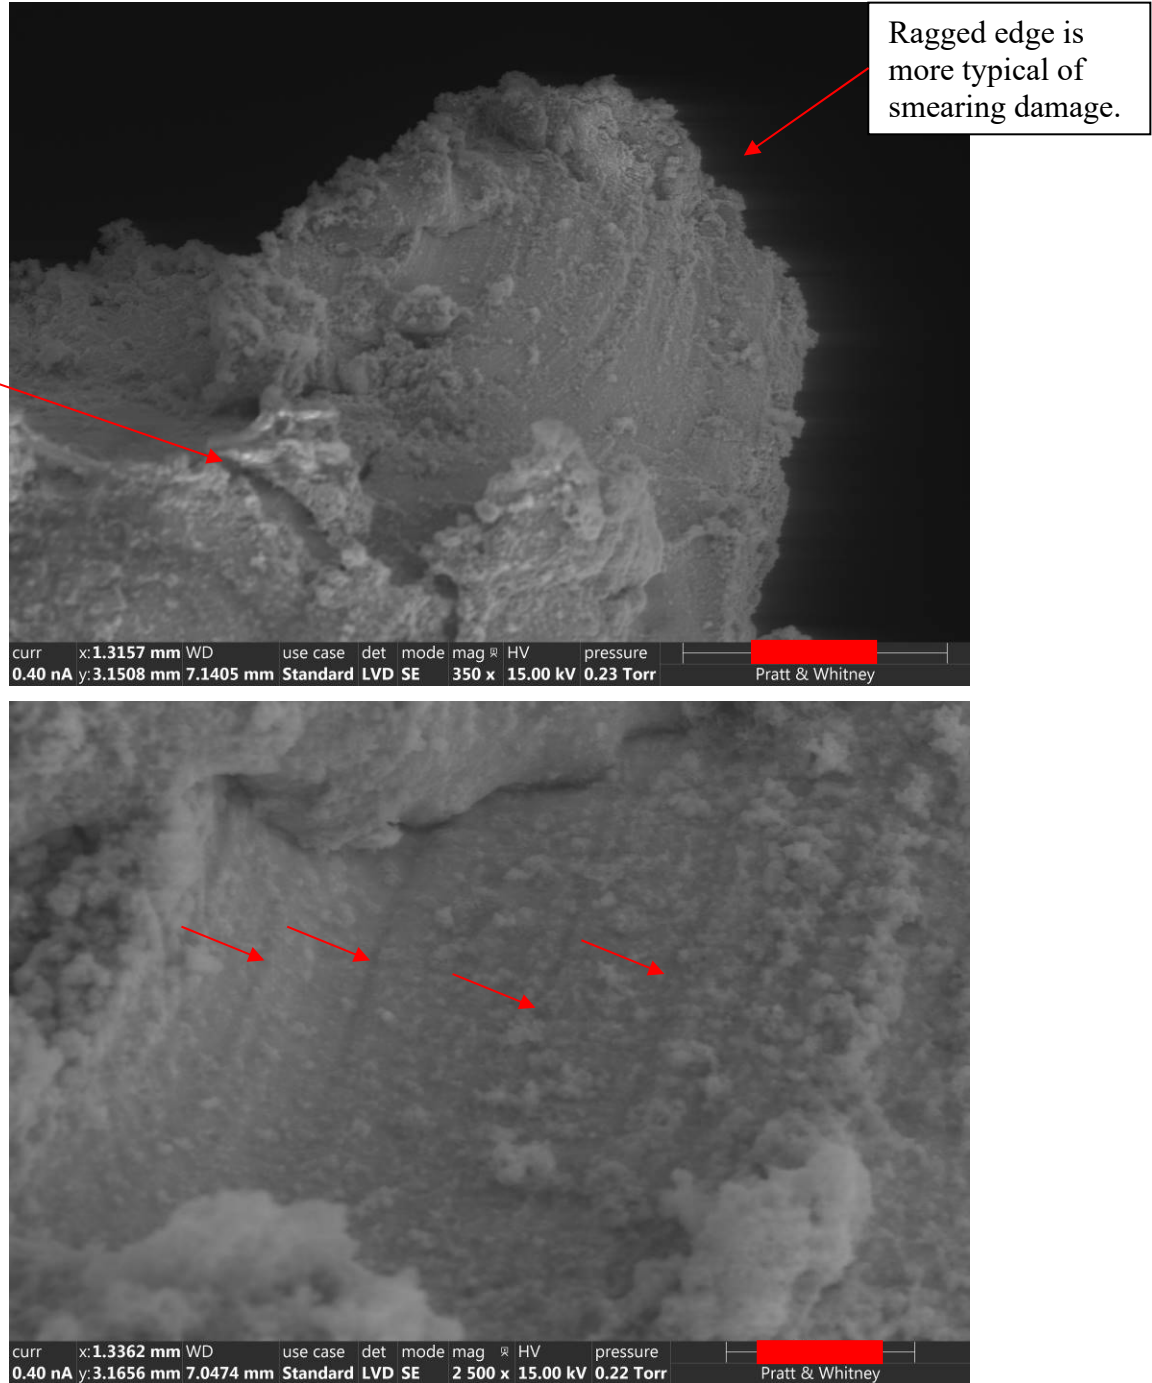
Blade 6 was sectioned and cleaned using the same procedure described for blade 1, and then the fracture surface was reviewed using SEM. Again, most of the visible fracture features were intergranular, with the exception of a smoother region around each hole. Review of the smoother region found no clear evidence of fatigue, with the possible exception of one small region shown in **Figure 11**. This region could also have been the result of smearing.

Figure 11: The images above taken from blade 6 around hole 2 were inconclusive. Features indicated in the top image suggest smearing, while feint plastic deformations of the crack surface indicated in the bottom image could be evidence of fatigue.

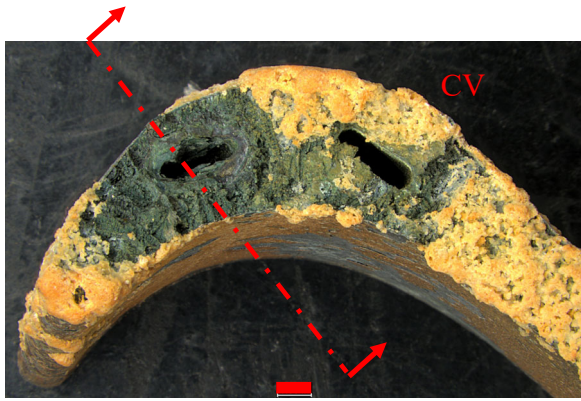
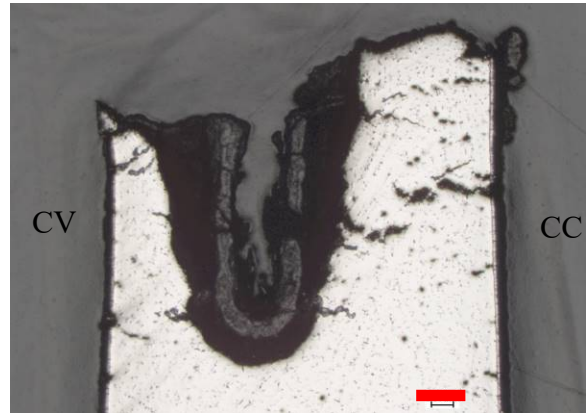
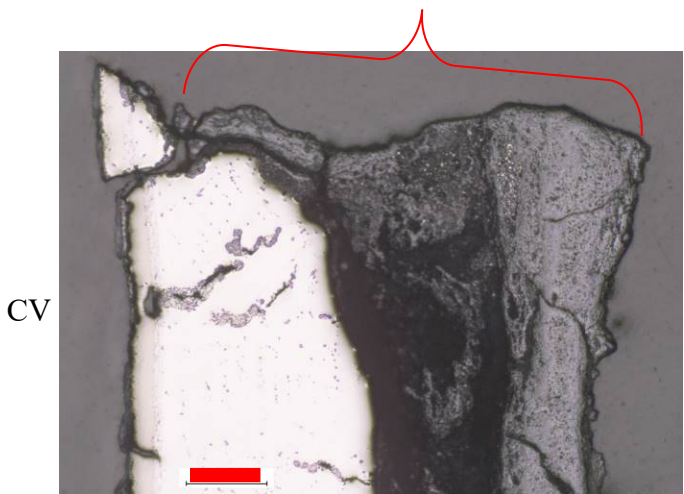
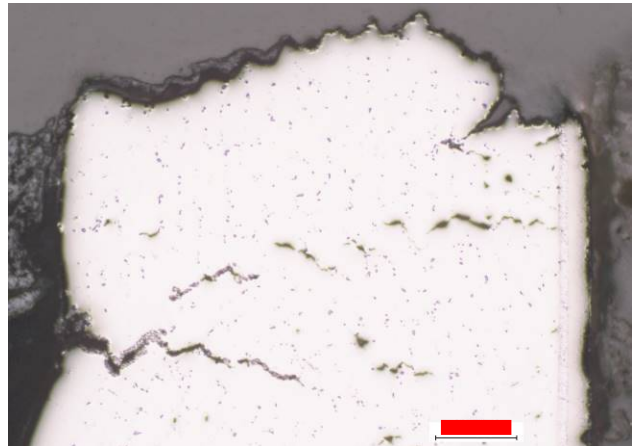
Metallographic examination of blade 6 found that the flat textured regions were actually in oxidation / corrosion scale, and not sound base metal. More than 75% of the convex wall at hole 1 had been consumed by oxidation / corrosion. Also, many secondary intergranular cracks were observed near the plane of fracture. Based on these observations, it seems likely that internal oxidation / corrosion resulted in loss of load bearing cross section, which resulted in a stress rupture fracture.

A metallographic section was prepared into lightening hole 1 of blade 6 approximately as sketched on the top image of **Figure 12**. This section was reviewed both as polished and in the etched condition using an inverted optical microscope. This review revealed many intergranular cracks in the vicinity of the fracture plane. Also, it was revealed that oxidation / corrosion had consumed more than 75% of the wall thickness on the CV side of hole 1. Based on this analysis, it is clear that the flat regions of fracture surrounding the holes in the blade were the result of cracking of the oxide scale. Review of the section using SEM and EDS found predominantly base metal and base metal oxides. The predominant phases observed decorating the attack front were aluminum oxide and aluminum nitride. A total of eight regions were analyzed by mapping, as shown in **Figure 13**. No evidence of sulfides, which typically exhibit a Ni-Cr-S composition, were observed. Maps from two representative regions are presented (**Figures 14**).

Figure 12: Metallographic review of Blade 6, hole 1 revealed multiple intergranular cracks near the fracture plane. Also, the CV wall was predominantly consumed by oxidation / hot corrosion at the fracture plane (red brace).
