DCA21FA174

Specialist's Factual Report - Attachment 7
Pratt & Whitney DCA21FA174 Metallurgical Investigation Report, July 29, 2022

Final Report for DCA21FA174

Subject: Metallurgical Investigation of High Pressure Turbine (HPT) Blades from an accident on July 2, 2021 in Honolulu, Hawaii involving a Boeing 737-200 aircraft, N810TA, operated by Rhodes Aviation Inc., dba Transair Flight 810.

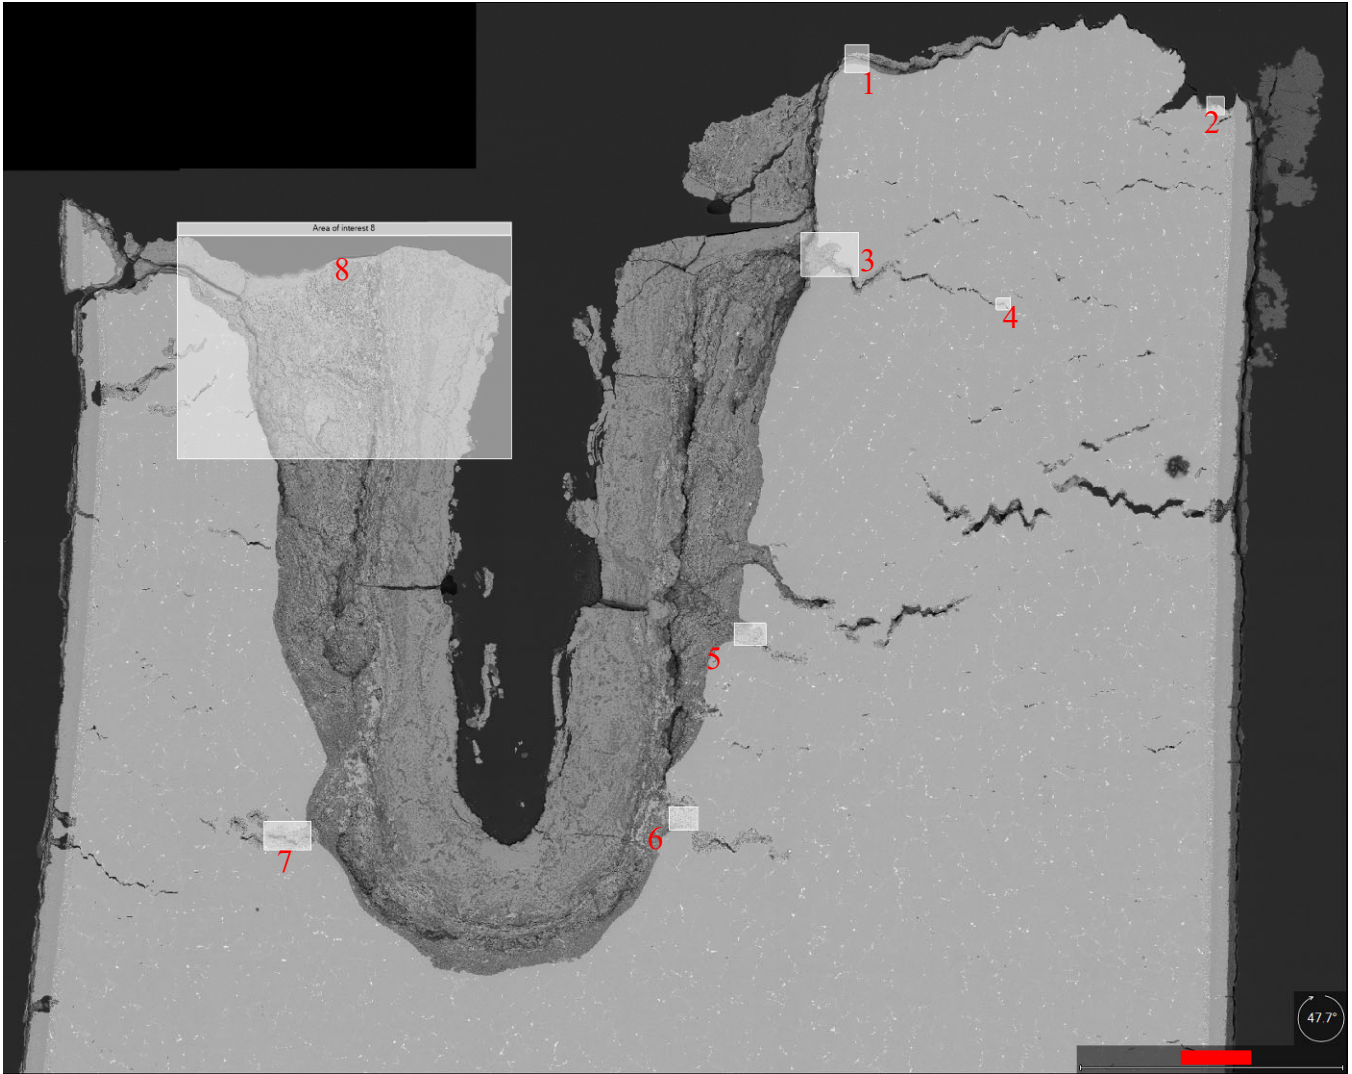
Figure 13: SEM metallographic review of Blade 6, hole 1. EDS Mapping was used to analyze the elements present within each of the regions enclosed in rectangles above. Results of this analysis follow.

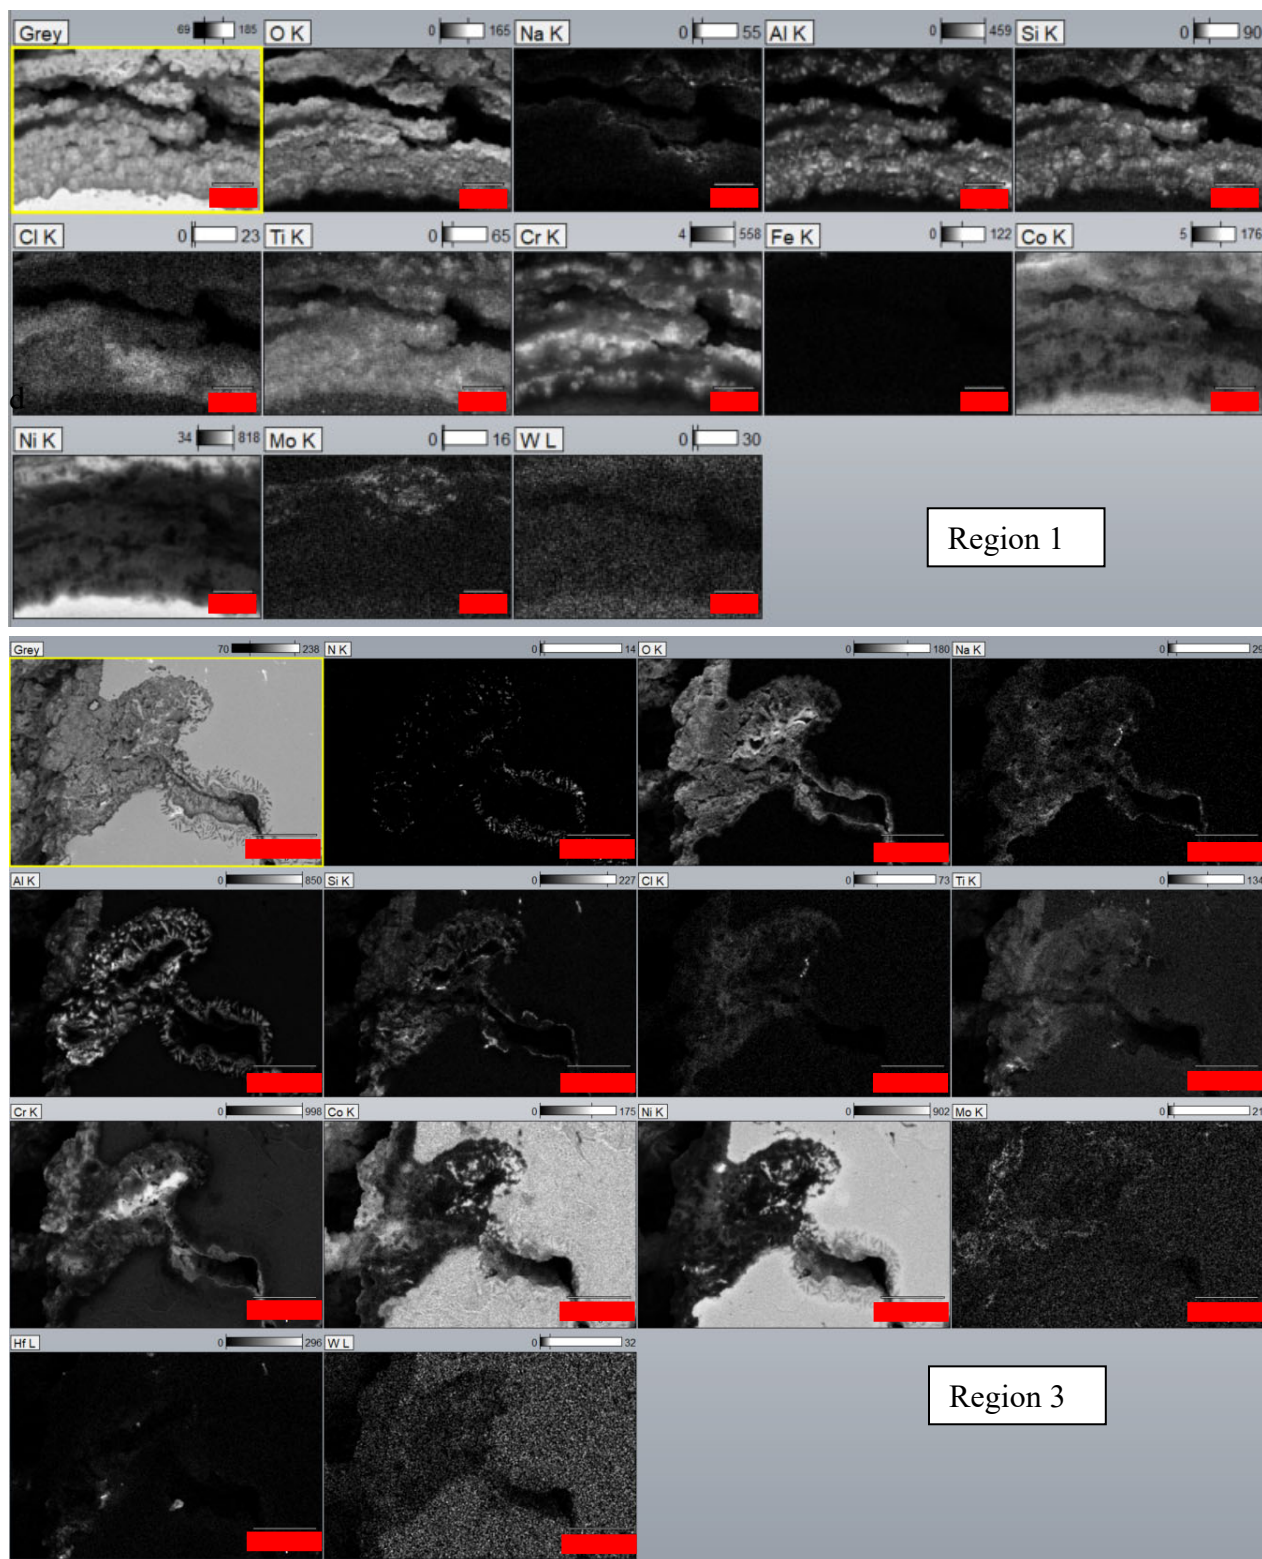
Figure 14: SEM metallographic review of Blade 6, hole 1. EDS net count maps of regions 1 and 3 revealed predominantly base metal and base metal oxides, with aluminum oxide and aluminum nitride decorating the attack front. No evidence of sulfidation was found.

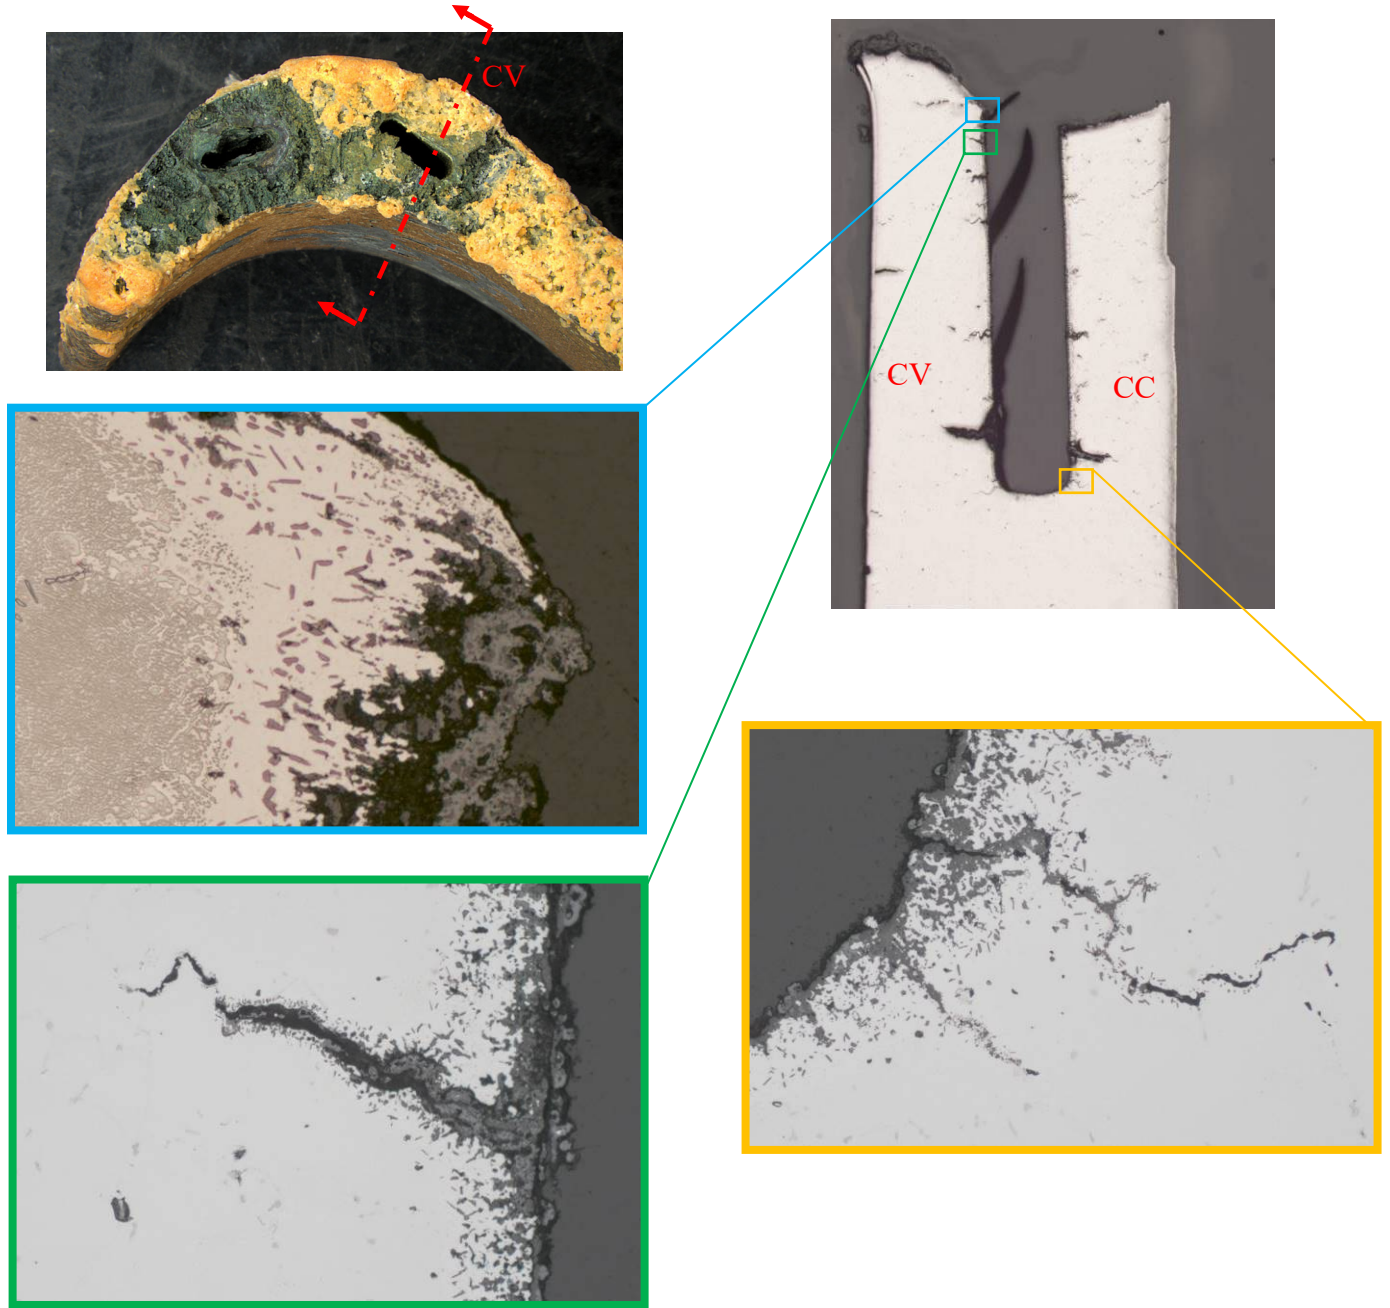
Another metallographic section was prepared into hole 2 of blade 6 approximately as sketched on the top image of **Figure 15**. This section was reviewed both as polished and in the etched condition using an inverted optical microscope. This review revealed many intergranular cracks in the vicinity of the fracture plane. Review of the attack front between the oxide scale and the base metal did not reveal any sulfides. Also, no conclusive evidence of aluminide coating was observed in the plane of polish. The part drawing³ requires 0.001”-0.004” of aluminide coating on the surface of the lightening holes, also known as “pockets,” at the time of manufacture. However, during strip and recoat repair no attempt is made to strip and recoat this region of the part. Instead, this region is supposed to be masked from the repair process. It is not possible now to determine if the parts conformed to the drawing requirement at the time they entered service, nor is it possible to know if the holes were successfully masked during the strip and recoat repair. Also, it is not possible to non-destructively determine if coating is present within the blade lightening holes, so it is very impractical to inspect a large number of blades for this condition.

Figure 15: Metallographic review of Blade 6, hole 2 revealed multiple intergranular cracks near the fracture plane. Higher magnification views of secondary cracks and oxidation / corrosion attack are also shown.

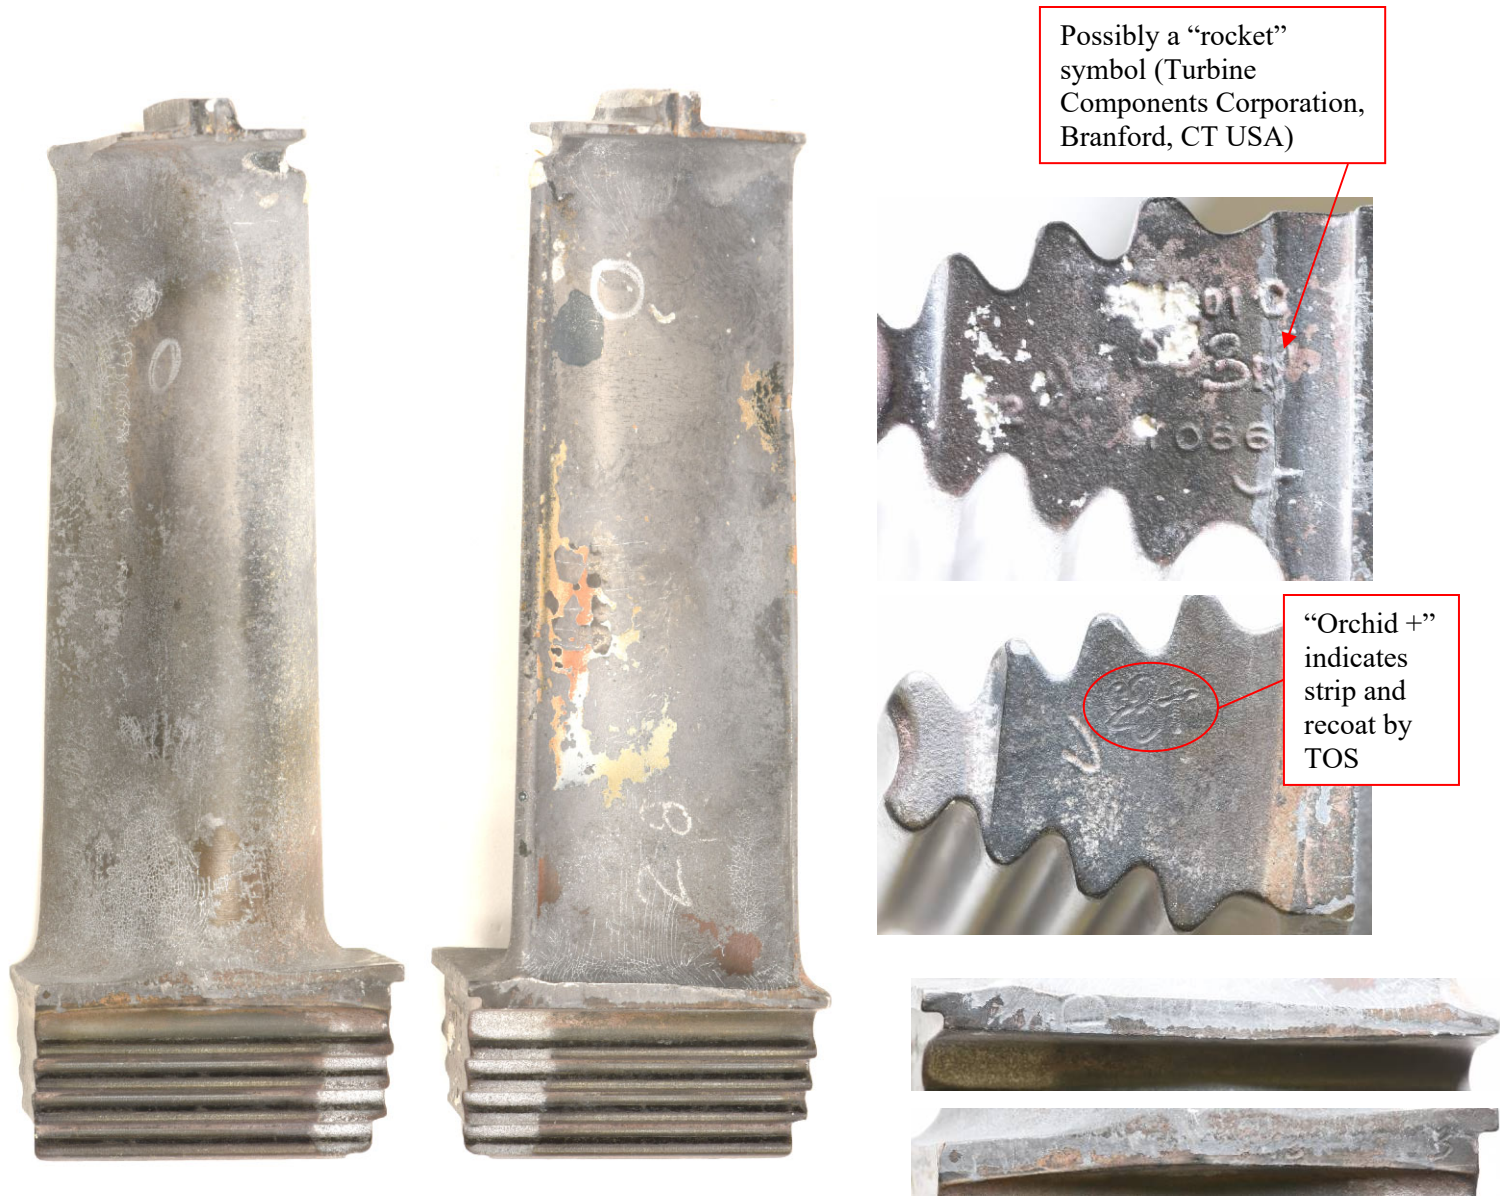
Blade 28 was chosen for further examination because it exhibited both low radial creep and low Magnetoscop readings. Closer views of cleaned blade 28, which was confirmed to be refurbished by TOS similar to fractured blade 6, are presented in **Figure 16**. The highest Magnetoscop locations on the concave and convex sides were circled by the Non-Destructive Evaluation (NDE) group.

Figure 16: Closer views of blade 28 after cleaning, which was confirmed to be refurbished by TOS. Images showing the CC and CV sides as well as the part markings. Some of the part markings were obscured by coral or barnacle growth, even after cleaning. The highest Magnetoscop locations on the concave and convex sides were circled by the NDE group.

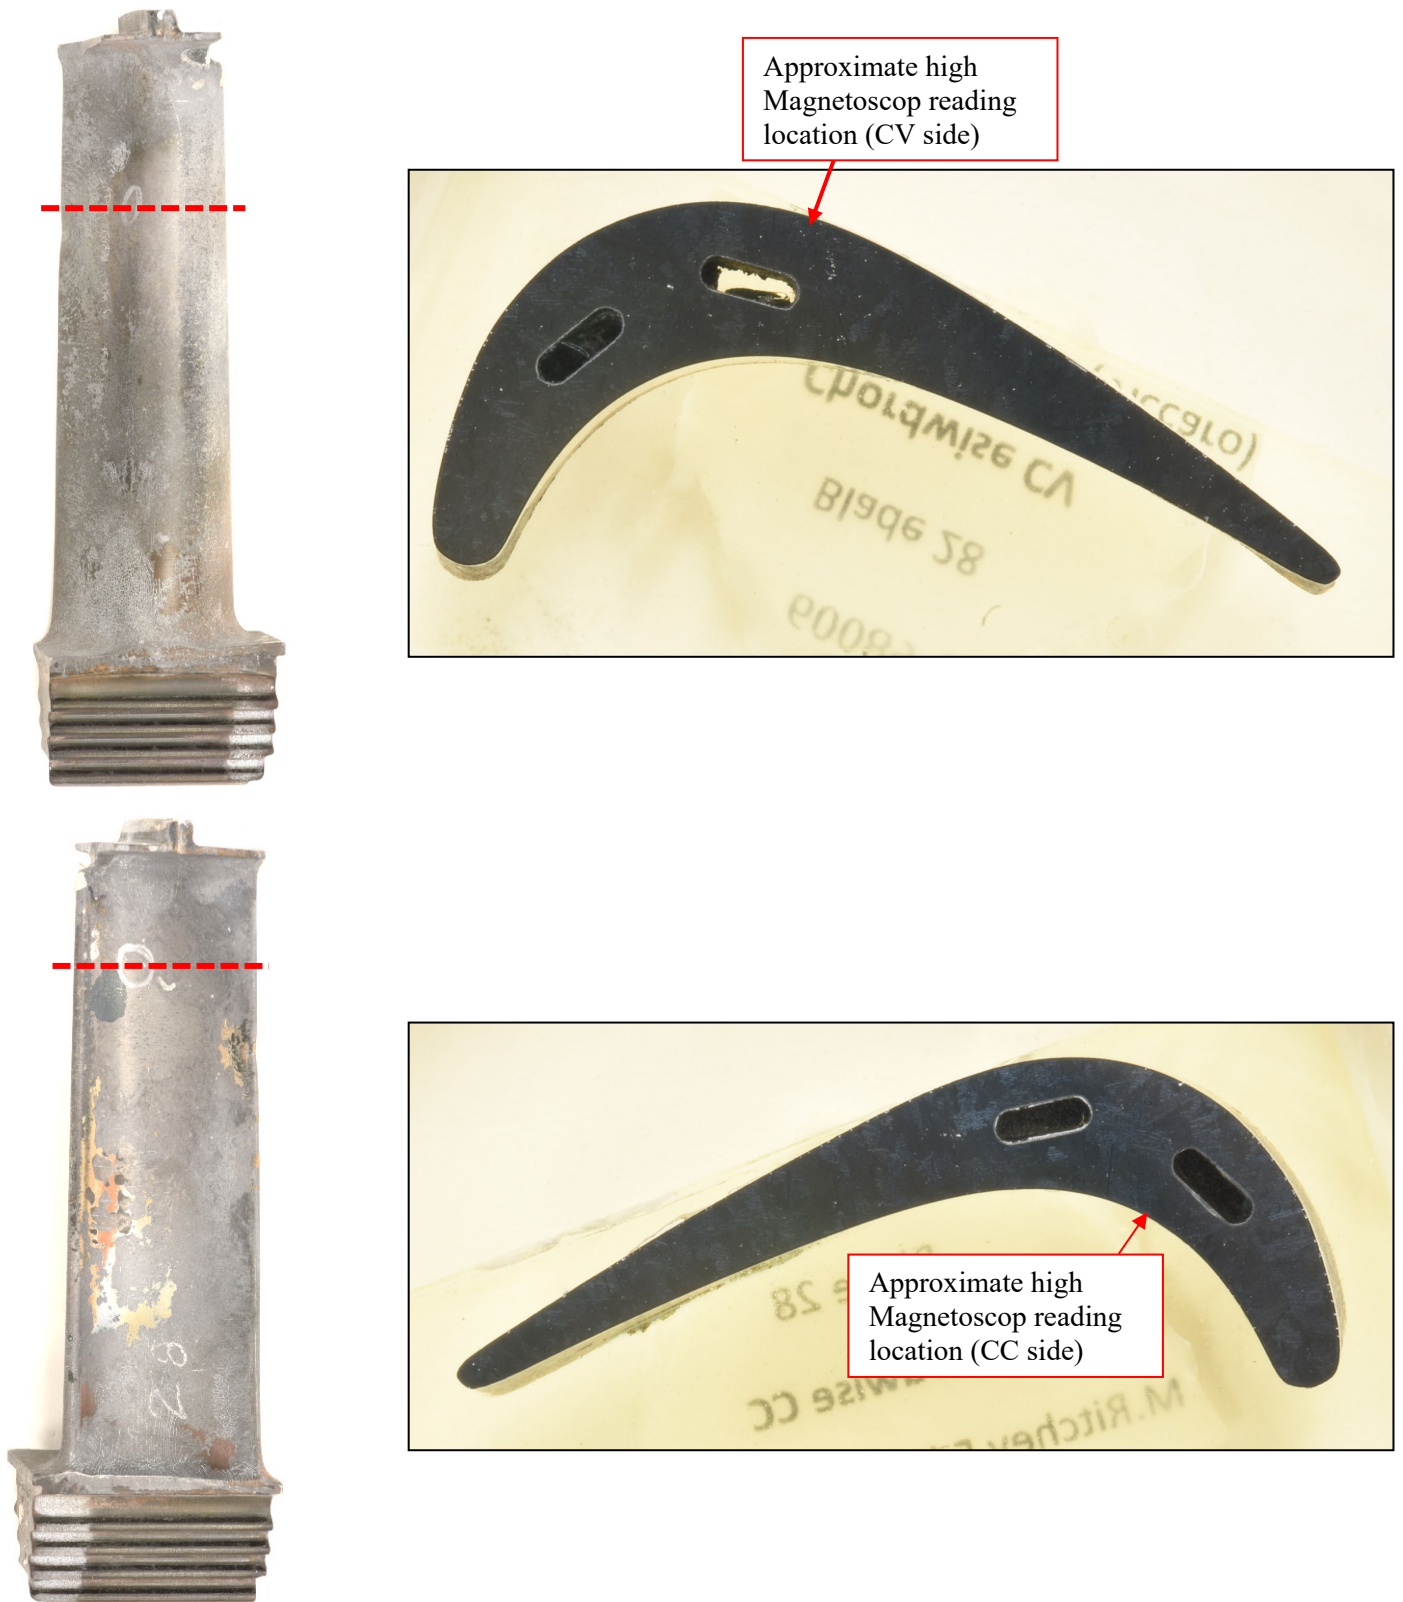
Figure 17: Images showing the locations of the metallographic sections prepared through the highest Magnetoscopy readings on the concave and convex sides of blade 28.

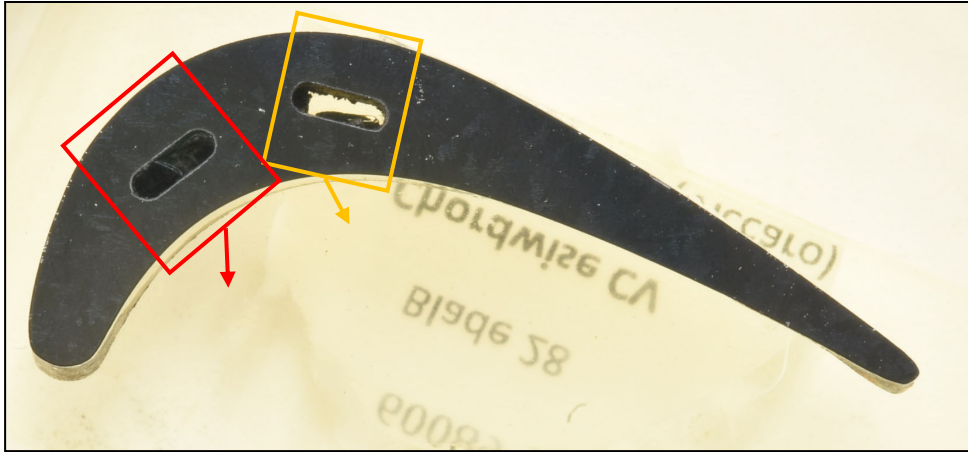
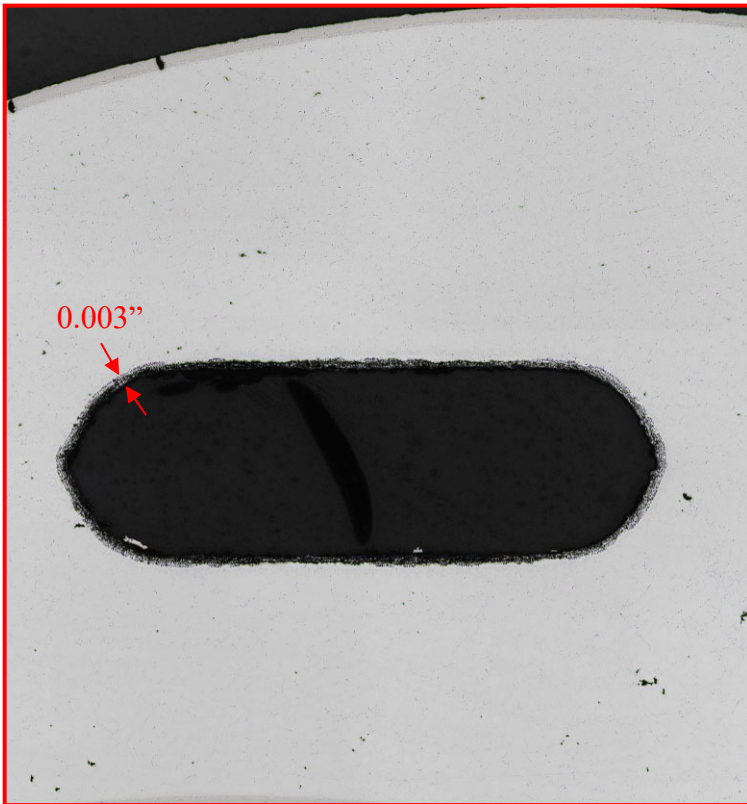
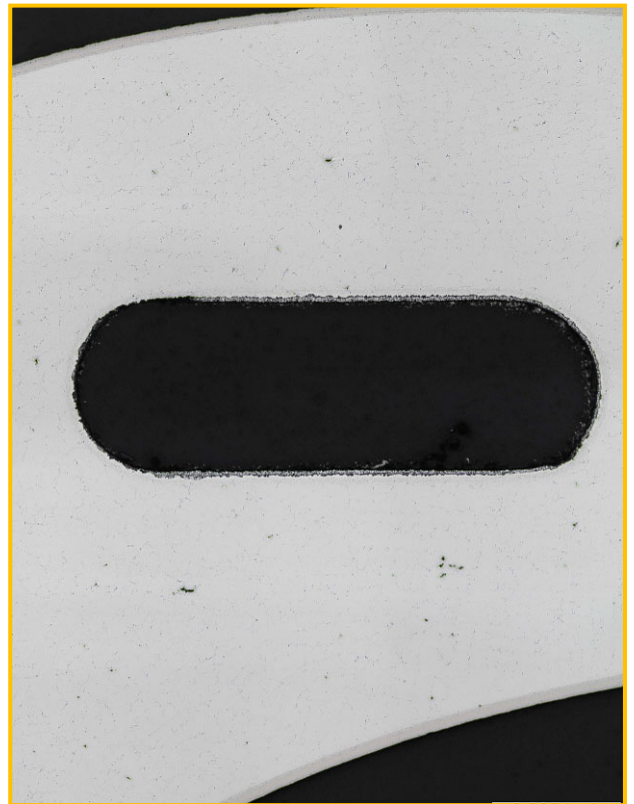
Metallographic sections were prepared chordwise through the blade at the span of the marked Magnetoscop locations as shown in **Figure 17**. Review of the metallographic section through the convex side Magnetoscop location revealed oxidation/corrosion less than 0.0032” in depth in the internal holes. Review of the metallographic section through the concave side Magnetoscop location revealed oxidation/corrosion less than 0.006” in depth in the internal holes. The holes did not appear to be aluminide coated (**Figures 18 and 19**). Metal temperature evaluation was completed at approximately 50% and 75% spans. A section was also taken through the root for comparison to baseline microstructure. The microstructure in the airfoil at both 50% and 75% spans was indicative of temperature exposure of at least 2000°F. Near the LE in the 75% span section, microstructure was indicative of temperature exposure of at least 2050°F (**Figure 20**). The microstructures observed would not be the expected result of repair processing and are more likely an indication of deteriorating engine health or the result of a single high temperature excursion.

Figure 18: Metallographic review of the section through the convex side Magnetoscop location on blade 28 revealed internal oxidation/corrosion less than 0.003" in depth. The internal surfaces of the holes did not appear to be coated.

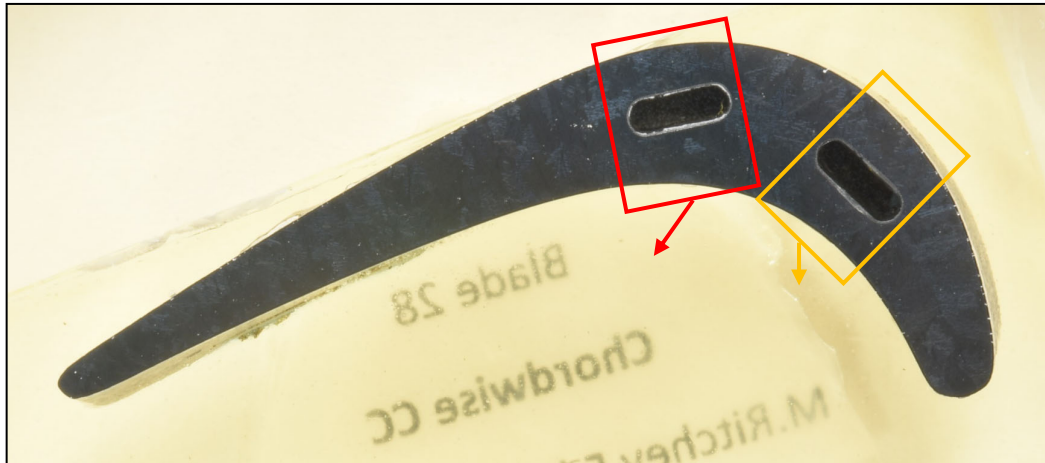
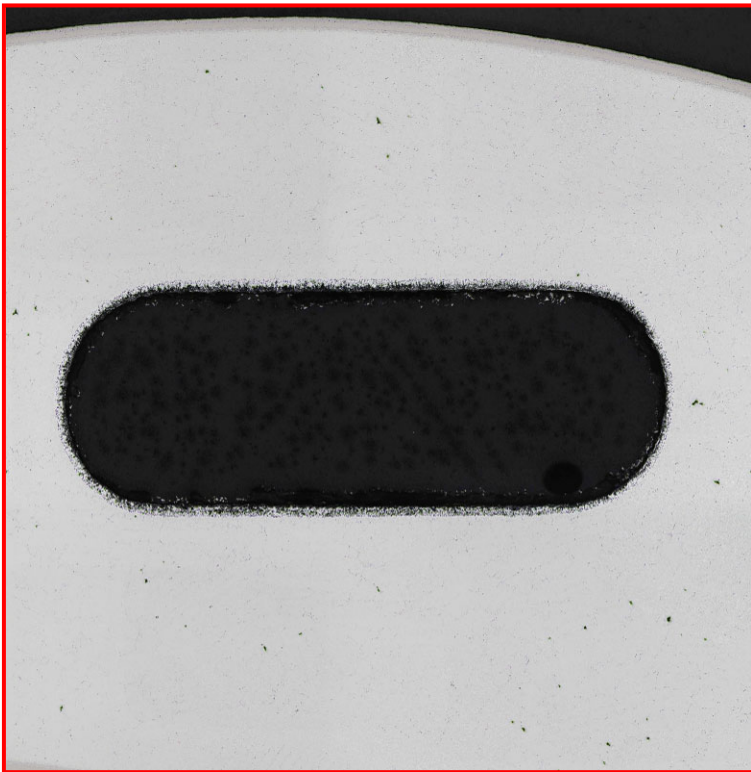
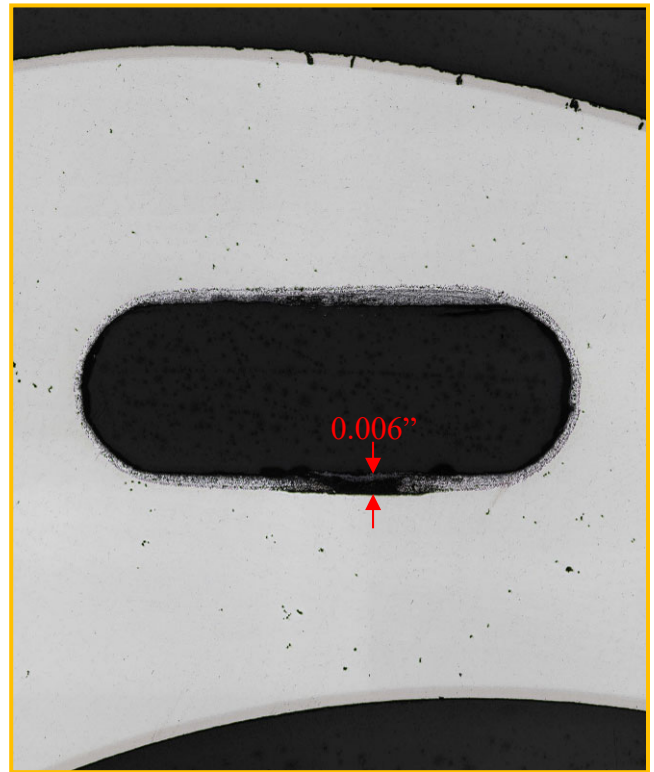
Figure 19: Metallographic review of the section through the concave side Magnetoscop location on blade 28 revealed internal oxidation/corrosion less than 0.006". The internal surfaces of the holes did not appear to be coated.

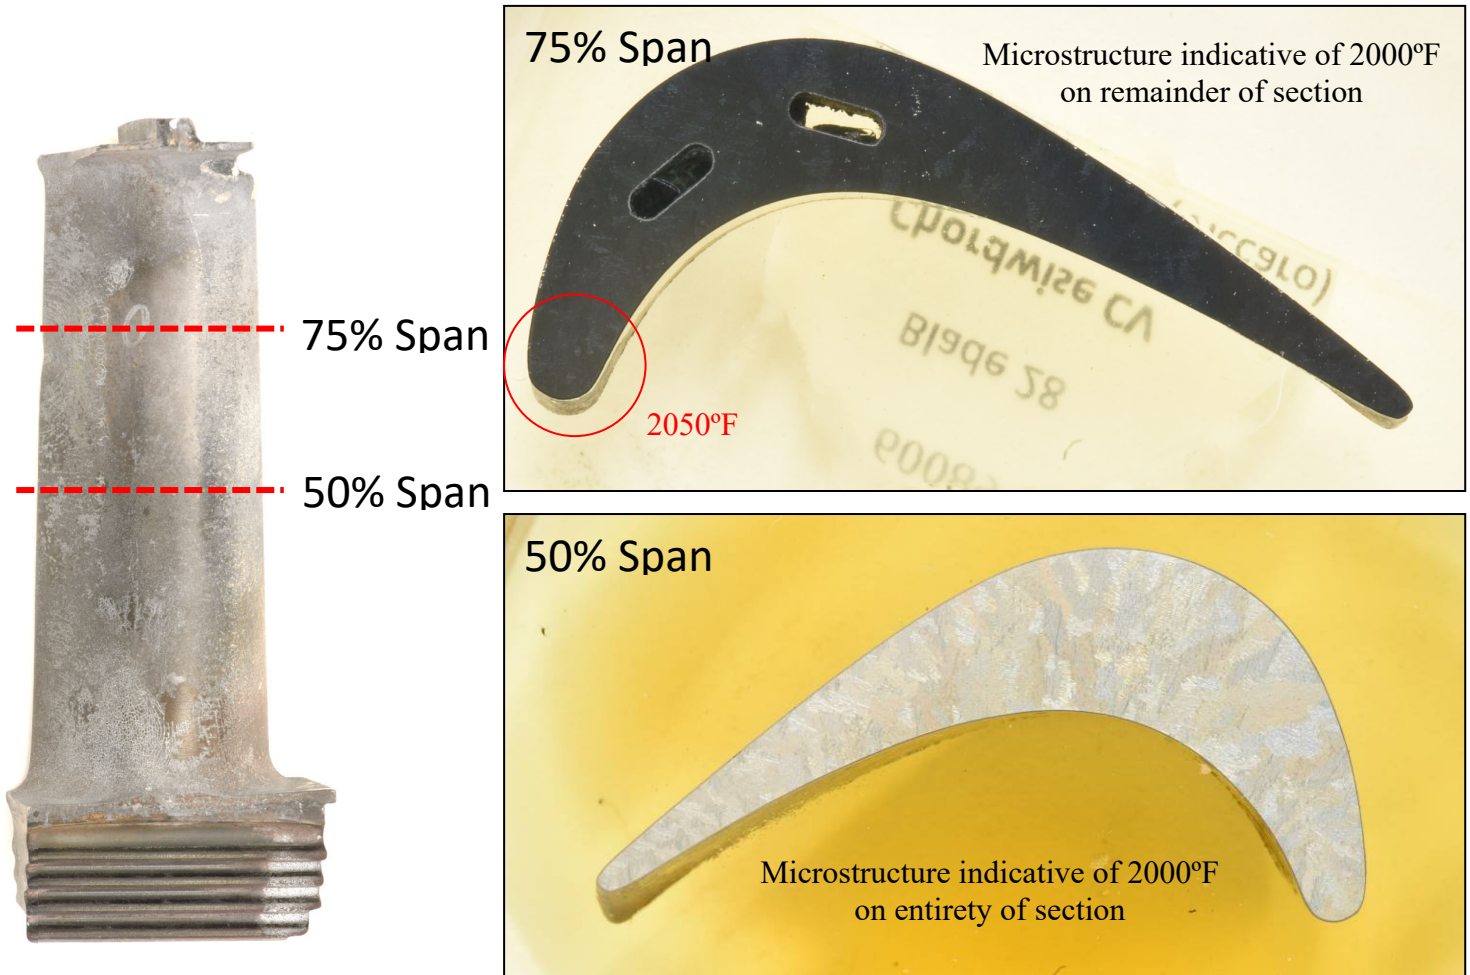
Figure 20: Metal temperature evaluation was completed at approximately 50% and 75% spans on blade 28. The microstructure in the airfoil at both 50% and 75% spans was indicative of temperature exposure of at least 2000°F. Near the LE in the 75% span section, microstructure was indicative of temperature exposure of at least 2050°F.

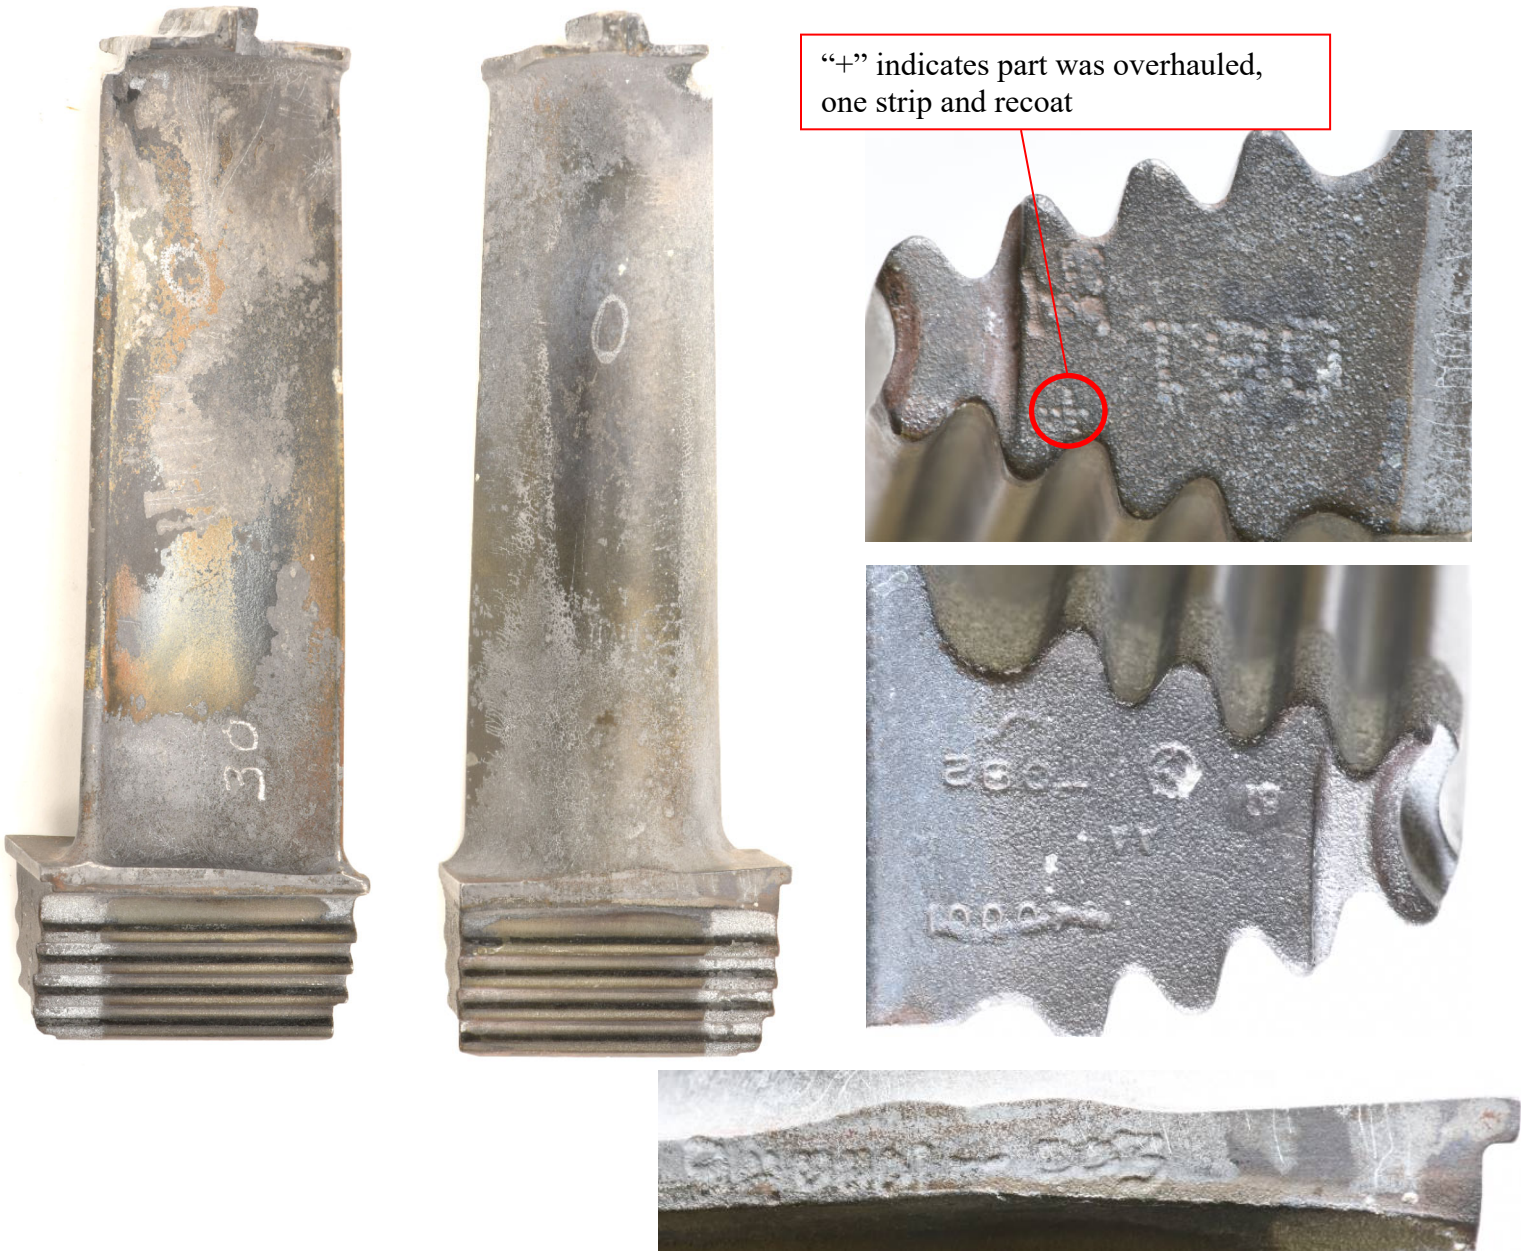
Blade 30 was chosen for further examination because it exhibited high radial creep and low Magnetoscop readings. Closer views of blade 30, which was confirmed to have a “+” similar to blade 1 indicating a strip and recoat, are presented in **Figure 21**. Some of the part markings were illegible. The highest Magnetoscop locations on the concave and convex sides were circled by the NDE group.

Figure 21: Closer views of blade 30 after cleaning, which was confirmed to be refurbished. Images showing the CC and CV sides as well as the part markings on the root and platform. Some of the part markings were illegible. The highest Magnetoscop locations on the concave and convex sides were circled by the NDE group.

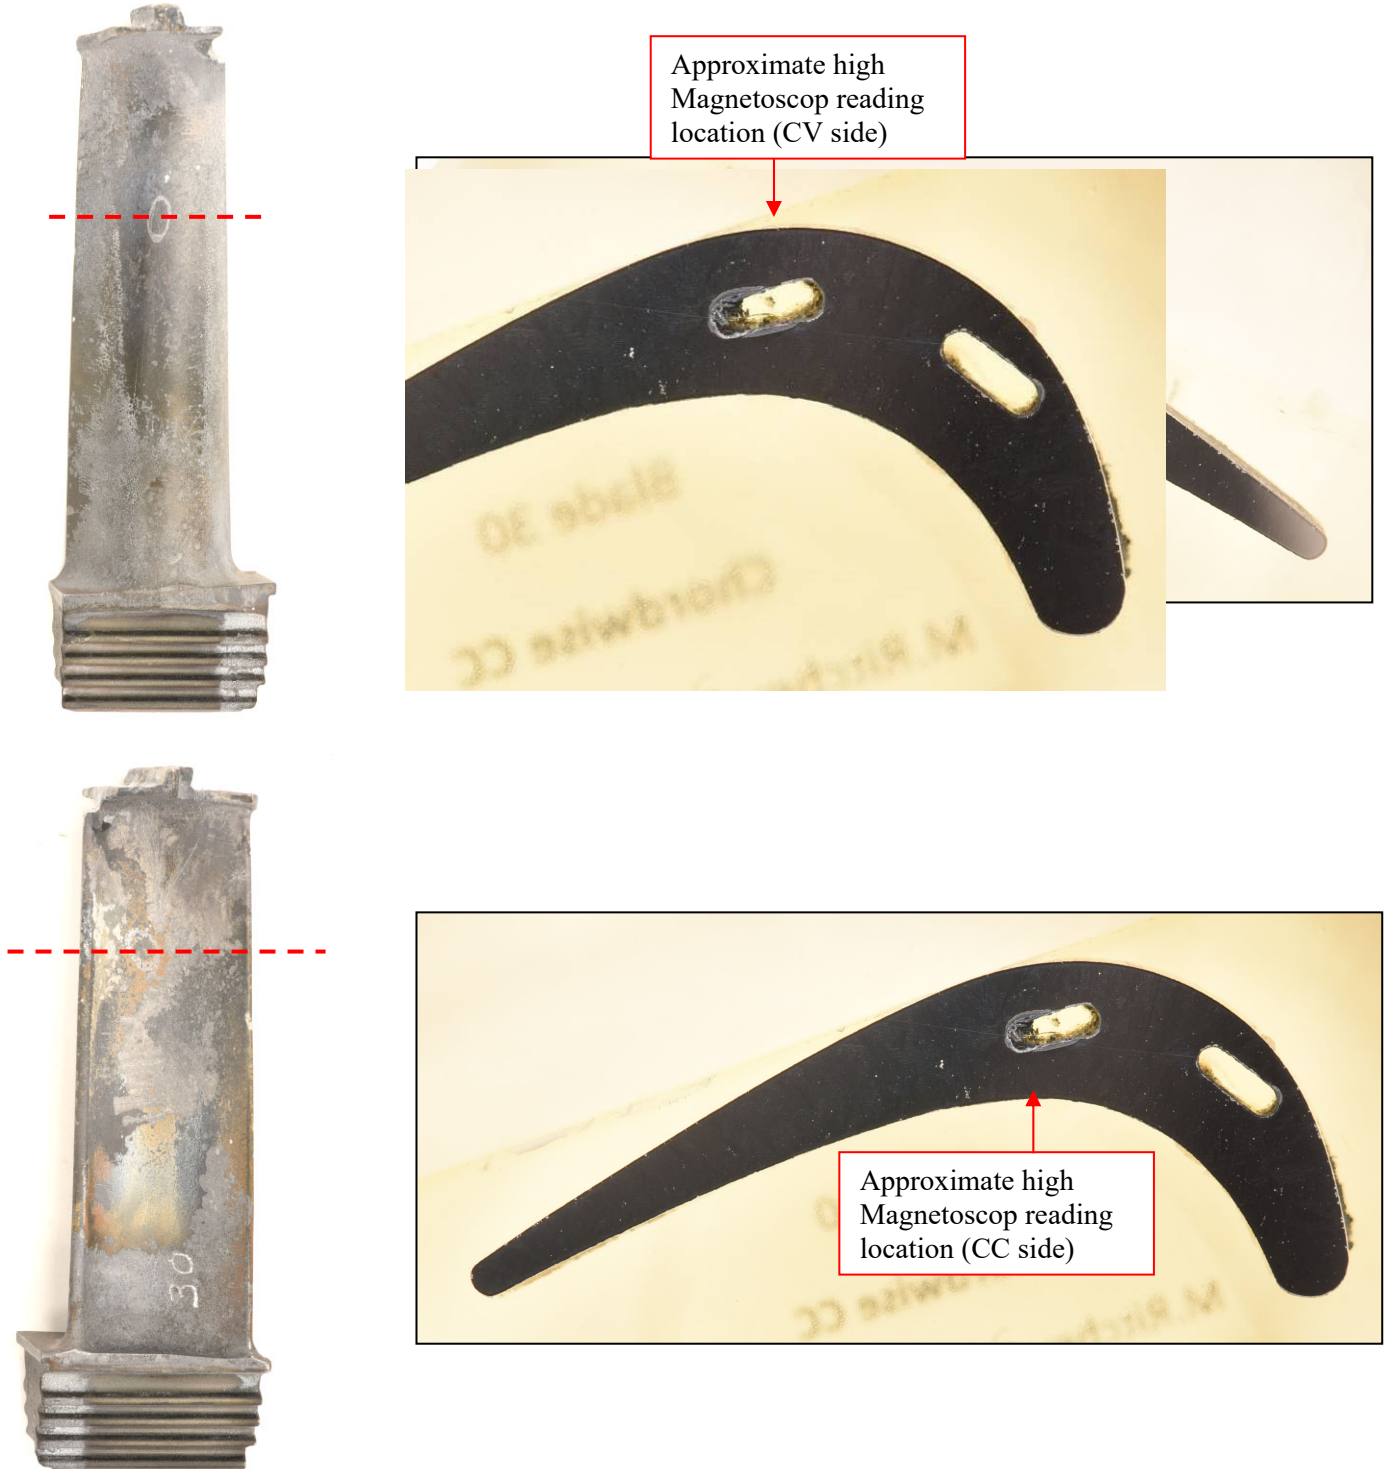
Figure 22: Images showing the locations of the metallographic sections prepared through the highest Magnetoscopy readings on blade 30.

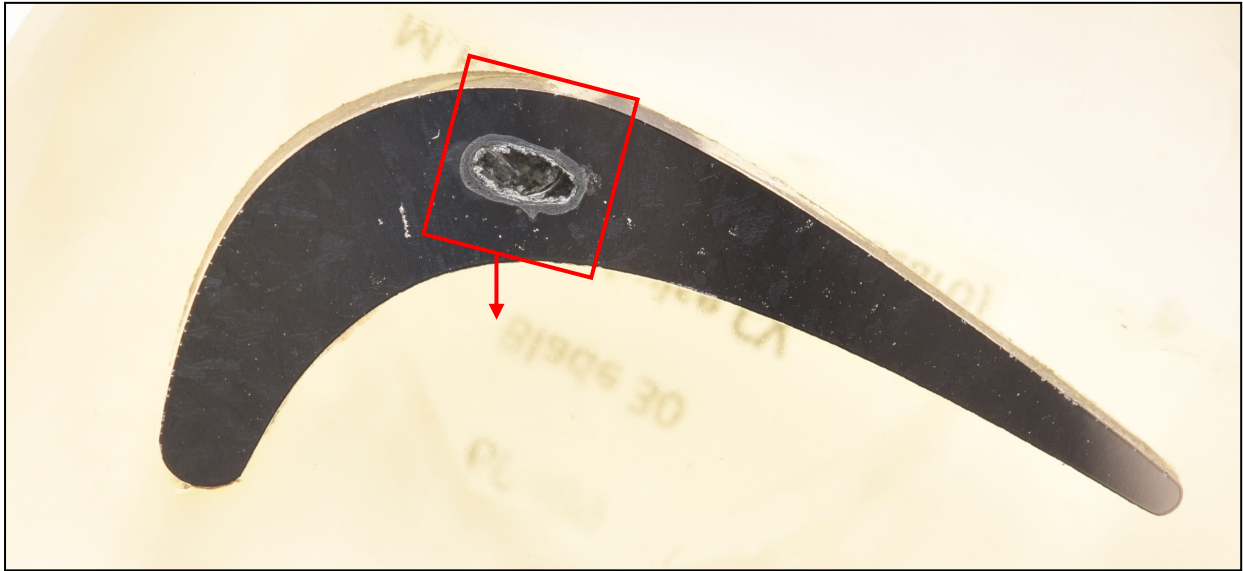
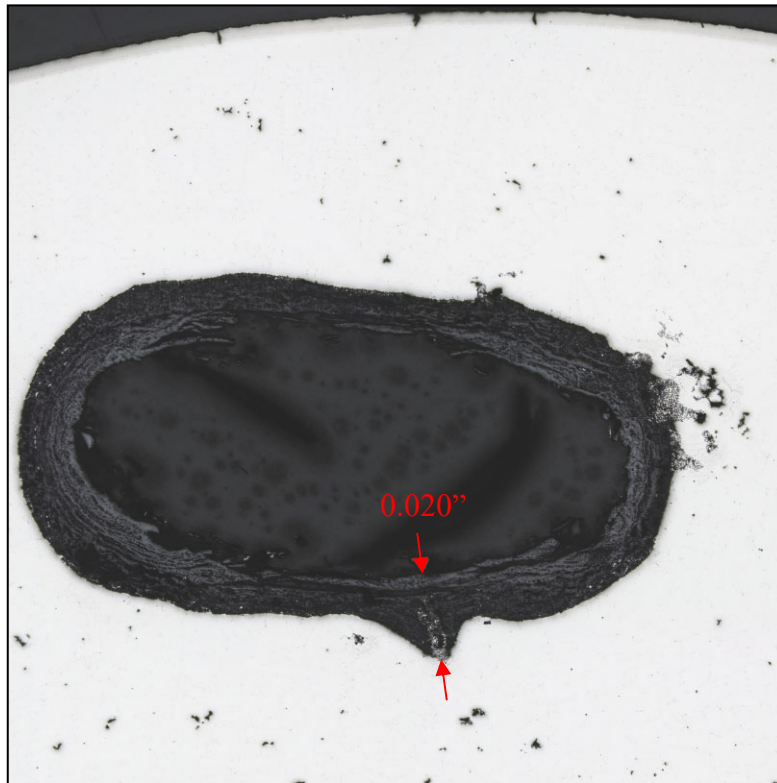
Two metallographic sections were prepared chordwise through the blade at the span of each of the marked Magnetoscop locations shown in **Figure 22**. Review of the metallographic section through the convex side Magnetoscop location revealed internal oxidation/corrosion up to 0.020” in depth at the internal hole nearest midchord (hole 2). The forward hole (hole 1) was not visible in the section (**Figure 23**). Review of the metallographic section through the concave side Magnetoscop location revealed internal oxidation/corrosion up to 0.011” in depth at hole 2. The internal hole closest to the LE exhibited less oxidation/corrosion (**Figure 24**). Metal temperature evaluation was completed at approximately 50% and 75% spans. A section was also taken through the root for comparison to baseline microstructure. The microstructure in the airfoil at both 50% and 75% spans was indicative of temperature exposure of at least 2000°F. Near the LE in the 75% span section, microstructure was indicative of temperature exposure of at least 2050°F (**Figure 25**).

Figure 23: Metallographic review of the section through the convex side Magnetoscop location on blade 30 revealed corrosion on the internal hole up to 0.020" in depth. Only the hole at midchord was visible in the section.

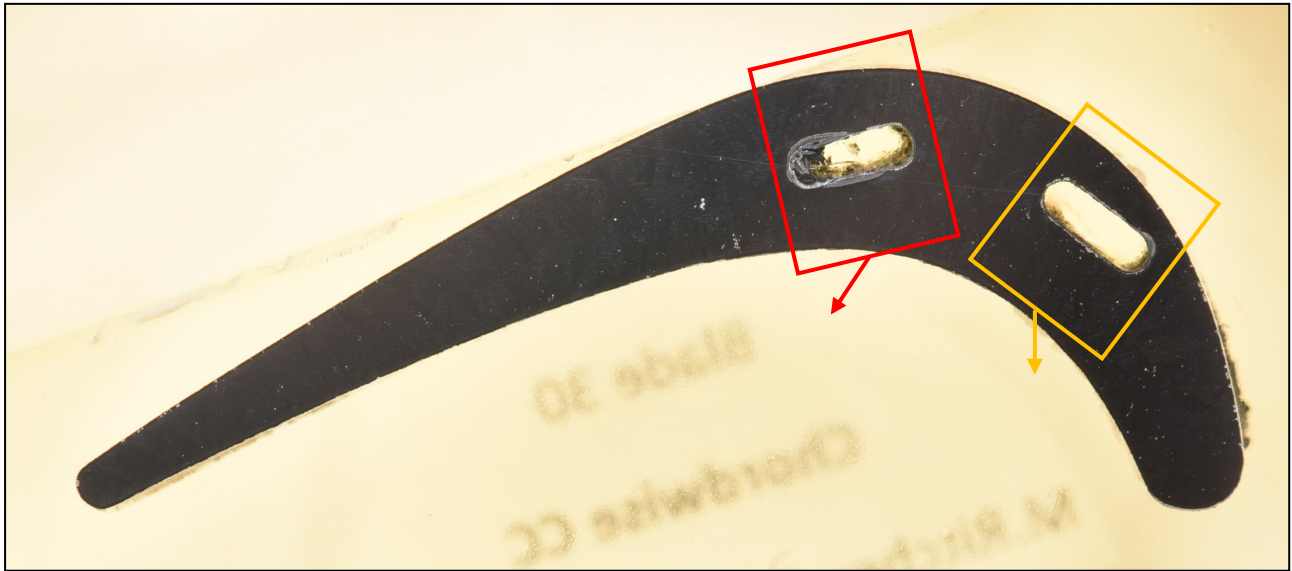
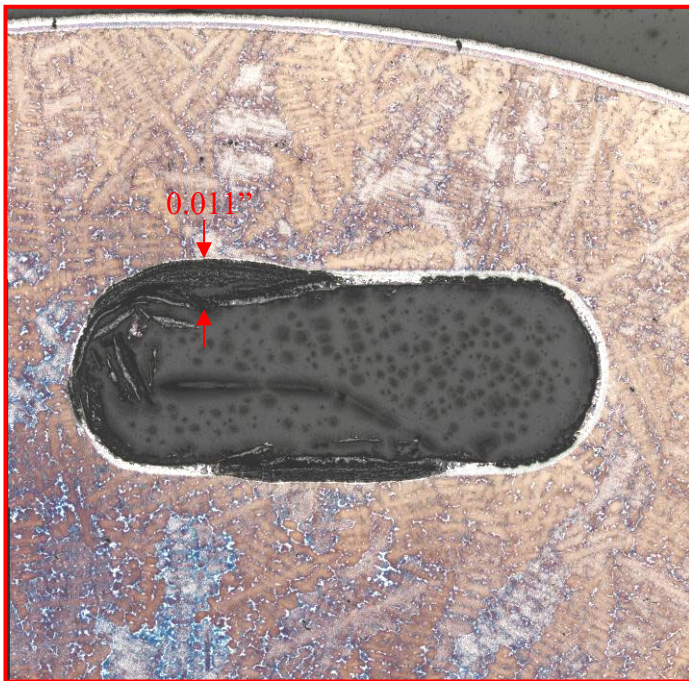
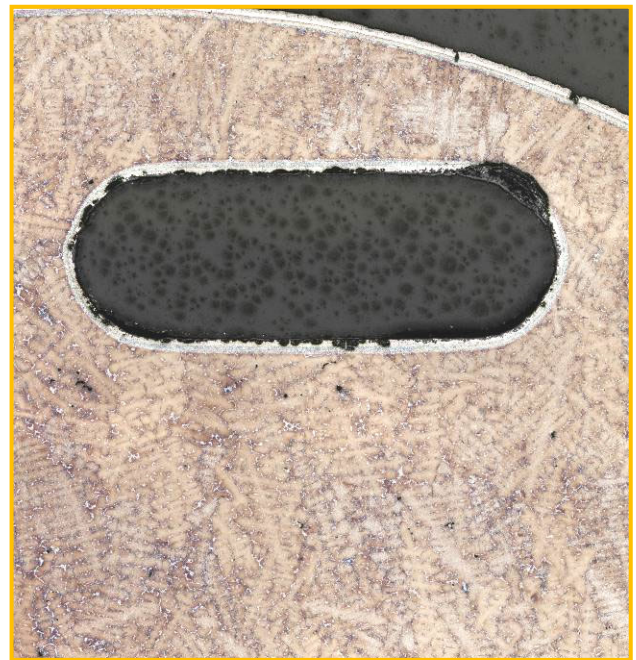
Figure 24: Metallographic review of the section through the concave side Magnetoscoop location on blade 30 revealed oxidation/corrosion on the internal holes up to 0.011" in depth. The sample was etched with AG-21.
