DCA21FA174

Specialist's Factual Report - Attachment 7
Pratt & Whitney DCA21FA174 Metallurgical Investigation Report, July 29, 2022

Final Report for DCA21FA174

Subject: Metallurgical Investigation of High Pressure Turbine (HPT) Blades from an accident on July 2, 2021 in Honolulu, Hawaii involving a Boeing 737-200 aircraft, N810TA, operated by Rhodes Aviation Inc., dba Transair Flight 810.

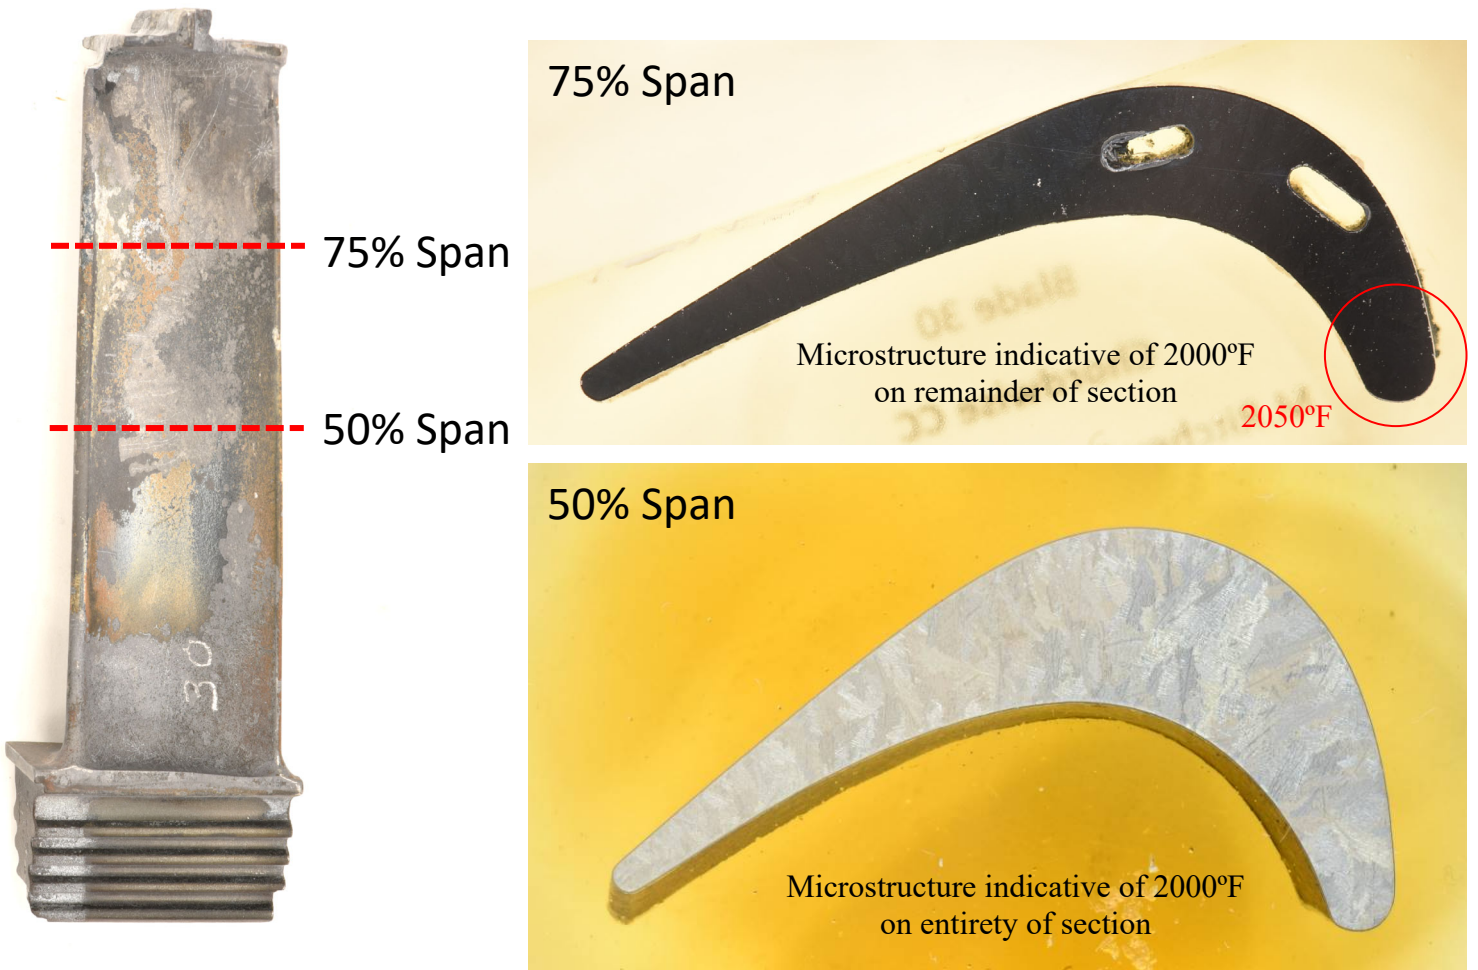
Figure 25: Metal temperature evaluation was completed at approximately 50% and 75% spans on blade 30. The microstructure in the airfoil at both 50% and 75% spans was indicative of temperature exposure of at least 2000°F. Near the LE in the 75% span section, microstructure was indicative of temperature exposure of at least 2050°F.

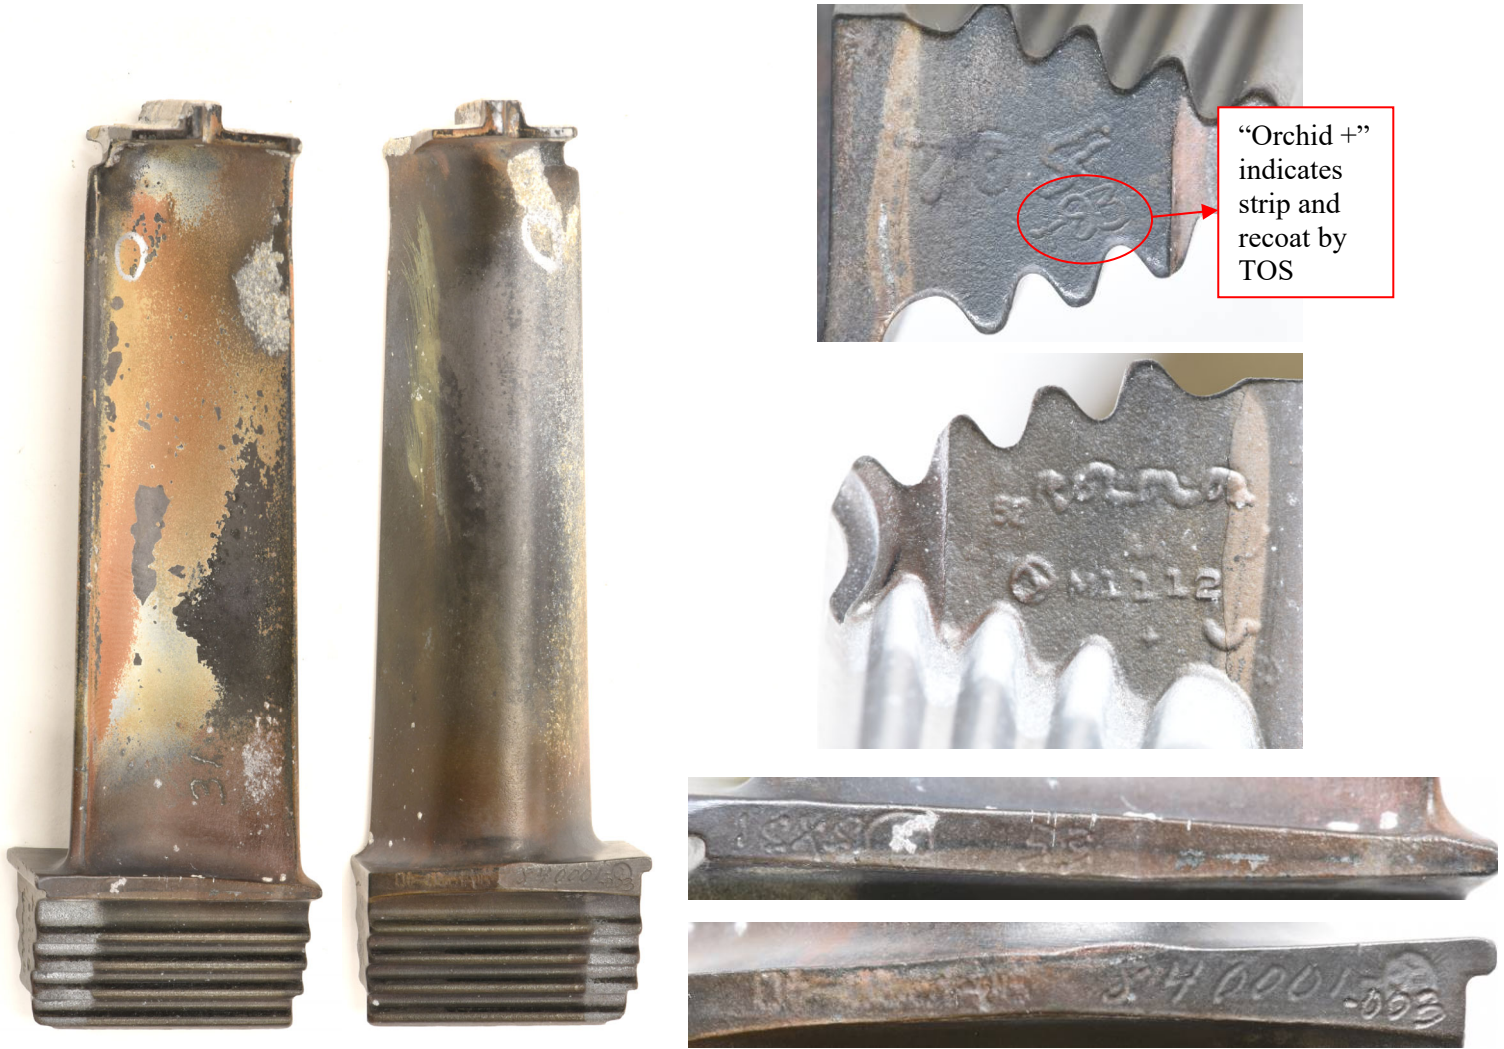
Blade 31 was chosen for further examination because it exhibited low radial creep and high Magnetoscop readings. Closer views of blade 31, which was confirmed to be refurbished by TOS similar to fractured blade 6, are presented in **Figure 26**. The highest Magnetoscop locations on the concave and convex sides were circled by the NDE group.

“Orchid +”
indicates
strip and
recoat by
TOS

Figure 26: Closer views of blade 31 after cleaning, which was confirmed to be refurbished by TOS. Images showing the CC and CV sides as well as the part markings on the root and platform. Some of the part markings were illegible. The highest Magnetoscop locations on the concave and convex sides were circled by the NDE group.

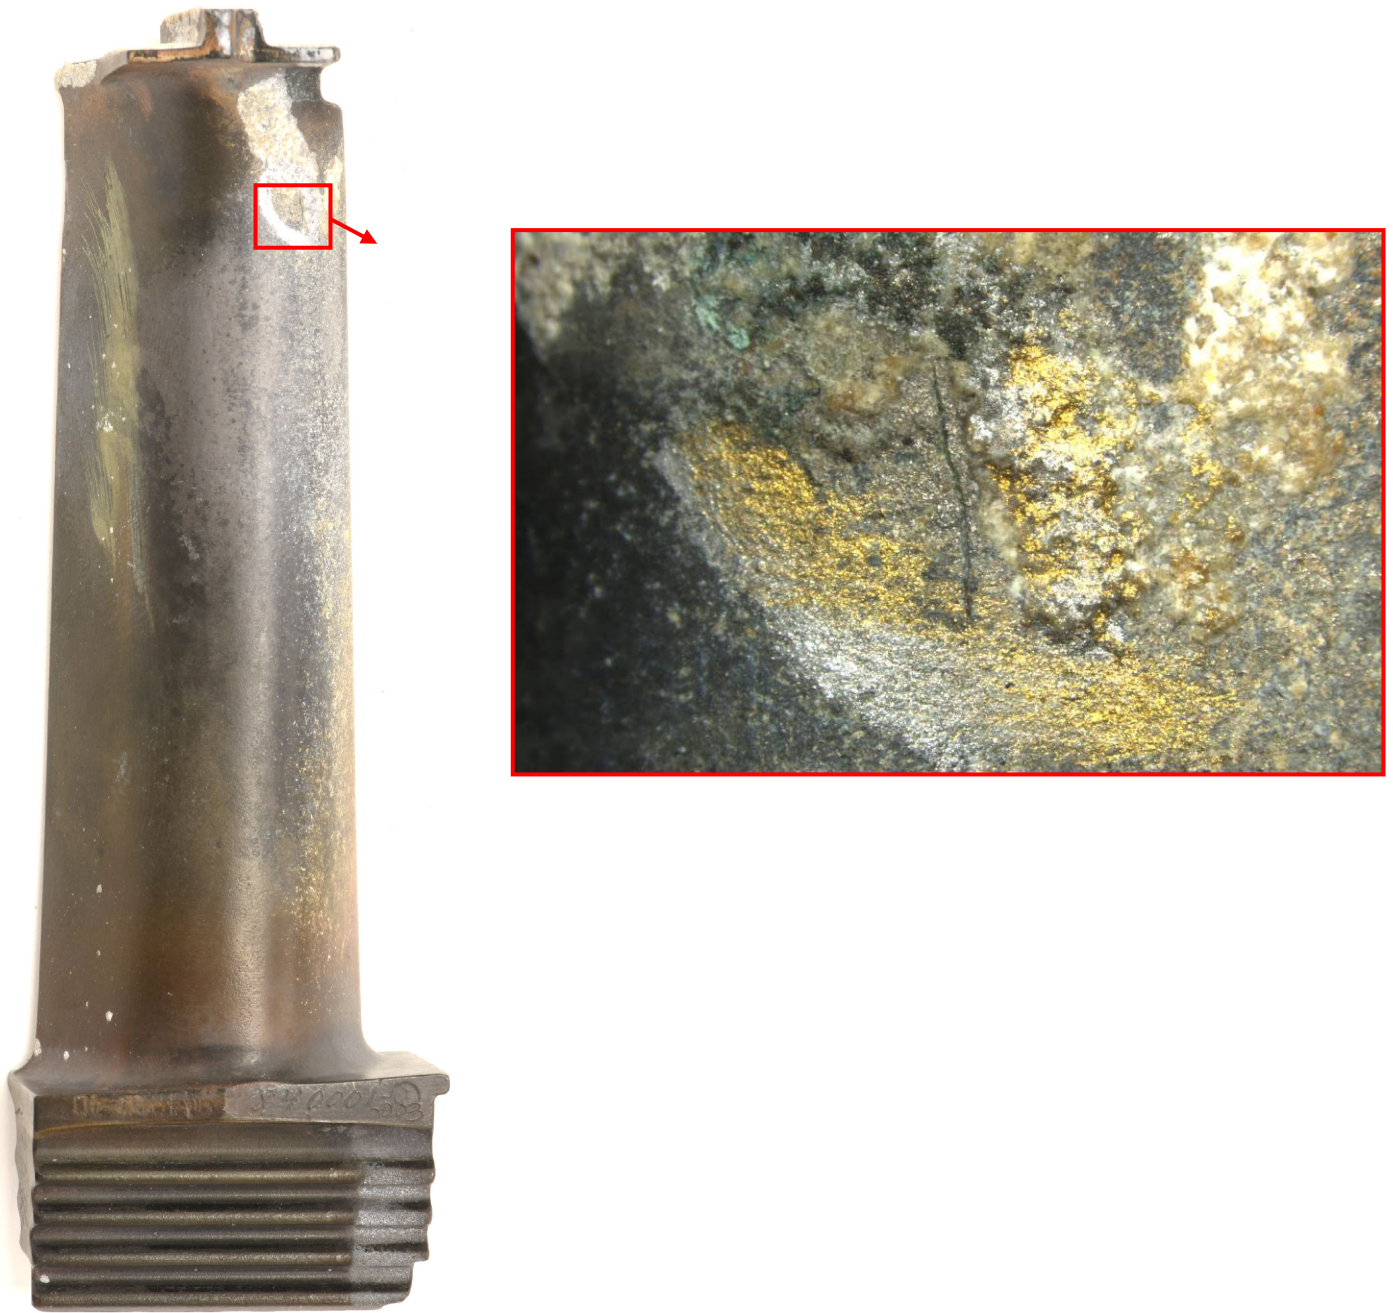
Binocular examination of the Magnetoscop location on the convex side of the blade identified a crack-like feature in the spanwise direction (**Figure 27**). The spanwise crack-like feature was broken open. Extensive oxidation/corrosion was observed from the internal hole. The discoloration, indicative of exposure during engine-run time, extended through-wall for at least 0.17” along the surface. Part of the crack was likely sectioned prior to breaking open (**Figure 28**). SEM examination identified features consistent with extensive oxidization/corrosion. The features along the concave wall were consistent with overstress from lab fracture (ductile dimples) (**Figure 29**).

Figure 27: Image showing a spanwise crack-like feature at the Magnetoscop location on blade 31.

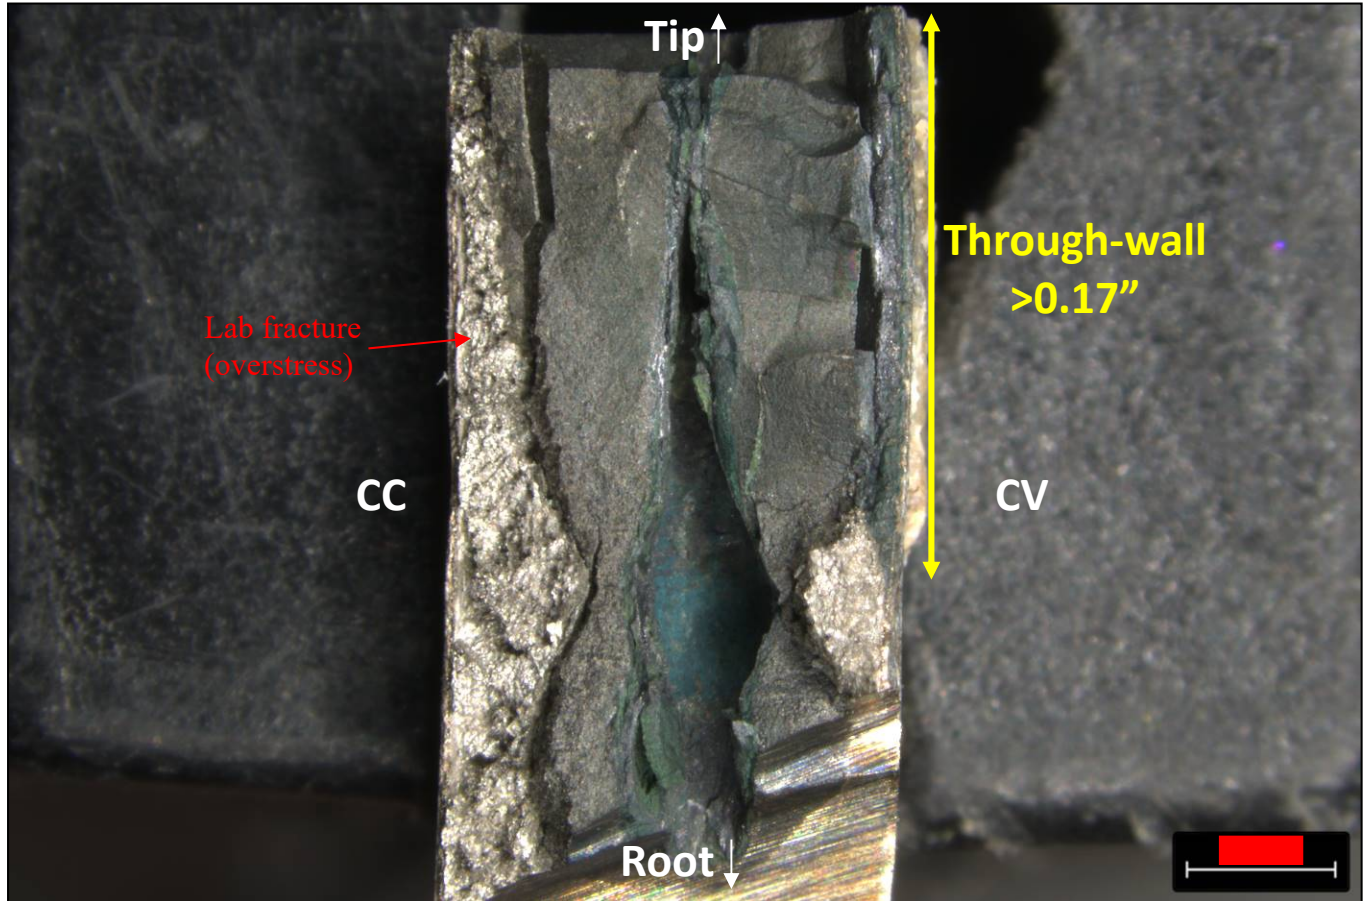
Figure 28: The spanwise crack-like feature was broken open. Extensive oxidation/corrosion was observed from the internal hole (dark-colored region). The discoloration extended through-wall for at least 0.17" along the convex surface.

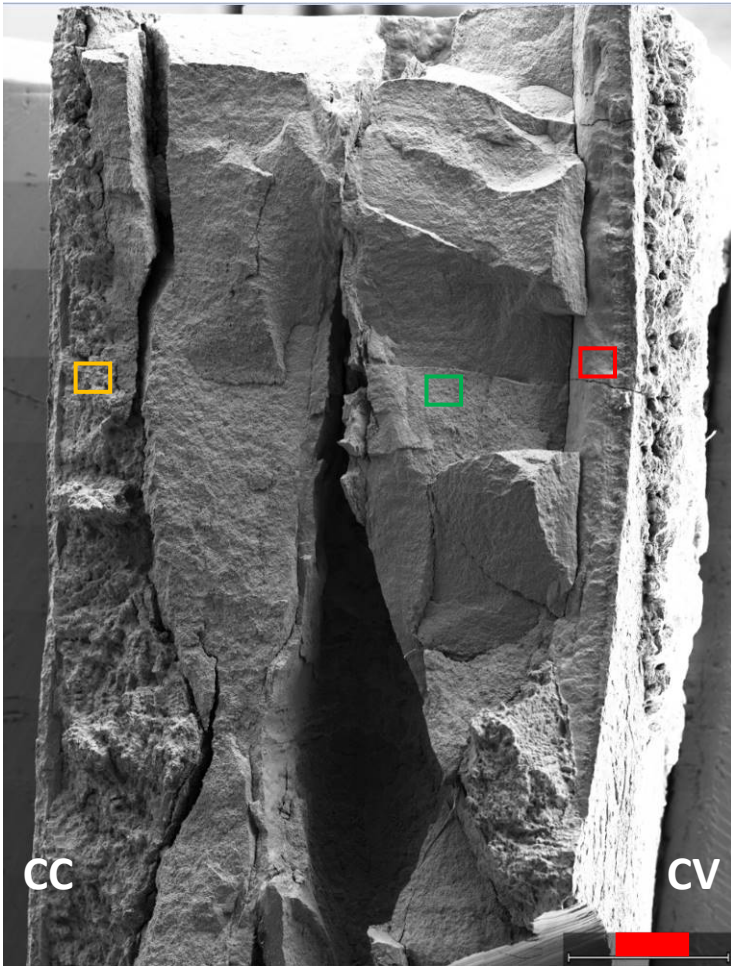
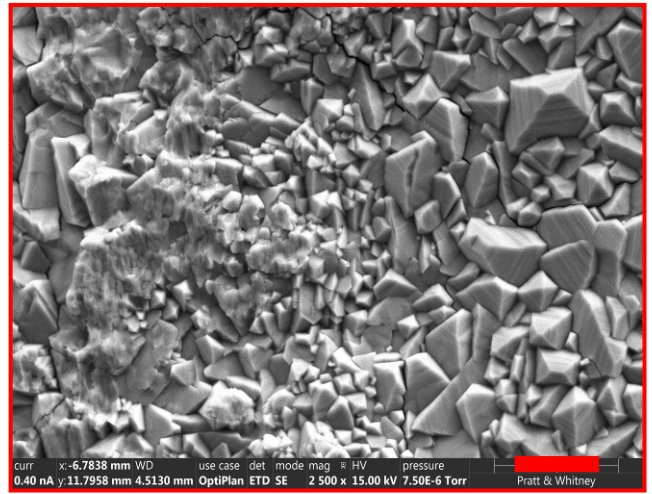
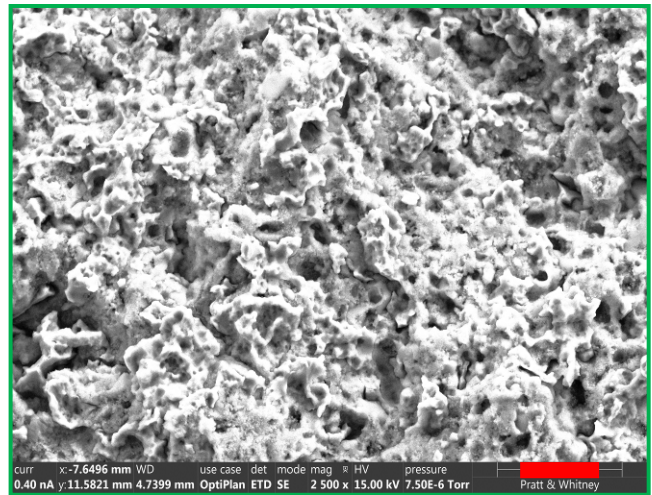
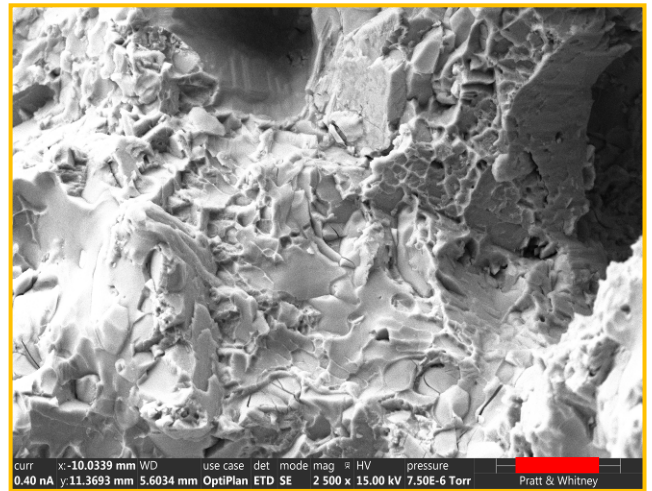
Figure 29: SEM examination identified features consistent with extensive oxidization/corrosion (top and middle images). The features along the concave wall were consistent with overstress from lab fracture (ductile dimples).

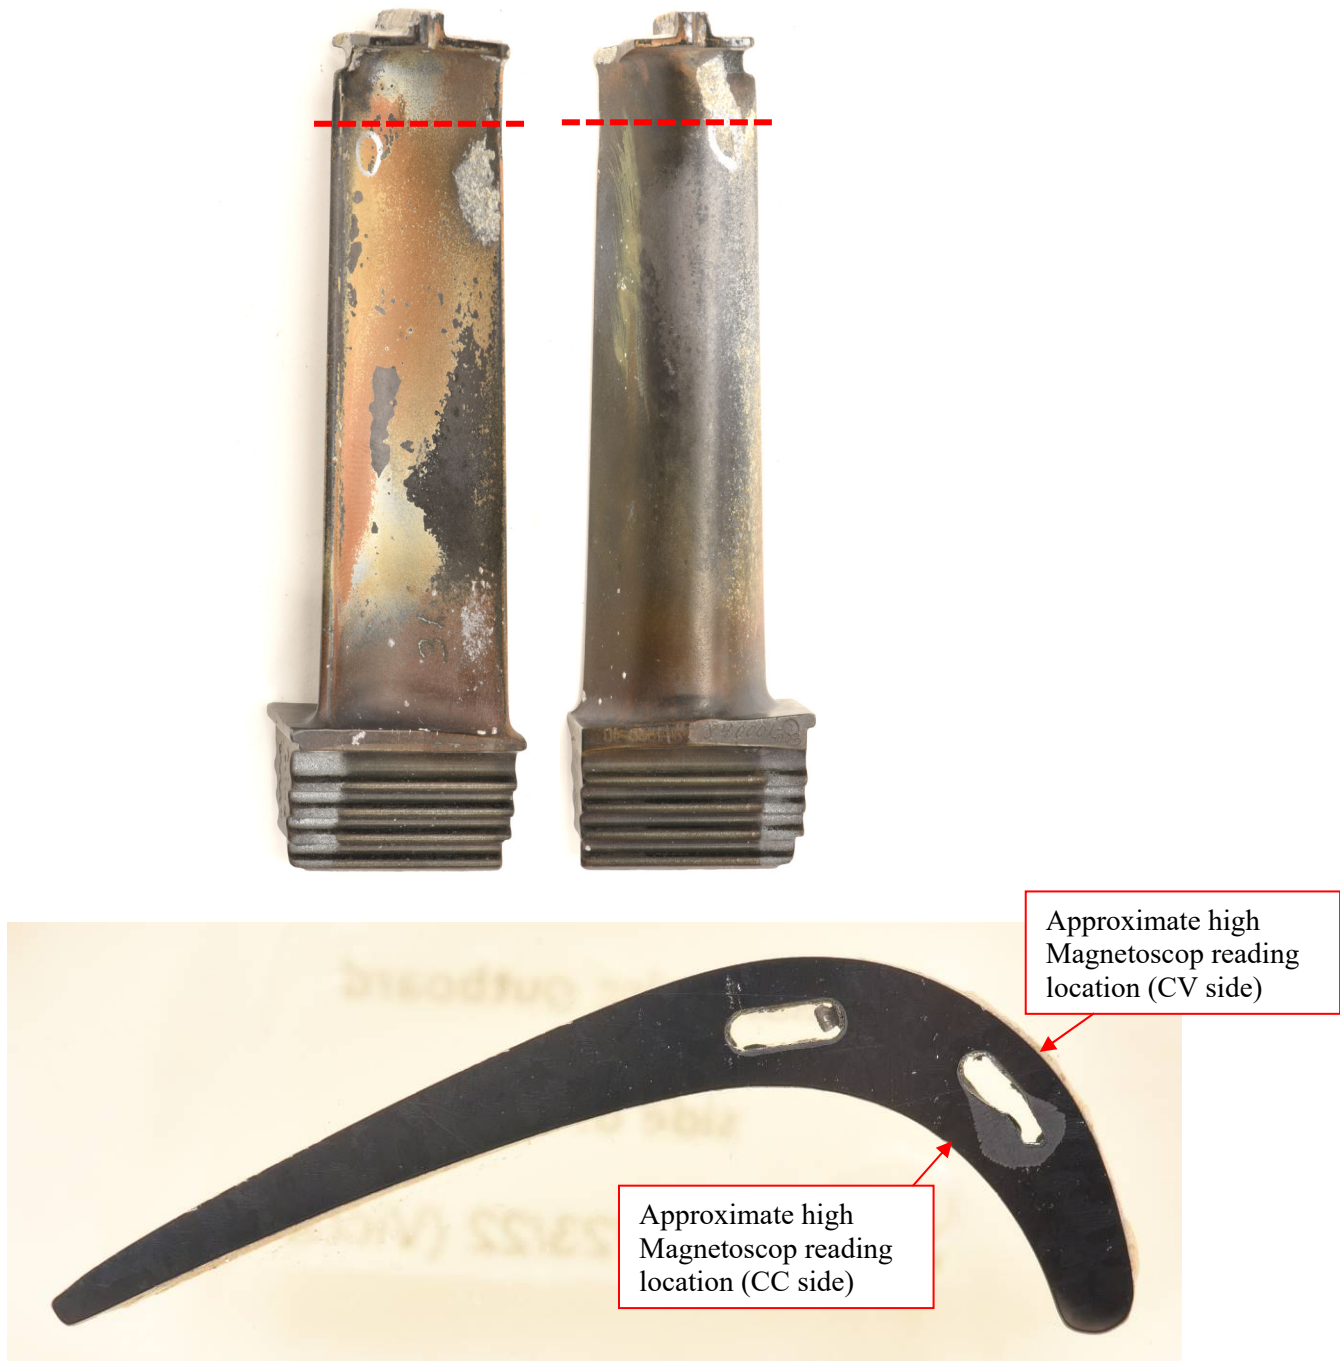
A metallographic section was prepared just outboard of the Magnetoscop location (outboard of where the crack was located). The locations of the highest convex and concave Magnetoscop readings were at approximately the same span so only one section was prepared (**Figure 30**). On the hole closest to the LE, the oxidation/corrosion extended up to 0.043” through the CC wall, approximately 2/3 of the wall thickness. The oxidation/corrosion measured less than 0.007” on the hole closer to midchord (**Figure 31**). Metal temperature evaluation was completed at approximately 50% and 75% spans. A section was also taken through the root for comparison to baseline microstructure. The microstructure in the airfoil at both 50% and 75% spans was indicative of temperature exposure of at least 2000°F. Near the LE in the 75% span section, microstructure was indicative of temperature exposure of at least 2050°F (**Figure 32**).

Figure 30: A metallographic section was prepared just outboard of the Magnetoscop location (outboard of where the crack-like feature was located). The locations of the highest convex and concave Magnetoscop readings were at approximately the same span so only one section was prepared.

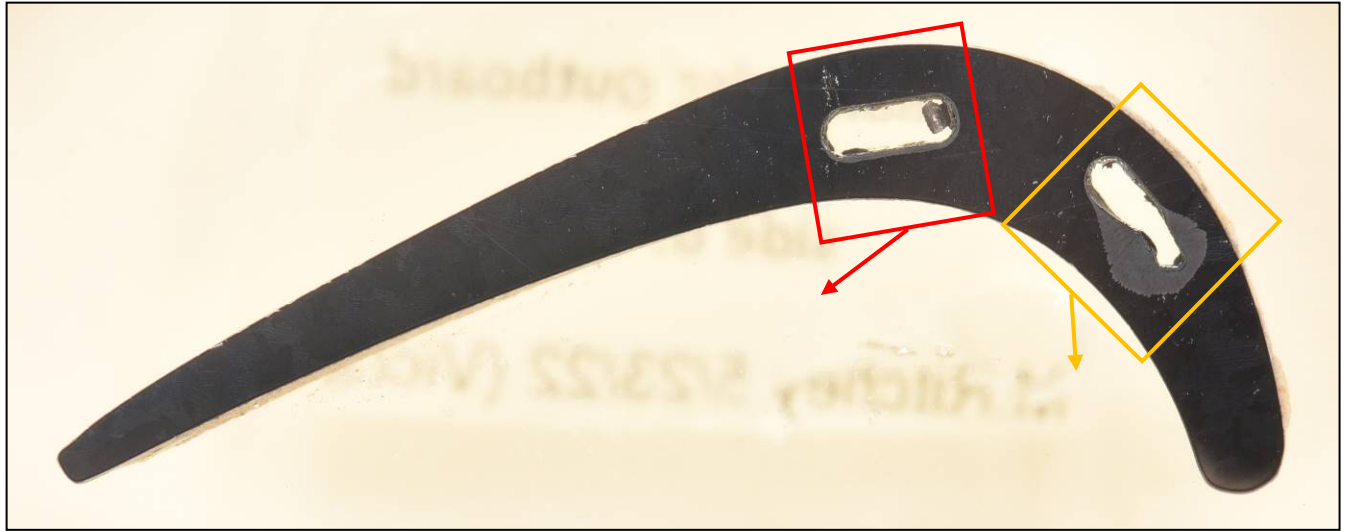
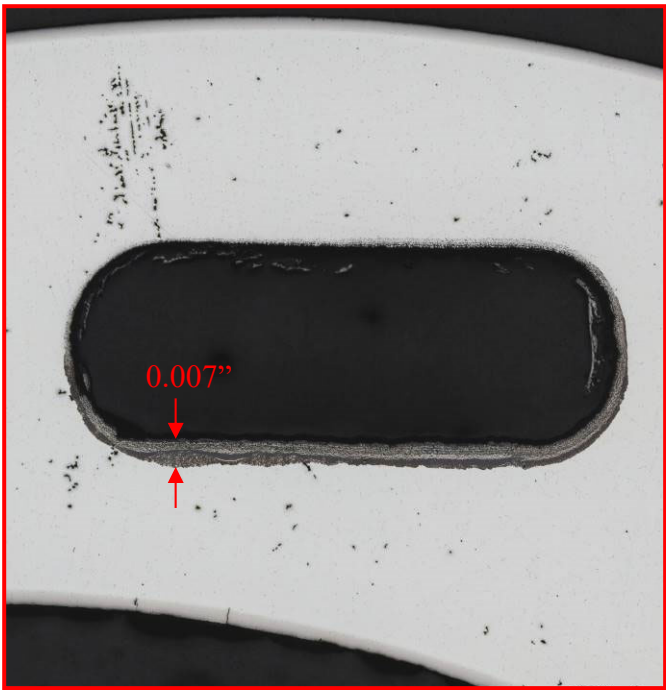
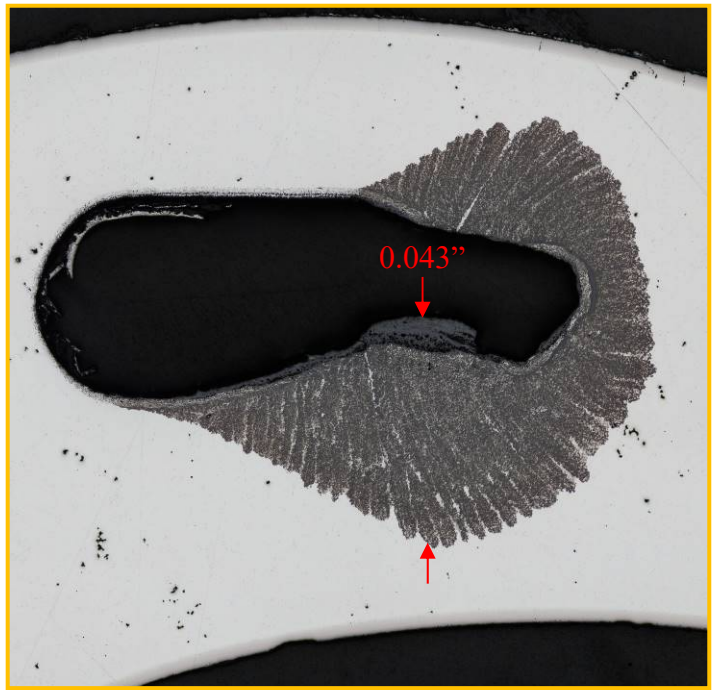
Figure 31: Metallographic review of the section just outboard of the CC and CV Magnetoscopy locations on blade 31 revealed oxidation/corrosion on the internal holes. On the hole closest to the LE, the oxidation/corrosion extended up to 0.043'' through the CC wall, approximately 2/3 of the wall thickness. The oxidation/corrosion measured less than 0.007'' on the hole closer to midchord.

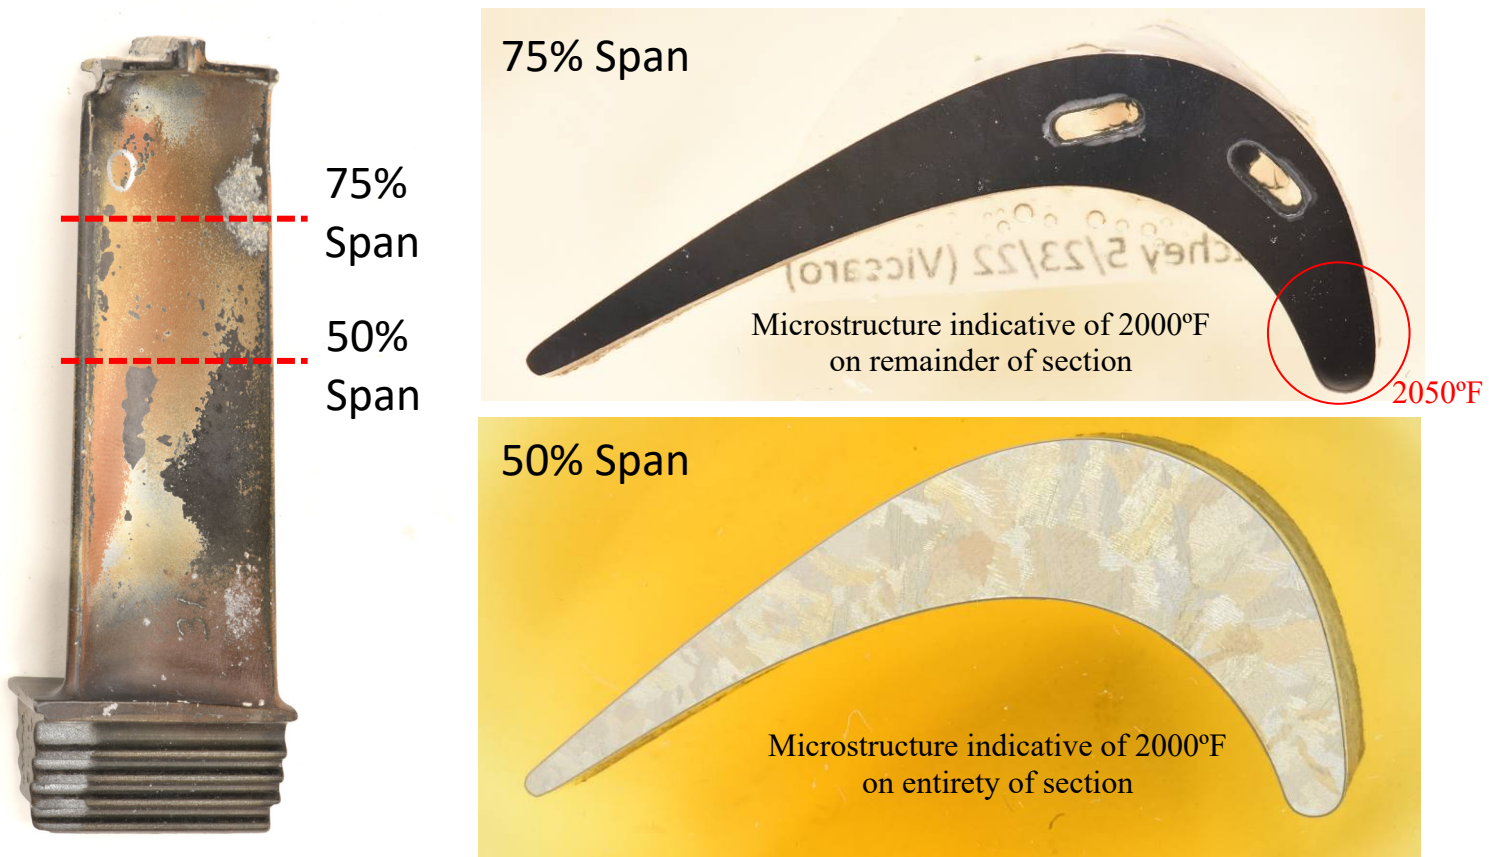
Figure 32: Metal temperature evaluation was completed at approximately 50% and 75% spans on blade 31. The microstructure in the airfoil at both 50% and 75% spans was indicative of temperature exposure of at least 2000°F. Near the LE in the 75% span section, microstructure was indicative of temperature exposure of at least 2050°F.

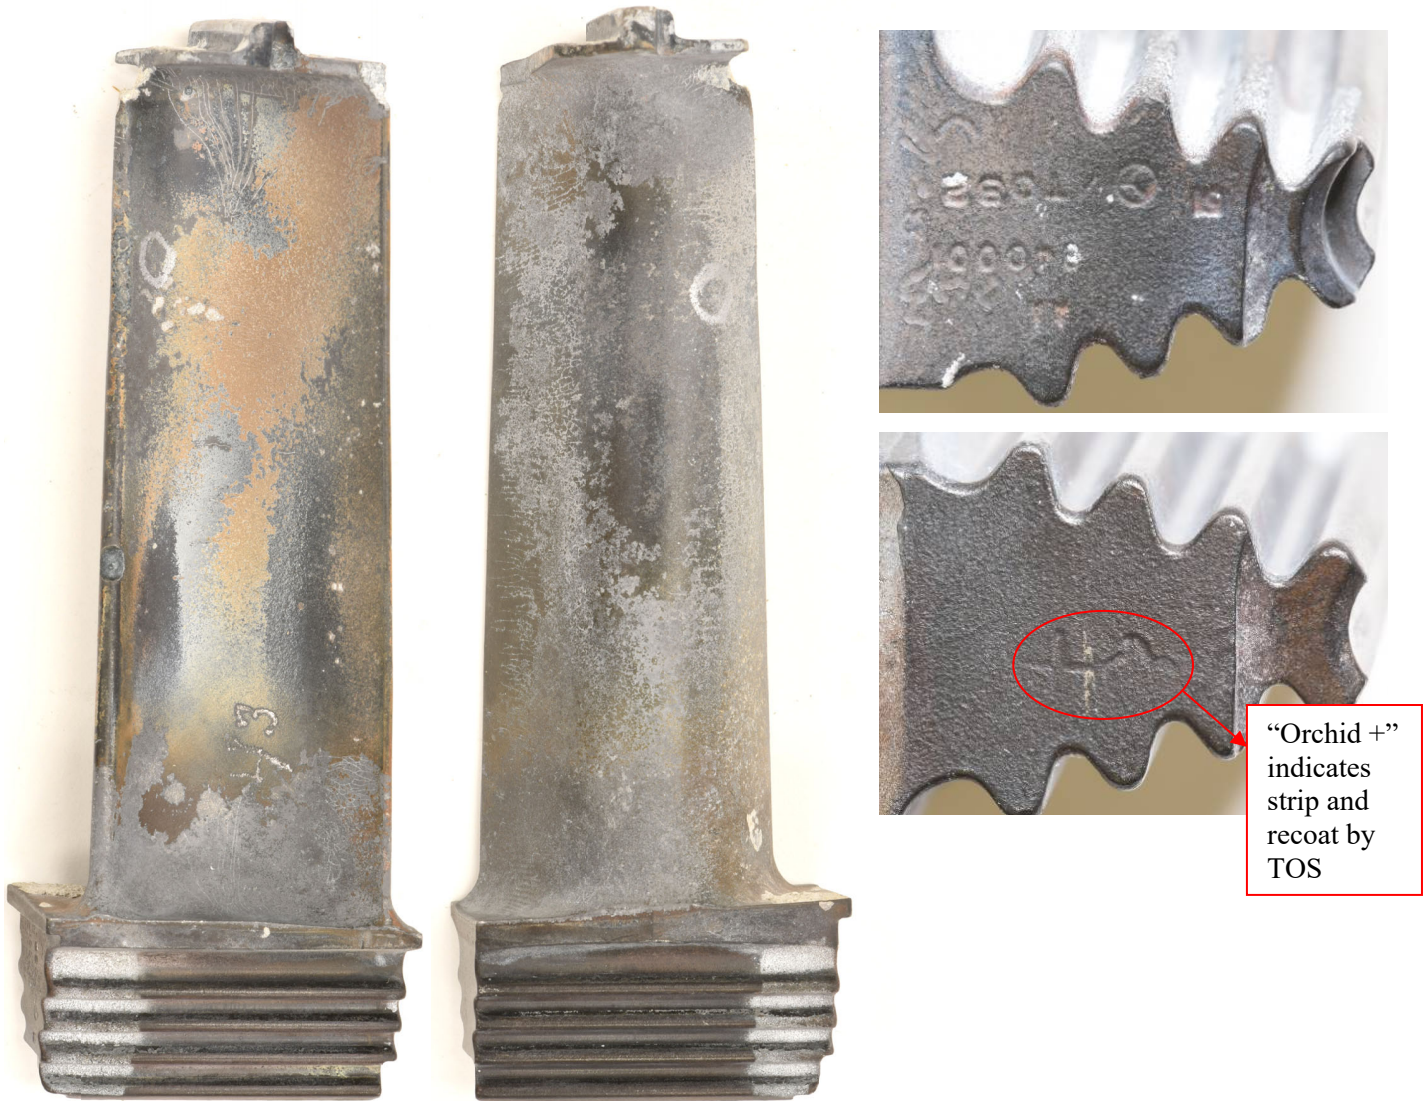
Blade 43 was chosen for further examination because it exhibited high radial creep and high Magnetoscop readings. Closer views of blade 43, which was confirmed to be refurbished by TOS similar to fractured blade 6, are presented in **Figure 33**. Some of the part markings were illegible. No part markings were observed on the platform. The highest Magnetoscop locations on the concave and convex sides were circled by the NDE group.

“Orchid +”
indicates
strip and
recoat by
TOS

Figure 33: Closer views of blade 43 after cleaning, which was confirmed to be refurbished by TOS. Images showing the CC and CV sides as well as the part markings on the root. No part markings were visible on the platform. Some of the part markings were illegible. The highest Magnetoscop locations on the concave and convex sides were circled by the NDE group.

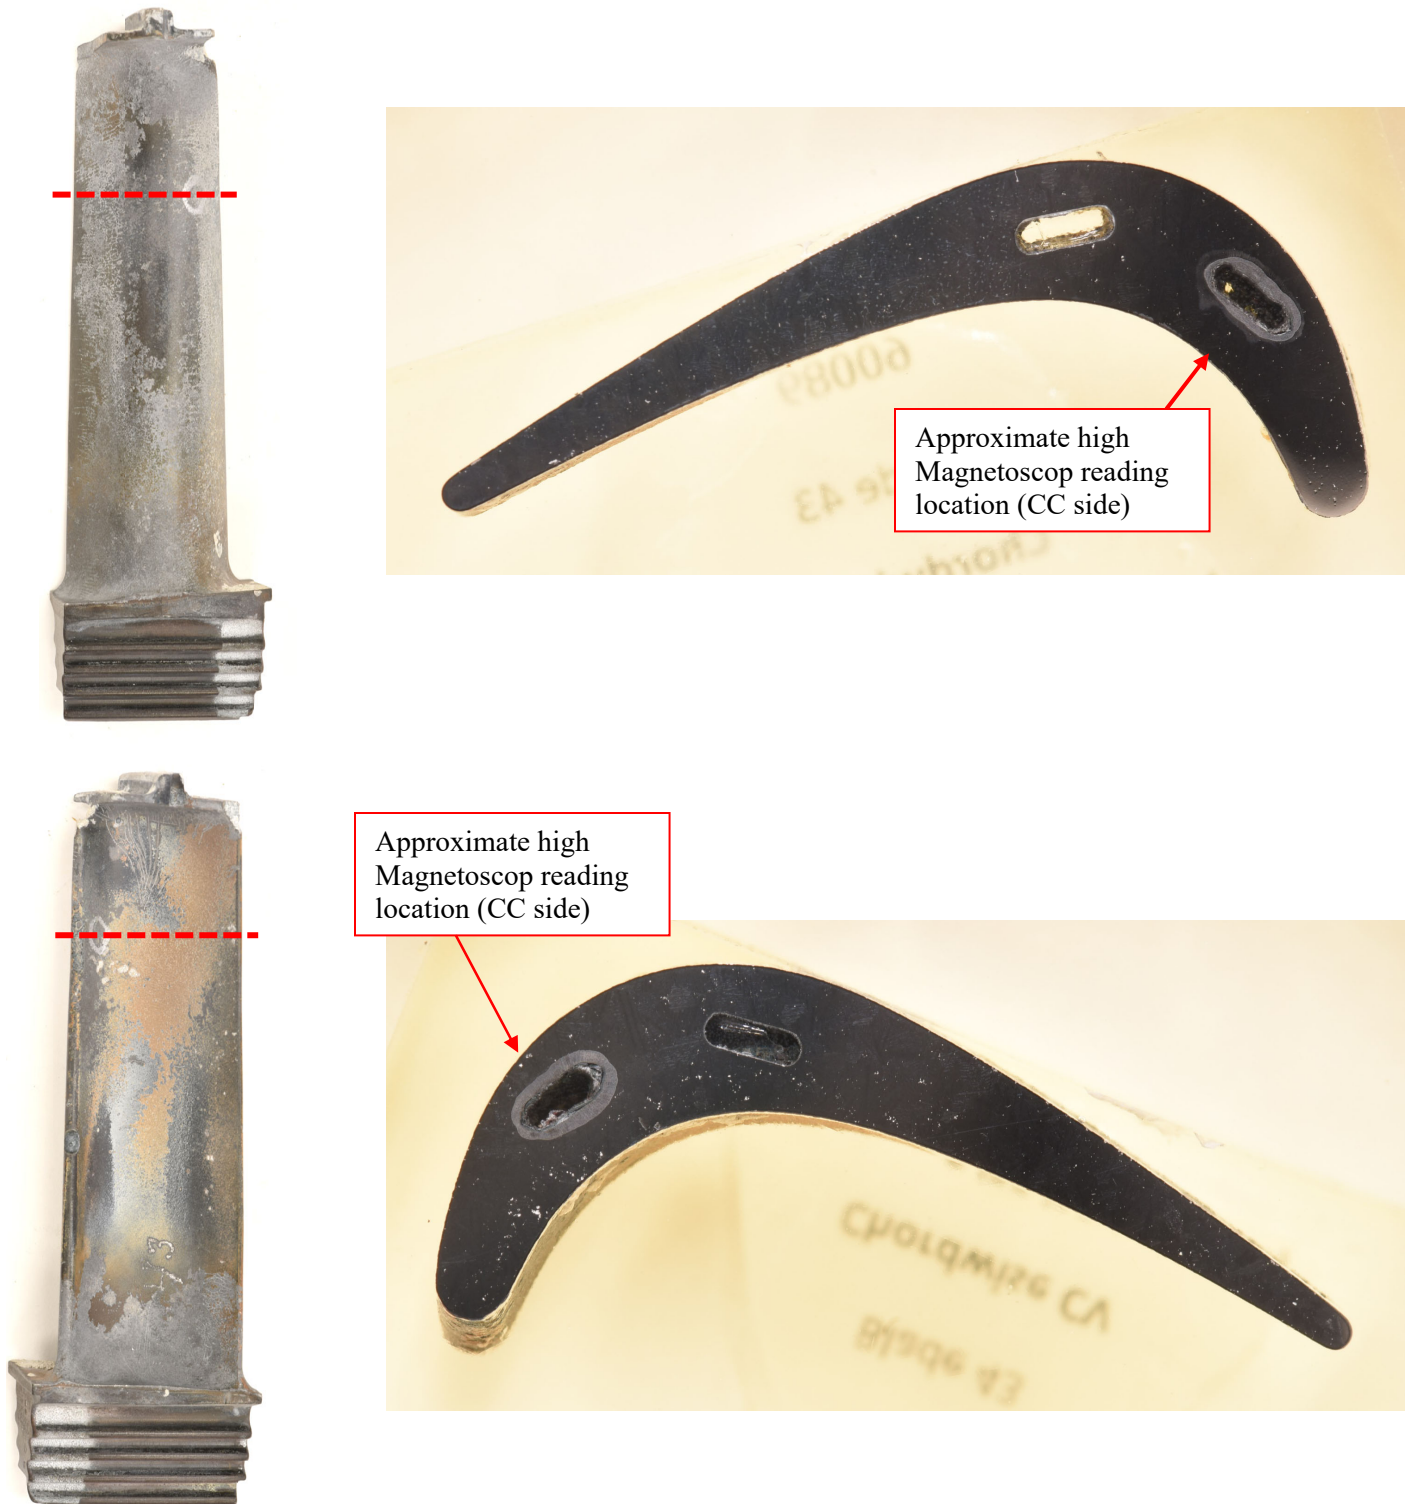
Figure 34: Images showing the locations of the metallographic sections prepared through the highest Magnetoscop readings on blade 43.

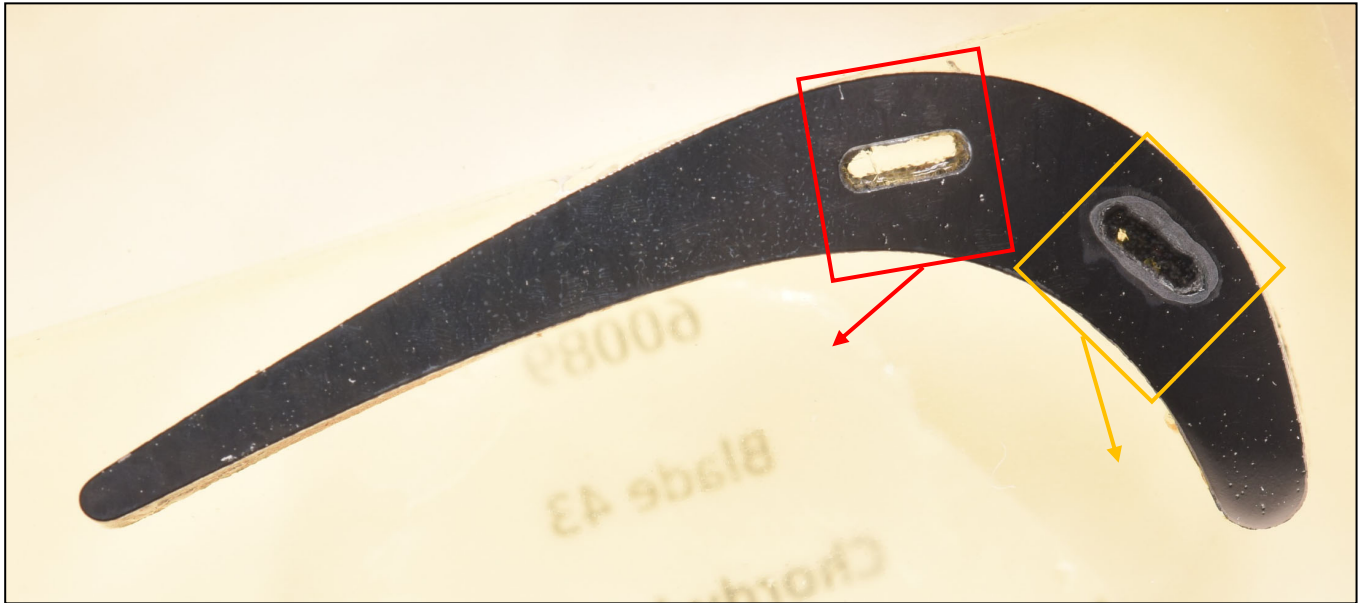
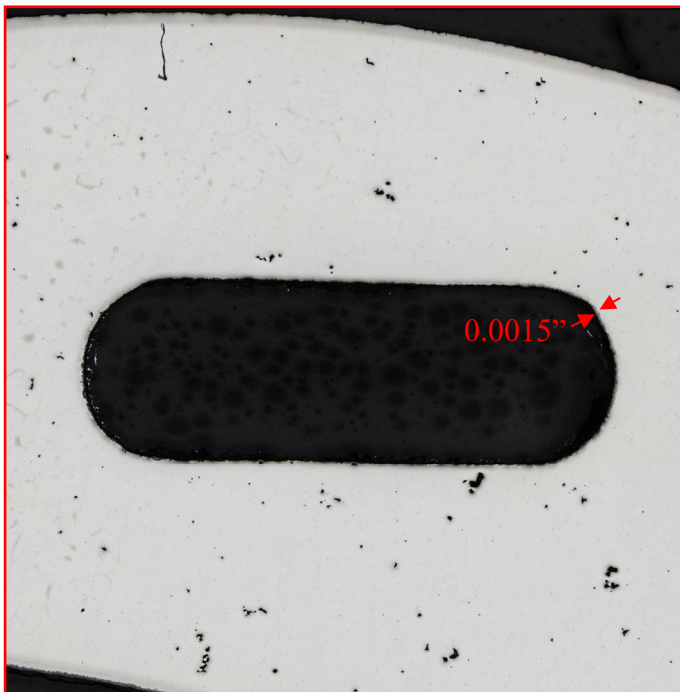
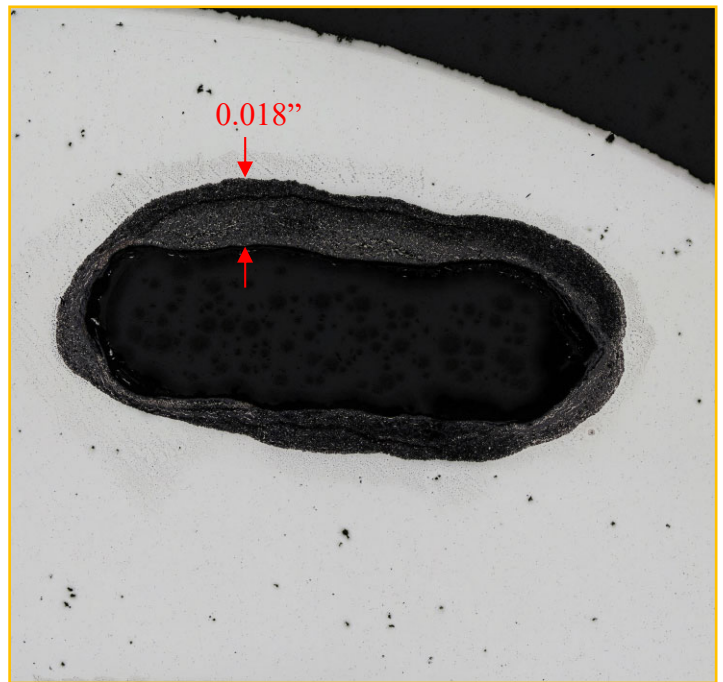
Metallographic sections were prepared chordwise through the blade at the span of the marked Magnetoscop locations as shown in **Figure 34**. Review of the metallographic section through the concave side Magnetoscop location revealed internal oxidation/corrosion up to 0.018” in depth (**Figures 35**). Review of the metallographic section through the convex side Magnetoscop location revealed internal oxidation/corrosion up to 0.022” in depth (**Figures 36**). Metal temperature evaluation was completed at approximately 50% and 75% spans. A section was also taken through the root for comparison to baseline microstructure. The microstructure in the airfoil at both 50% and 75% spans was indicative of temperature exposure of at least 2000°F. Near the LE in the 75% span section, microstructure was indicative of temperature exposure of at least 2050°F (**Figure 37**).

Figure 35: Metallographic review of the section through the concave side Magnetoscop location on blade 43 revealed oxidation/corrosion on the internal holes up to 0.018" on the hole closest to the LE, and 0.0015" on the hole near midchord.

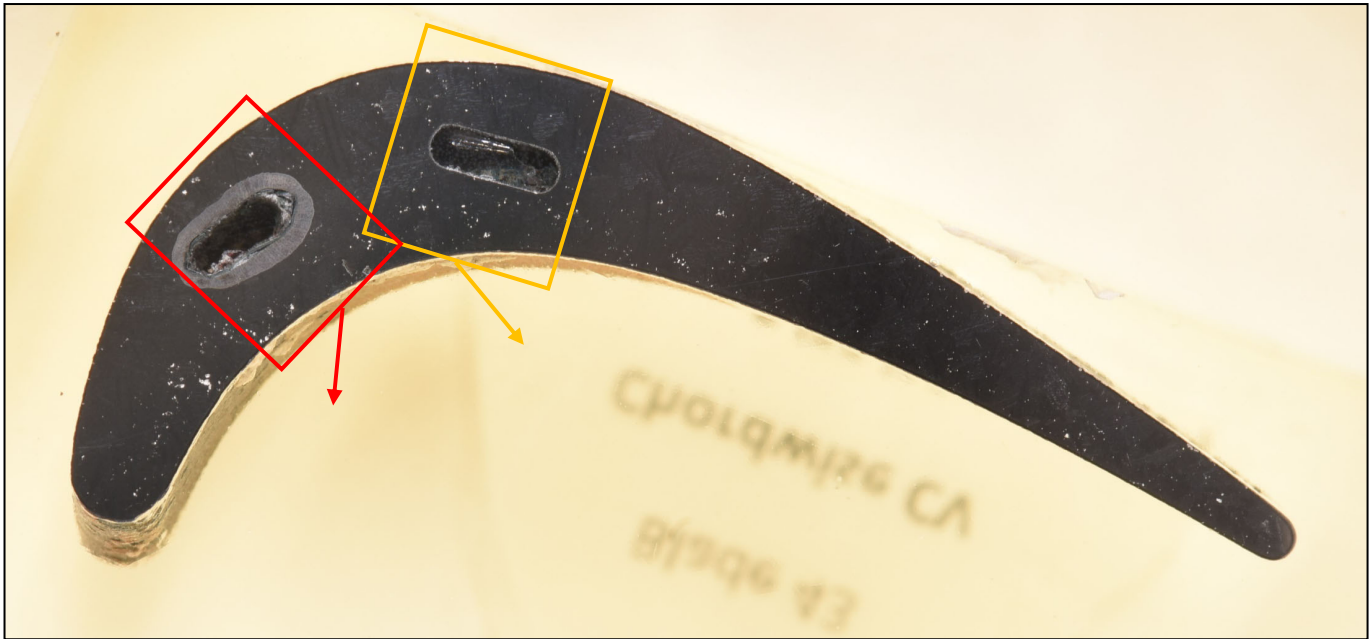
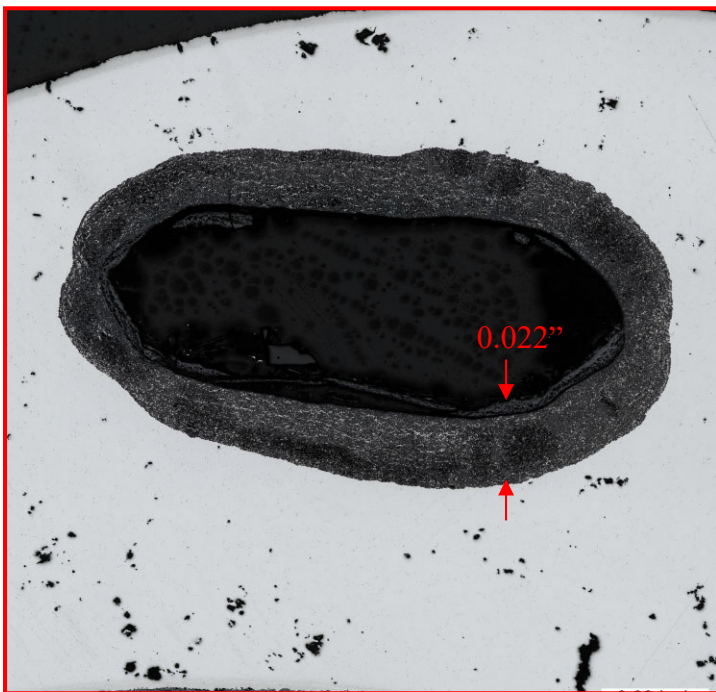
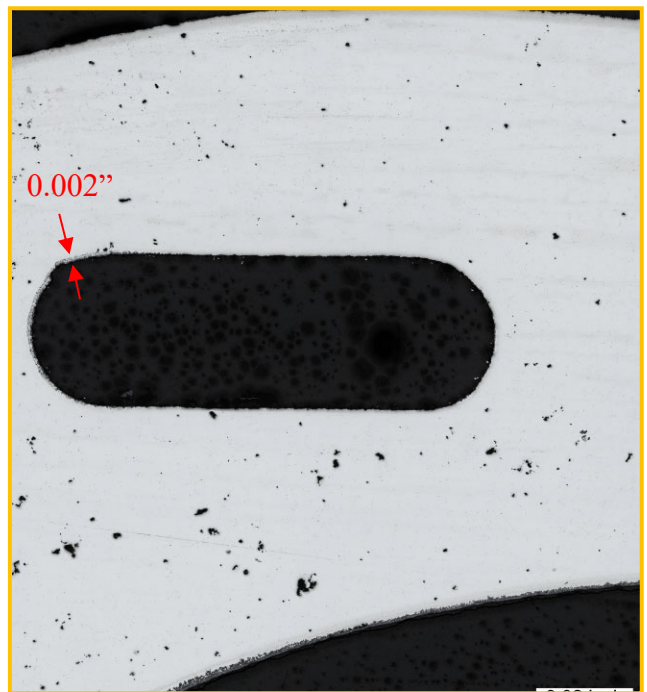
Figure 36: Metallographic review of the section through the convex side Magnetoscop location on blade 43 revealed oxidation/corrosion on the internal holes up to 0.022" on the hole closest to the LE, and 0.002" on the hole near midchord.
