DCA21FA174

Specialist's Factual Report - Attachment 7
Pratt & Whitney DCA21FA174 Metallurgical Investigation Report, July 29, 2022

Final Report for DCA21FA174

Subject: Metallurgical Investigation of High Pressure Turbine (HPT) Blades from an accident on July 2, 2021 in Honolulu, Hawaii involving a Boeing 737-200 aircraft, N810TA, operated by Rhodes Aviation Inc., dba Transair Flight 810.

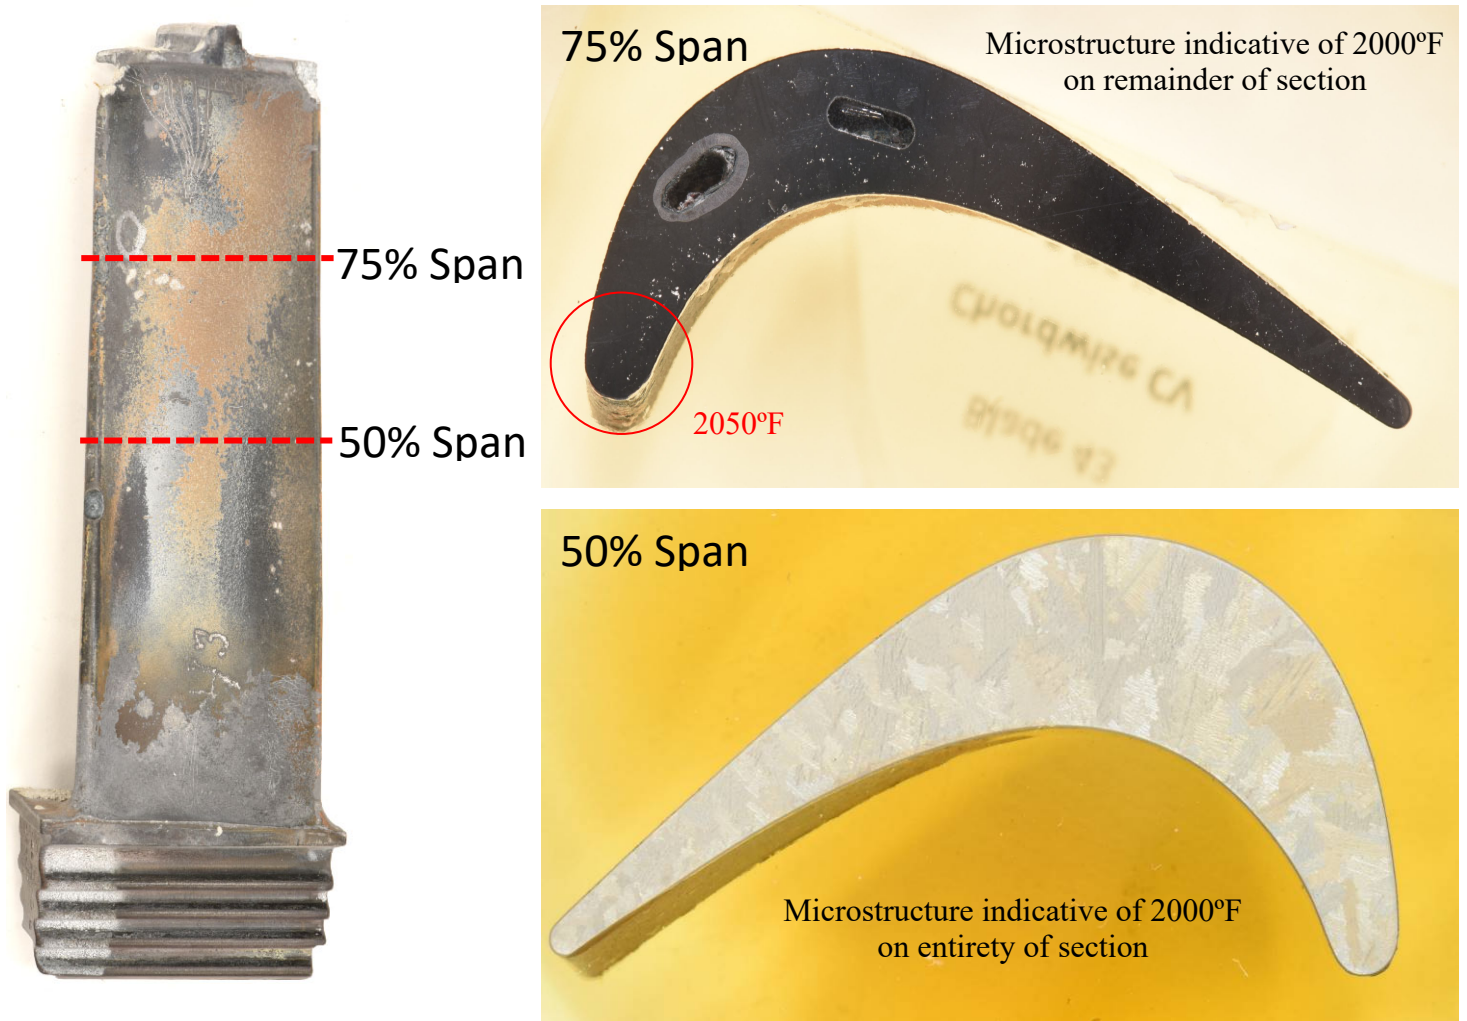
Figure 37: Metal temperature evaluation was completed at approximately 50% and 75% spans on blade 43. The microstructure in the airfoil at both 50% and 75% spans was indicative of temperature exposure of at least 2000°F. Near the LE in the 75% span section, microstructure was indicative of temperature exposure of at least 2050°F.

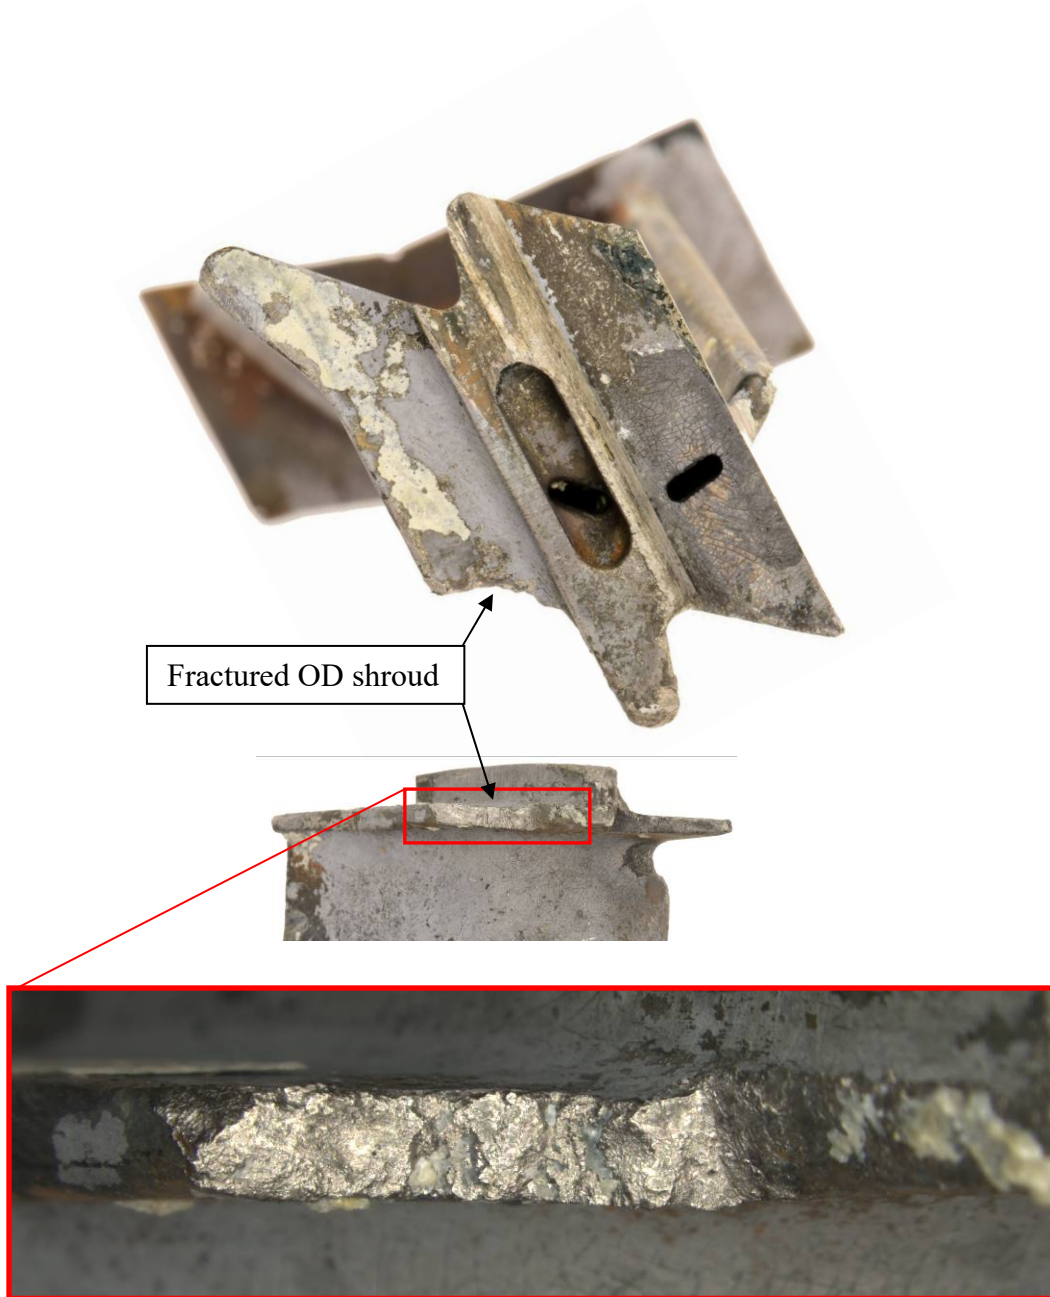
These two blades were positioned adjacent to fractured blades 1 and 6, in the positions where the direction of rotation makes secondary damage more likely. Both of these blades exhibited shroud fractures, which appeared to be secondary. Both fracture surfaces were rough textured and shiny, suggesting they were caused by overstress and was not exposed hot gases for much time (**Figures 38 and 39**).

Figure 38: Blade 5 shroud fracture was rough textured and shiny, suggesting that it was due to overstress and was not exposed hot gases for much time.

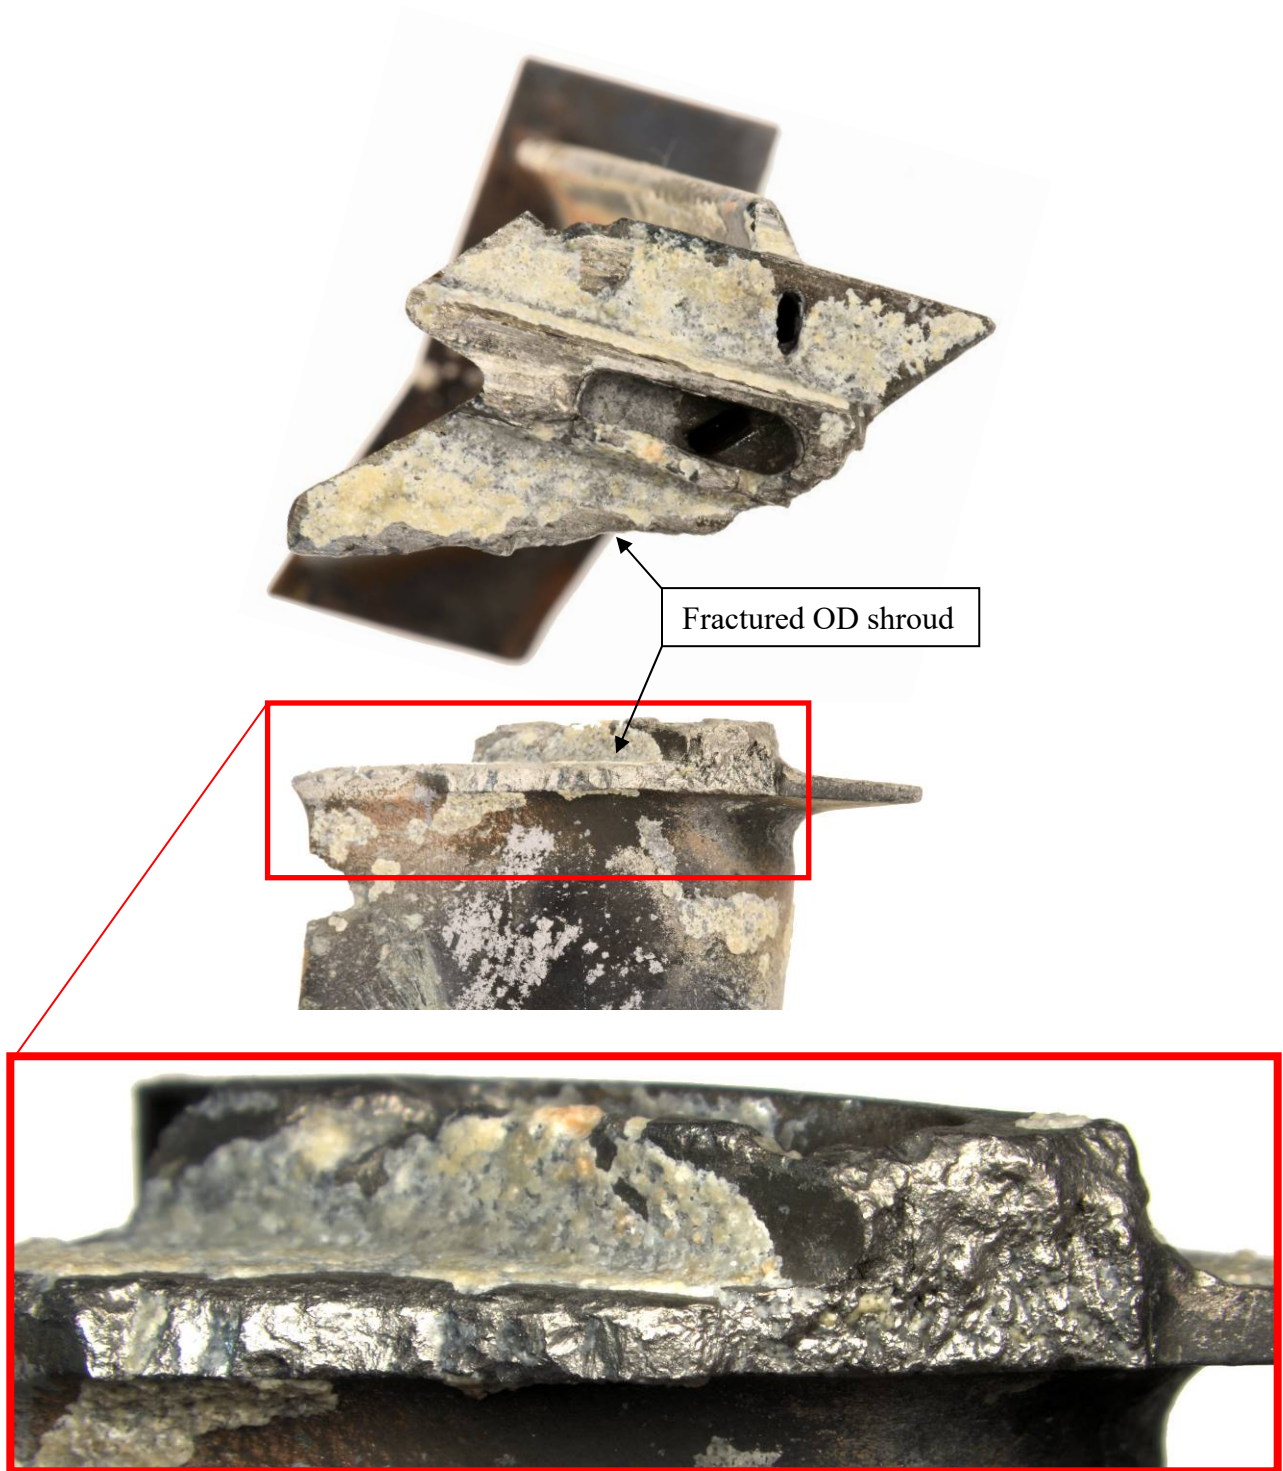
Figure 39: Blade 80 shroud fracture surface was rough textured and shiny, suggesting that it was due to overstress and was not exposed hot gases for much time.
