Bridge Factors Factual Report Attachment 73 – FHWA Assessment of Bridge Design and Performance

**Florida International University Pedestrian Bridge Collapse Investigation:
Assessment of Bridge Design and Performance**

National Transportation Safety Board
NTSB Accident ID: HWY18MH009

September 12, 2019

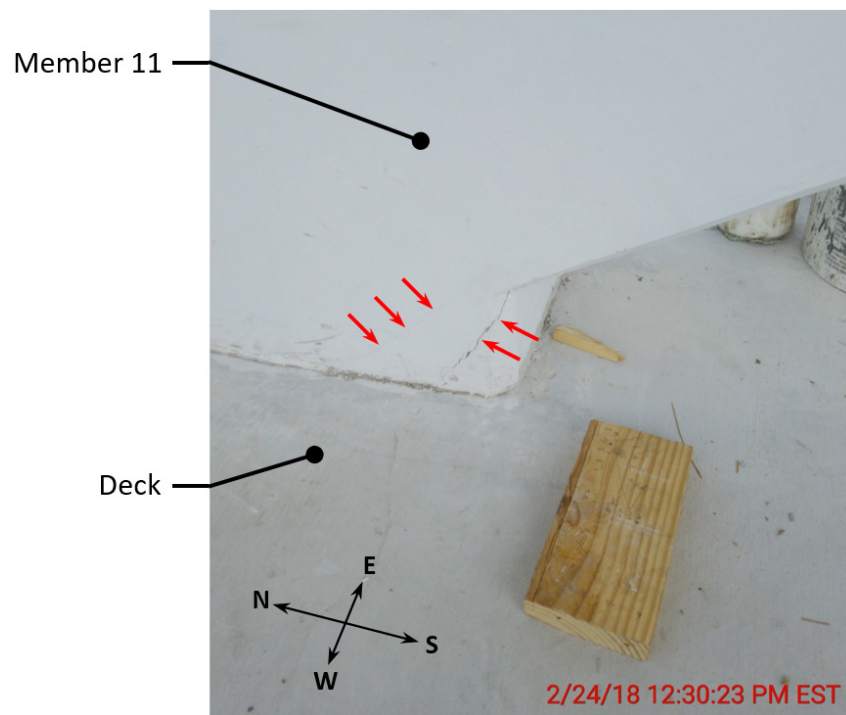
The crack in the truss member 11 and 12 nodal region began at the reentrant corner between the south face of truss member 11 and the deck. It largely followed the location of the cold joint between truss member 11 and the deck. The southernmost portion of the crack deviated from the cold joint, instead following the projection of the south face of truss member 11 through the chamfer that closed the reentrant corner between the south face of truss member 11 and the deck. This specific path of the southernmost portion of this crack is of significance in that this path allowed the crack to bypass 21 percent of the reinforcing steel area that was, per the FIGG Design and FIGG Plans, intended to offer interface shear resistance at the base of truss member 11. Per the construction plans, eight #7 reinforcing bars and two #6 reinforcing bars were to cross the cold joint under truss member 11. Although all ten bars were present in the structure, because of the detailing specified on the FIGG Plans, the southernmost two #7 bars were not anchored above the crack. Thus, those two bars were not engaged by the crack and could not offer resistance to the northward thrusting shear demand of the upper portion of the node. Figure 14 provides an illustration showing the size and location of the ten legs of these reinforcing bars. These bars are also shown later in the report in Figure 57.

Figure 9. Photograph showing cracking at southwest corner of truss member 11 near where it met the deck. Captured on February 24, 2018 at 12:30 p.m. Corresponds to Bridge Factors Factual Report Photo 39.

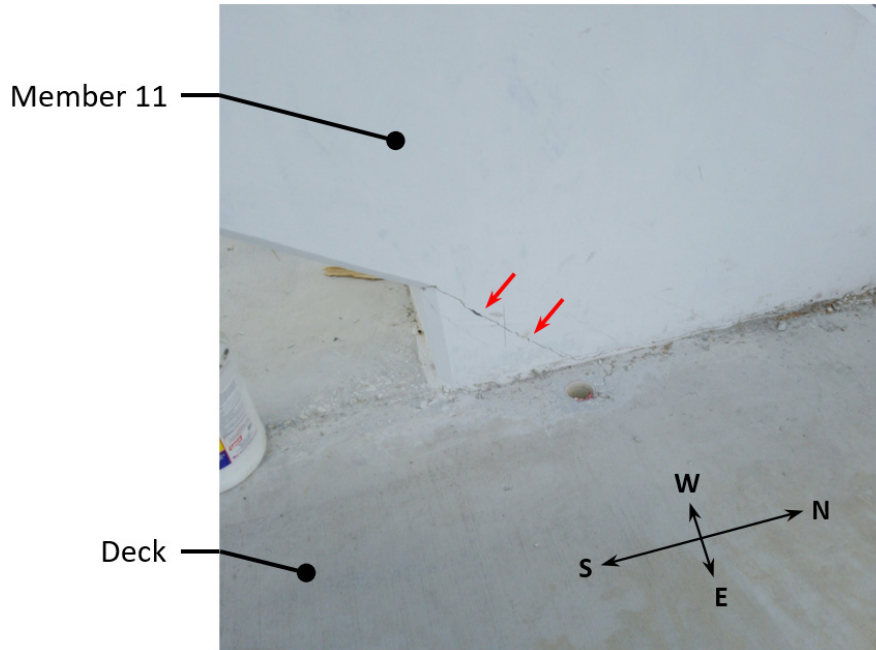
Figure 10. Photograph showing cracking at southeast corner of truss member 11 near where it met the deck. Captured on February 24, 2018 at 12:29 p.m. Corresponds to Bridge Factors Factual Report Photo 38.

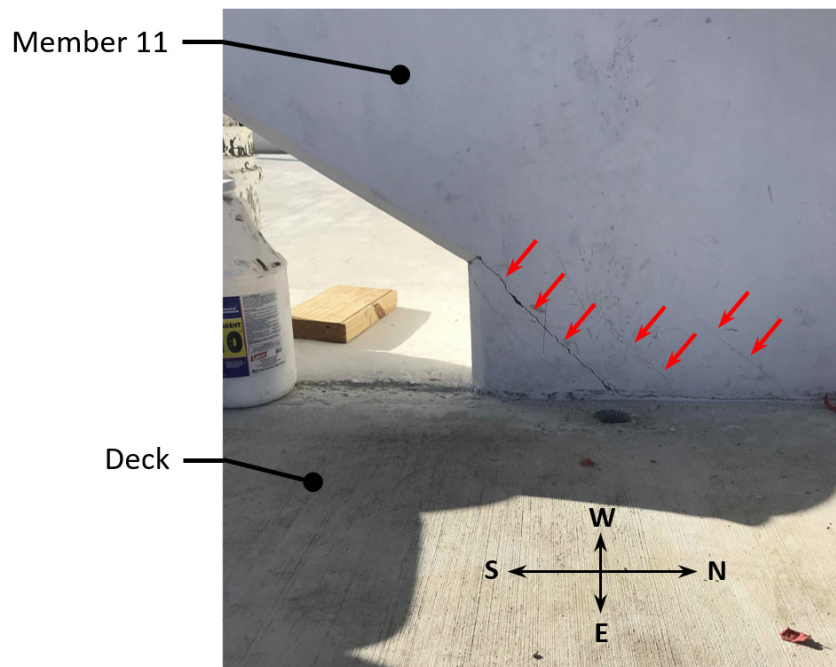
Figure 11. Photograph showing cracking at southeast corner of truss member 11 near where it met the deck. Captured on February 26, 2018 at 8:38 a.m. Corresponds to Bridge Factors Factual Report Photo 42.

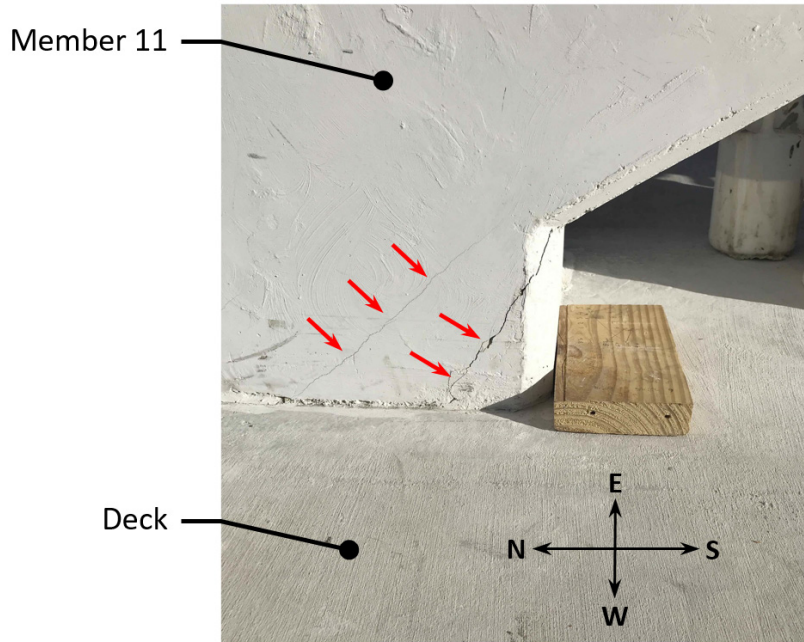
Figure 12. Photograph showing cracking at southwest corner of truss member 11 near where it met the deck. Captured on February 26, 2018 at 8:38 a.m. Corresponds to Bridge Factors Factual Report Photo 43.

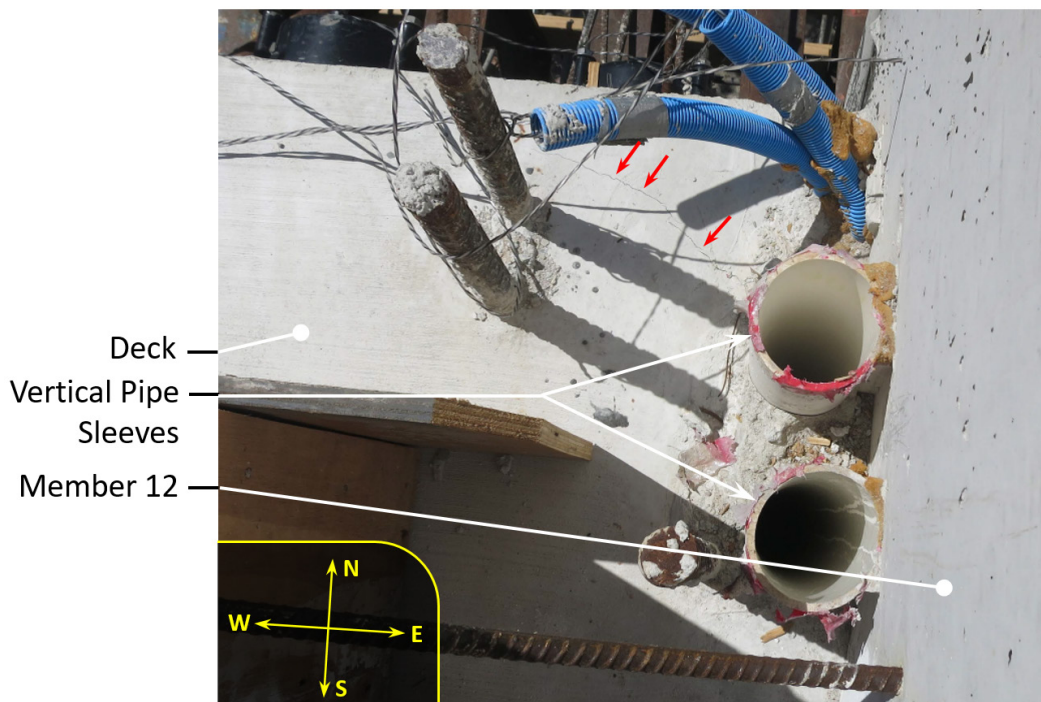
Additionally, note that the photograph shown in Figure 13 was captured on March 8, 2018 during the timeframe between the formwork removal and the initiation of the self-propelled modular transporter (SPMT) transport of the bridge.⁸ The photo was captured by the company that operated the SPMTs. The identified cracking, in the deck on the west face of member 12, extends from the vertical pipe sleeves toward the north end of the bridge. This cracking demonstrates that the distress in the member 11 and 12 nodal region extended across the nodal region prior to the SPMT transport and all subsequent construction actions.

Figure 13. Photograph showing the deck on the west side of member 12 prior to SPMT transport. Captured on March 8, 2018. Corresponds to Bridge Factors Photographs – FIGG Bridge Engineers, Inc. Photo Submission FCA 10-9.

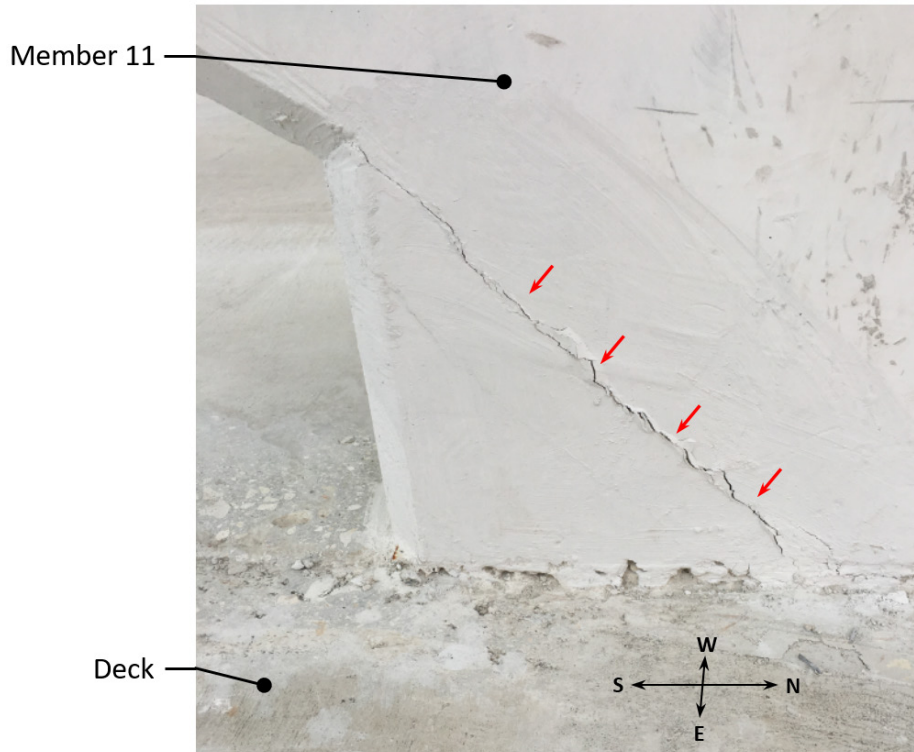
A photograph of the cracking observed in the chamfer of truss member 11 at the deck was captured immediately after the SPMT transport. This photograph, shown in Figure 17, was captured prior to the initiation of the detensioning operation.^h The photos in Figure 18 and Figure 19 were also captured after the SPMT transport and before the detensioning operation; however, the specific time is unknown. Figure 18 shows that cracks in members 11 and 12, and a crack at the north end of the deck near the east face of member 12, were present and relatively narrow. Figure 19, although somewhat out of focus, shows the crack in the deck on the west side of member 12 that was previously observed in Figure 13. The cracks in Figure 18 and Figure 19 are significantly narrower and less extensive than those observed on the same day at approximately 3:16 p.m. after the detensioning of member 11. The 3:16 p.m. photographs are shown in Figure 25 and Figure 26 and are discussed in the next section.

Figure 17. Photograph showing east side of member 11 at the deck after SPMT transport. Captured on March 10, 2018 at 12:29 p.m. Corresponds to Bridge Factors Factual Report Photo "FIGG Bridge Engineers, Inc. Photo Submission FCA-S7".

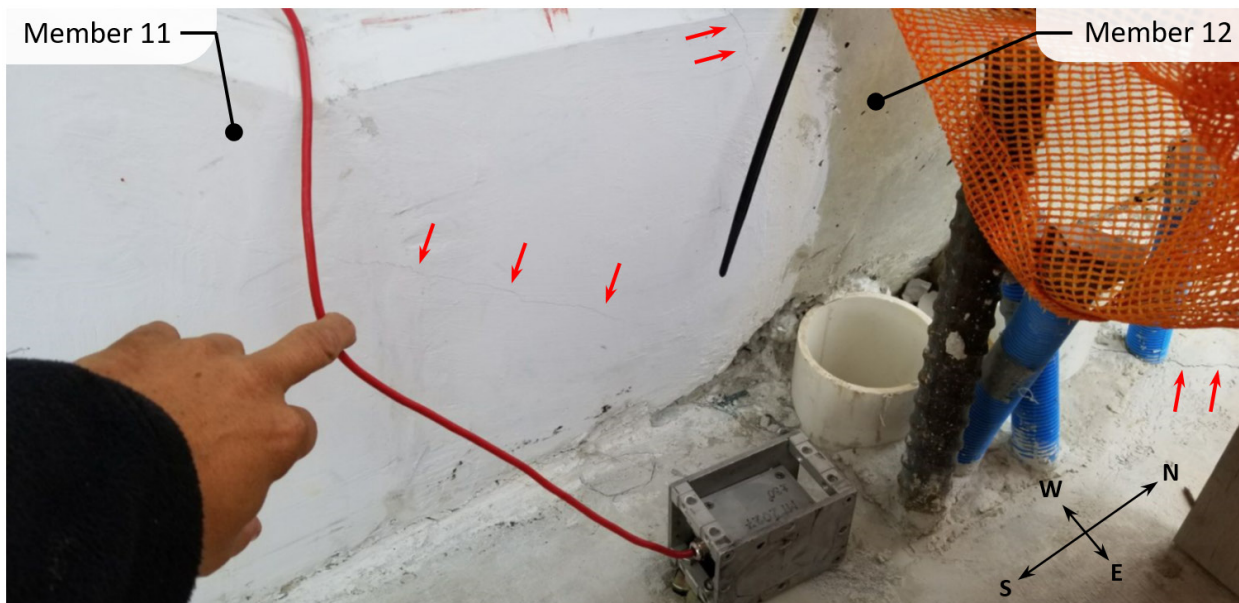
Figure 18. Photograph showing east side of members 11 and 12 at the deck after SPMT transport. Captured on March 10, 2018. Corresponds to Bridge Factors Factual Report Photo "MCM's Photo Submission MCM-4".

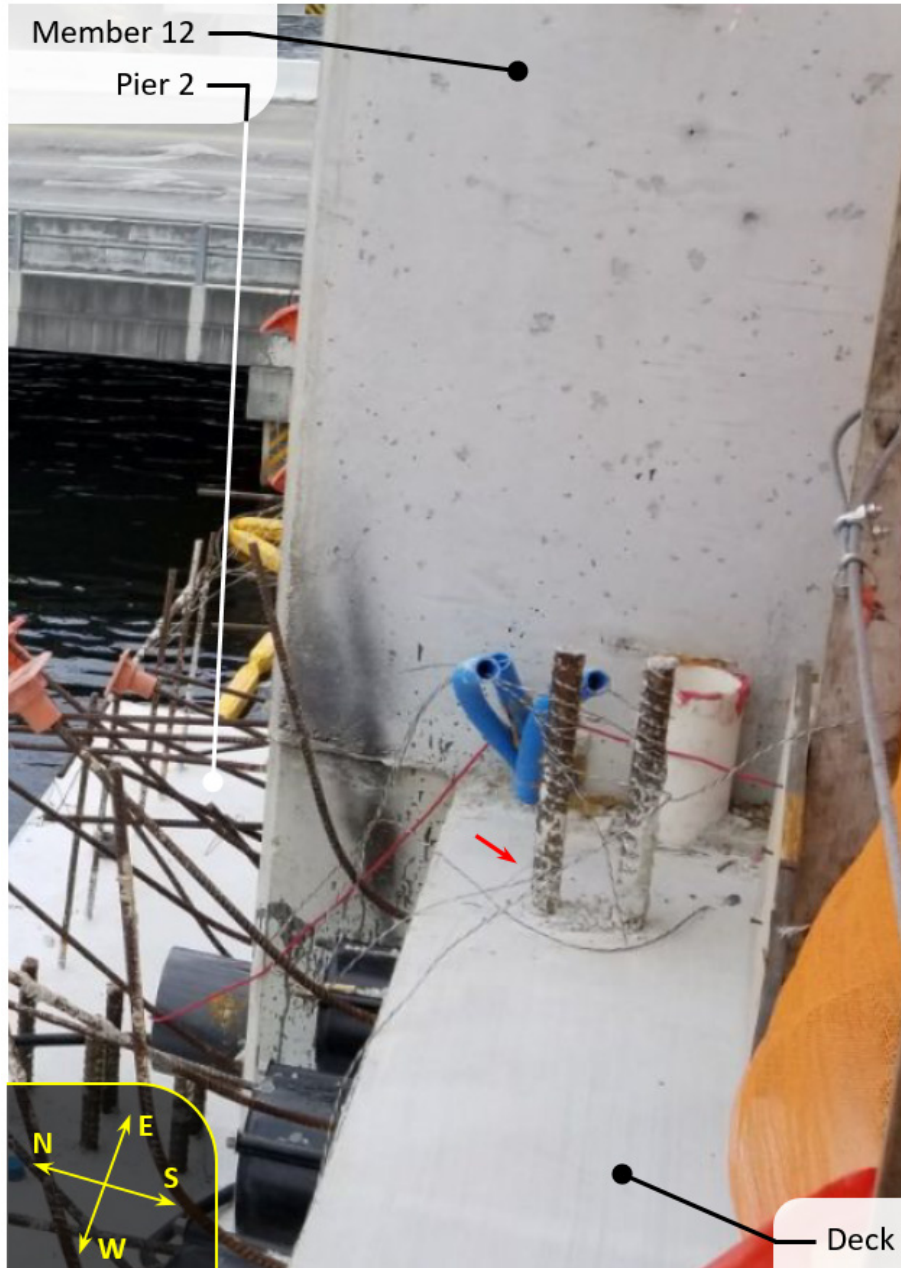
Figure 19. Photograph showing west side of member 12 at the deck after SPMT transport. Captured on March 10, 2018. Corresponds to Bridge Factors Factual Report Photo “MCM’s Photo Submission MCM-3”.

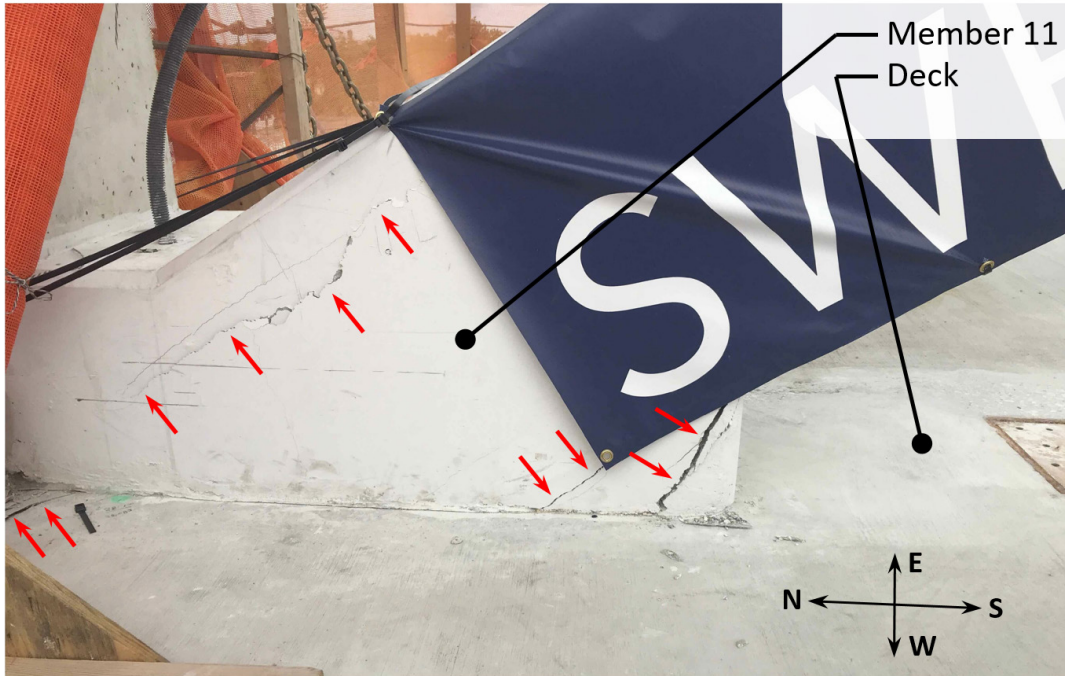
Figure 22. Photograph showing west side of member 11 at the deck after the truss member 11 post-tensioning rod detensioning operation. Captured on March 10, 2018 at 3:16 p.m. Corresponds to Bridge Factors Factual Report Photo 62.

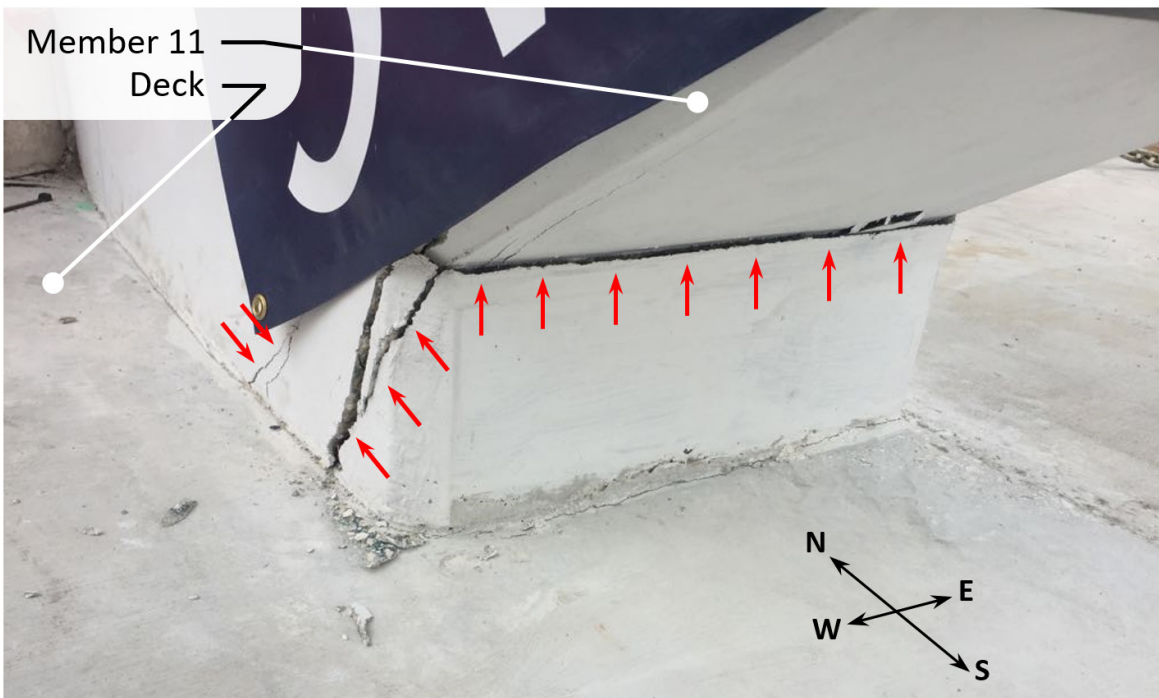
Figure 23. Photograph showing south side of member 11 at the deck after the truss member 11 post-tensioning rod detensioning operation. Captured on March 10, 2018 at 3:16 p.m.

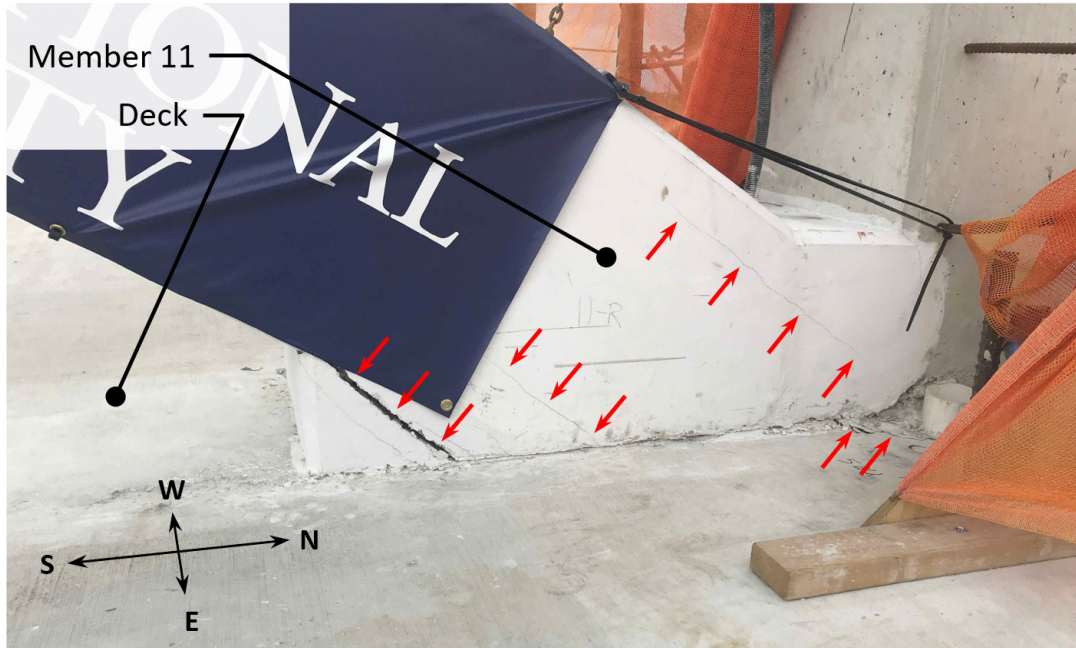
Figure 24. Photograph showing east side of truss member 11 at the deck after the member 11 post-tensioning rod detensioning operation. Captured on March 10, 2018 at 3:17 p.m. Corresponds to Bridge Factors Factual Report Photo 64.

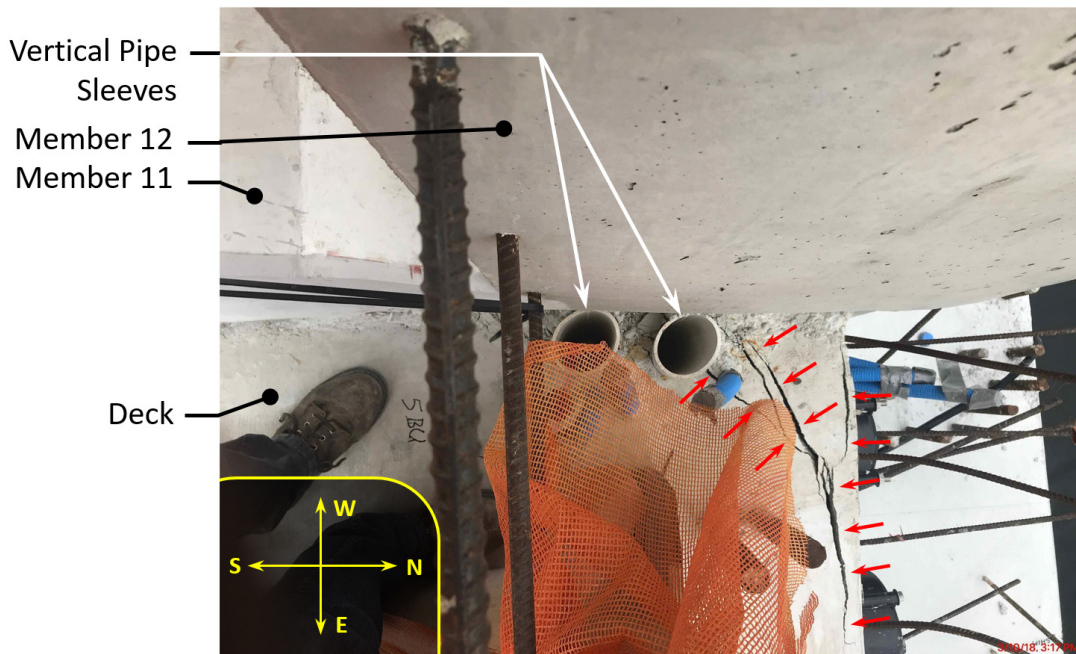
Figure 25. Photograph looking vertically downward along east side of truss member 12 after the truss member 11 post-tensioning rod detensioning operation. Captured on March 10, 2018 at 3:17 p.m. Corresponds to Bridge Factors Factual Report Photo 65.

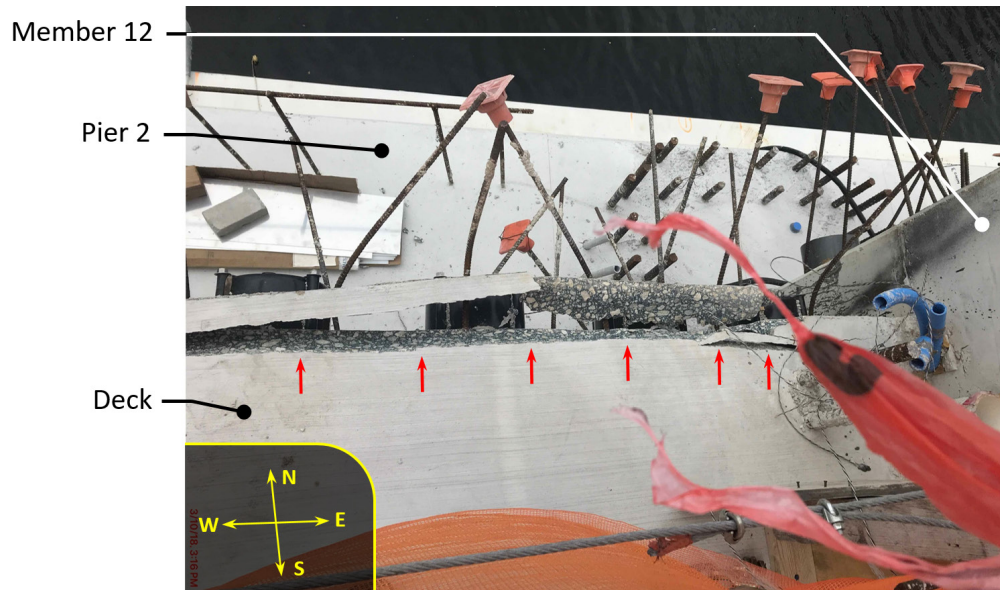
Figure 26. Photograph showing the north end of the bridge deck immediately west of member 12 after the member 11 post-tensioning rod detensioning operation. Captured on March 10, 2018 at 3:16 p.m. Corresponds to Bridge Factors Factual Report Photo 63.

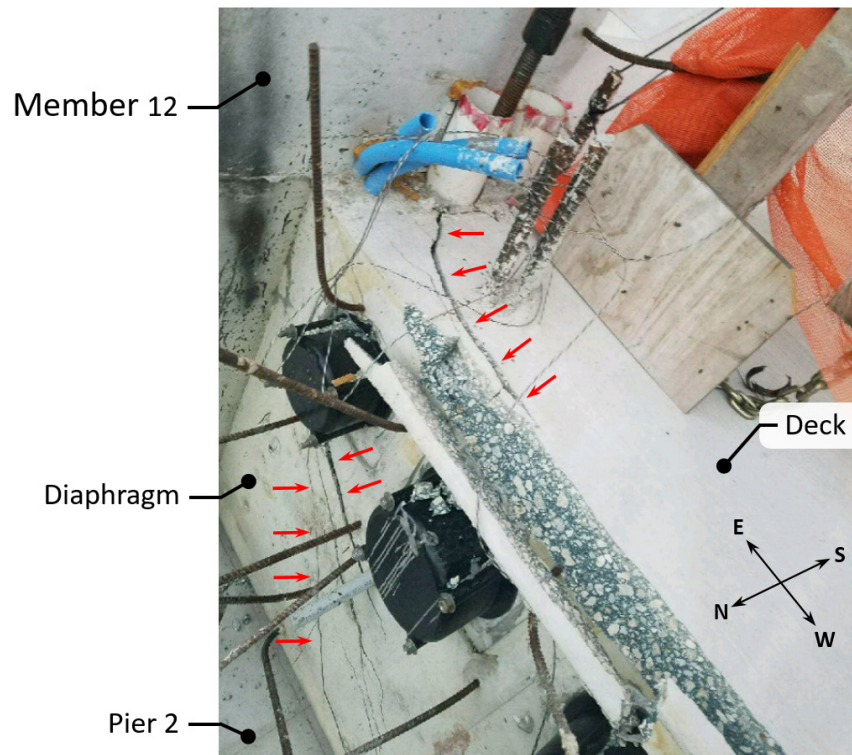
Figure 27. Photograph showing the north end of deck and north face of the north diaphragm immediately west of member 12 after detensioning of members 2 and 11. Source is text message sent by Kevin Hanson on March 10, 2018 at 7:08 p.m.

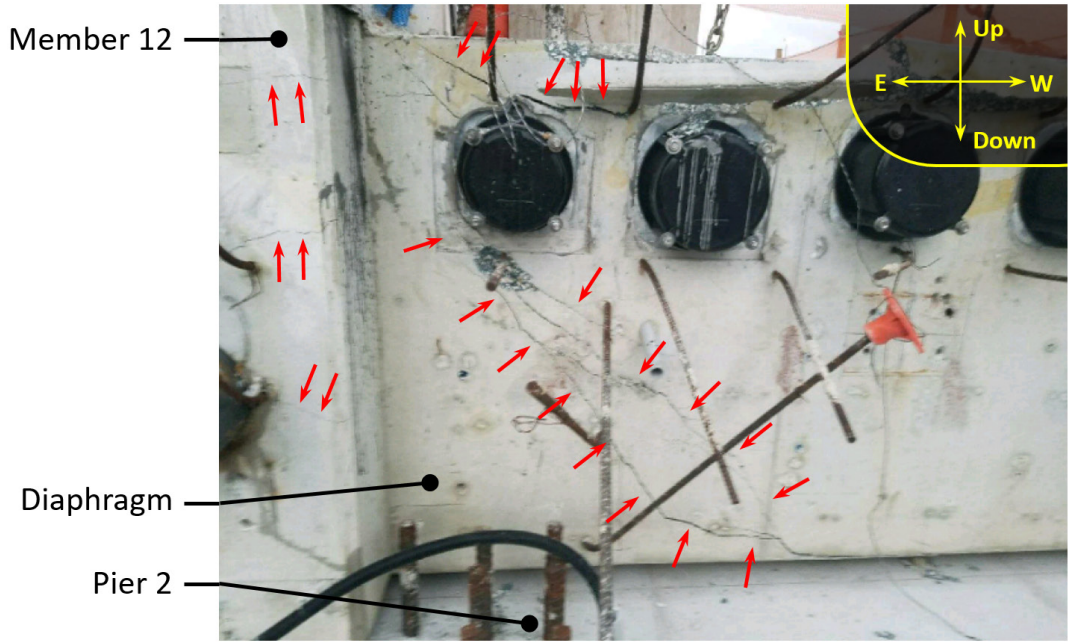
Figure 28. Photograph showing the north face of the north diaphragm immediately west of member 12 after detensioning of members 2 and 11. Source is text message sent by Kevin Hanson on March 10, 2018 at 7:08 p.m.

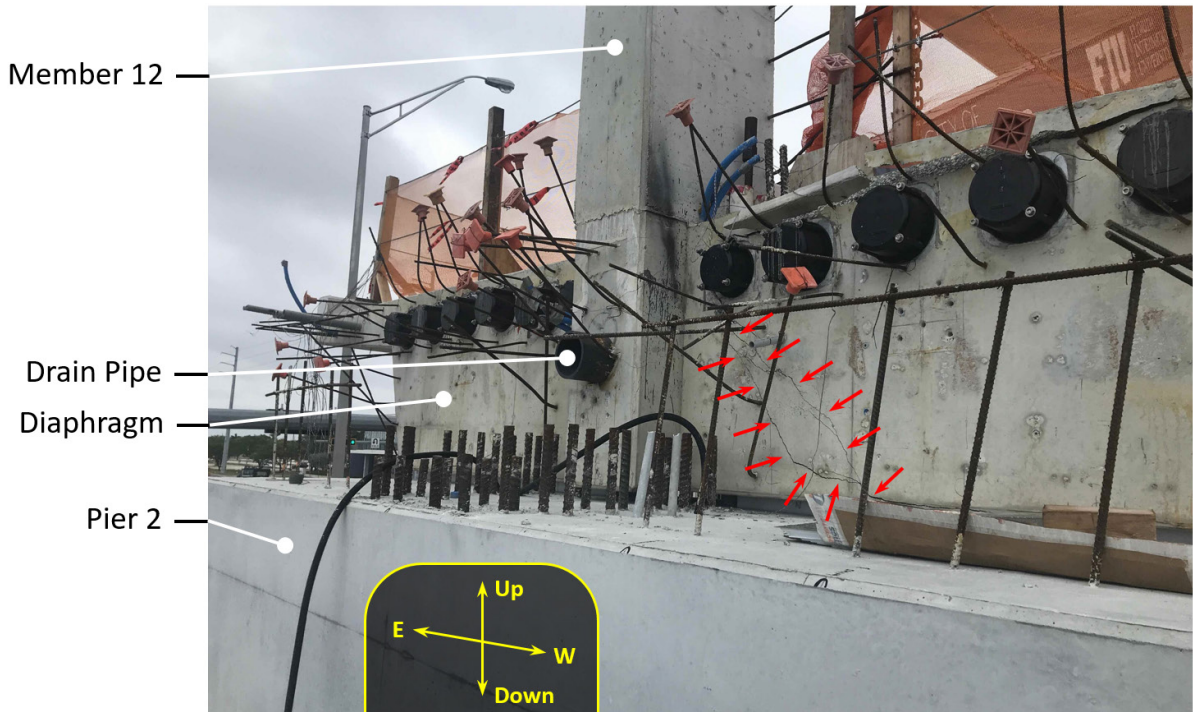
The photographs in Figure 29, Figure 30, and Figure 31 were captured at approximately 10 a.m. on March 12, 2018. They focus on the north face of the north diaphragm, showing significant distress on either side of truss member 12. Specifically, tension cracks parallel the compression struts that would have been carrying the dead load of the bridge through the nodal region and into the shim stacks. The upper end of these cracks also disconnects the truss member 12 nodal concrete from the surrounding deck along the vertical shear planes to the east and west of truss member 12. The Figure 32 photograph, also captured at approximately 10 a.m. on March 12, 2018 shows cracks on the south face of the north diaphragm. This cracking is consistent with the high shear present in this diaphragm caused by the outboard positioning of the shim stacks relative to the centerline of the bridge.

Figure 29. Photograph showing the north face of the north diaphragm on March 12, 2018 at 9:46 a.m. Corresponds to Bridge Factors Factual Report Photo 67.

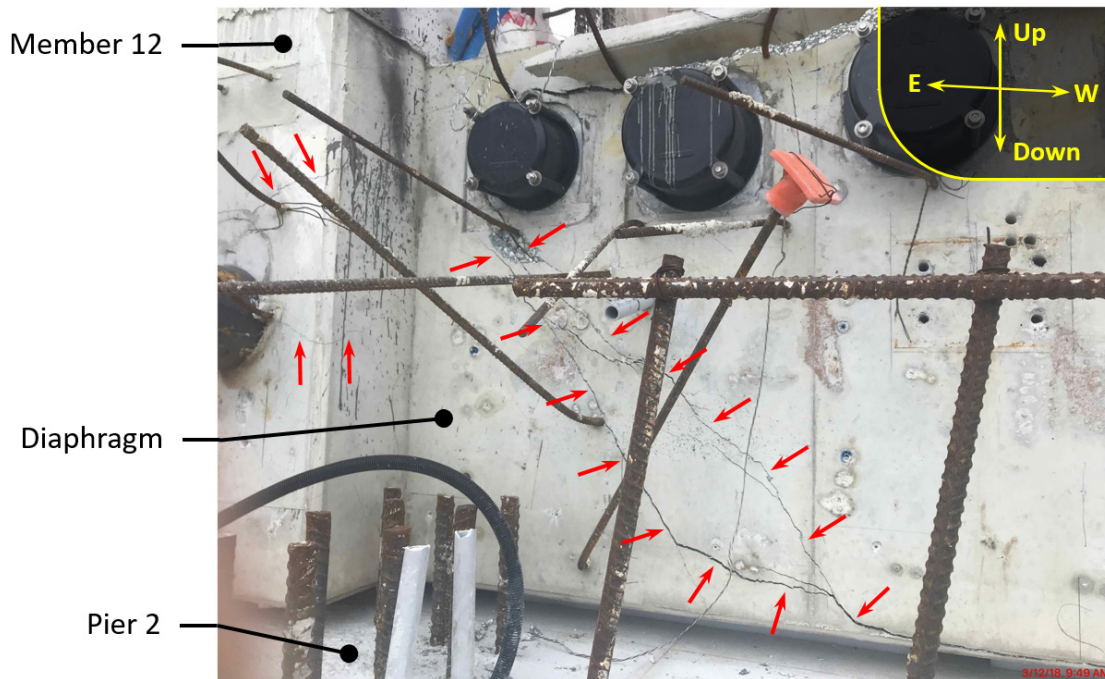
Figure 30. Photograph showing the north face of the north diaphragm immediately west of member 12 on March 12, 2018 at 9:49 a.m. Corresponds to Bridge Factors Factual Report Photo 68.

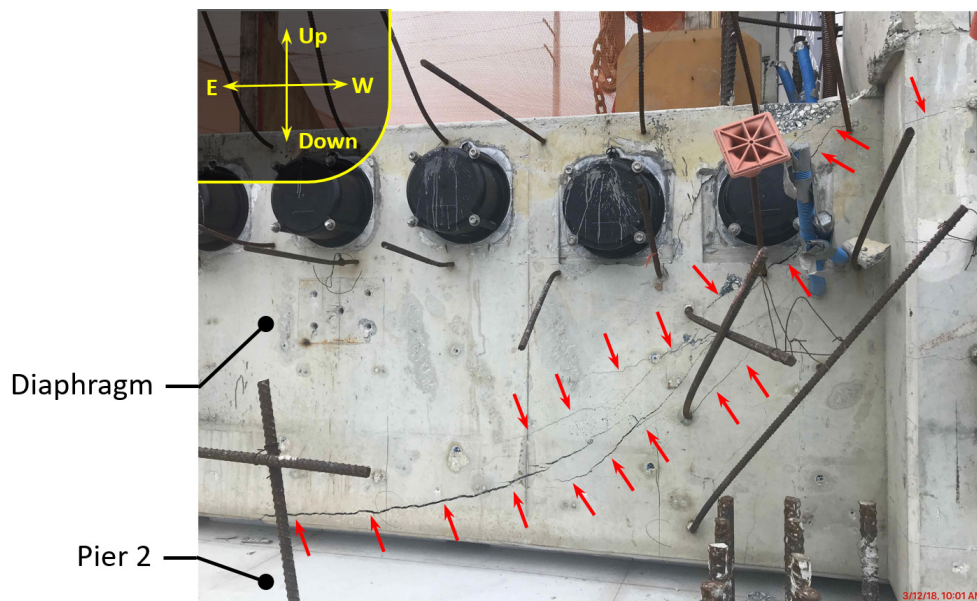
Figure 31. Photograph showing the north face of the north diaphragm immediately east of truss member 12 on March 12, 2018 at 10:01 a.m. Corresponds to Bridge Factors Factual Report Photo 69.

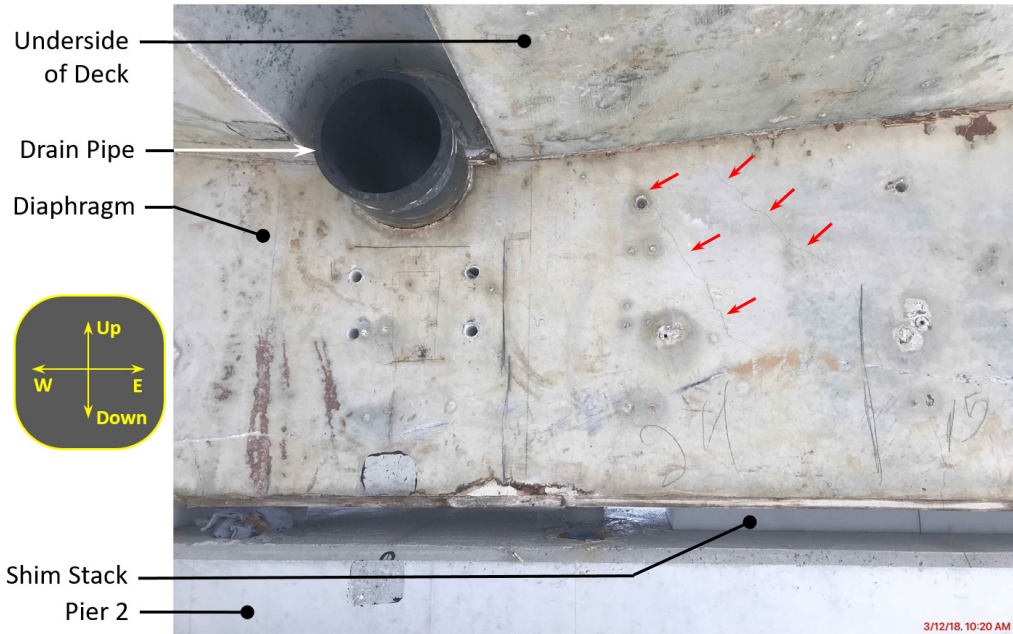
Figure 32. Photograph showing the south face of the north diaphragm between the midline of the bridge and the first bearing pad toward the east on March 12, 2018 at 10:20 a.m. Corresponds to Bridge Factors Factual Report Photo 70.

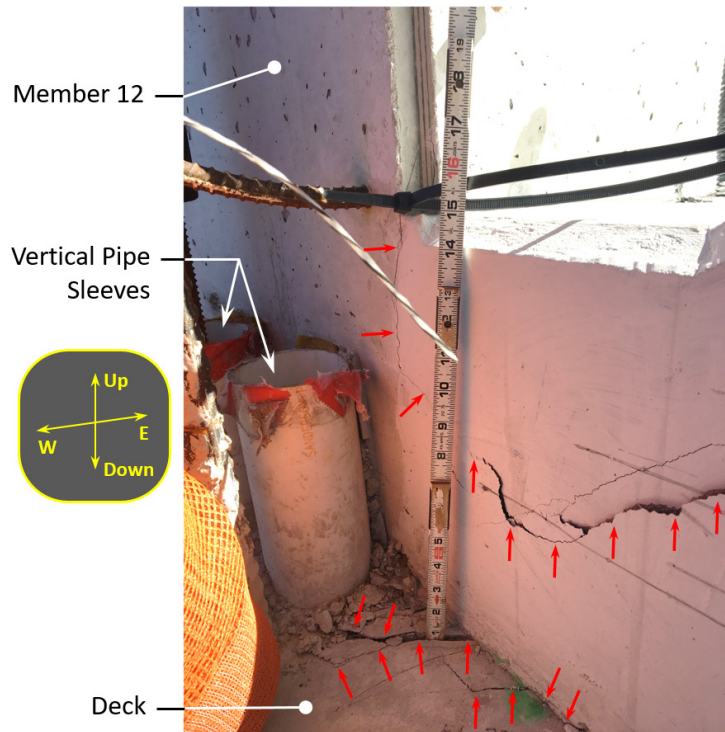
Figure 33 and Figure 38 show the location on the west side of truss members 11 and 12 at the deck where the horizontal shearing plane under member 11 transitions into being a vertical shearing plane along the west side of member 12. Figure 34 and Figure 37 show the distress apparent on the west and east faces, respectively, of truss member 11 where it meets the deck. Figure 36 provides a close-up view of the northward translation that was occurring along the interface under member 11. Figure 35 and Figure 41 show the flexural cracks on the north face of truss member 12. Figure 39 and Figure 40 show the distress observed at the north end of the deck on the east and west side of truss member 12.

Figure 33. Photograph showing the west face of truss members 11 and 12 where they meet the deck on March 13, 2018 at 11:25 a.m. Corresponds to Bridge Factors Factual Report Photo 79.

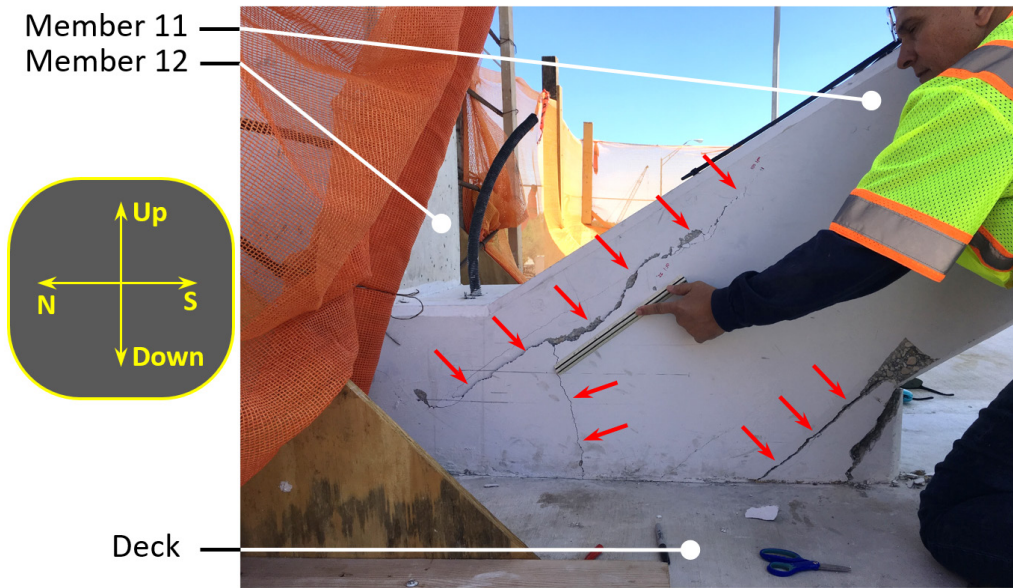
Figure 34. Photograph showing the west face of truss member 11 where it meets the deck on March 13, 2018 at 11:17 a.m. Corresponds to Bridge Factors Factual Report Photo 83.

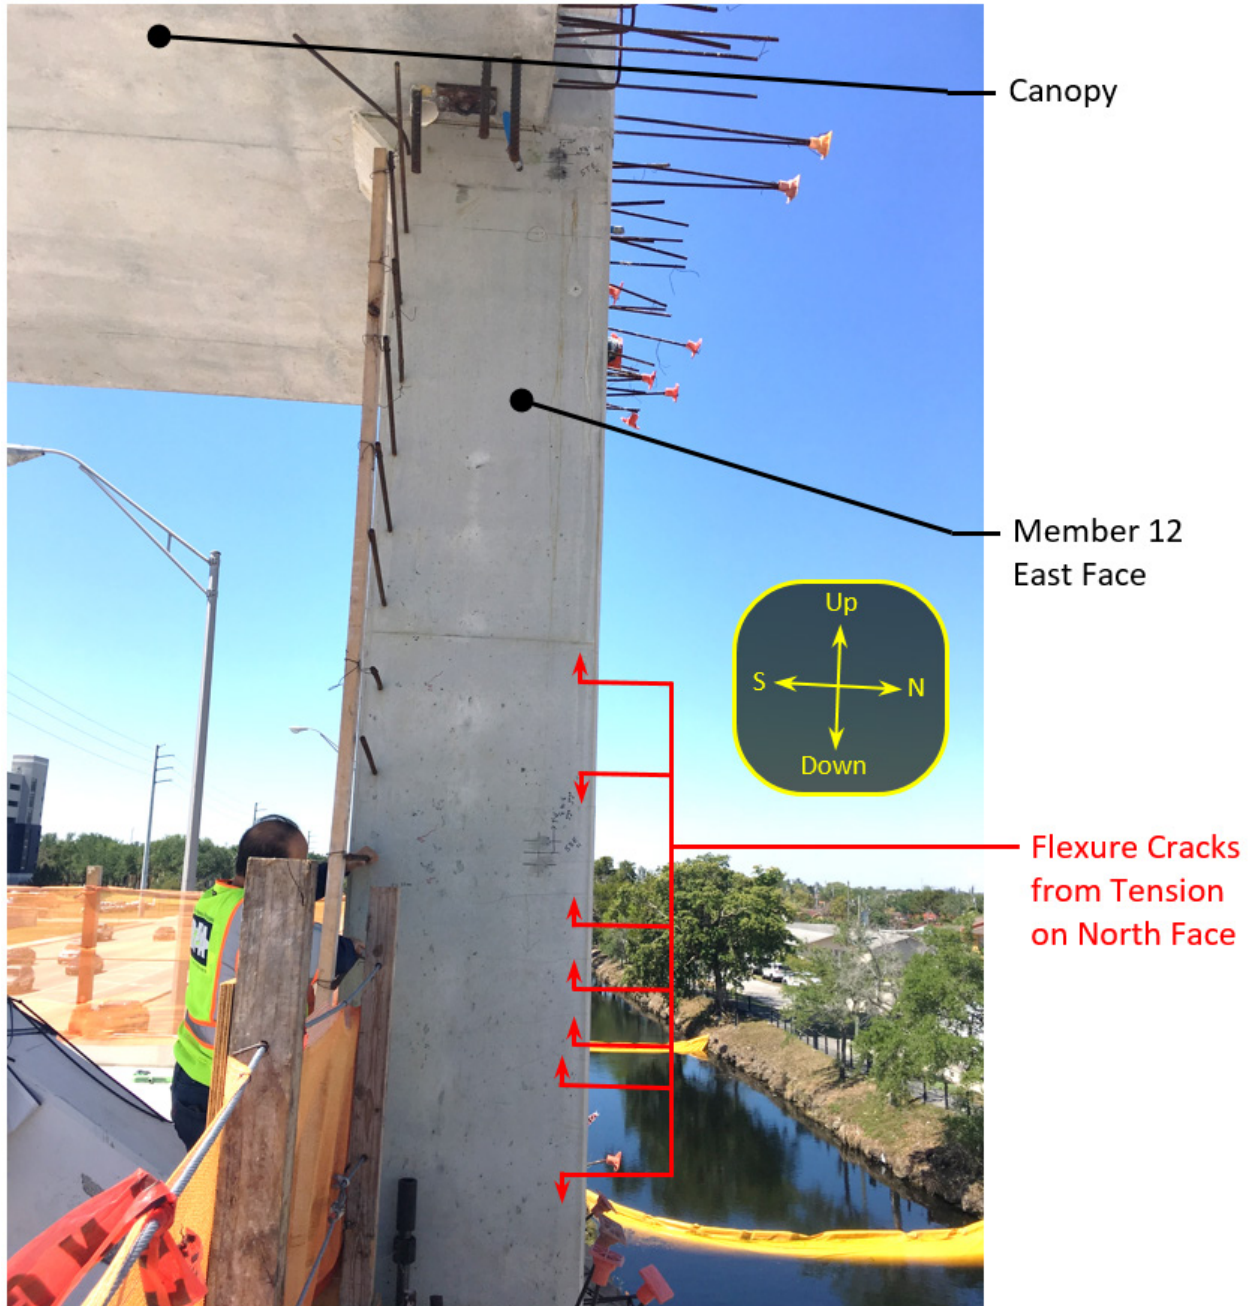
Figure 35. Photograph showing the east face of truss member 12 on March 13, 2018 at 1:21 p.m.

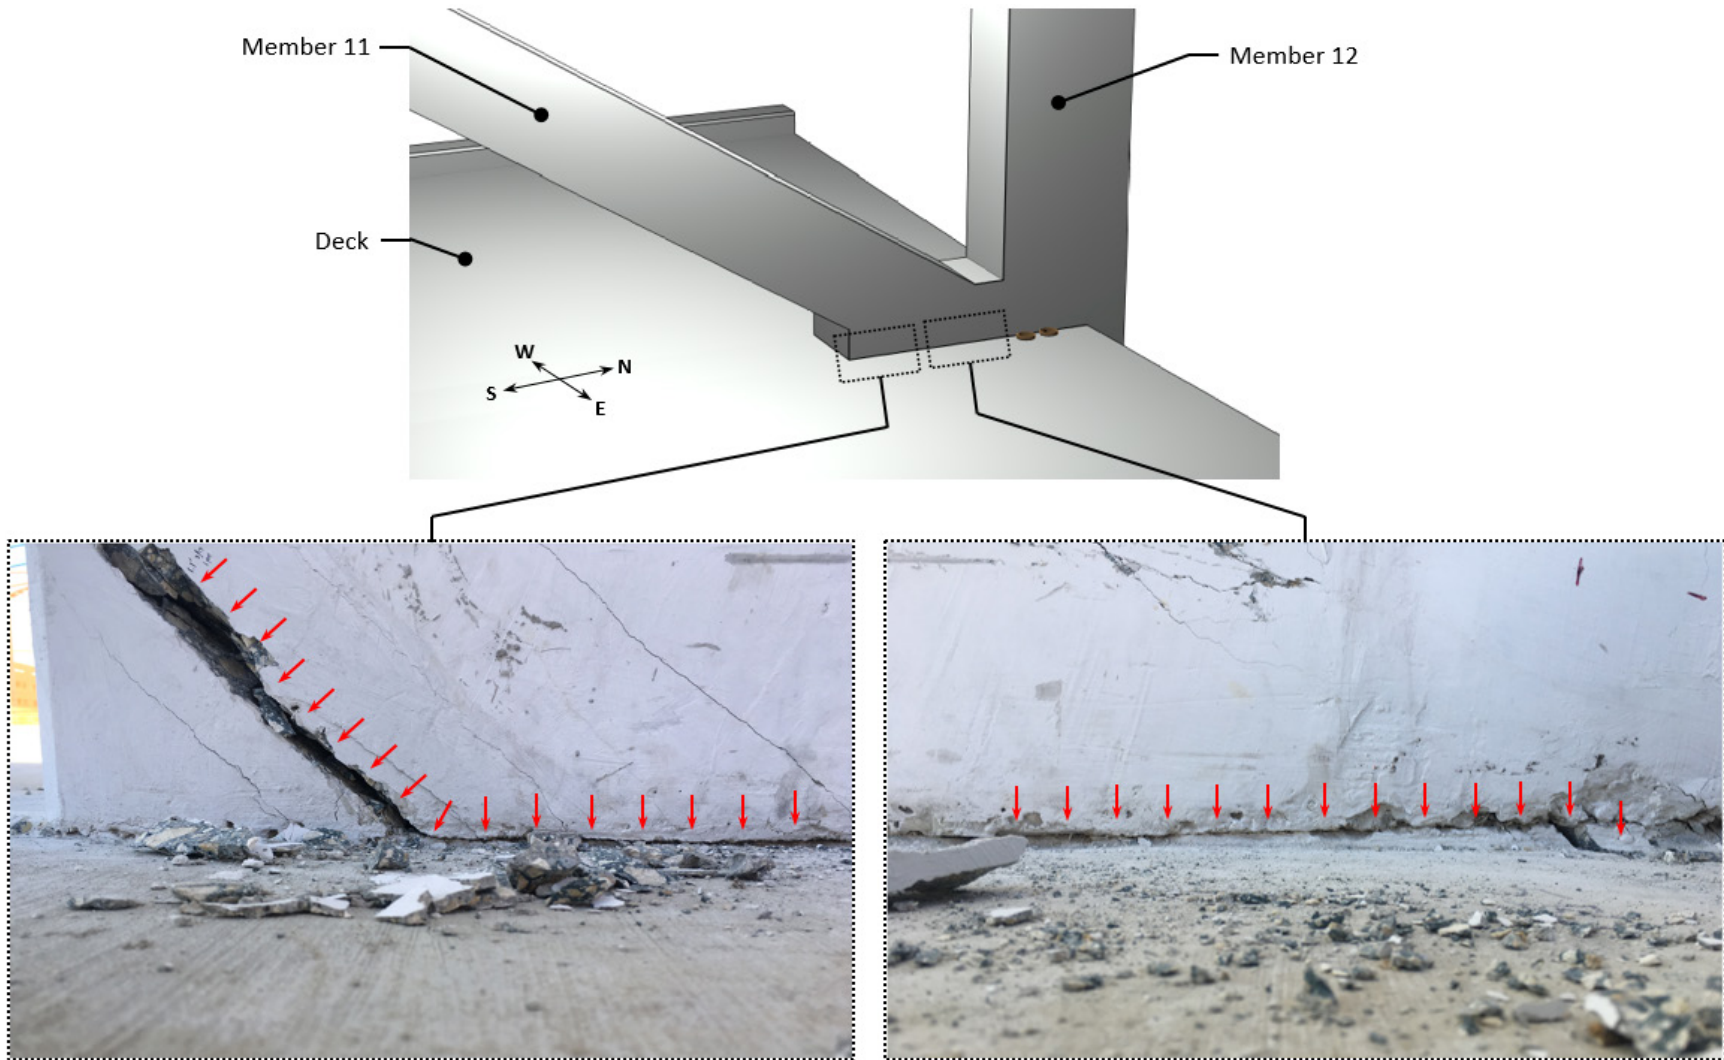
Figure 36. Photographs showing the east interface between of truss member 11 and the deck on March 13, 2018 at 1:29 p.m.

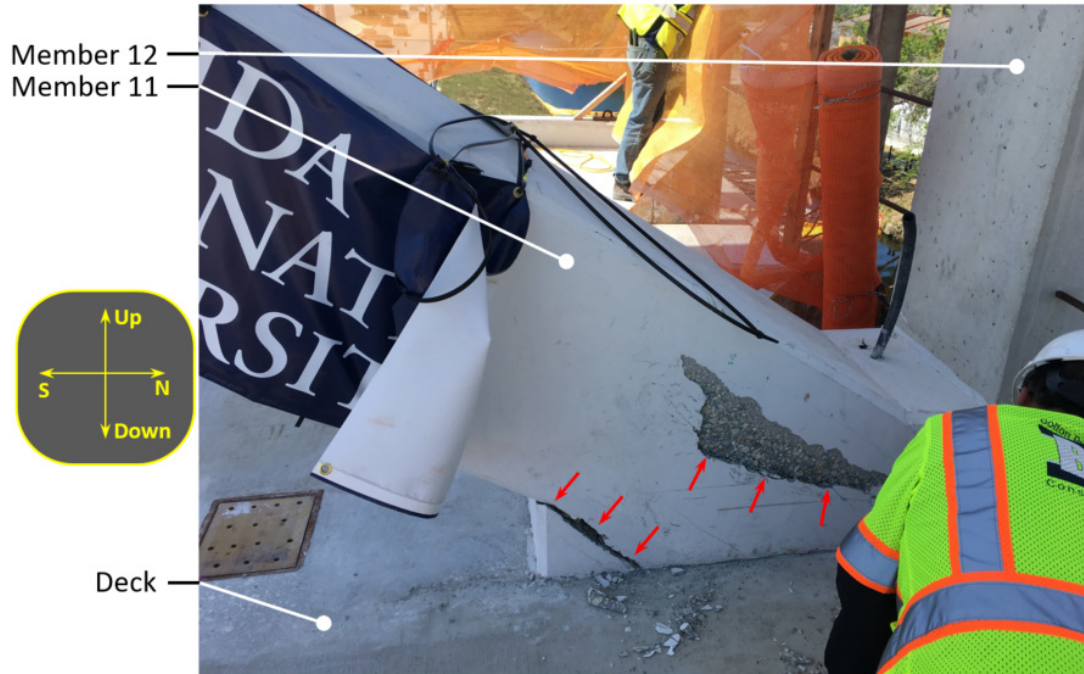
Figure 37. Photograph showing the east face of truss member 11 where it meets the deck on March 14, 2018 at 1:42 p.m. Corresponds to Bridge Factors Factual Report Photo 90.

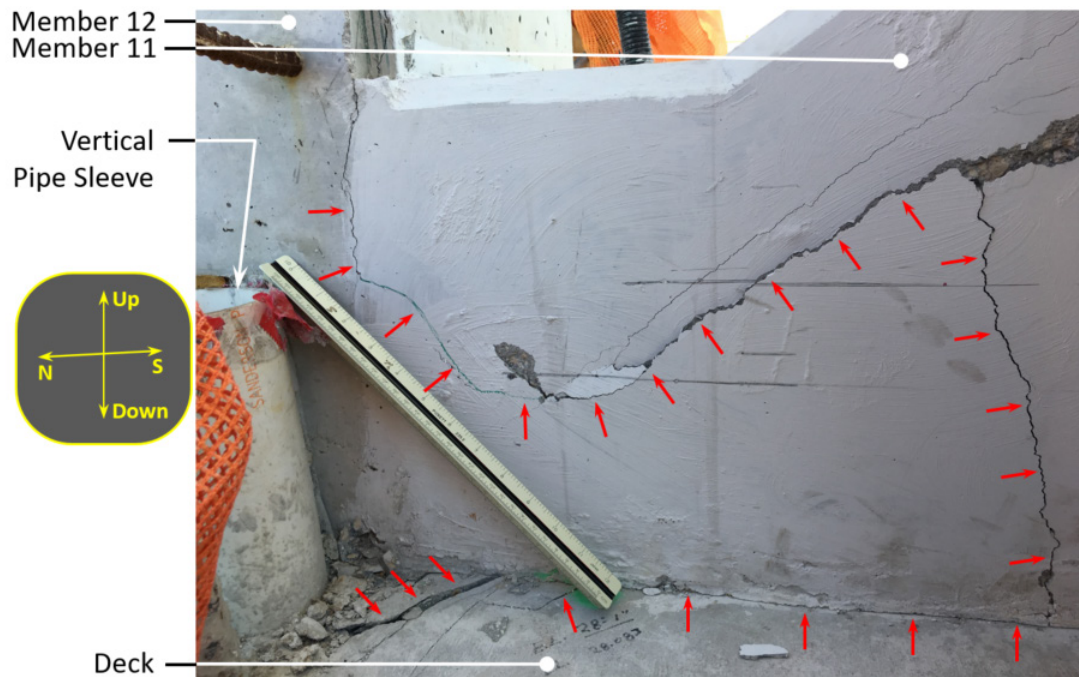
Figure 38. Photograph showing the west face of truss member 11 where it meets the deck on March 14, 2018 at 1:45 p.m. Corresponds to Bridge Factors Factual Report Photo 92.
