Bridge Factors Factual Report Attachment 73 – FHWA Assessment of Bridge Design and Performance

**Florida International University Pedestrian Bridge Collapse Investigation:
Assessment of Bridge Design and Performance**

National Transportation Safety Board
NTSB Accident ID: HWY18MH009

September 12, 2019

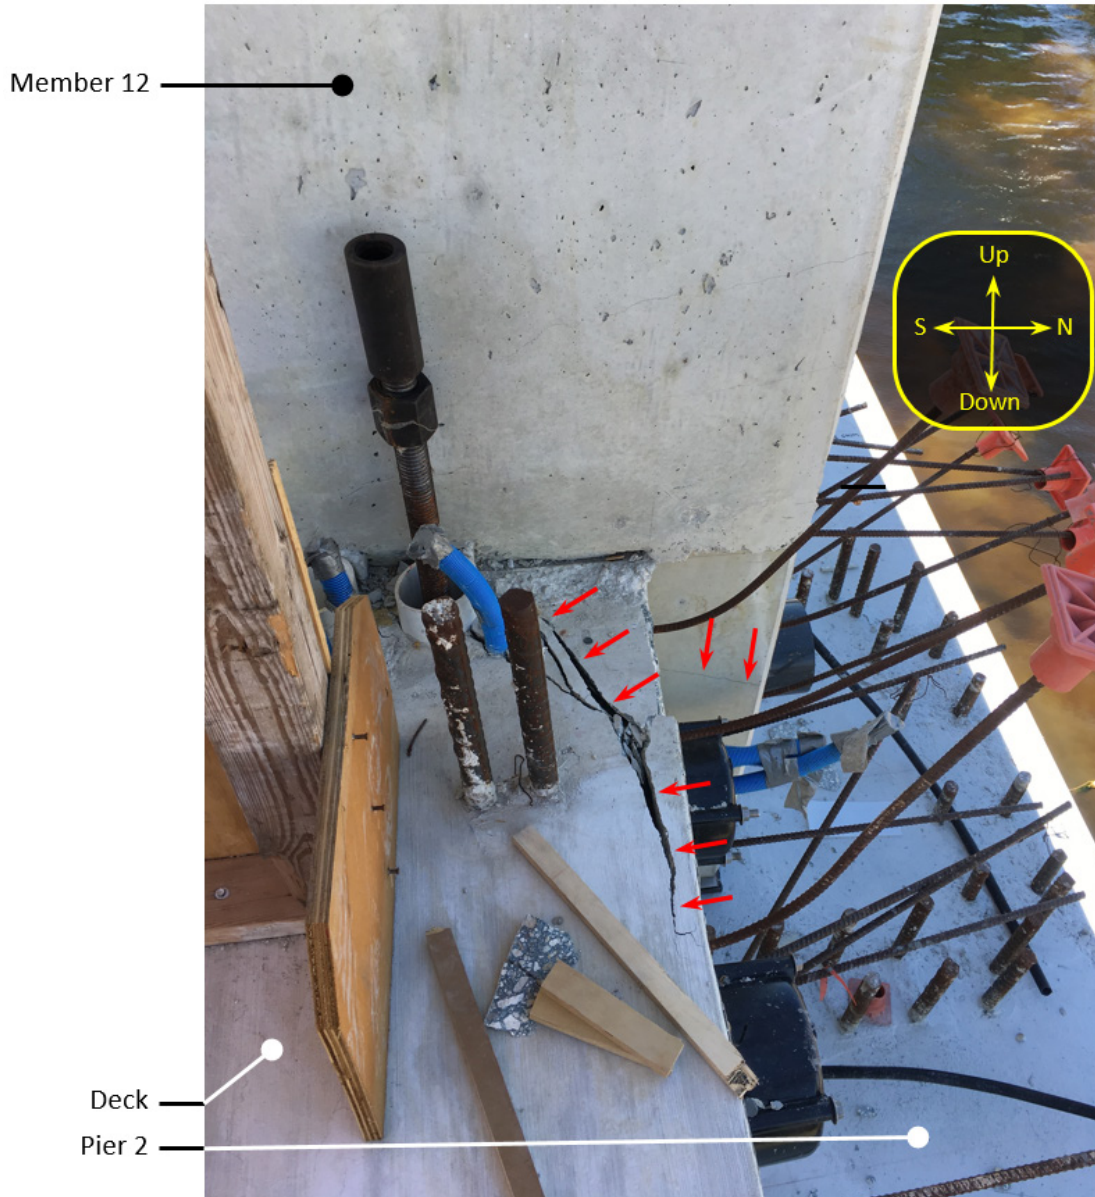
Figure 39. Photograph showing the east face of truss member 12 where it meets the deck on March 14, 2018 at 1:50 p.m. Corresponds to Bridge Factors Factual Report Photo 96.

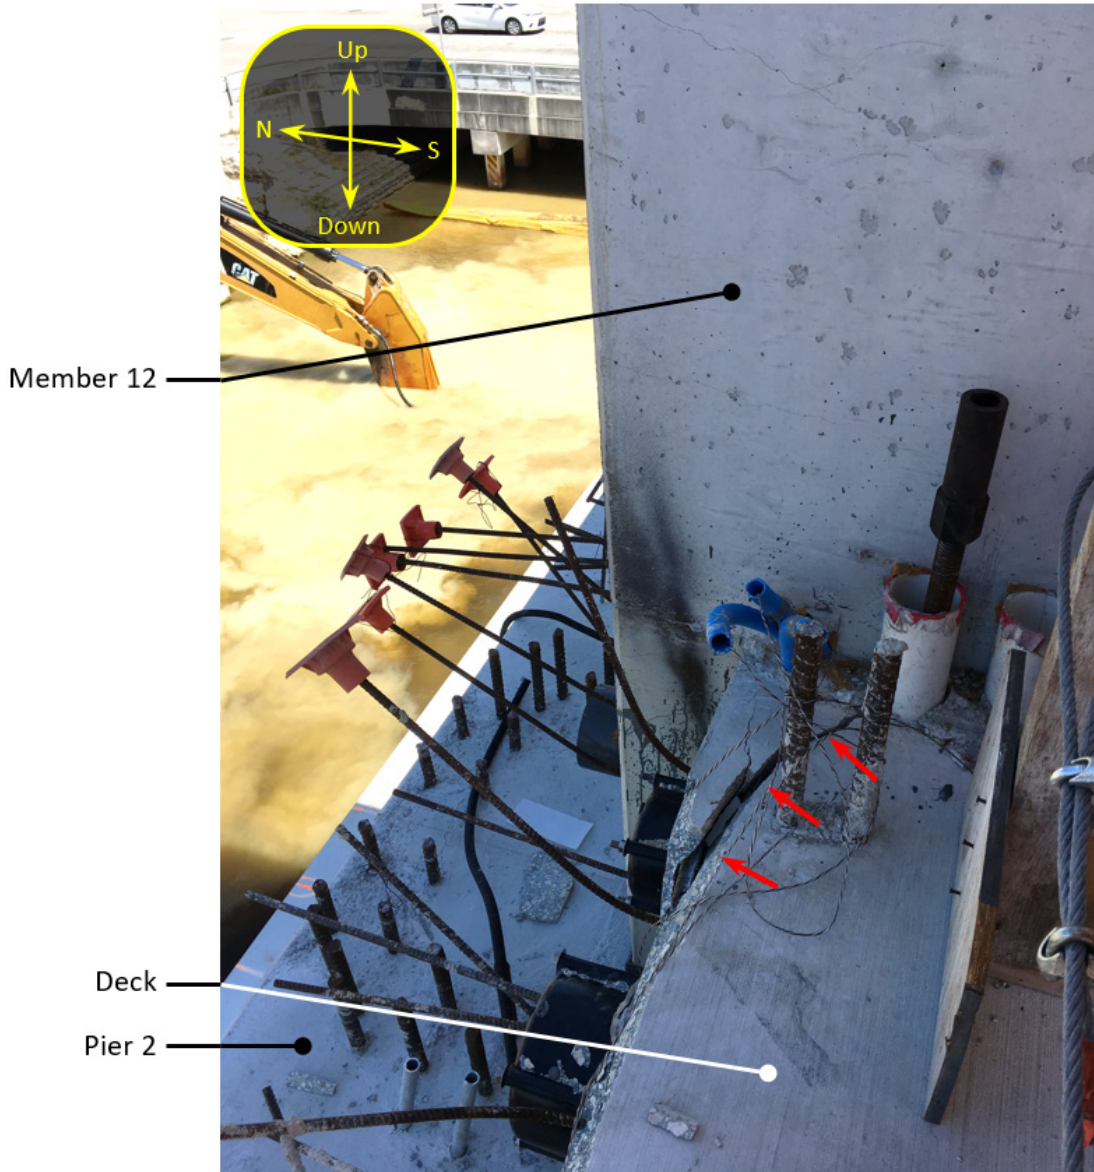
Figure 40. Photograph showing the west face of truss member 12 where it meets the deck on March 14, 2018 at 1:51 p.m. Corresponds to Bridge Factors Factual Report Photo 98.

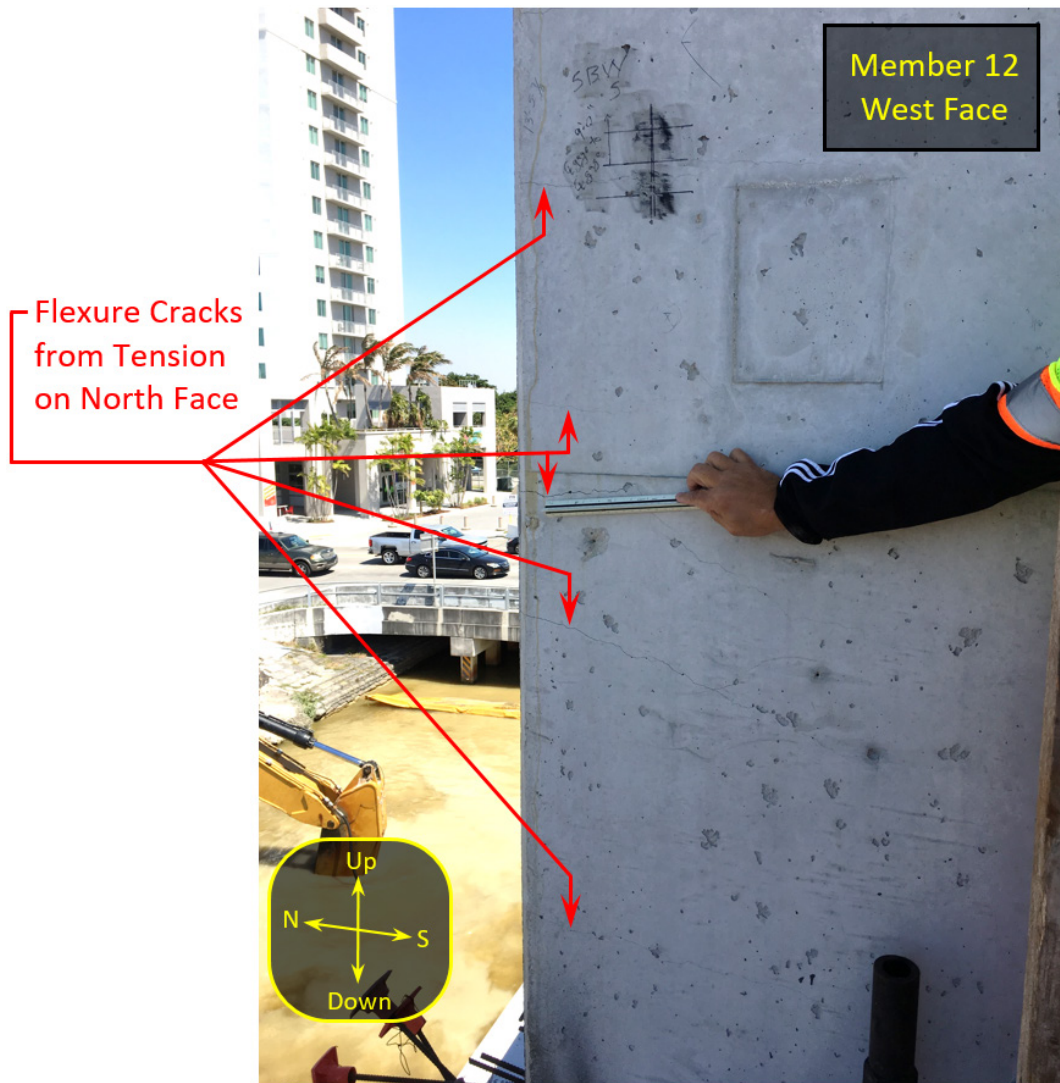
Figure 41. Photograph showing the west face of truss member 12 on March 14, 2018 at 1:51 p.m. Corresponds to Bridge Factors Factual Report Photo 100.

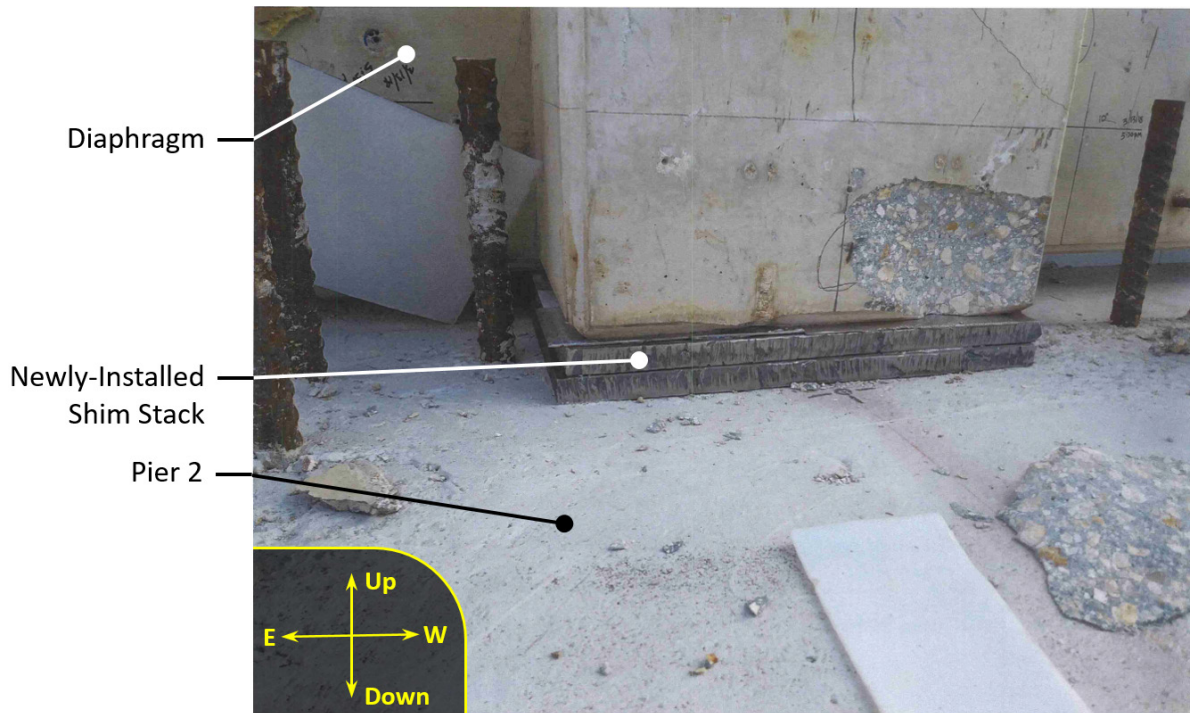
Given that the four existing shim stacks were already supporting the weight of the bridge on Pier 2, the manual insertion of a new shim stack under the diaphragm (i.e., insertion without the lifting of the bridge to rebalance the loads between the five shim stacks) is not anticipated to have permitted any sizeable load to be distributed into the new shim stack. Thus, the new shim would have only carried load in a situation where further distress caused a downward movement of the center of the diaphragm relative to the remainder of the diaphragm.

Figure 42. Photograph showing the north side of the north diaphragm after the installation of the new shim and before March 14, 2018 at 1:38 p.m.

The distress observed in the structure between March 10 and March 13, 2018 prompted FIGG Bridge Engineers to direct the bridge construction contractor to install supplemental support under the north diaphragm. This diaphragm, illustrated in Figure 16, was originally supported on Pier 2 via four shim stacks. Until this time there had been no support along the centerline of the bridge in the area between the vertical pipe sleeves that passed through the diaphragm.

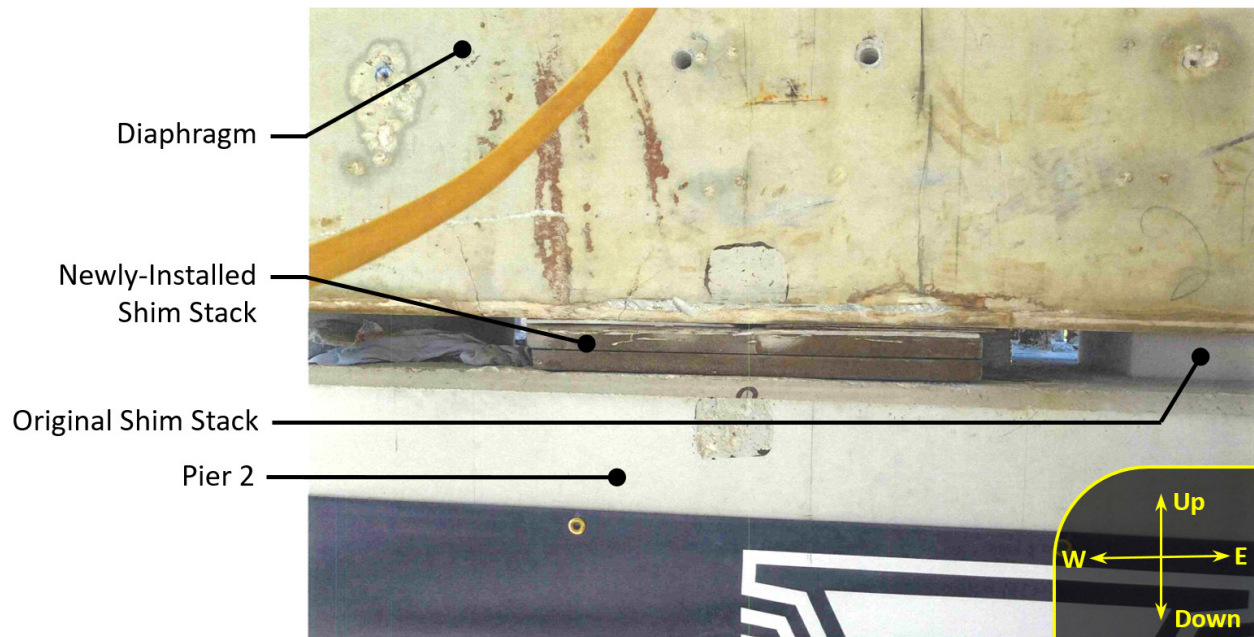
Figure 43. Photograph showing the south side of the north diaphragm after the installation of the new shim and before March 14, 2018 at 1:38 p.m.

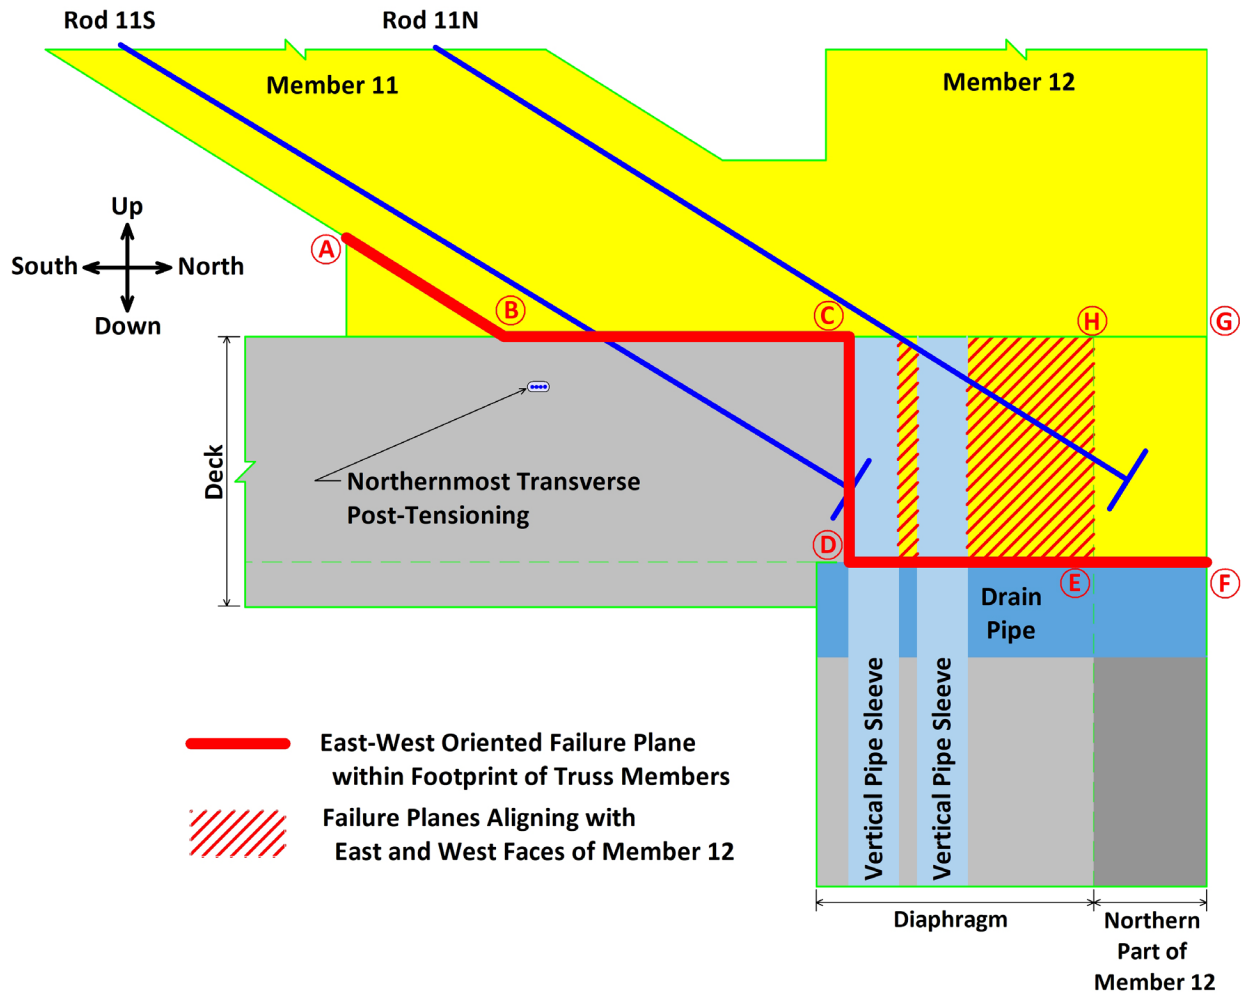
Annotations in Figure 44 identify key locations within the nodal region. An approximation of the east-west oriented failure plane is identified by the solid red line A-B-C-D-E-F. An approximation of the north-south oriented failure planes in the deck is identified by the red crosshatched region bounded by C-D-E-H. There are two red crosshatched planes, one at each of the east and west faces of truss member 12. The drain pipe (dark blue fill) that bounded the bottom of the D-E-F failure plane and the vertical pipe sleeves (light blue fill) that perforated the C-D-E-H failure planes are shown.

The resistance mechanisms afforded by the structure across the identified failure planes can be deduced by comparing the distress observed prior to collapse with the construction plans and the retained portions of the collapsed structure. Wide structural cracks with rigid body translation along the A-B-C plane (see Figure 37, Figure 45, and Figure 46) and continuing along the C-H line (see Figure 40 and Figure 47) indicate that the concrete bounding these failure planes was offering little resistance. Along inclined plane A-B, two #6 reinforcing bars crossed the plane. Along horizontal plane B-C, six #7 reinforcing bars cross and are perpendicular to the plane. Three additional #7 reinforcing bars, these being the axial reinforcement in the south face of truss member 11, also pass through plane B-C and may have offered some resistance to northward translation along the plane. Vertical plane C-D, which would have experienced direct tensile forces that moved the upper part of the node northward relative to the lower part of the node, did not have any reinforcing bars crossing the plane. Additionally, the steel anchorage plate for post-tensioning rod 11S aligned with this plane and thus served as a discontinuity on the plane. The pair of vertical planes C-D-E-H aligning with the east and west

Figure 44. Illustration showing a midline cross section of the truss member 11 and 12 nodal region with annotations indicating resistance mechanisms and distress.

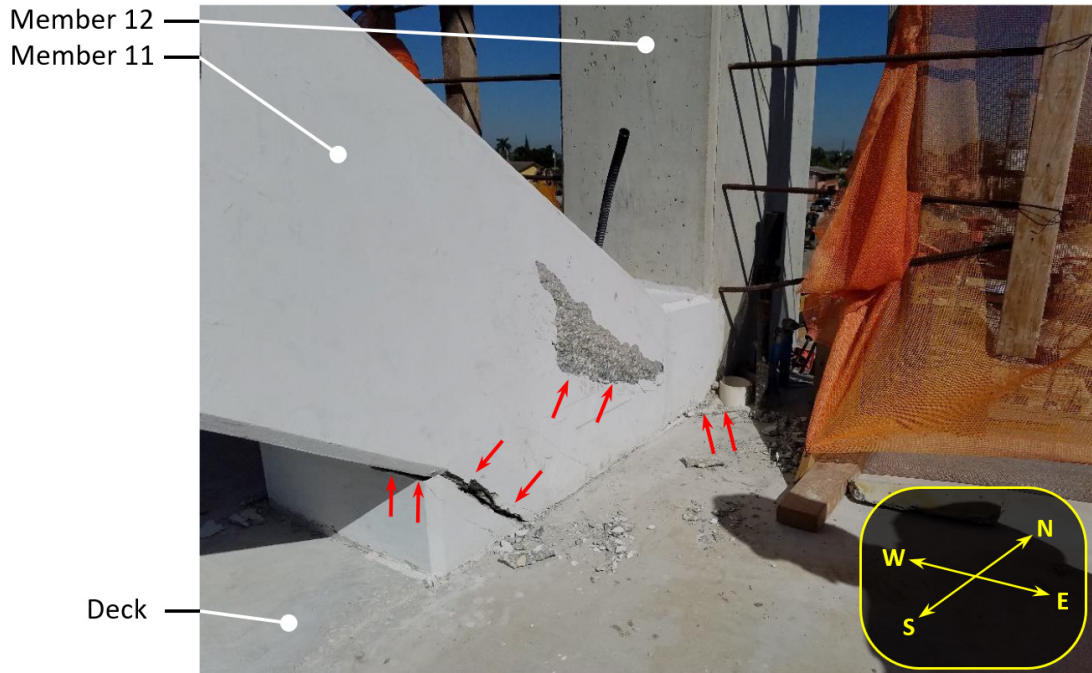
The distress apparent in the structure surrounding the base of truss members 11 and 12 can be seen in Figure 45, Figure 46, and Figure 47. Figure 48, Figure 49, and Figure 50 provide three post-collapse views of the nodal region under member 12, offering a view of the reinforcements, the plastic pipes that were in and surrounding the failure region, and the validation of the failure planes A-B-C-D-E-F and C-D-E-H identified in Figure 44.

Figure 45. Photograph showing the east face of truss member 11 where it met the deck on March 15, 2018 at 10:53 a.m. Corresponds to Bridge Factors Factual Report Photo 102.

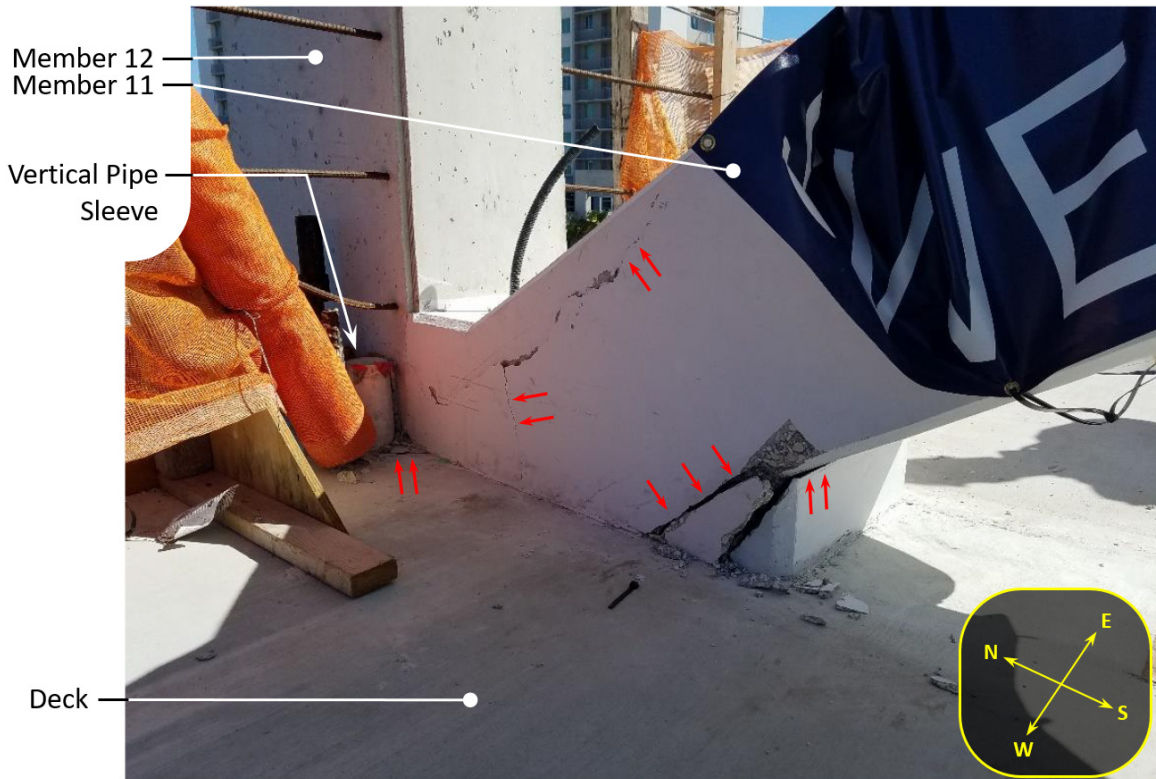
Figure 46. Photograph showing the west face of truss member 11 where it met the deck on March 15, 2018 at 10:55 a.m. Corresponds to Bridge Factors Factual Report Photo 103.

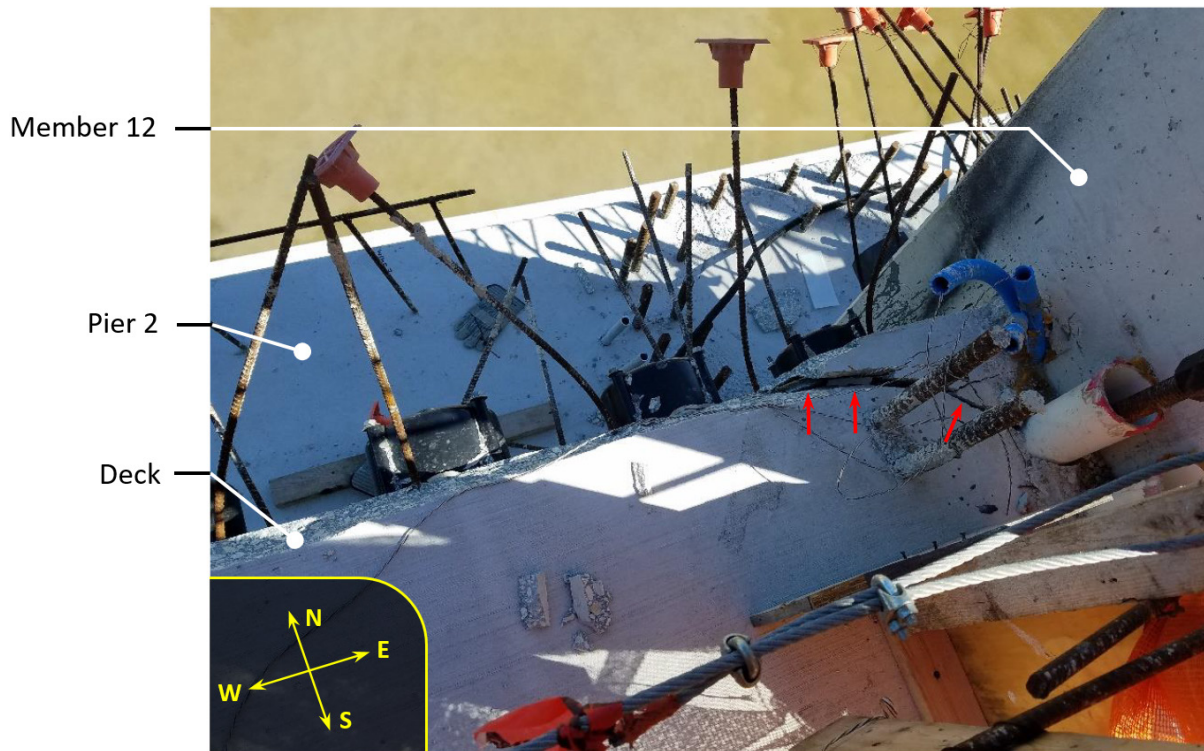
Figure 47. Photograph showing the north end of deck on west side of truss member 12 on March 15, 2018 at 10:55 a.m. Corresponds to Bridge Factors Factual Report Photo 104.

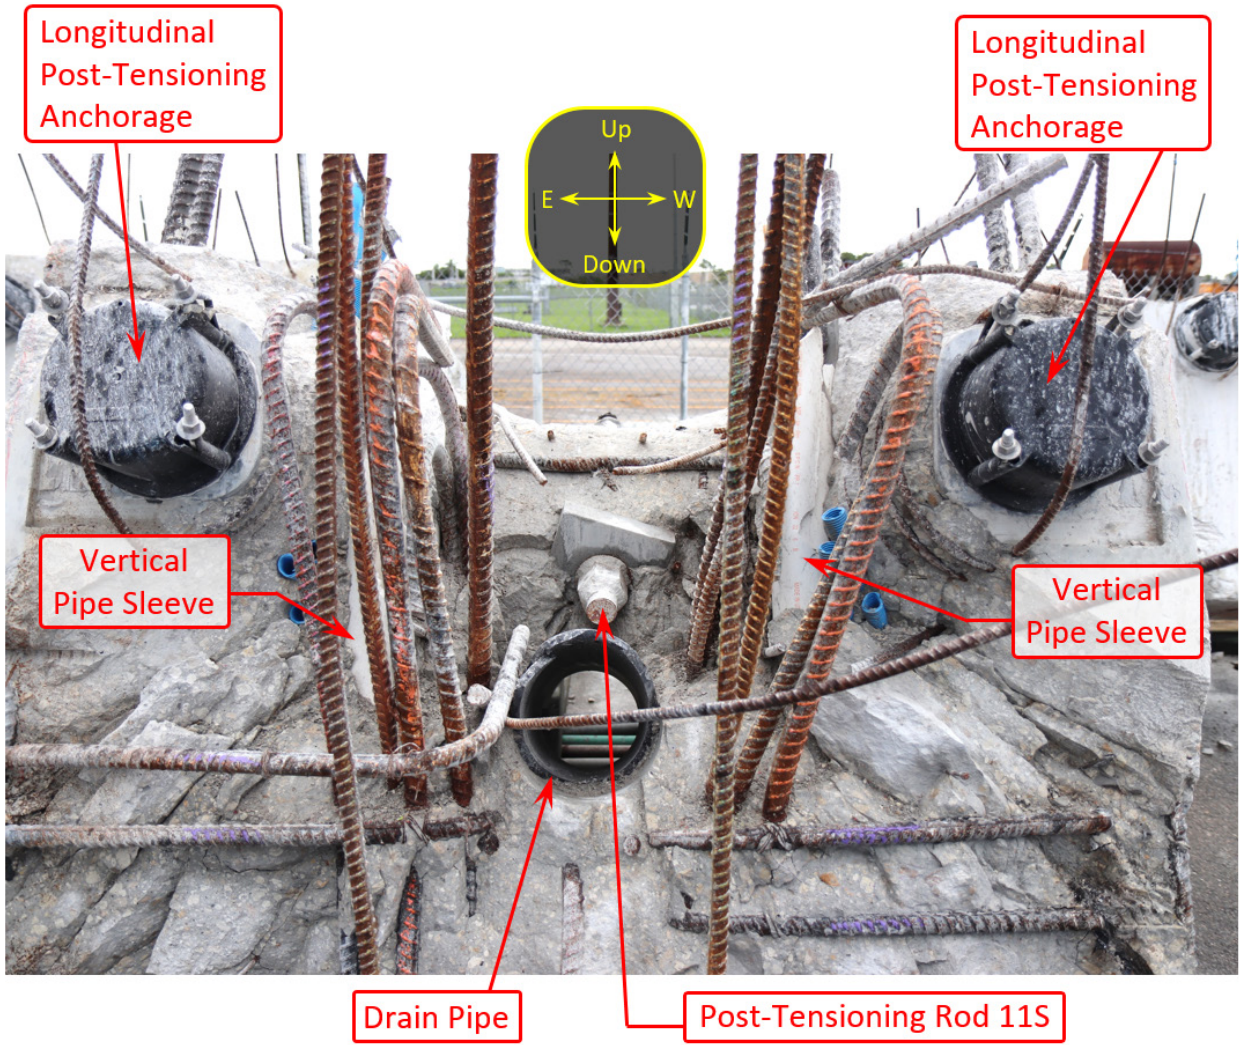
Figure 48. Photograph showing post-collapse condition of deck portion of truss member 11 and 12 nodal region looking from north toward south along bridge centerline.

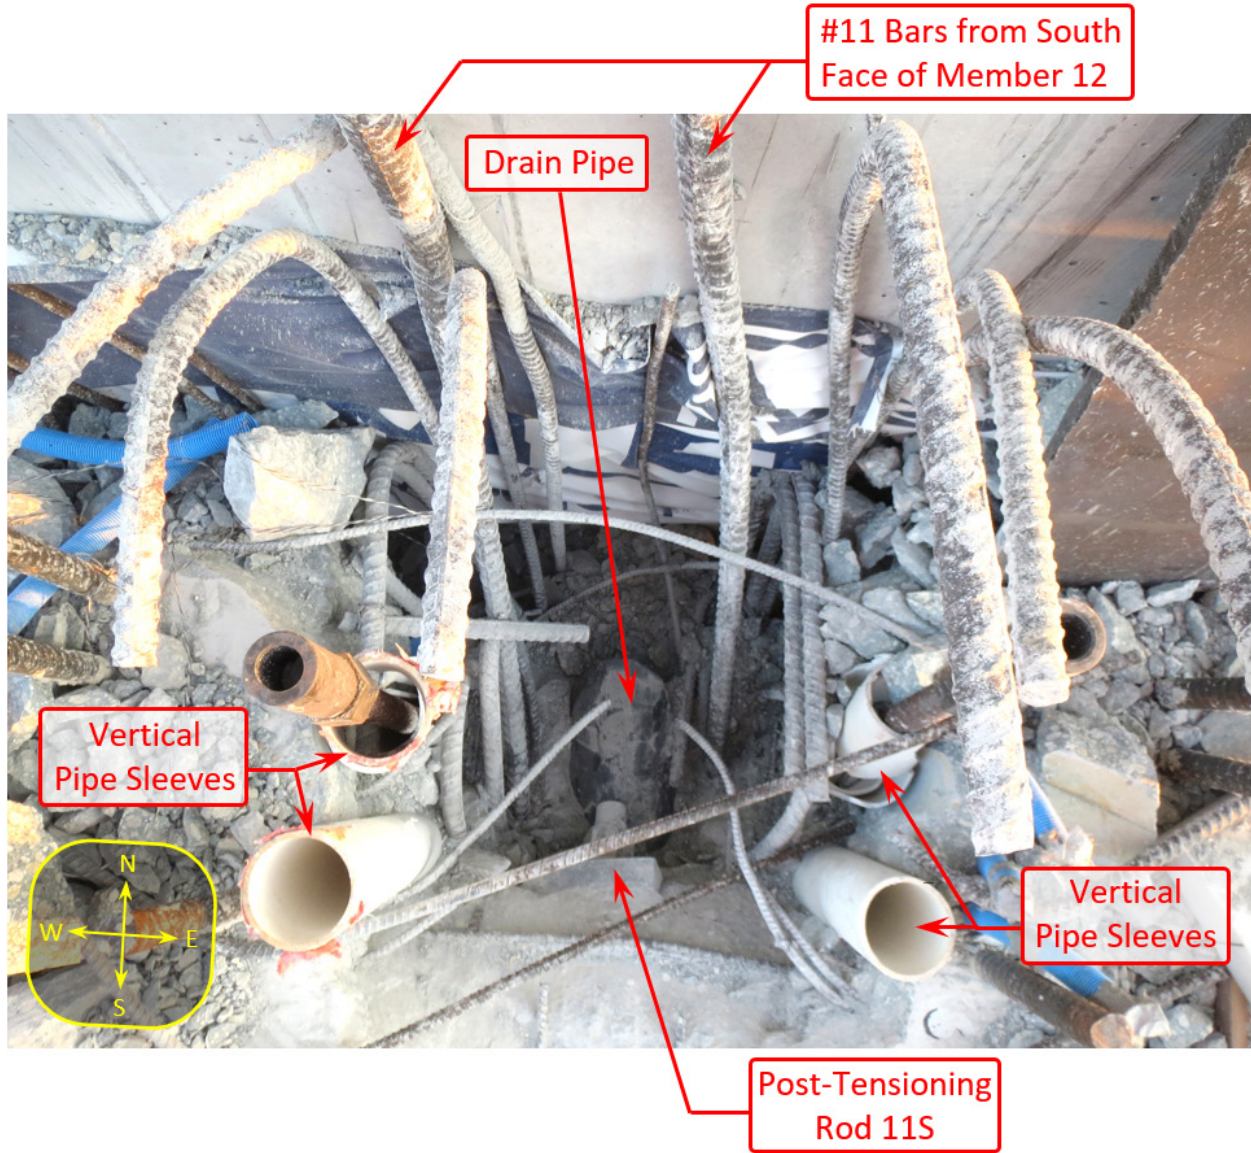
Figure 49. Photograph showing post-rubble removal condition of deck portion of truss member 11 and 12 nodal region looking down with north toward the top of photo.

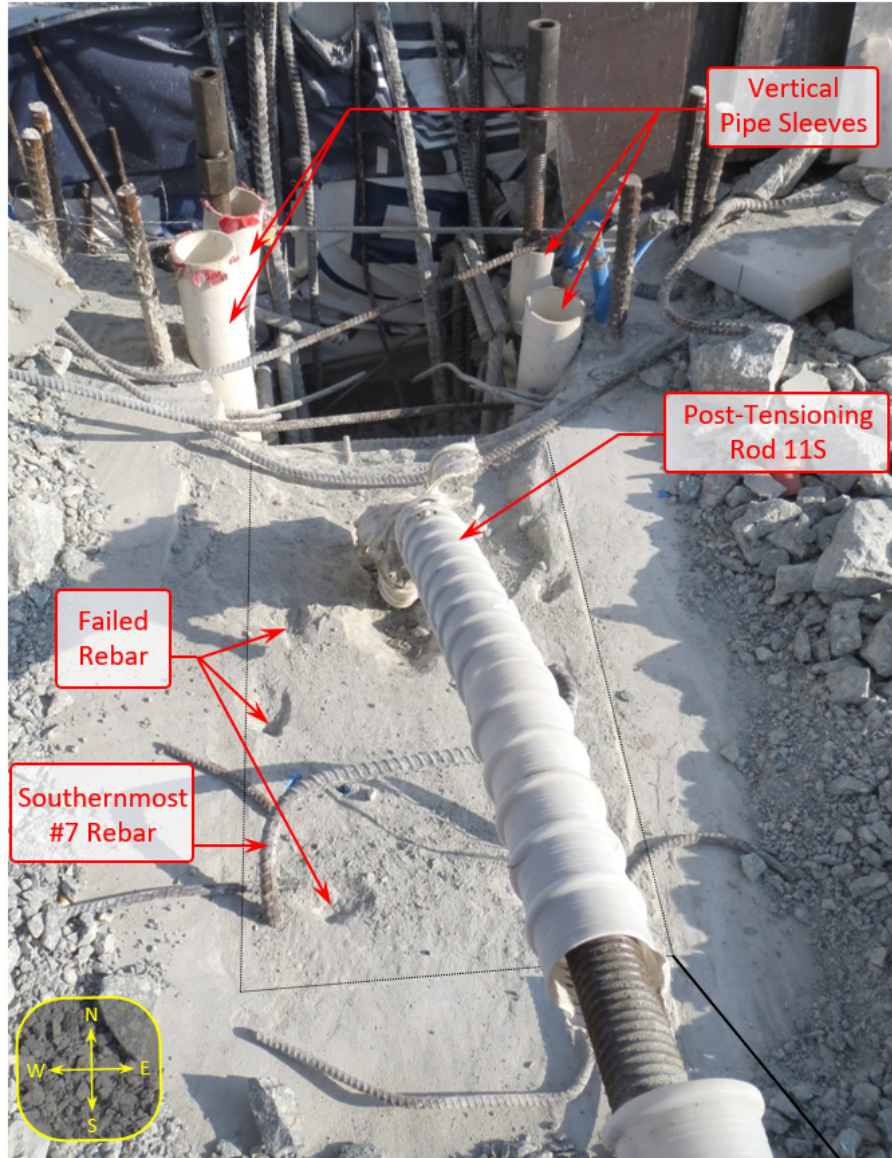
Footprint of Member 11 on deck indicated with superimposed dotted line

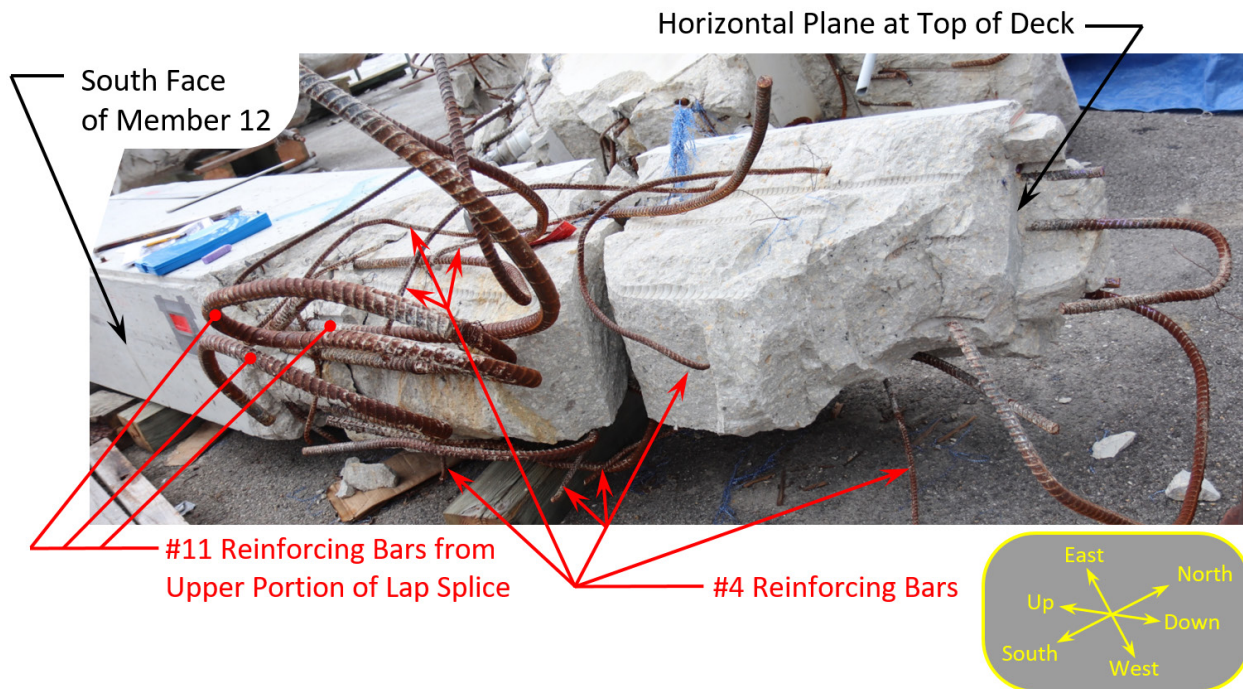
Figure 51. Photograph showing post-collapse condition of the bottom portion of truss member 12. The level of the deck was approximately at the right extent of the member and the east face is on top.

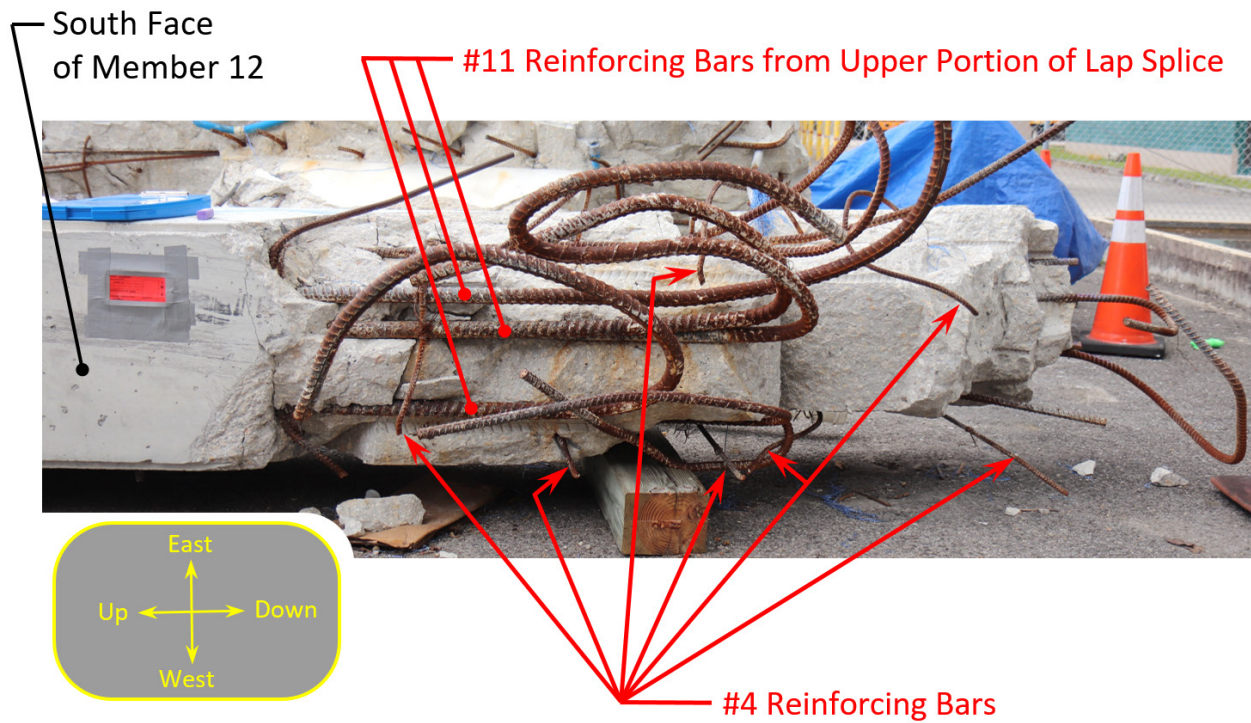
Figure 52. Photograph showing post-collapse condition of the south face of the lower portion of truss member 12. The level of the deck was approximately at the right extent of the member.

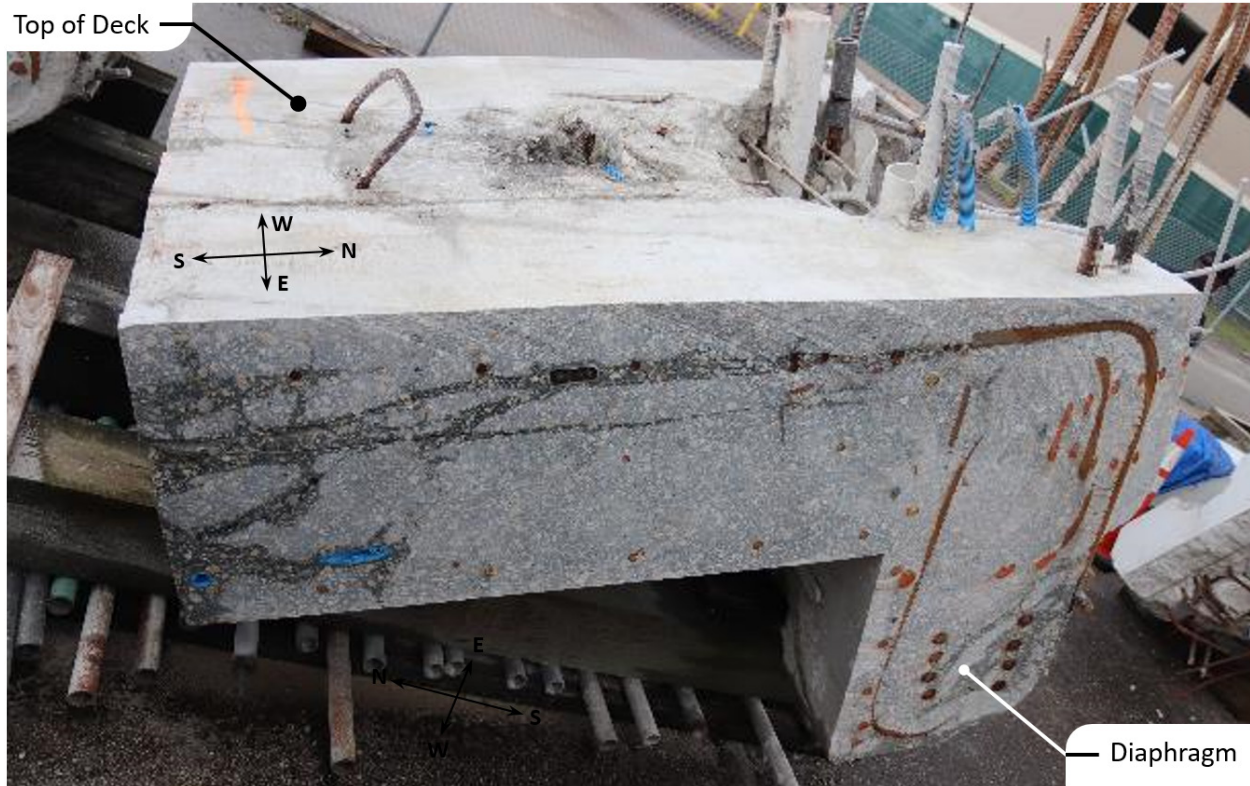
Figure 53. Photograph of longitudinal cross section of bridge deck after being cut from retained nodal region deck element. The vertical cut is approximately 20-inches east of the east face of member 12.
