Federal Railroad Administration
Tank Car Damage Assessment Form

Reporting Marks	CBTX 781553		Car Location City/State	HYNOMAN, PA	
Date inspected	8/5/17	Railroad	CSX	DOT Specification	
Last Contained	LPG		Was product released?	YES	
(Jacket thickness)	Jacket <u>YES</u>	Non-jacketed	Does car contain product		
Car builder		Stub Sill Design		Built Date	
Capacity (GAL)	33440		LD Limit (LB)

Car Damage Report

Car Number CBTX 781553

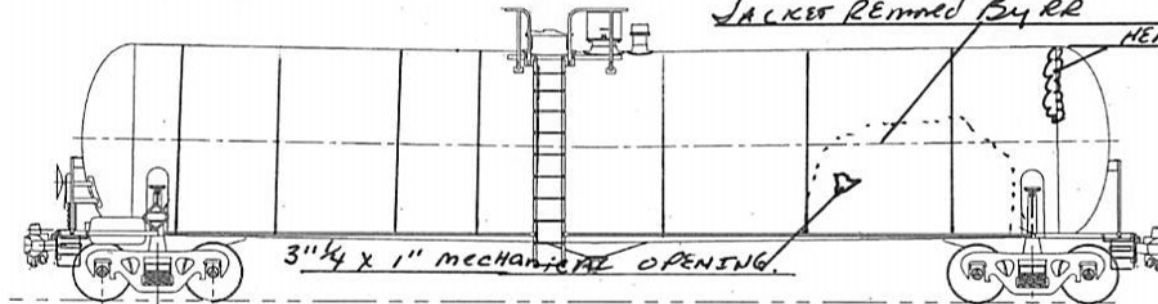
JACKET REMOVED BY RR

HEAD PUSHED IN.

DENT 2' x 3'

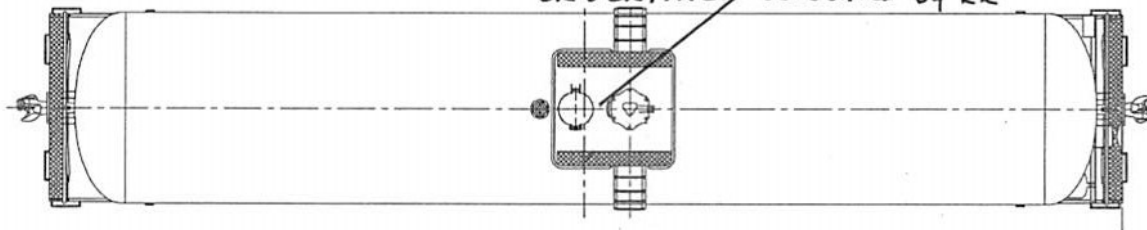
PRESSURE DOME INTACT NO SIGNS OF FIRE OR VENTING. SEPERATED BY RR

NO DENT ONLY SCRAPED

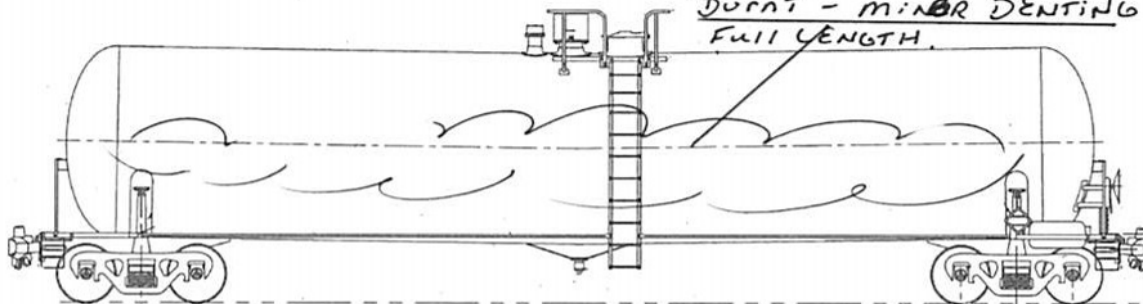
BURNT - MINOR DENTING FULL LENGTH.

Top fittings INTACT
Bottom Outlet NA
Punctures 1 3/4" x 1" AR @ 3:00
Draft sill AB INTACT
