Federal Railroad Administration
Tank Car Damage Assessment Form

(# 45)

Reporting Marks	UTLX 953969		Car Location City/State	Manuelito, NM	
Date inspected	4/29/24	Railroad	BNSF	DOT Specification	112J 340W
Last Contained	LPG (Non-odorized)		Was product released?	No	
(Jacket thickness)	Jacket <input checked="" type="checkbox"/>	Non-jacketed	Does car contain product	No	
Car builder	UTC	Stub Sill Design	UTL-2BG	Built Date	2006
Capacity (GAL)	30,147		LD Limit (LB)

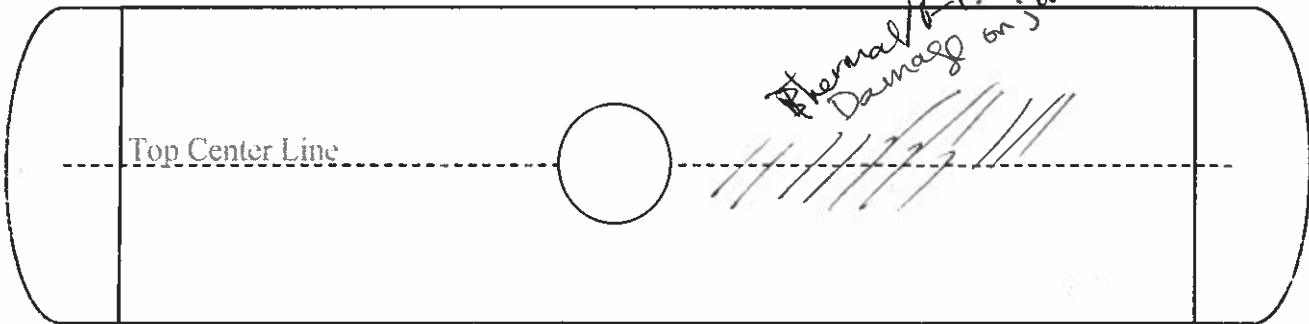
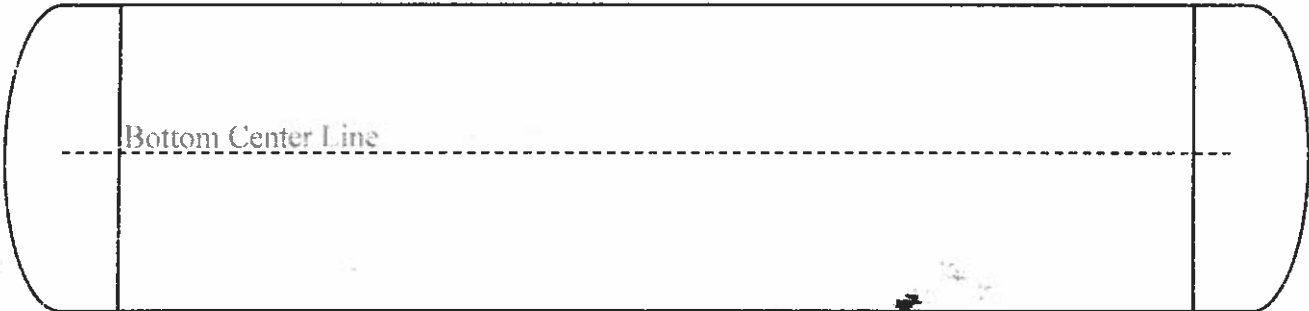
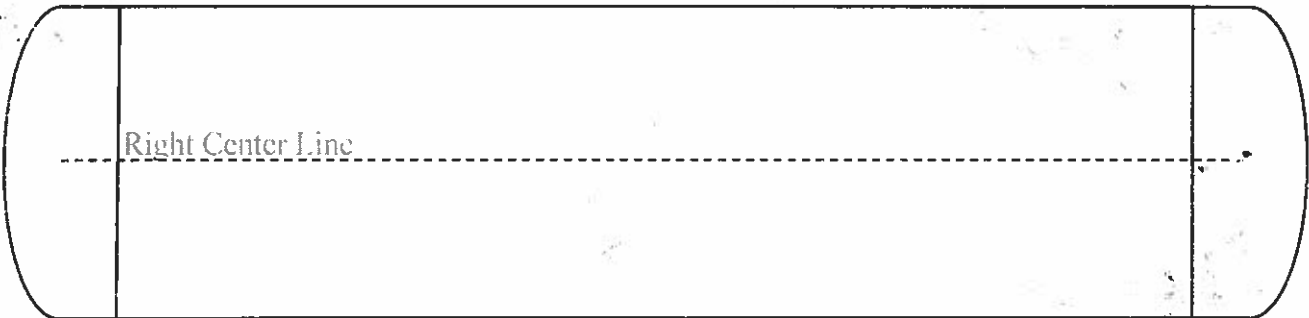
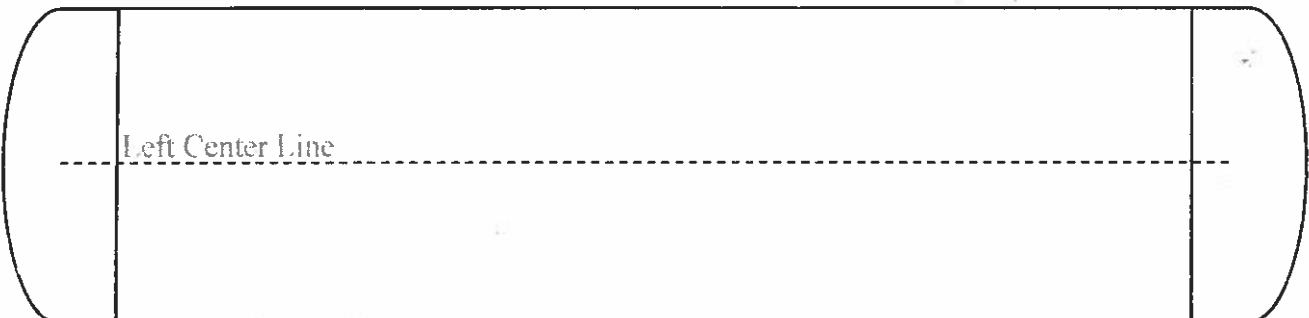
- Head shield Removed only showing a dent on the shell, no tear
 - Product was transferred to another car ; Car #47 was in front of it in the original orientation
 - No breach on this car

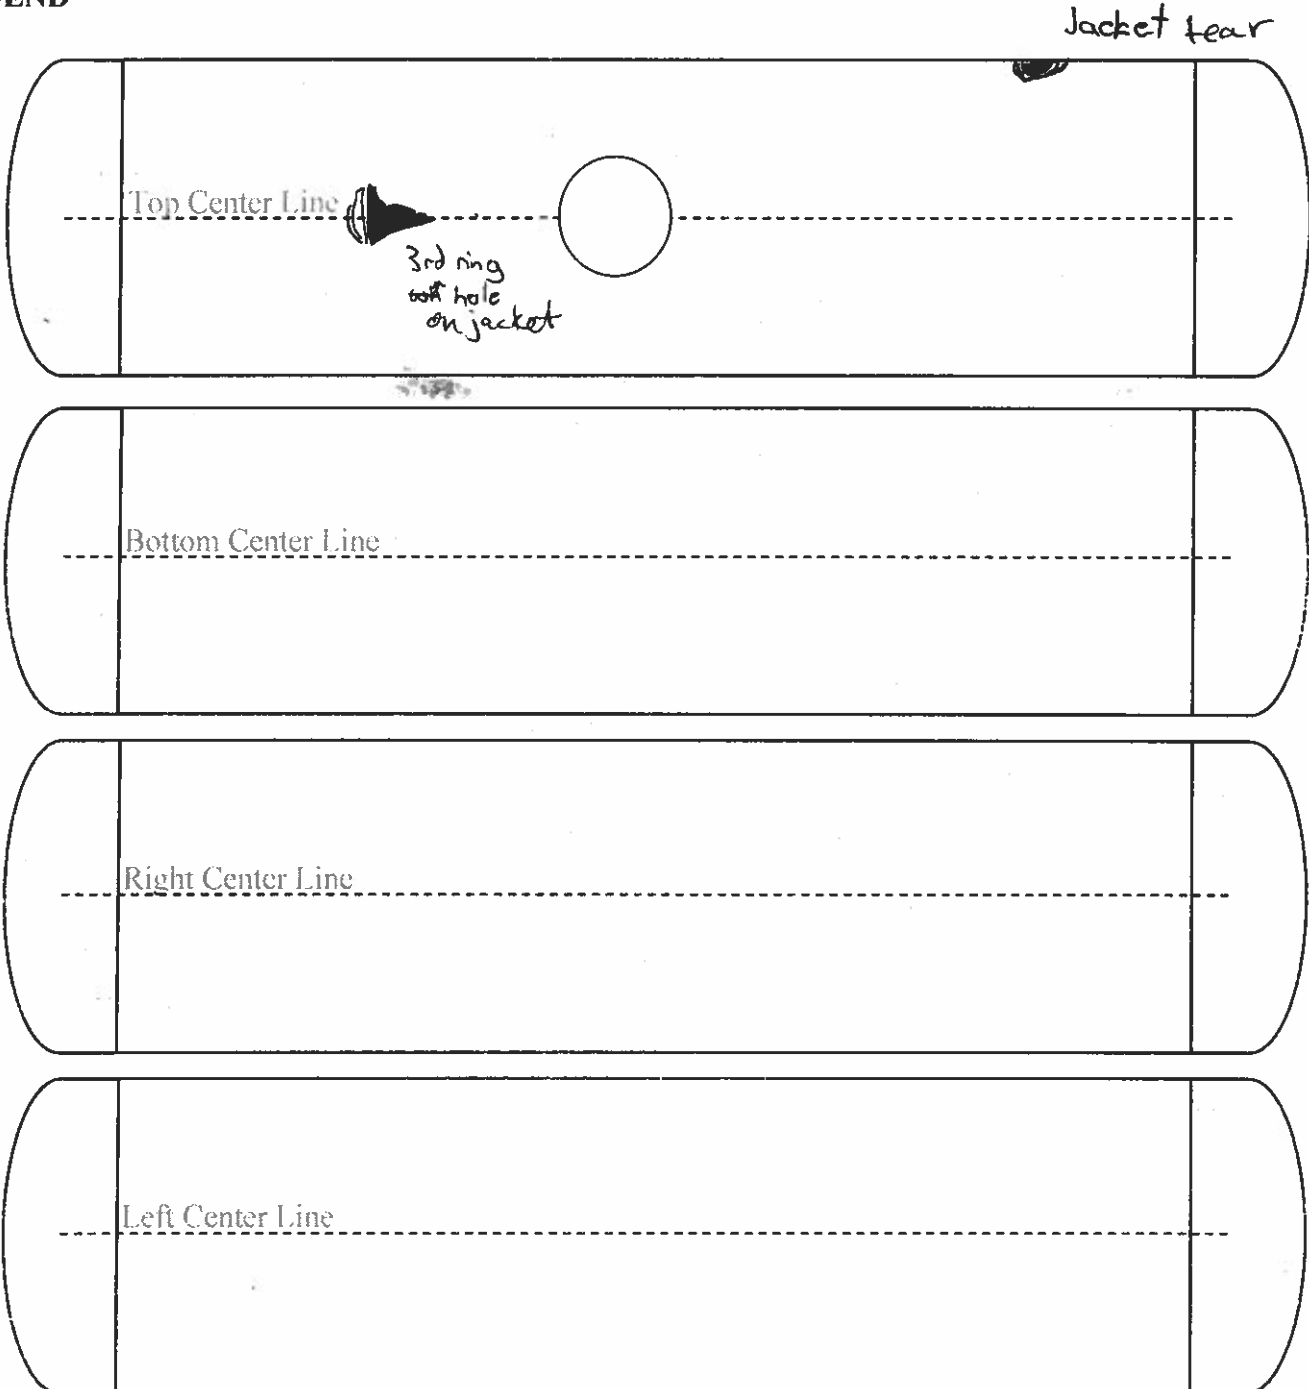
- No tear on the B-end headshield; No tear found on A-end head shield removed, just dent
- coupon of the tear taken (3ft x 3ft); Bent bolster (A-end)

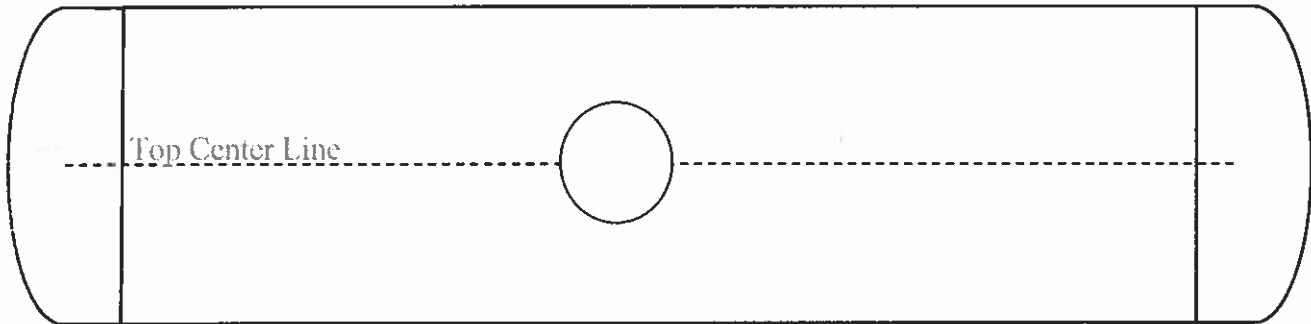
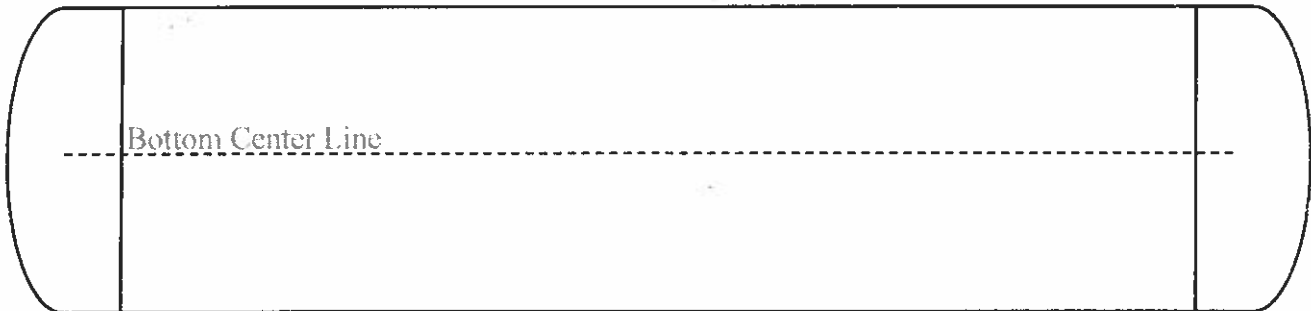
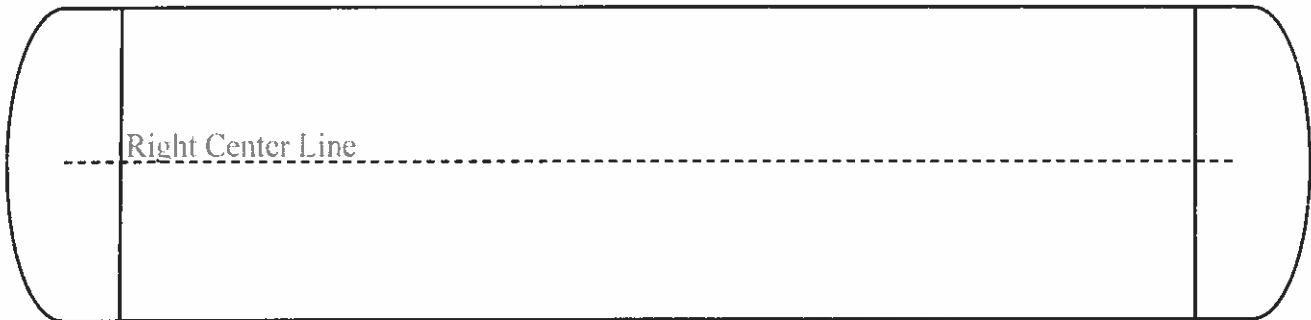
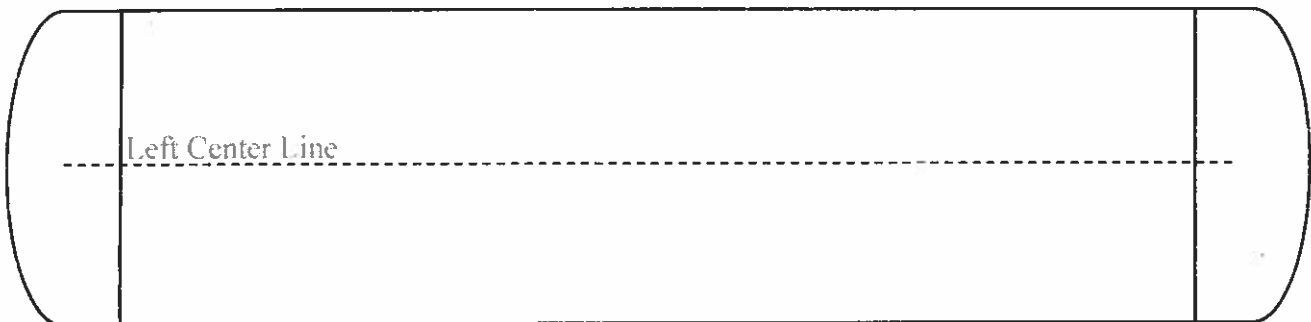
- Drone footage shows the ^{flair}car next to car # 50, which was on-fire
 - No Breach found after removing B-end headshield, large dent only
 - car was turned upside to flare off product from the housing

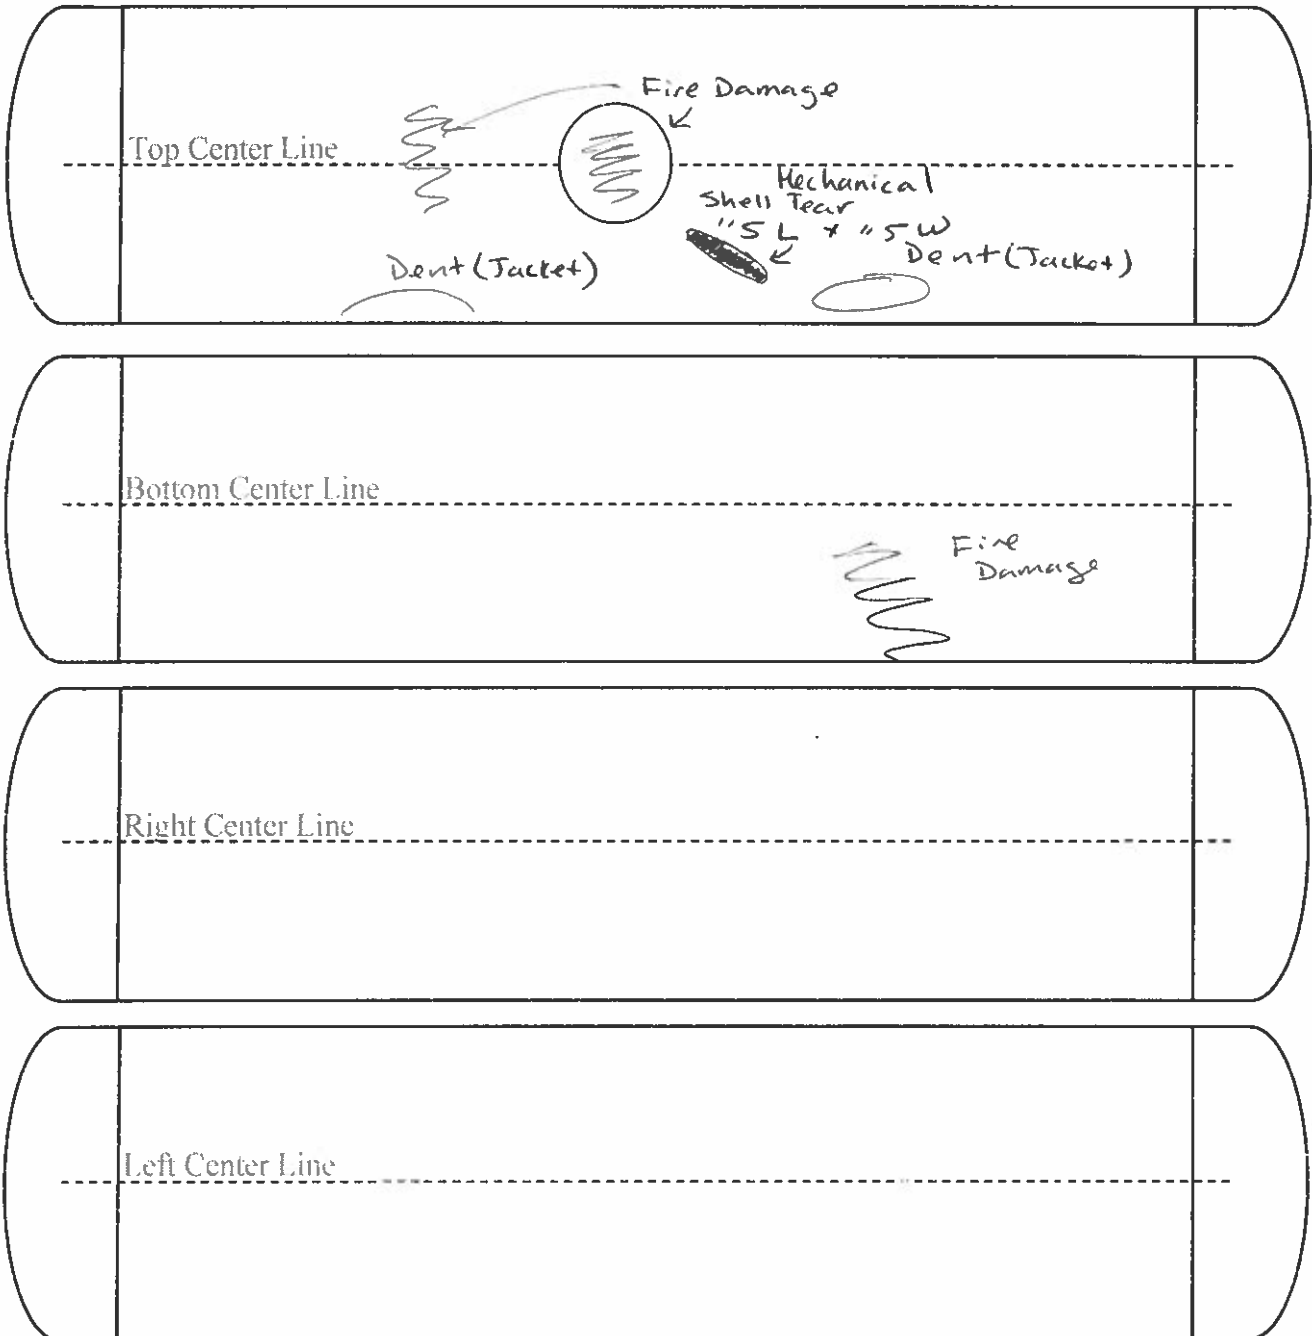
- Car was in the middle of the pileup
- belly bar cracked/busted
