Duckworth Pipeline Integrity Services, Inc.
1911 Quarterpath Drive
Richmond, Texas 77469
hnduck@houston.rr.com

To: Peter Katchmar
Fm: H. Noel Duckworth
Date: August 26, 2002

Ref: Olympic Pipeline – Bellingham, WA

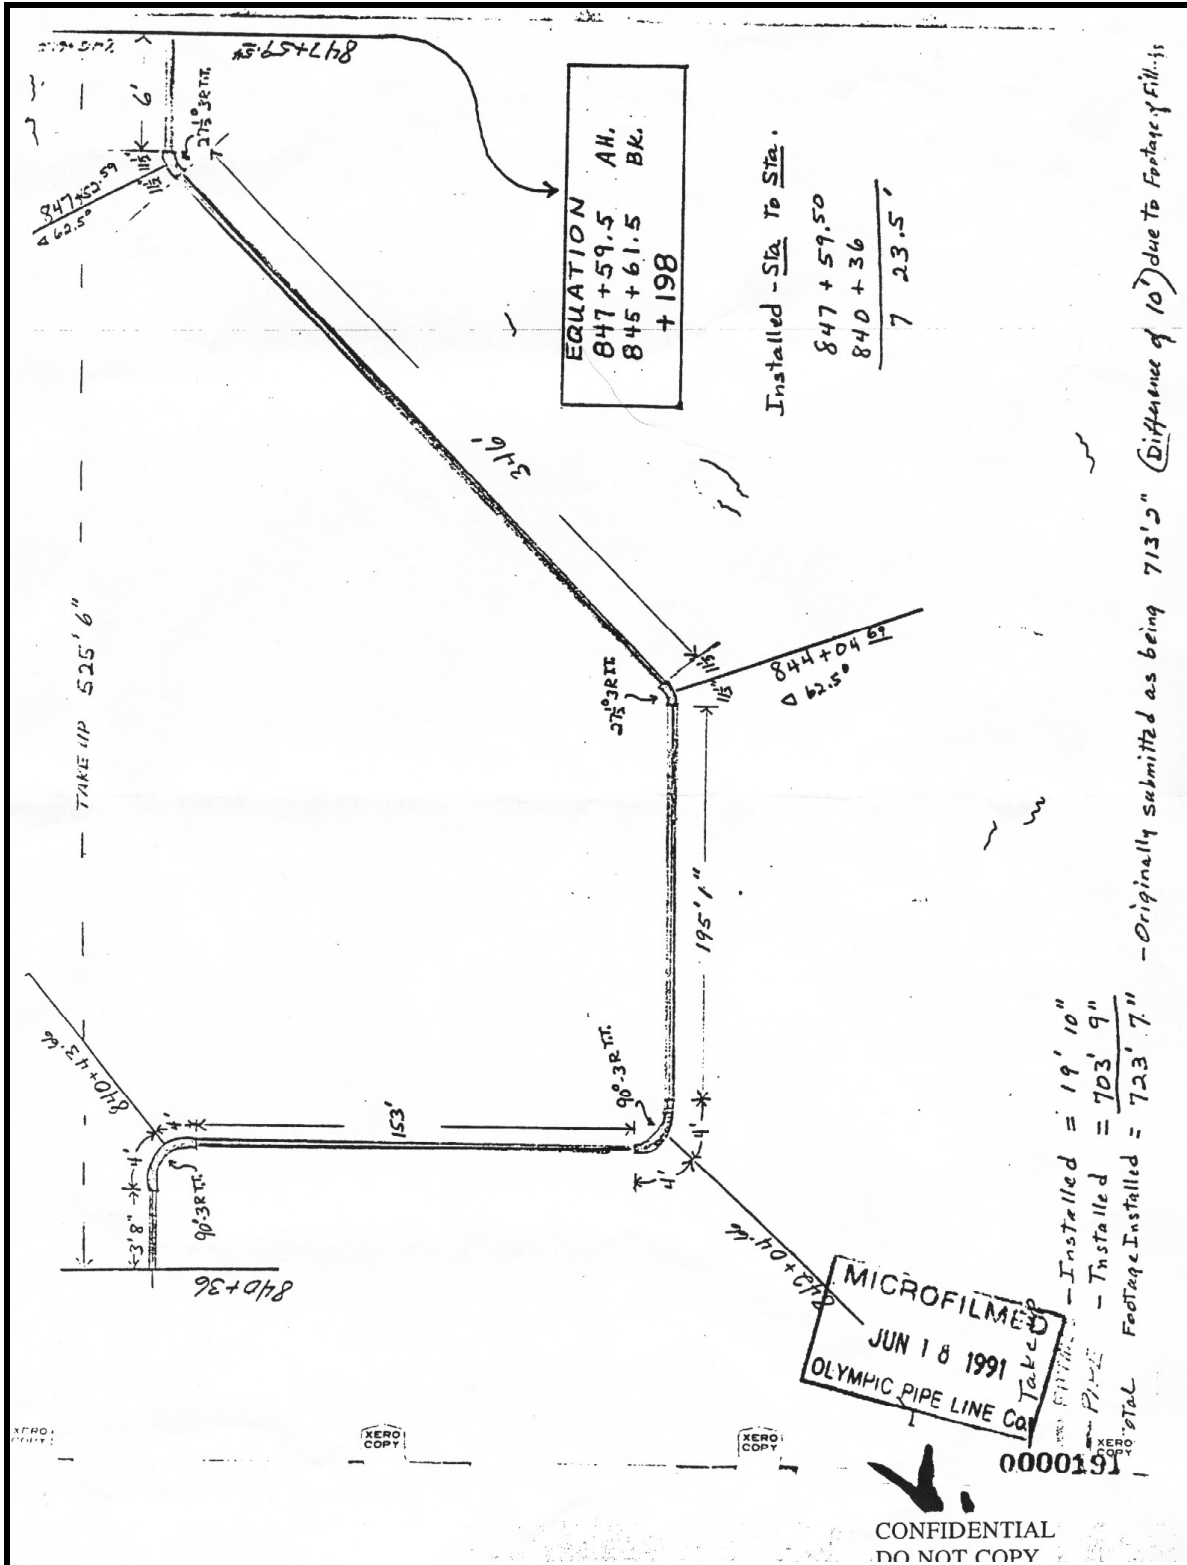
As-Built Drawing of Relocation at Bellingham Water Treatment Plant
Figure 1.

First, OPL knew exactly where the pipeline route was located in the area because they had relocated it for the proposed expansion at the City of Bellingham water treatment plant (Figure 1). At the conclusion of this relocation, OPL prepared an "as-built" drawing showing great detail as to the relocated position of the pipeline. This "as-built" drawing shows: a 3'8" pup joint beginning at OPL Station 840+36, a 90° 3R bend 8' long (*designated as "bend a" by HND for this report*) centered at OPL Station 840+43.66, a 153' straight run of pipe, another 90° 3R bend 8' long (*designated as "bend b" by HND for this report*) centered at OPL Station 842+04.66, a 195' 1" straight run of pipe, a 27.5° 3R bend 1' 11" long (*designated as "bend c" by HND for this report*) centered at OPL Station 844+04.69, a 346' straight run of pipe, another 27.5° 3R bend 1' 11" long (*designated as "bend d" by HND for this report*) centered at OPL Station 847+52, and another pup joint 6' long before the downstream tie-in point at OPL Station 847+59.54. The welds between the bends were not identified or located, so therefore, the only welds for which we know the locations are the tie-ins on each end of the relocation and the welds on either side of the four bends within the relocation. The length of each bend

is shown as measured along its arc length. The radius of curvature for the four bends is erroneously shown to be 3D (3 pipeline diameters). In 16" pipe, it would take an 8D bend to produce an arc length of 8' in a 90° bend.

The correlation of ILI data to this OPL-generated "as-built" will provide evidence as to the linear accuracy of the ILI systems employed. It will also provide confidence that the log location area corresponds to the failure location area due to the unique lengths of the bends, the approximate angle of the bends, the bend sequence, and the unique distances between the bends.

Third, the 1996 Linalog survey database "report of features and anomalies" correlates to the OPL "as-built" drawing as it relates to the tie-in welds and the bends except, the Tuboscope analyst erroneously identified the bends as being sleeves. These are clearly bends and not sleeves. It is obvious that OPL concluded that these were bends and they included them as such on their dig sheet (Bates # 0000082). I consider this to be a reasonable deduction on the part of OPL and it is not one that would be prudently made without looking back in the records to confirm the presence of bends and the lack of evidence that there were sleeves at those locations. This 1996 survey also confirmed the Tap found in the 1991 survey.

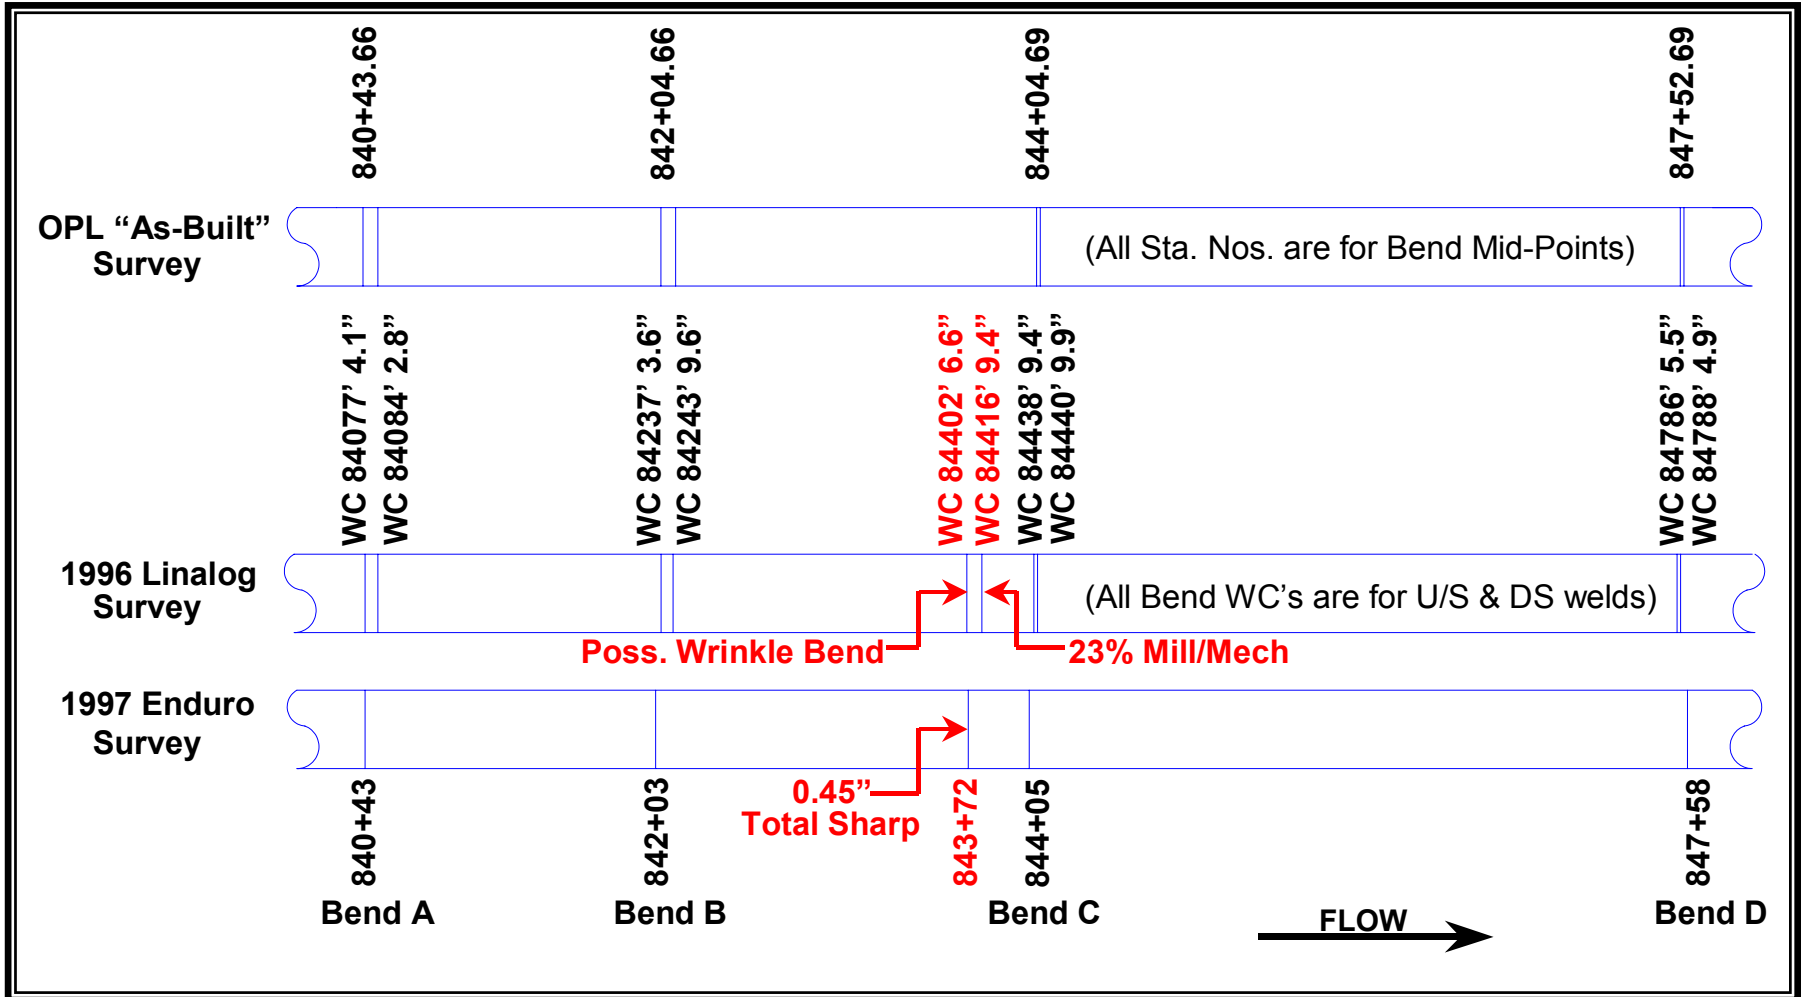
Scenario 1

In Scenario 1., attached, I have aligned the station at Bend A on Enduro to the upstream weld of the same bend on the 1996 Linalog and in that case, the 0.45" Total Sharp reasonably aligns with the Possible Wrinkle Bend at WC 84402' 6.6" which we know to be the origin of failure. In Scenario 2., attached, I have aligned the station at Bend A on Enduro to the downstream weld of the same bend on the 1996 Linalog and in that case, the 0.45" Total Sharp reasonably aligns with the 23% metal loss at WC 84416' 9.4". Note how closely the Linalog data correlates to the "as-built" survey and how poorly, relatively speaking, the Enduro data correlates to the "as-built" data, regardless of which scenario you choose.

* Assumption: The Enduro Station # for Bend A is aligned with the upstream weld of Bend A on the Linalog Survey.

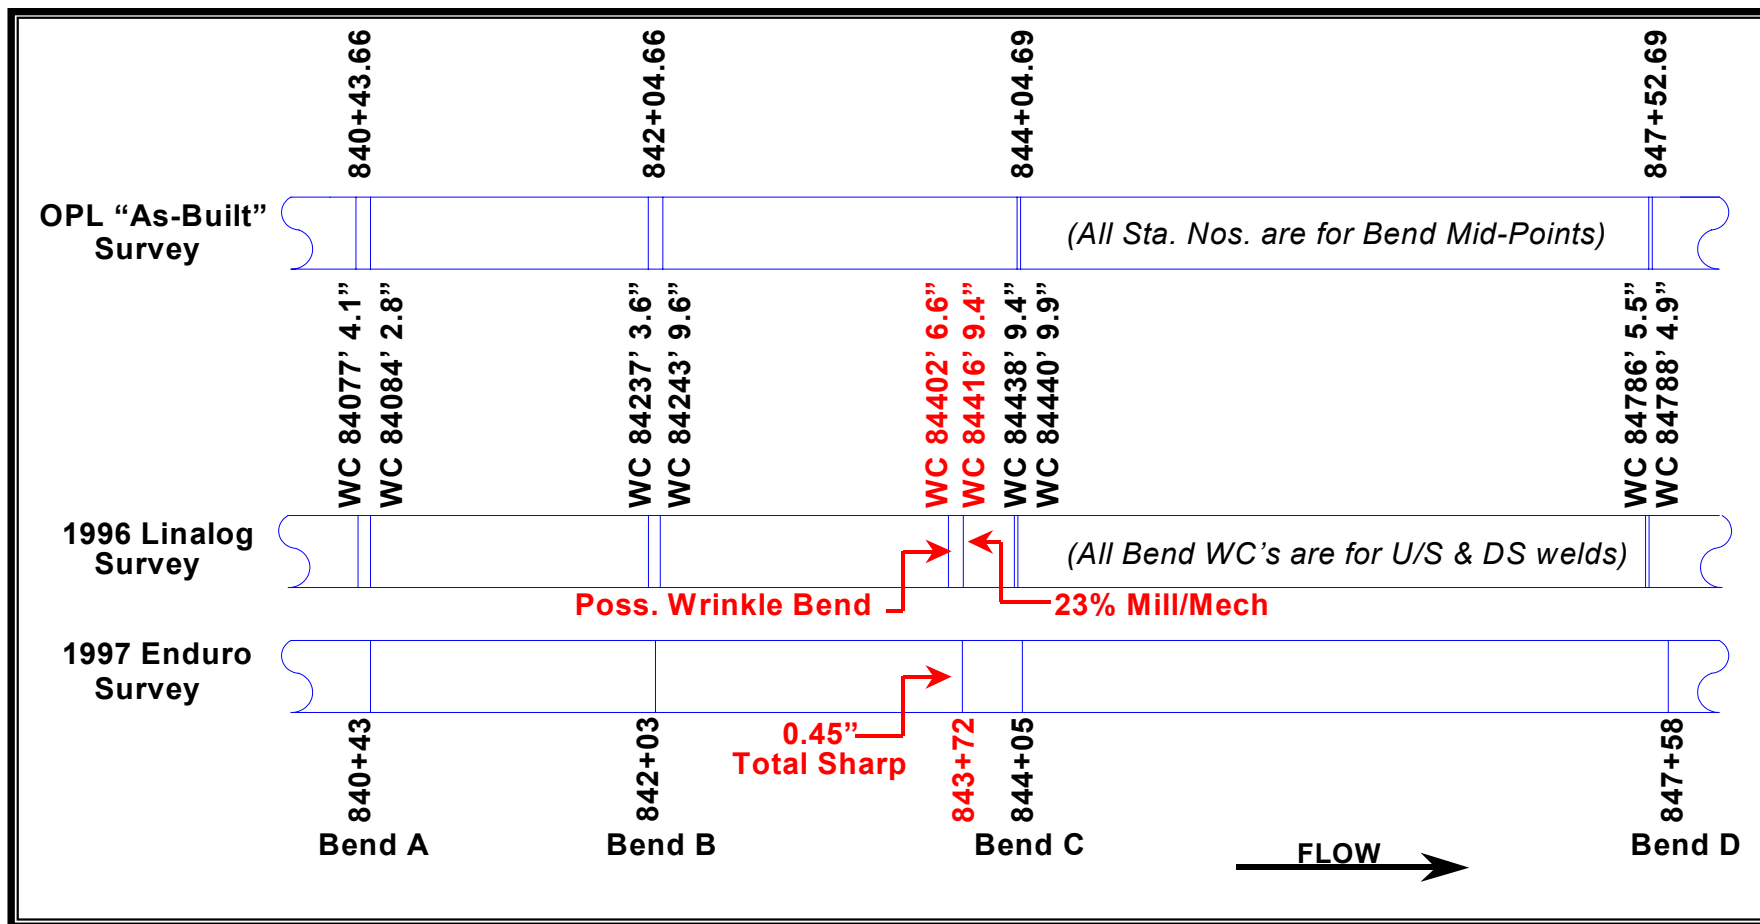
Scenario 2

* Assumption: The Enduro Station # for Bend A is aligned with the downstream weld of Bend A on the Linalog Survey.
