NTSB Aviation Accident Final Report - Accident no. ANC15FA049

FAA Petition for Reconsideration to NTSB  
for  
NTSB case no. ANC15FA049

# National Transportation Safety Board Aviation Accident Final Report

<b>Location:</b>	Juneau, AK	<b>Accident Number:</b>	ANC15FA049
<b>Date &amp; Time:</b>	07/17/2015, 1318 AKD	<b>Registration:</b>	N62AK
<b>Aircraft:</b>	CESSNA 207A	<b>Aircraft Damage:</b>	Substantial
<b>Defining Event:</b>	Controlled flight into terr/obj (CFIT)	<b>Injuries:</b>	1 Fatal, 4 Serious
<b>Flight Conducted Under:</b>	Part 135: Air Taxi & Commuter - Scheduled

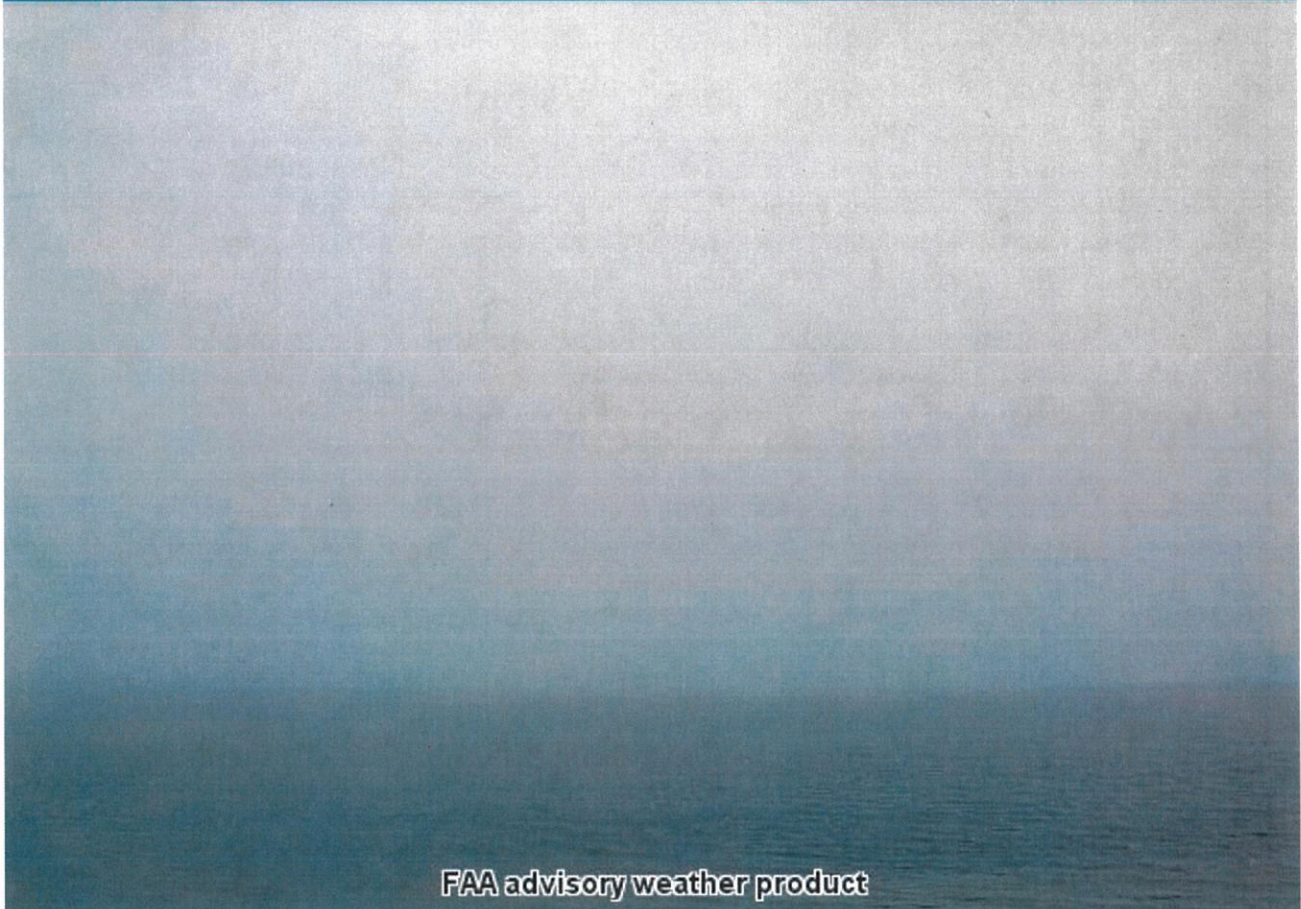
Figure. A video camera image showing visibility conditions at Juneau Airport about 5 minutes before the estimated accident time, facing the direction of the accident location.
