**AUTOMATION AND DATA SUMMARY
FACTUAL REPORT**

Mountain View, CA

HWY18FH011

Location: Southbound US Highway 101 (US-101) south of North Shoreline Boulevard at the exit ramp transition to State Route 85 (SR-85), milepost 48.38, Santa Clara County, Mountain View, California.

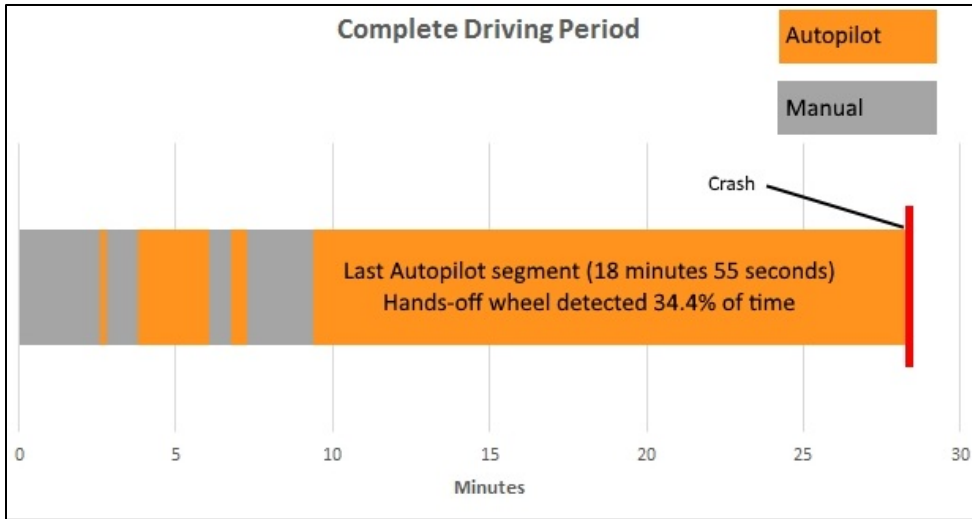
Carlog data shows that the ignition cycle that preceded the crash lasted about 28 minutes and 33 seconds. Autopilot was engaged for a total of 21 minutes and 53 seconds during the last ignition cycle (see figure 5). During the final Autopilot segment, the system did not detect driver-applied steering wheel torque for 34.4 percent of the time.

Figure 5. Depiction of manual and Autopilot controlled operation of the Tesla during the crash trip.

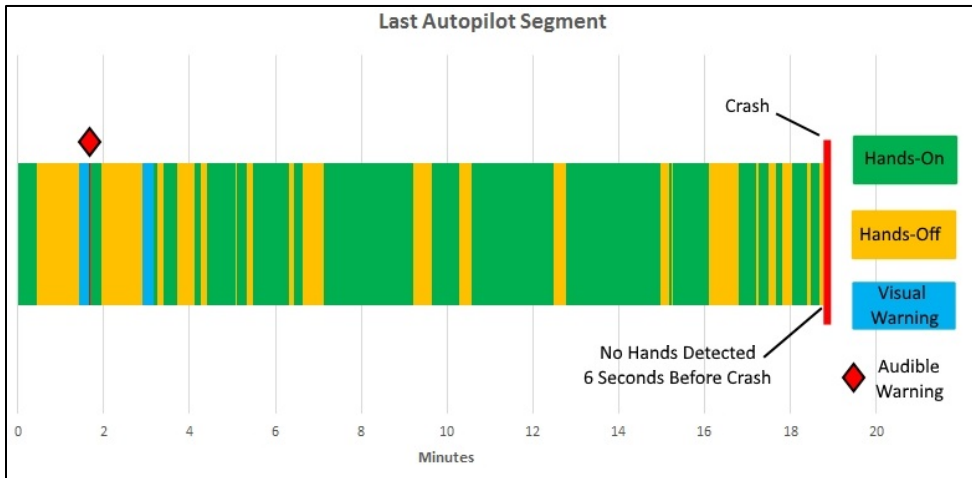
The driver had Autopilot engaged continuously for the final 18 minutes and 55 seconds of the crash trip, including the time of the crash. During this last Autopilot segment, the system issued two visual alerts for hands-off driving operation and one first level auditory alert (see figure 6).

Figure 6. Depiction of the last Autopilot segment of the crash trip, including the warnings for hands-off driving operation.

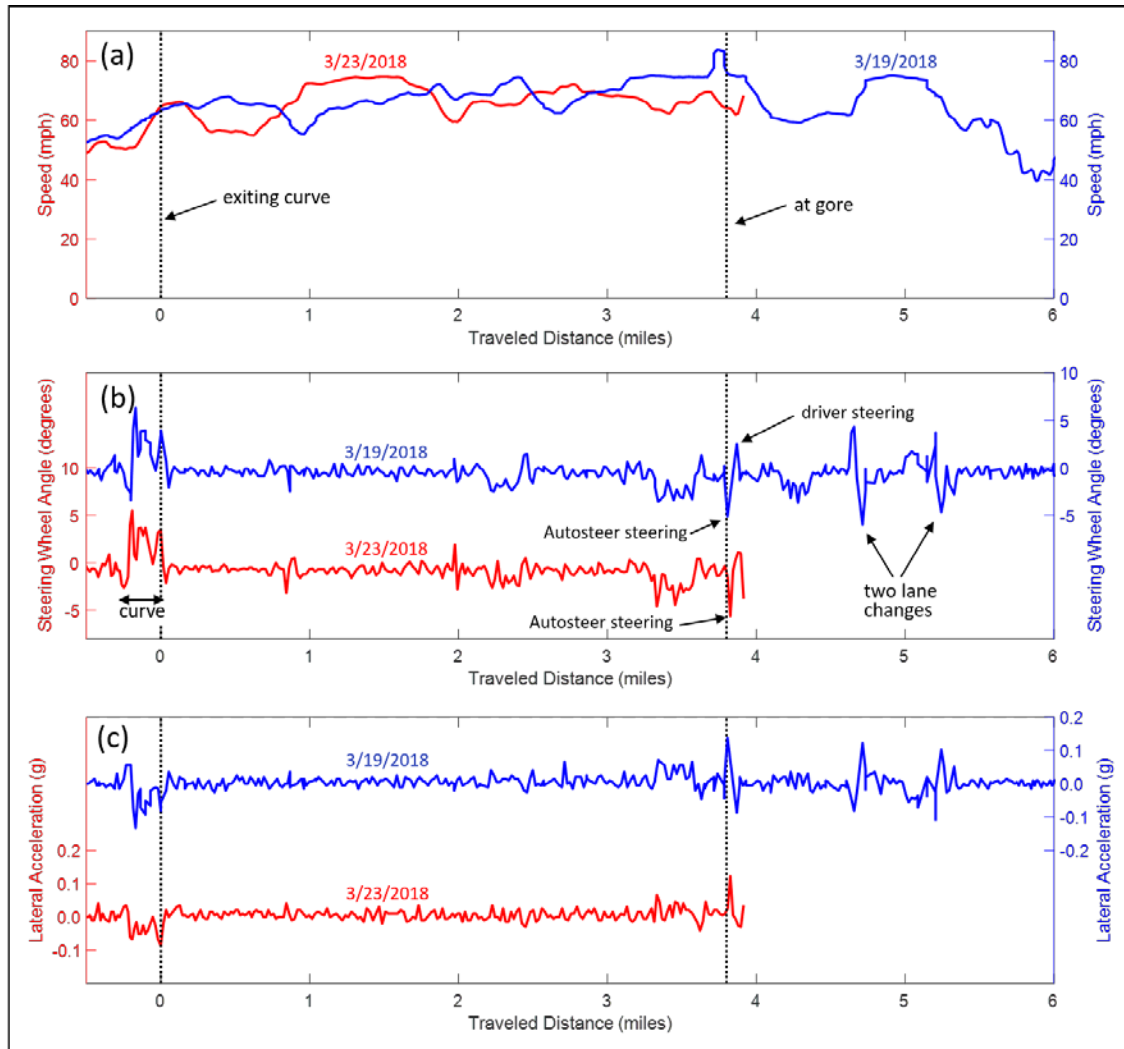
a text message was provided to the NTSB showing that the Tesla driver reported Autopilot steering the Tesla toward the gore area that morning.¹⁹

Figure 7. Data from the Tesla Model X Carlogs on March 19 and March 23 showing the similarity between the Autosteer actions while traveling in the vicinity of the gore area.

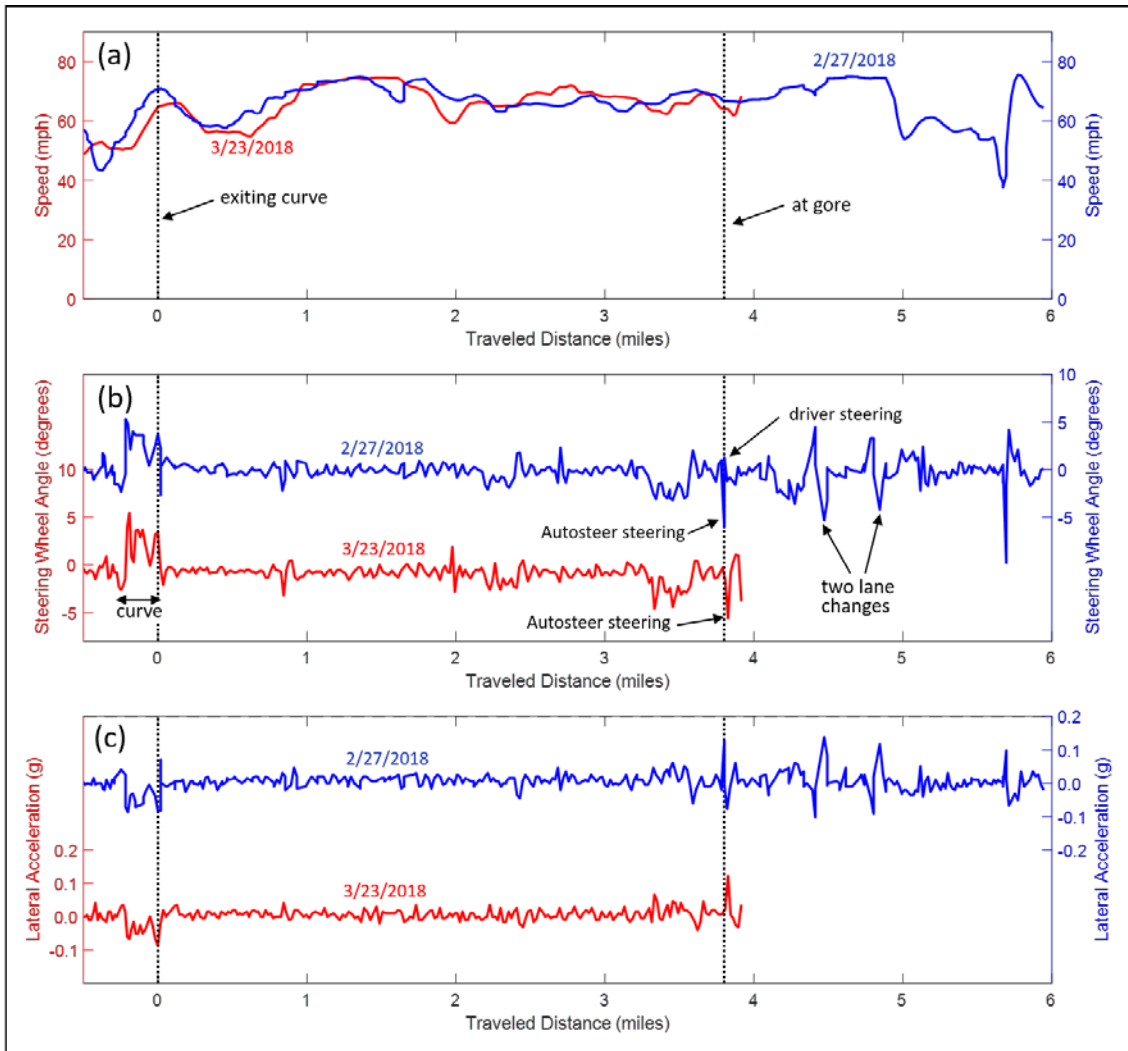
Another similar incident was identified in the Carlog data for February 27, 2018. At about 9:31:30, the Tesla was traveling at 66.95 mph, following a lead vehicle at about 83.7 feet (0.85 second following time). The Tesla was being operated with Autopilot activated and the driver's hands were detected on the steering wheel. Autosteer applied a -6° steering wheel angle toward the gore area, which was followed two seconds later by a $+1.3^{\circ}$ corrective steering wheel angle away from the gore area (see Figure 8).

Figure 8. Data from the Tesla Model X Carlogs on February 27, 2018 and March 23, 2018 showing the similarity between the Autosteer actions while traveling in the vicinity of the gore area.
