NATIONAL TRANSPORTATION SAFETY BOARD
OFFICE OF AVIATION SAFETY
WASHINGTON, D.C. 20594

POWERPLANTS GROUP CHAIRMAN'S FACTUAL REPORT

NTSB ID No.: ERA20MA001

Location: Bradley International Airport, Windsor Locks, Connecticut
Date: October 2, 2019
Time: 0953 eastern daylight time
Aircraft: Boeing B-17G, N93012, Collings Foundation

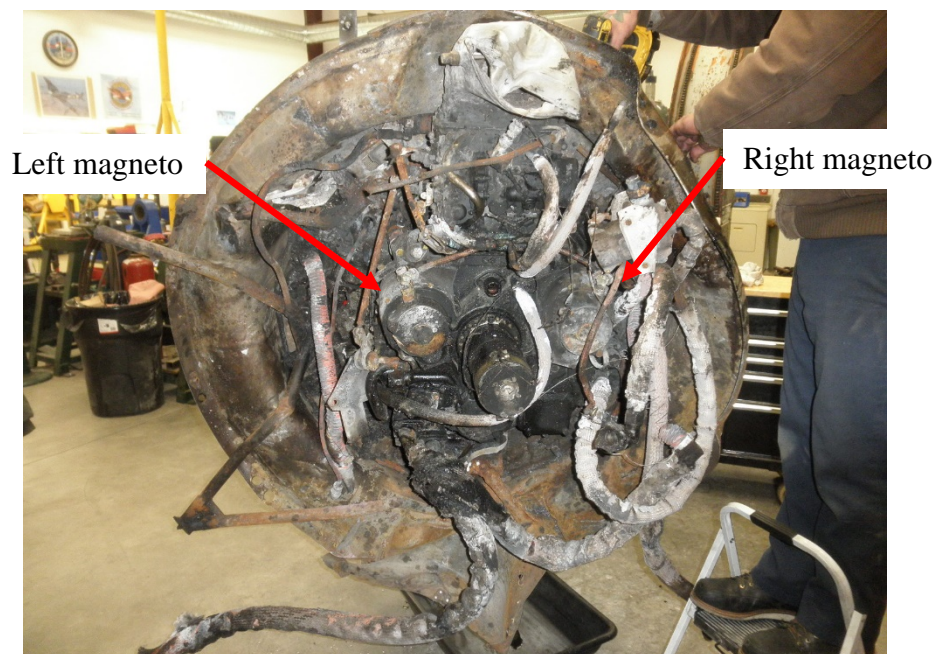
The left and right magnetos were still in place on the rear of the engine. (Photo No. 1) The left and right magnetos' serial numbers were D7384 and CC-44131, respectively. The left magneto's P-lead was pulled out of its fitting. The left and right magnetos' P-leads were both safety wired to their respective housings with a single strand of safety wire that was loose. The right magneto's P-lead was still in place, although it was partially pulled out of its fitting. (Photos Nos. 2 and 3) According to the maintenance instructions, the magnetos' P-leads should be secured with a clip rather than safety wire. The left magneto's lead had pulled out of the swaged fitting causing the magneto to internally ground when the grounding tab contacted the housing. (Photo No. 4) The right magneto's grounding tab had a gap between the tab and the magneto's housing. (Photo No. 5) It appeared that the safety wire was being used to hold the P-leads in position to the fittings.

Photo No. 1: View of the rear of the No. 4 engine showing the left and right magnetos were still in place.

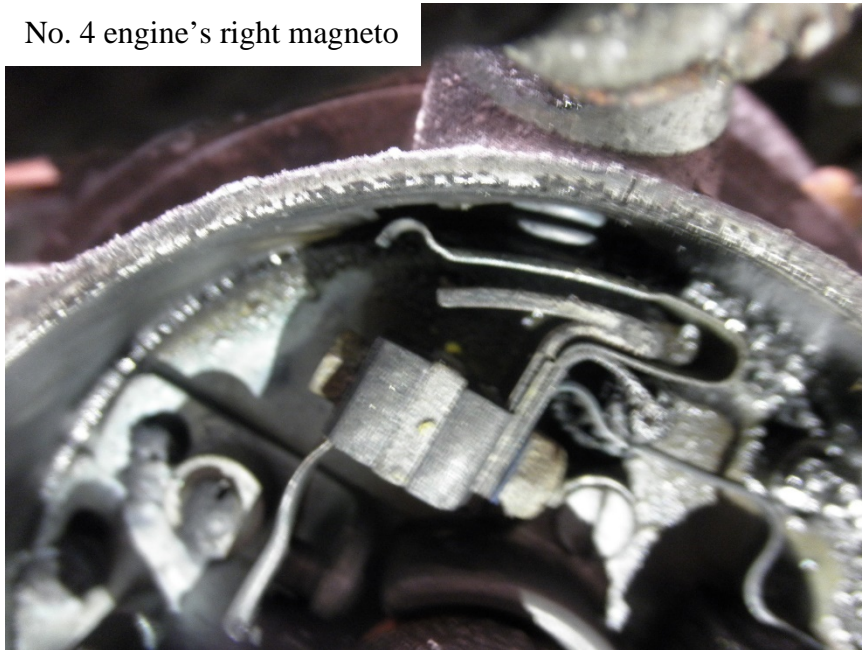
Photo No. 5: Close up view of No. 4 engine's right magneto showing grounding tab separated from the housing wall.

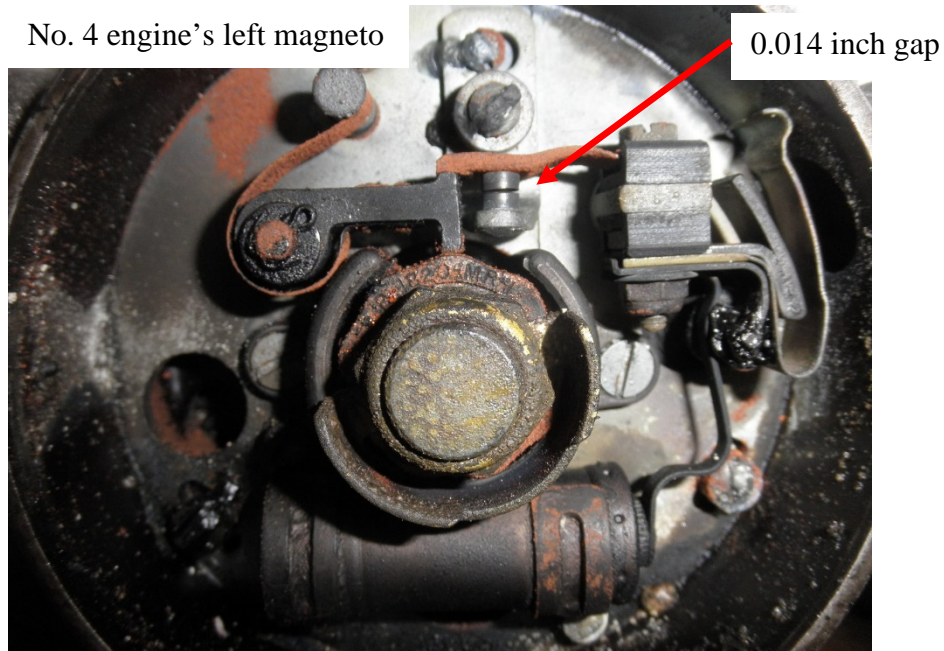
When the left magneto's drive shaft was rotated, the cam follower would open and close the points. The gap when the points were open was measured with a feeler gauge⁸ and found to be 0.014 inches. (Photo No. 6) When the right magneto's drive shaft was rotated, the

gap when the points were open was measured and found to be 0.006 inches. (Photo No. 7) The gap should be 0.008 to 0.010 inches.

Photo No. 6: Close up of the No. 4 engine's left magneto points showing a gap of 0.014 inches.

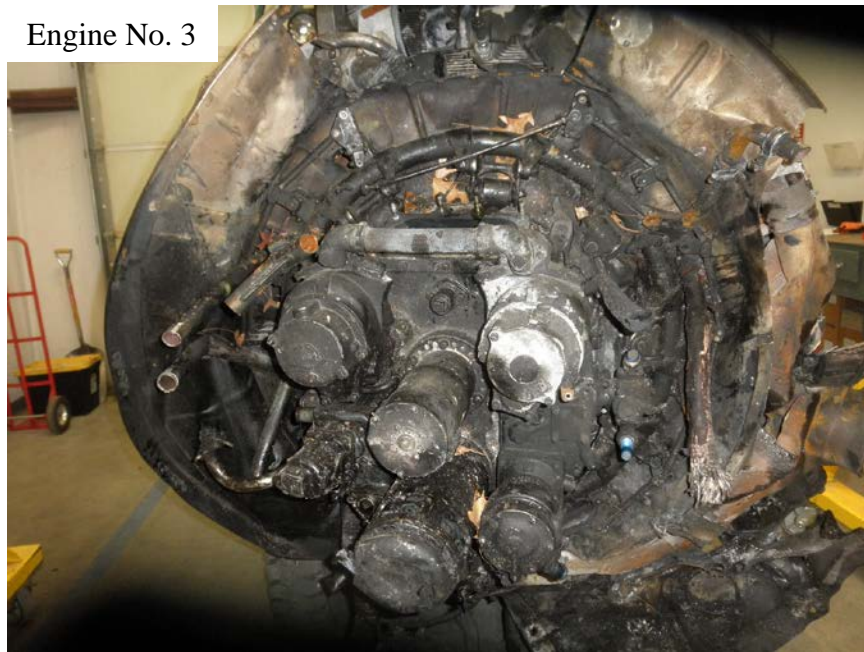
Engine No. 3

Photo No. 39: View of rear of No. 3 engine showing sooting, hose with charred and burned heat resistant covering, and accessories bent to the left.

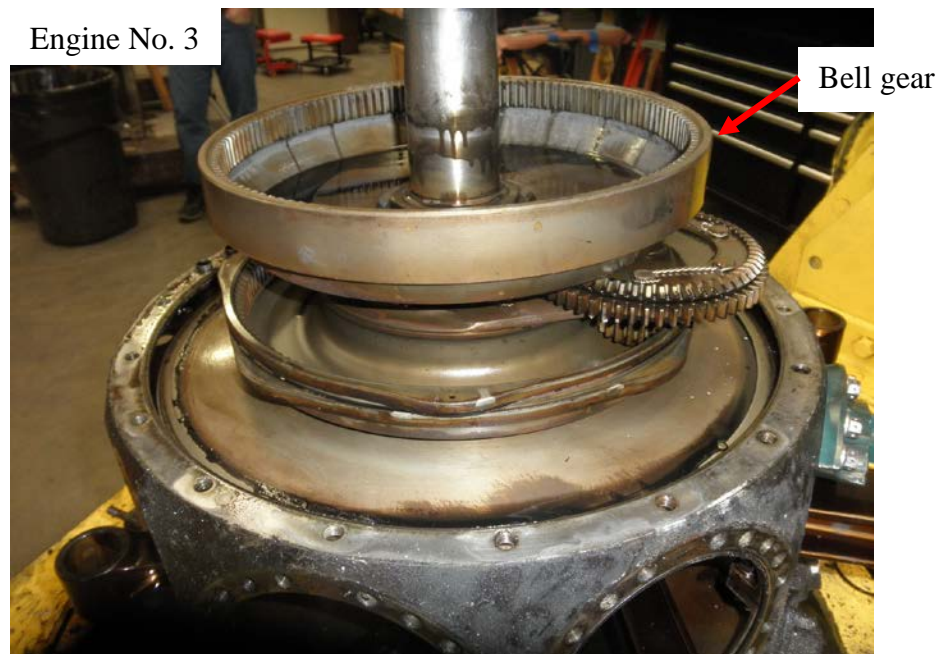
Photo No. 40: View of the bell gear showing that it was intact and had no rotational damage to the gear teeth.

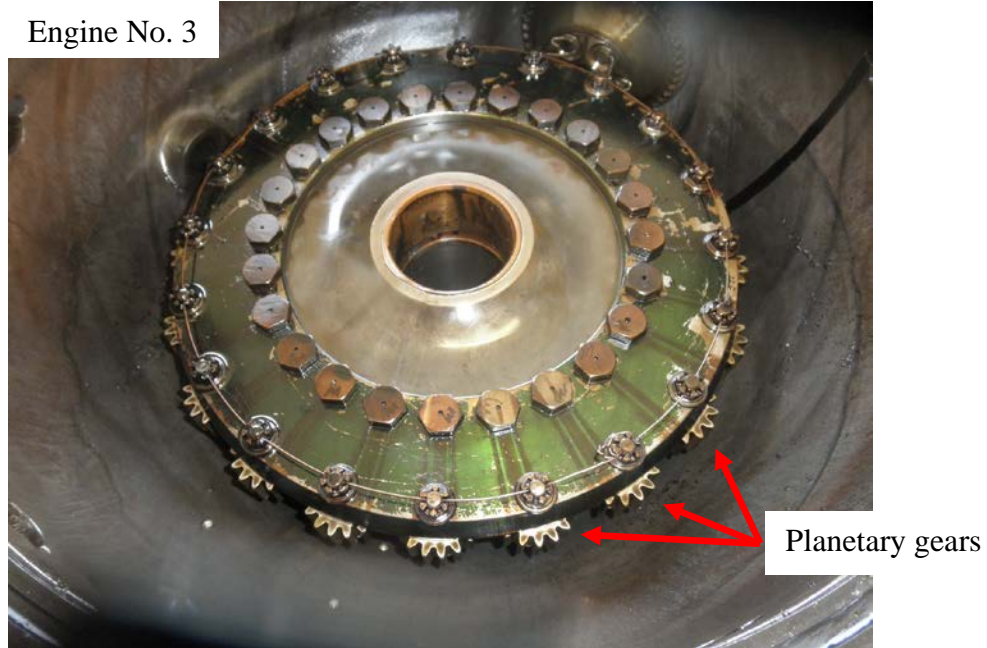
Engine No. 3

Photo No. 41: View of the planetary gear carrier showing it was intact and all of the planetary gears were in place.

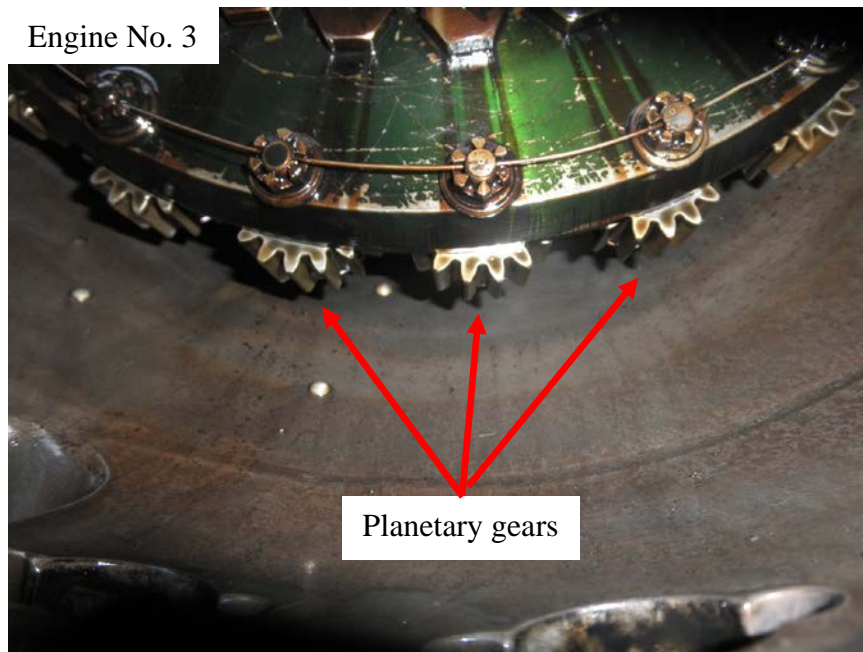
Engine No. 3

Photo No. 42: Close up of the planetary gears showing that they were intact and there was no damage to the gear teeth.

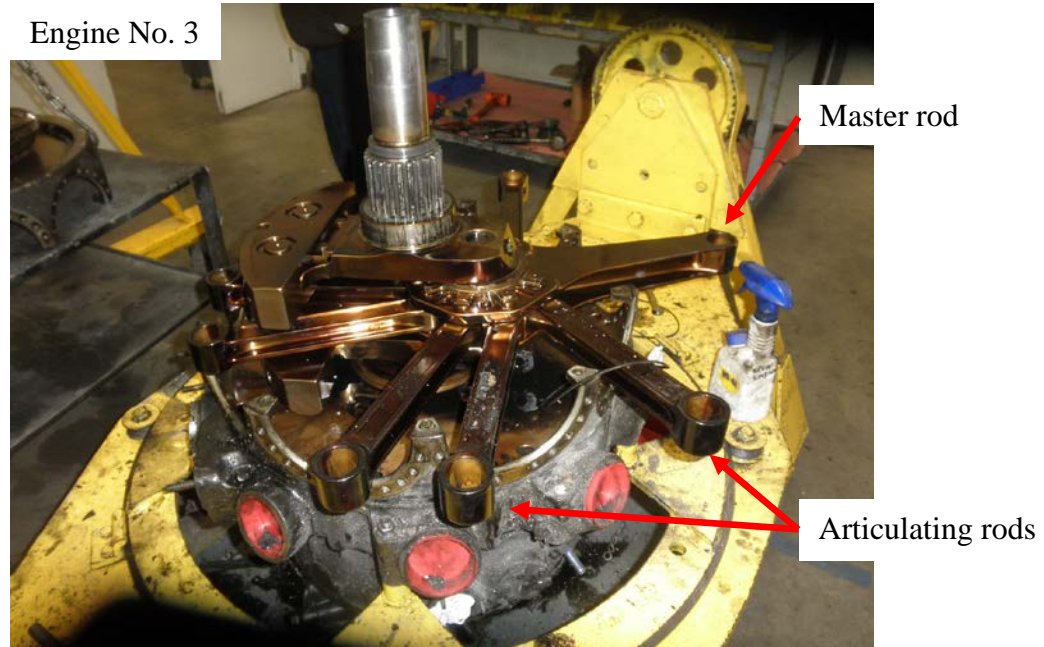
Photo No. 45: View of the crankshaft showing it and the master rod were intact with the counterweights and all of the articulating rods were in place and undamaged.

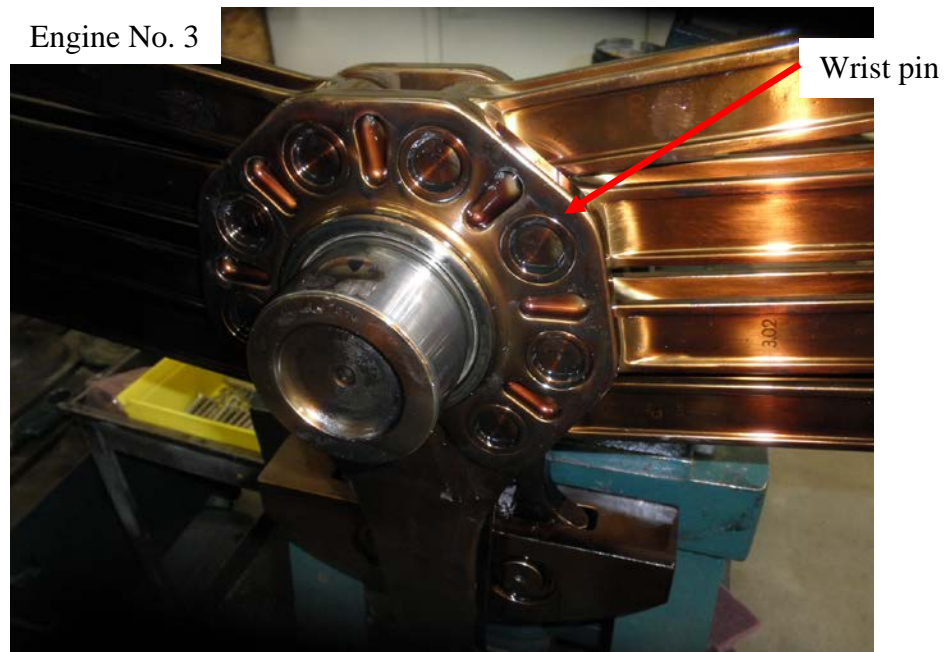
Photo No. 46: Close up crank shaft showing all of the wrist pins were in place with no damage.

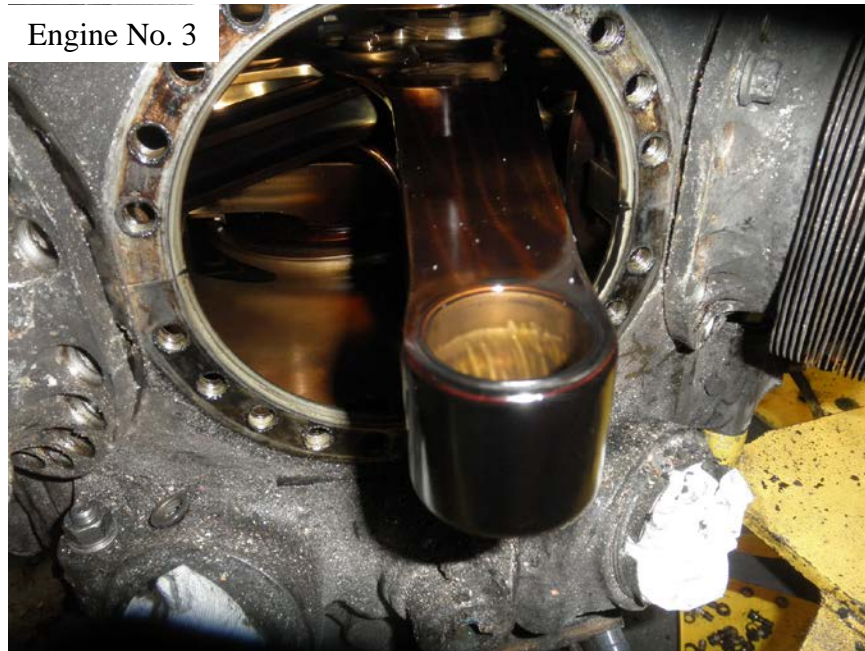
Photo No. 49: Close up view of the master rod piston pin bearing surface showing that it was not damaged.

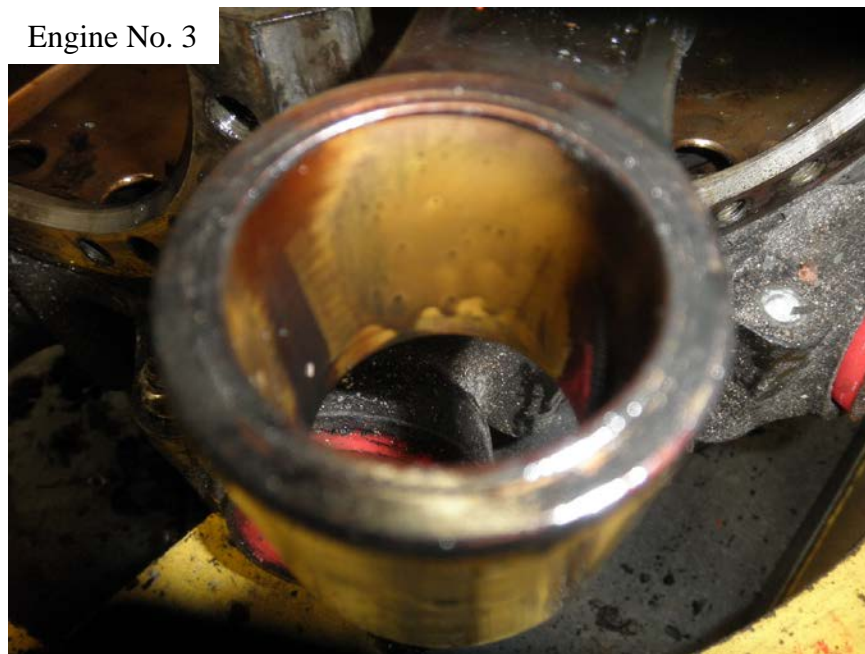
Photo No. 50: Close up of a typical articulating rod piston pin bearing surface showing that it was not damaged.

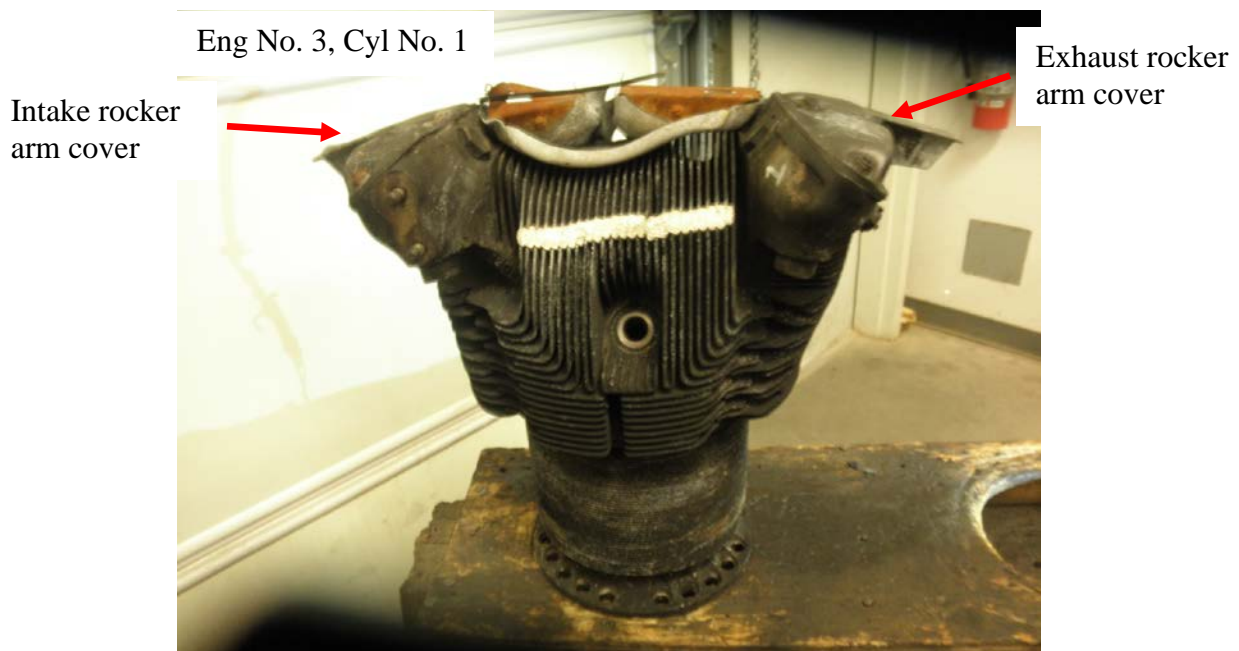
Photo No. 51: View of front of No. 1 cylinder showing it was intact with the head in place and intact, and the intake and exhaust rocker arm covers were in place.

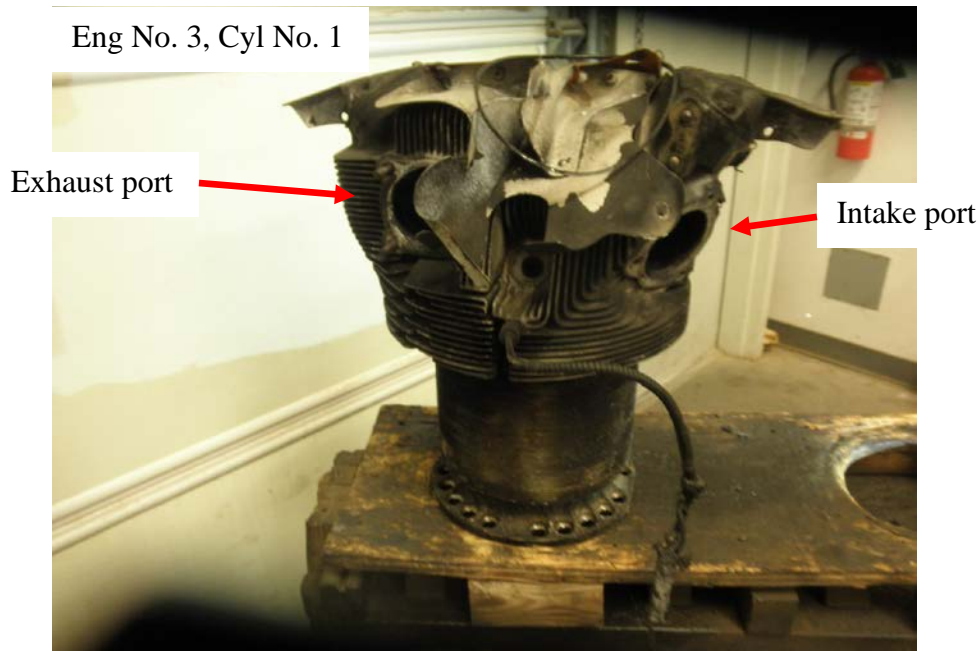
Photo No. 52: View of rear of No. 1 cylinder showing it was intact with the head in place and intact, and the intake and exhaust rocker arm covers were in place. The exhaust and intake ports are identified.

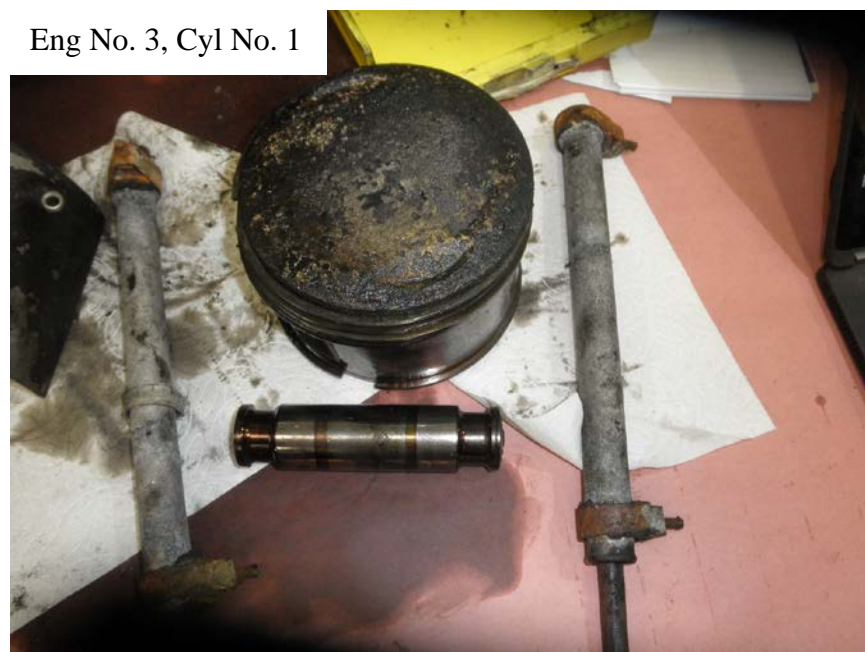
Photo No. 53: View of No. 1 cylinder's piston, piston pin, and push rod shrouds.

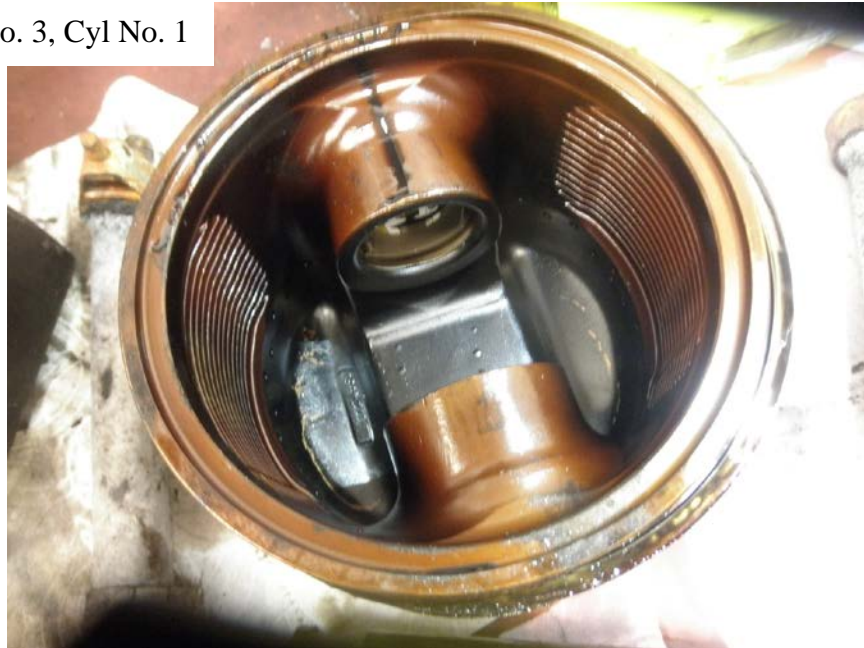
Eng No. 3, Cyl No. 1

Photo No. 55: Close up view of underside of No. 1 cylinder's piston showing no damage.

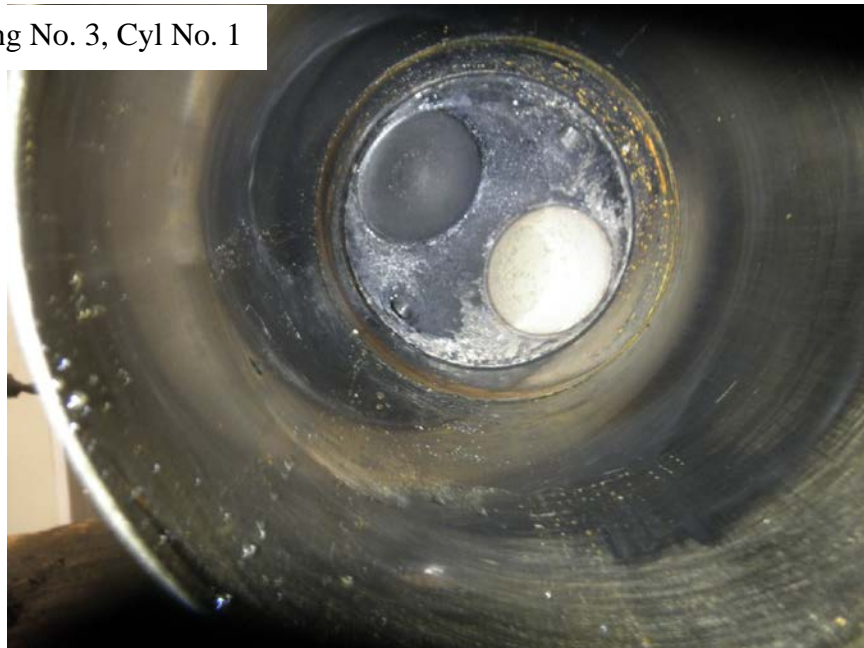
Eng No. 3, Cyl No. 1

The cylinder barrel was intact and the inner surface did not have any damage. There were a few metal fragments on the wall of the cylinder barrel. The two valves were in place in the closed position centered on the valve seats. (Photo No. 57)

Photo No. 57: View of the inside of the No. 1 cylinder showing no damage to the barrel and the two valves centered in place in the close position.

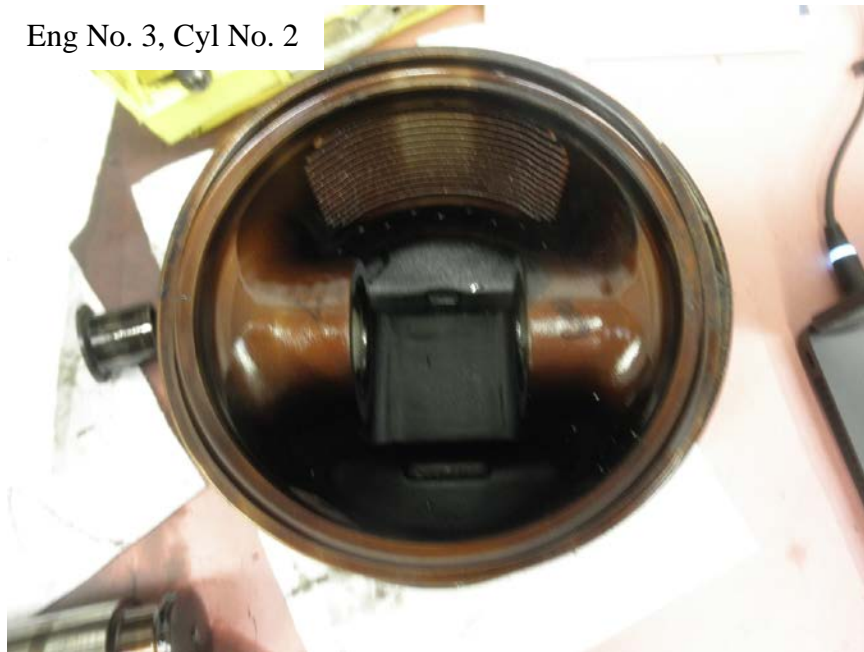
Eng No. 3, Cyl No. 2

Photo No. 63: Close up of underside of No. 2 cylinder's piston showing no damage.

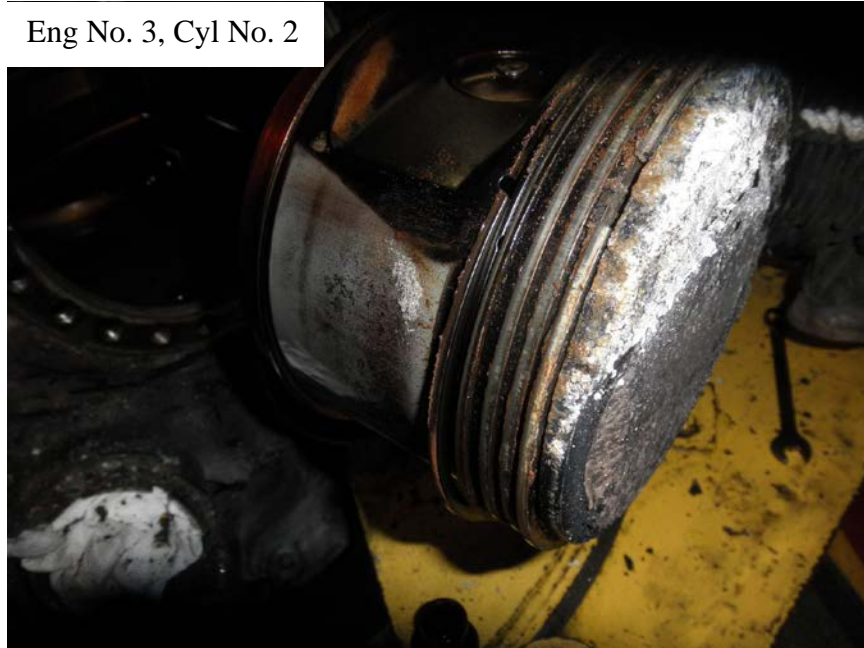
Eng No. 3, Cyl No. 2

Photo No. 64: Close up view of side of No. 2 cylinder's piston showing the rings were in place.

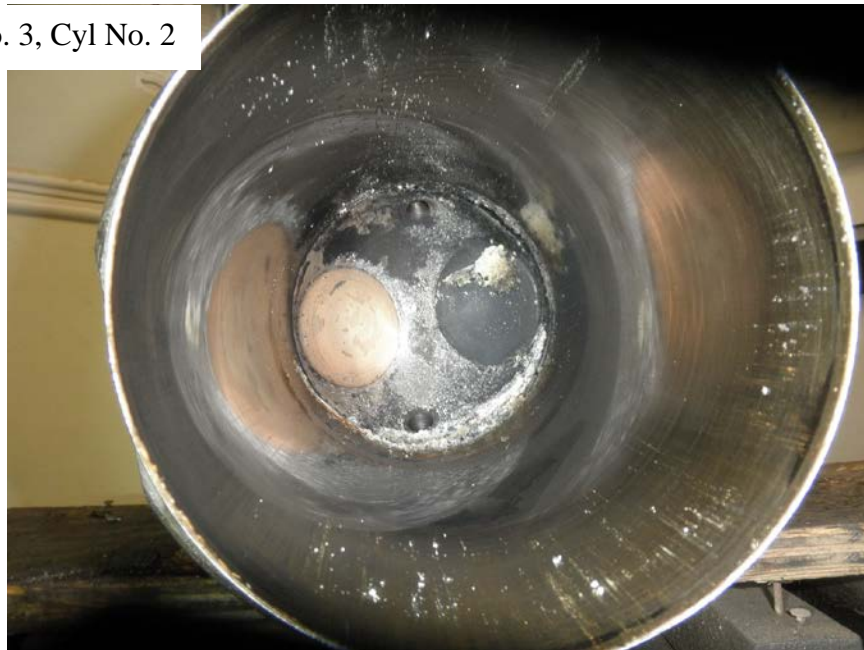
Eng No. 3, Cyl No. 2

The cylinder barrel was intact and the inner surface did not have any damage. The two valves were in place in the closed position centered on the valve seats. (Photo No. 65) The valves did not have any damage.

Photo No. 65: View of the inside of the No. 2 cylinder showing no damage to the barrel and the two valves centered in place in the closed position.

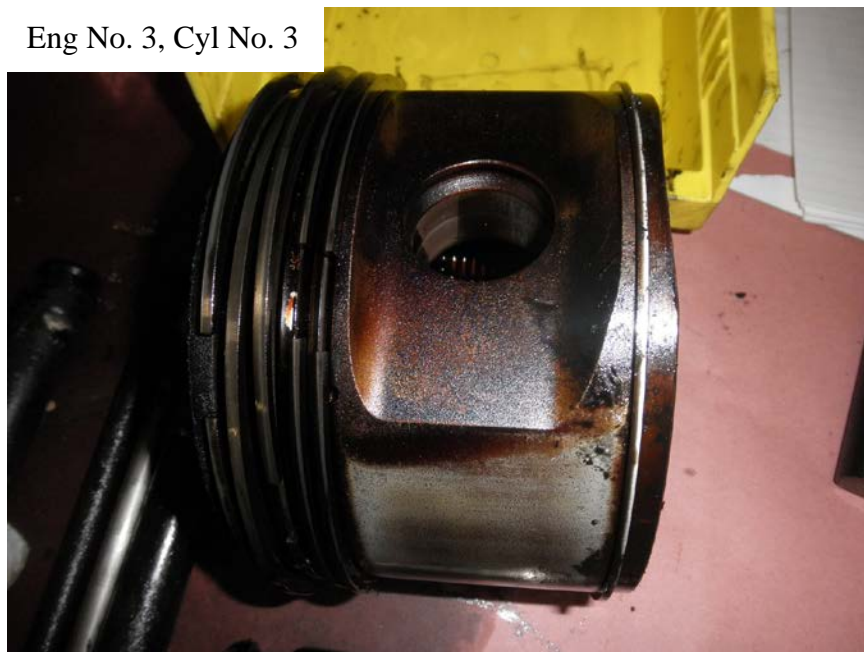
Eng No. 3, Cyl No. 3

Photo No. 71: Close up view of the side of the No. 3 cylinder's piston showing the rings were in place.

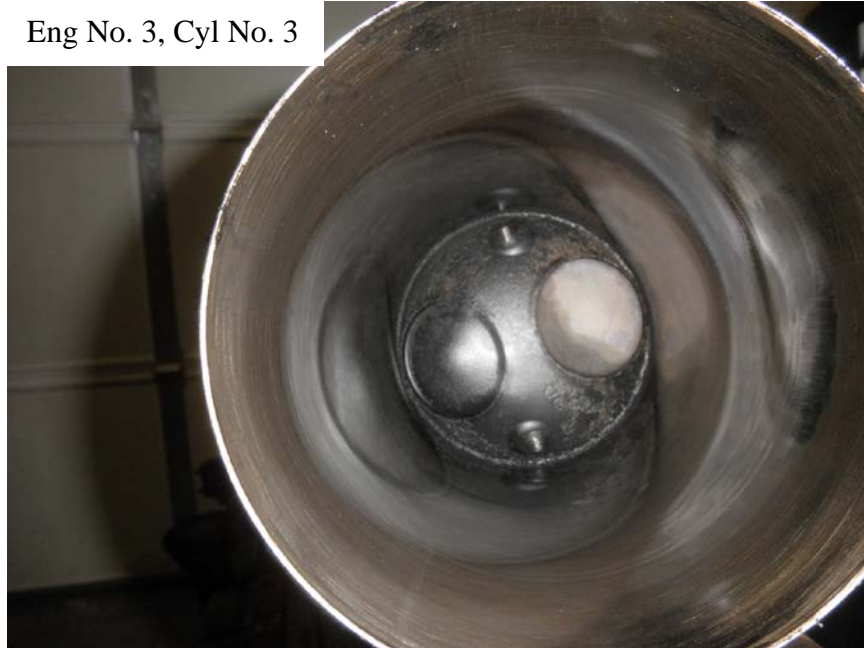
Eng No. 3, Cyl No. 3

The cylinder barrel was intact and the inner surface did not have any damage. The dome of the cylinder was black in color. The two valves were in place in the closed position centered on the valve seats. (Photo No. 72) The valves did not have any damage.

Photo No. 72: View of the inside of the No. 3 cylinder showing no damage to the barrel and the valves centered in the closed position.

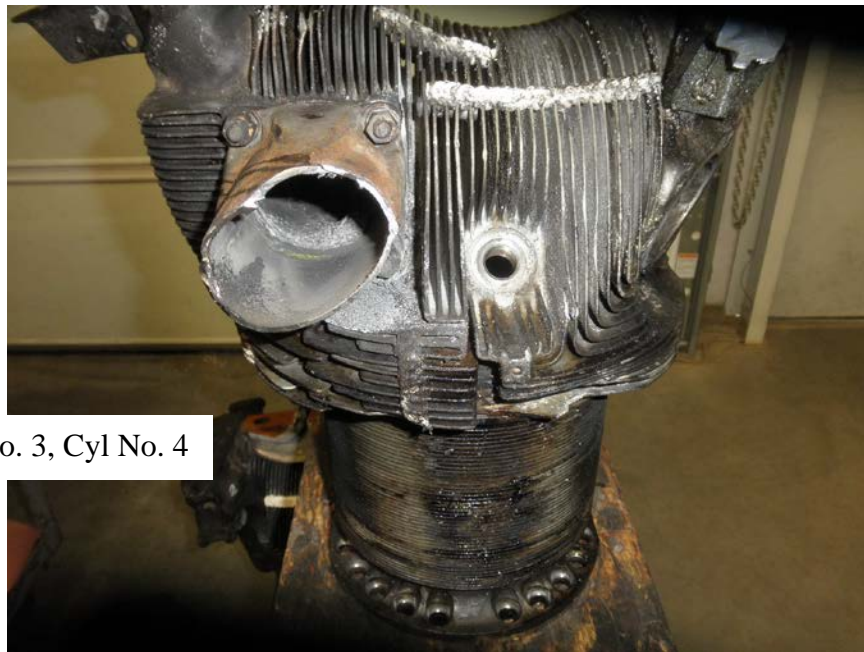
Photo No. 74: View of rear of No. 4 cylinder showing it was intact with the head in place and intact.

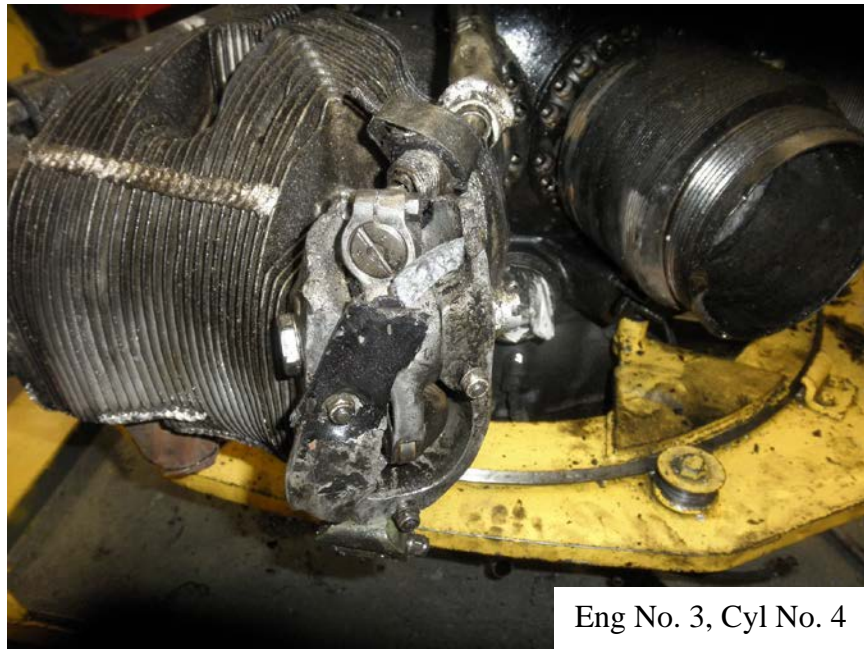
Eng No. 3, Cyl No. 4

Photo No. 75: Close up view of broken intake rocker arm assembly and cover showing rocker arm intact.

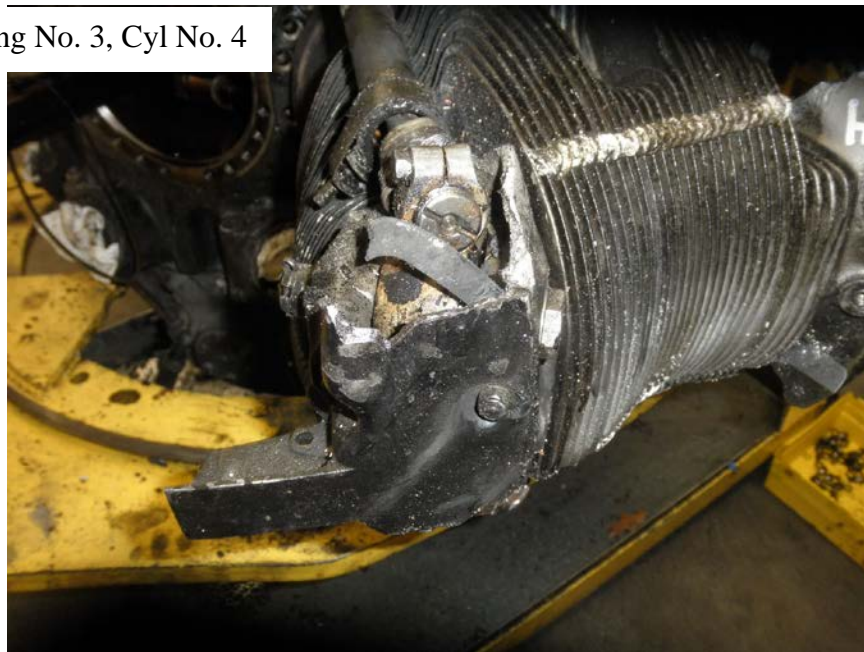
Eng No. 3, Cyl No. 4

Photo No. 76: Close up view of broken exhaust rocker arm assembly and cover showing rocker arm intact.

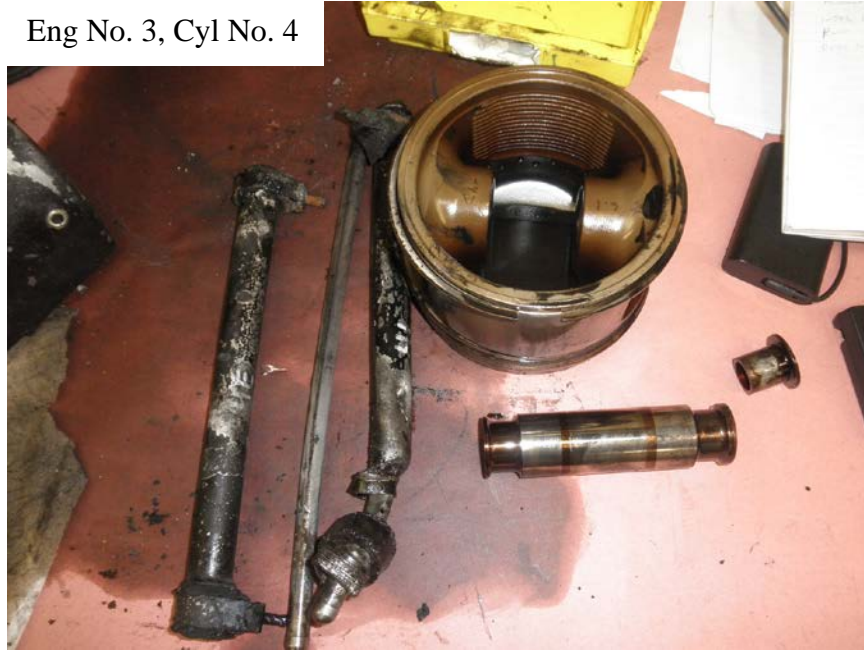
Eng No. 3, Cyl No. 4

Photo No. 77: View of No. 4 cylinder's piston, wrist pin, push rod shrouds, and push rods.

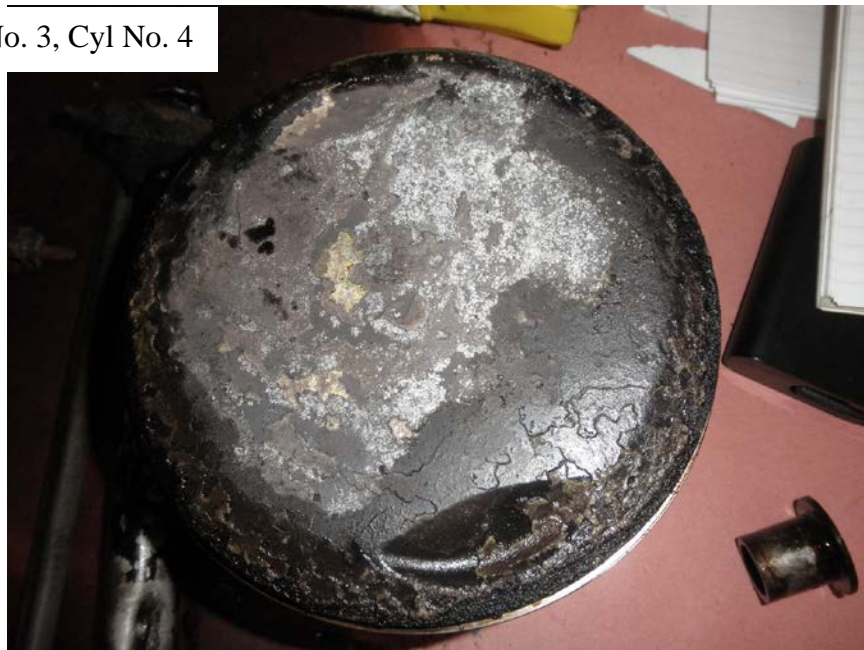
Eng No. 3, Cyl No. 4

of the piston was a dark gray color with areas of white. (Photo No. E3zu) According to Vintage Radial, the condition of the head of the piston was consistent with detonation.

Photo No. 80: Close up view of the top of the No. 4 cylinder's piston showing areas of dark gray and white coloration that is indicative of detonation.

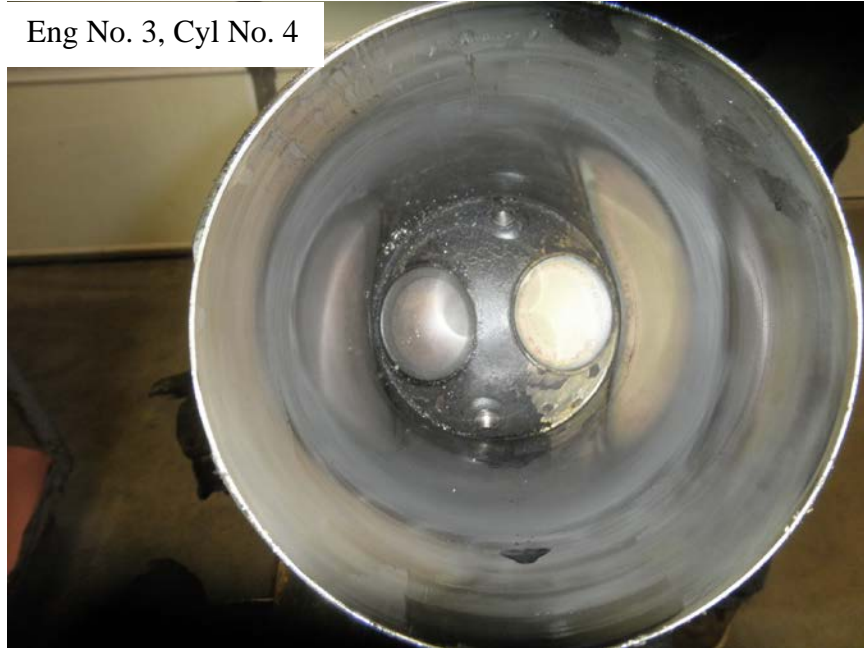
Eng No. 3, Cyl No. 4

The cylinder barrel was intact and the inner surface did not have any damage. The two valves were in place in the closed position centered on the valve seats. The valves did not have any damage. (Photo No. 81)

Photo No. 81: View of the inside of the No. 4 cylinder showing no damage to the barrel and the two valves centered in place in the closed position.

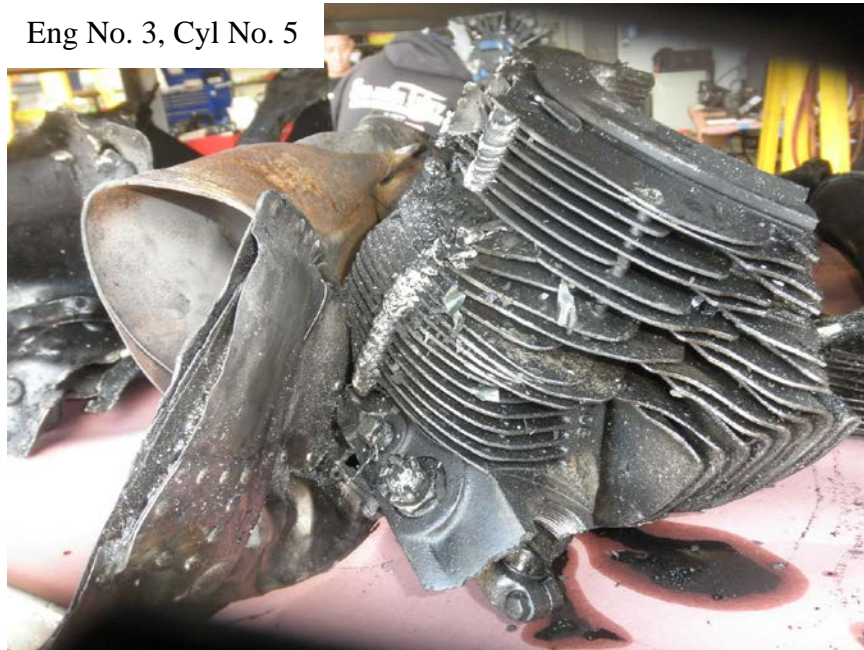
Photo No. 83: Broken piece of No. 5 cylinder head.

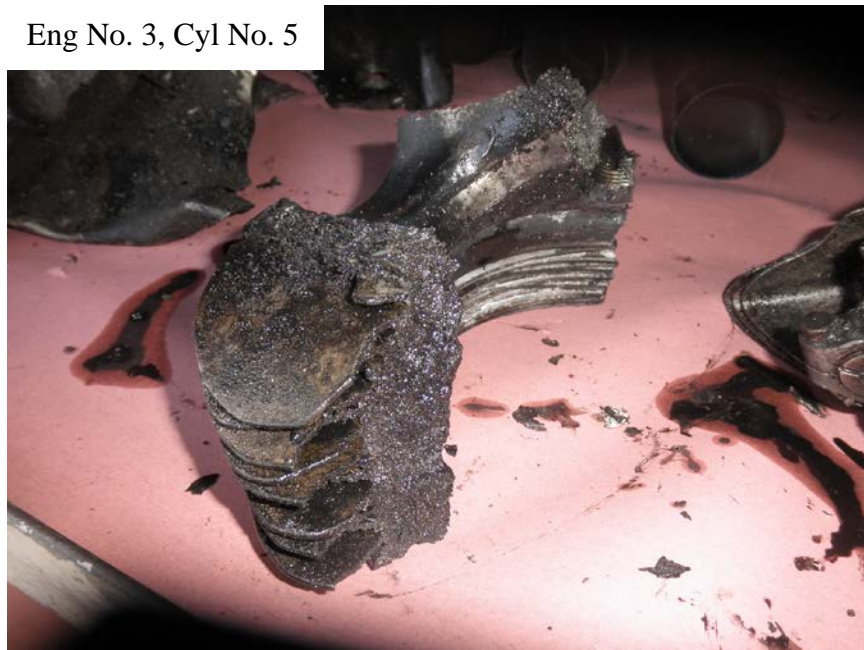
Eng No. 3, Cyl No. 5

Photo No. 85: Broken piece of No. 5 cylinder head.

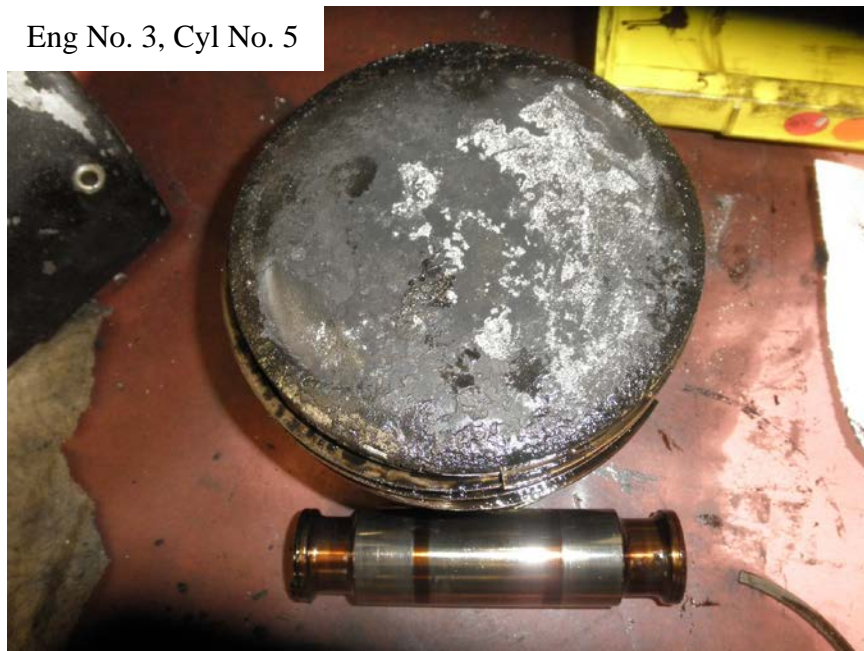
Eng No. 3, Cyl No. 5

The No. 5 piston was connected to the articulating rod with the piston pin and the piston pin buttons were in place. The piston pin remained attached to the articulating rod when the cylinder was removed from the crank case, but the pin slipped out of the piston when the cylinder barrel was removed. The piston was intact. (Photos Nos. 86 and 87) All of the piston rings were in place and intact except the No. 1, top, ring that was broken. (Photos Nos. 88 and 89) The break in the ring was coincidental to some damage to the corner of the piston. The head of the piston was a dark gray color with areas of white. (Refer to Photo No. 86)

Photo No. 86: View of No. 5 cylinder's piston head and wrist pin.

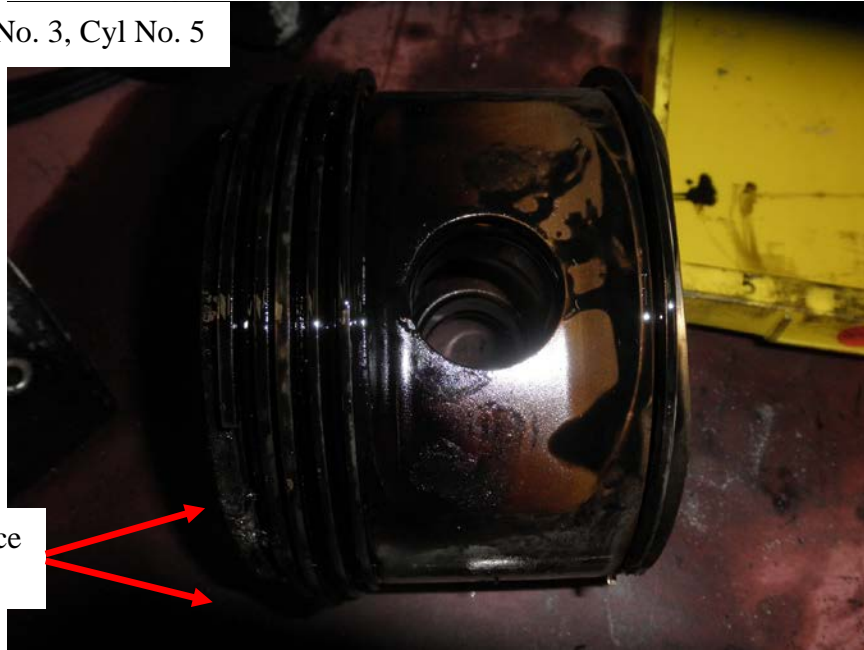
Photo No. 88: Close up of No. 5 cylinder's piston rings showing all were in place.

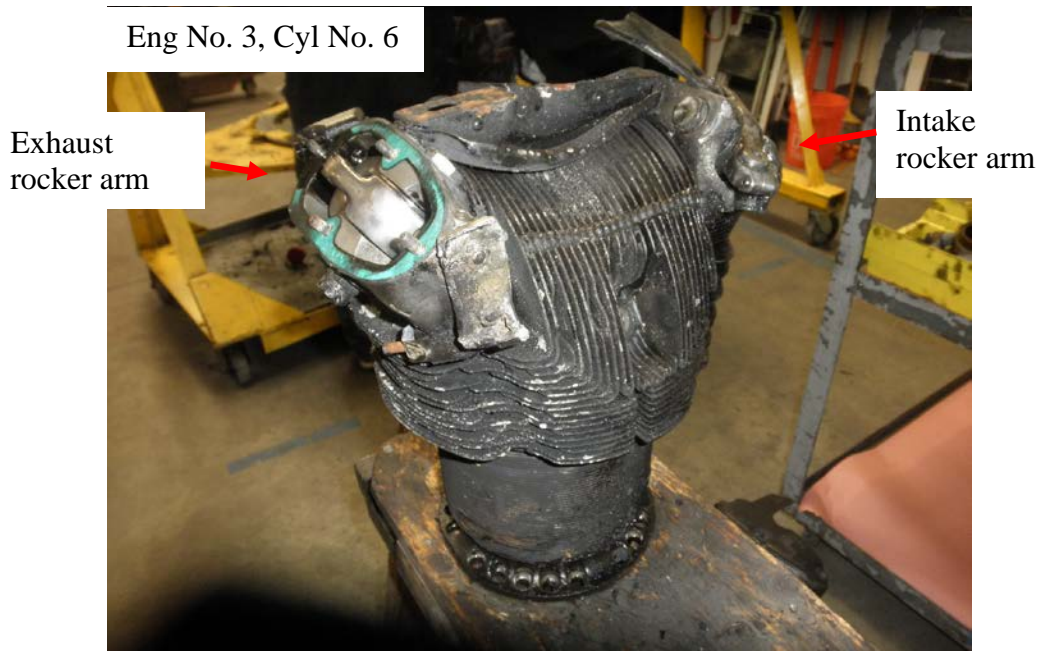
Photo No. 95: View of head of the No. 6 cylinder showing the intake and exhaust rocker arm assemblies were broken open exposing the rocker arms.

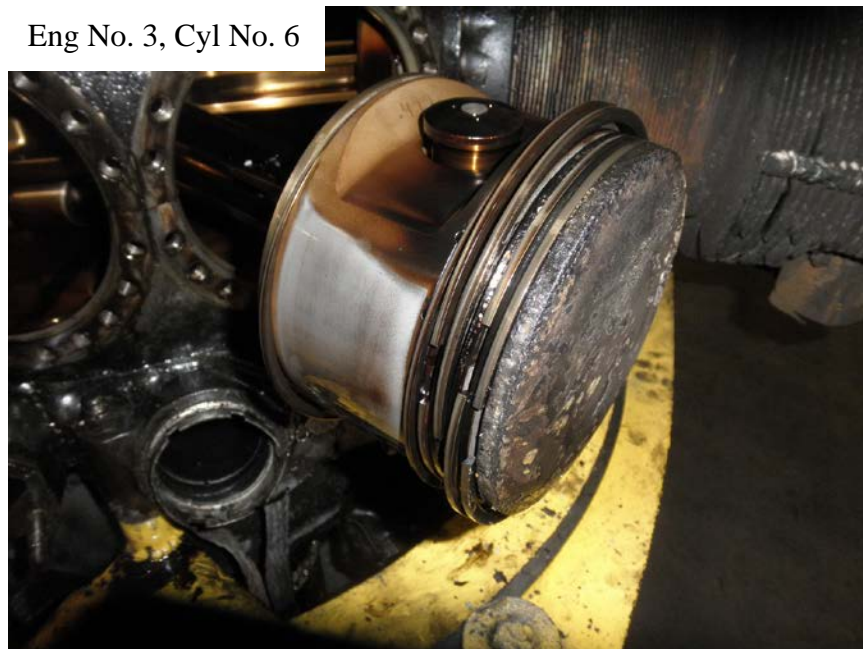
Photo No. 96: View of No. 6 cylinder piston showing it is intact with all of the rings in place.

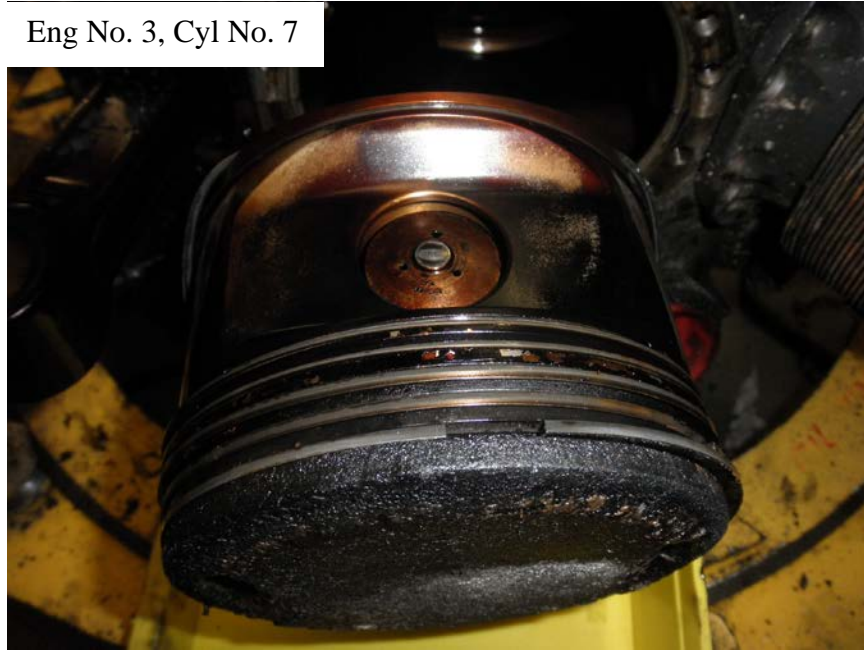
Eng No. 3, Cyl No. 7

Photo No. 104: Close up view of side of No. 7 cylinder's piston showing all of the rings were in place.

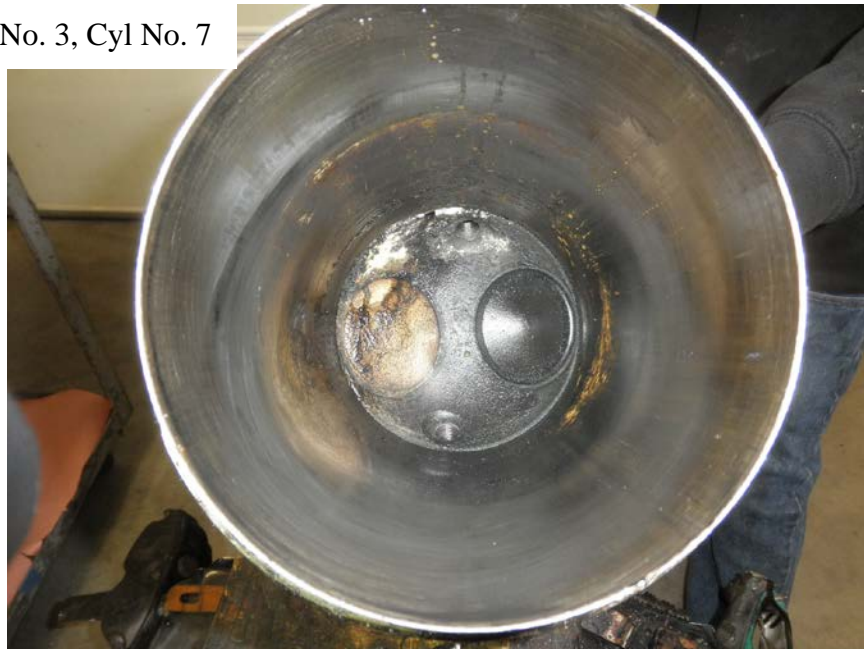
Eng No. 3, Cyl No. 7

Photo No. 105: View inside of the No. 7 cylinder's barrel showing the dark color of the barrel and head and that the two valves were in place in the closed position.
