NATIONAL TRANSPORTATION SAFETY BOARD
OFFICE OF AVIATION SAFETY
WASHINGTON, D.C. 20594

POWERPLANTS GROUP CHAIRMAN'S FACTUAL REPORT

NTSB ID No.: ERA20MA001

Location: Bradley International Airport, Windsor Locks, Connecticut
Date: October 2, 2019
Time: 0953 eastern daylight time
Aircraft: Boeing B-17G, N93012, Collings Foundation

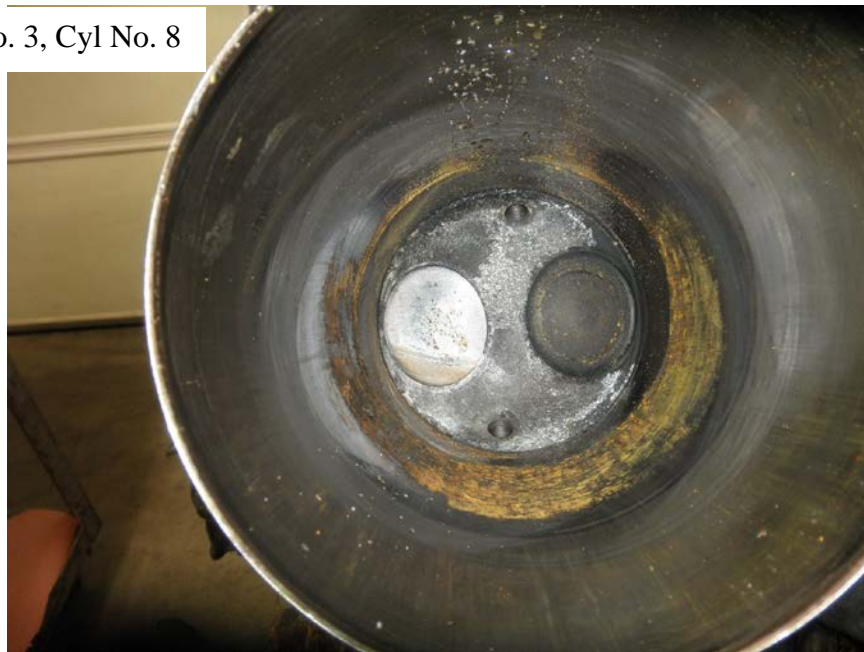
Eng No. 3, Cyl No. 8

Photo No. 113: View inside of the No. 8 cylinder's barrel showing the metal fragments, but no damage to the barrel and that the two valves were in place in the closed position.

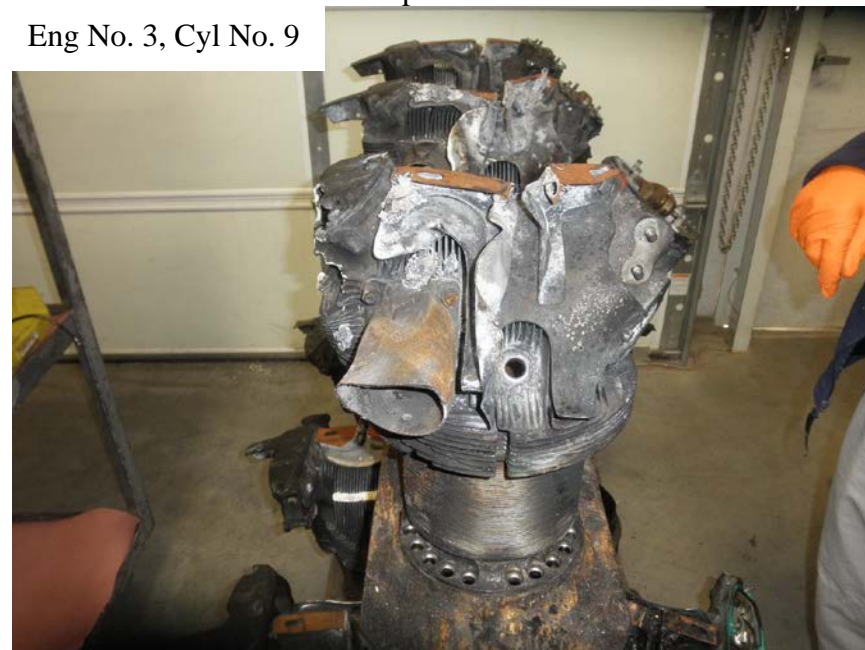
Photo No. 115: View of the rear of No. 9 cylinder showing that it was intact with the head in place. Also showing the broken exhaust rocker arm cover and the missing intake rocker arm cover.

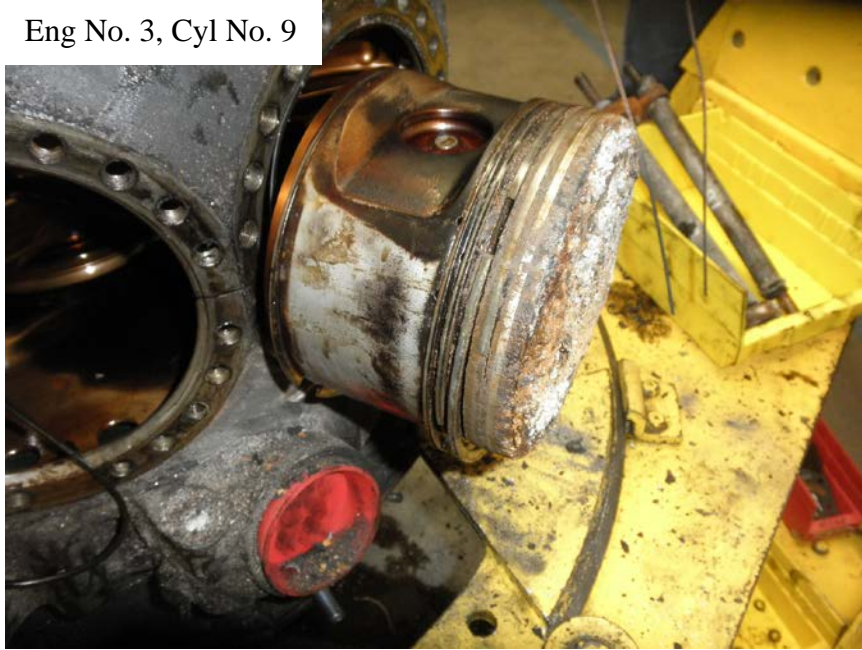
Eng No. 3, Cyl No. 9

Photo No. 116: View of No. 9 cylinder's piston showing that it was intact.

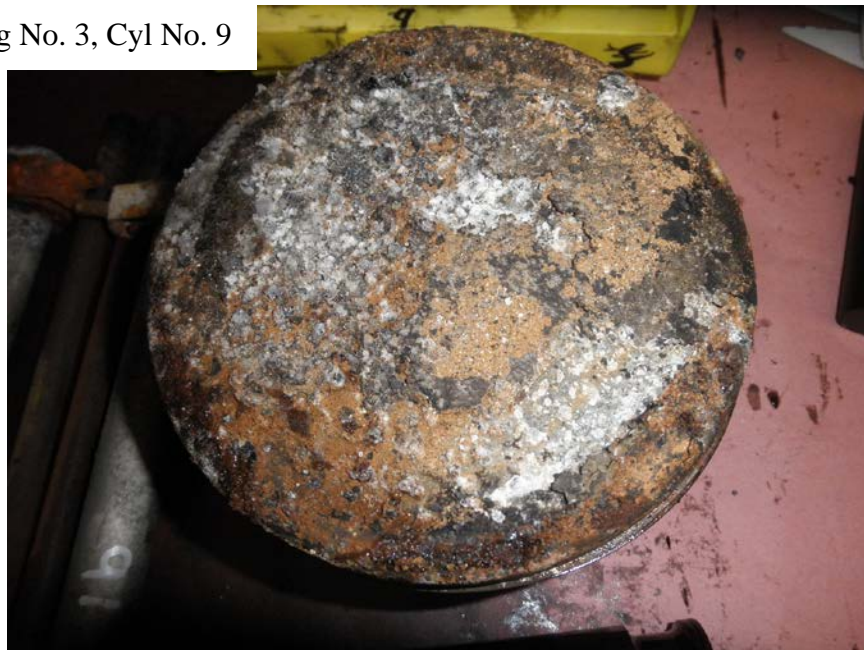
Photo No. 119: Close up view of the head of the No. 9 cylinder's piston showing the brown color with the white crystals consistent with corrosion.

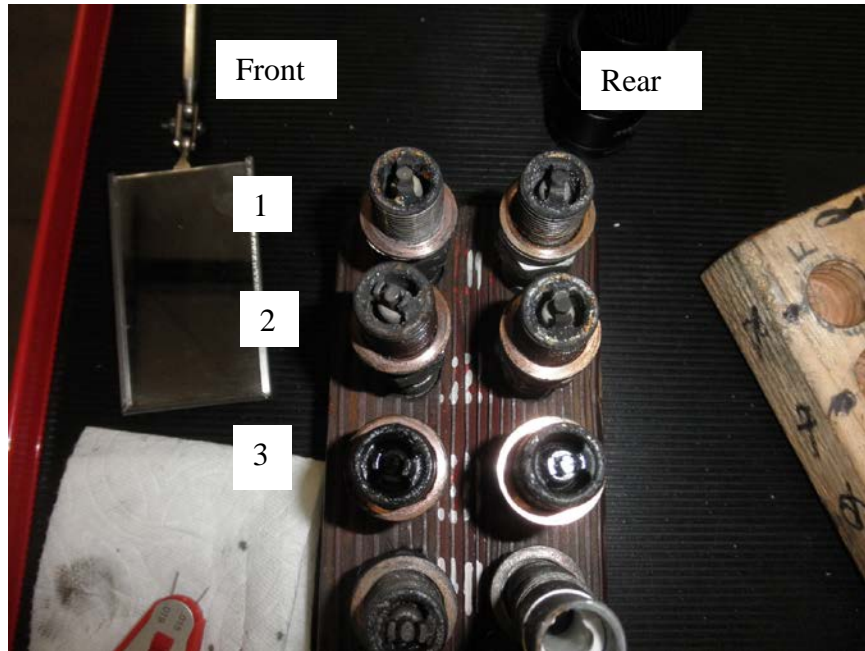
Photo No. 121: No. 3 engine's spark plugs for cylinders Nos. 1, 2, and 3.

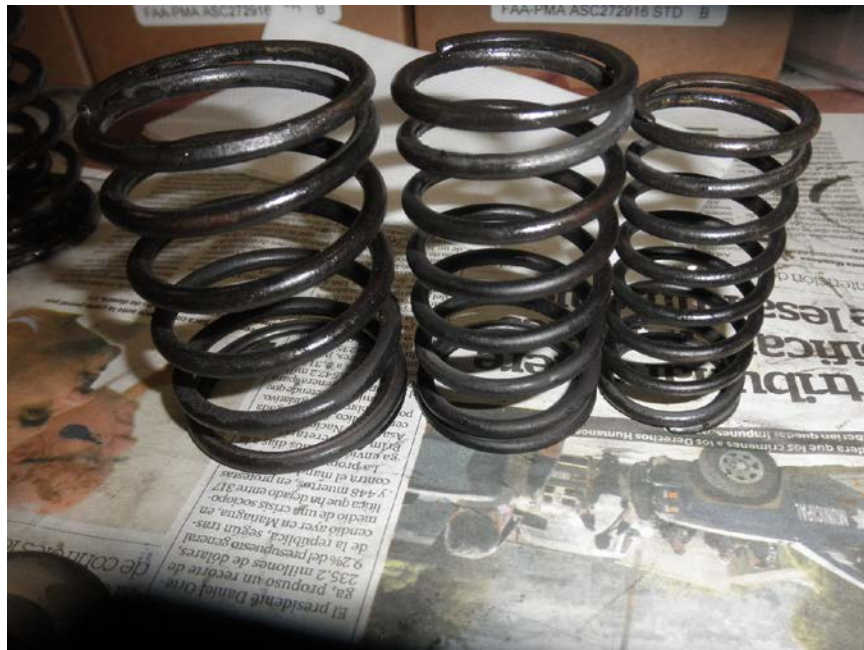
Photo No. 125: View of the three valve springs that should normally be installed in a R-1820 engine.

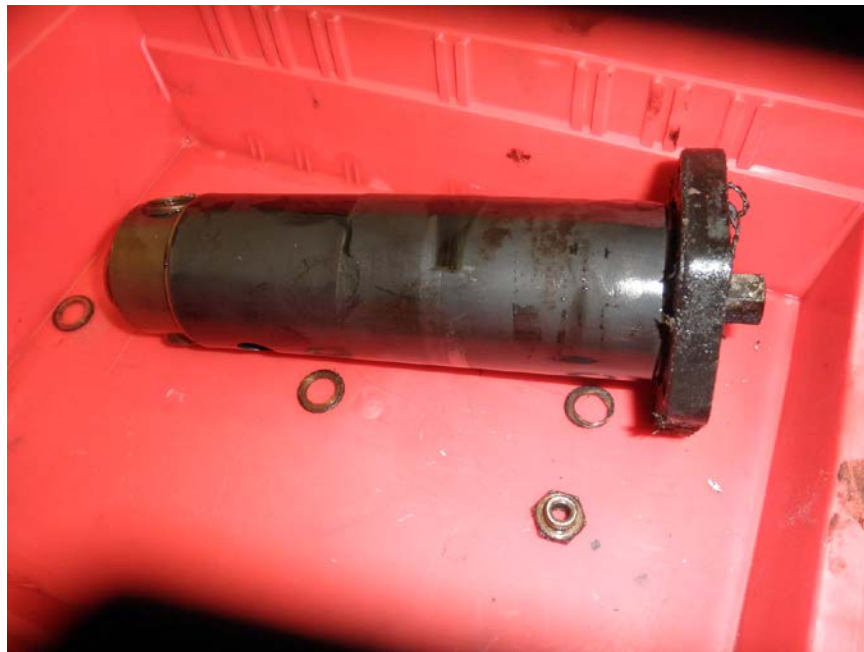
Photo No. 129: The No. 3 engine's Cuno oil filter after removal from the engine.

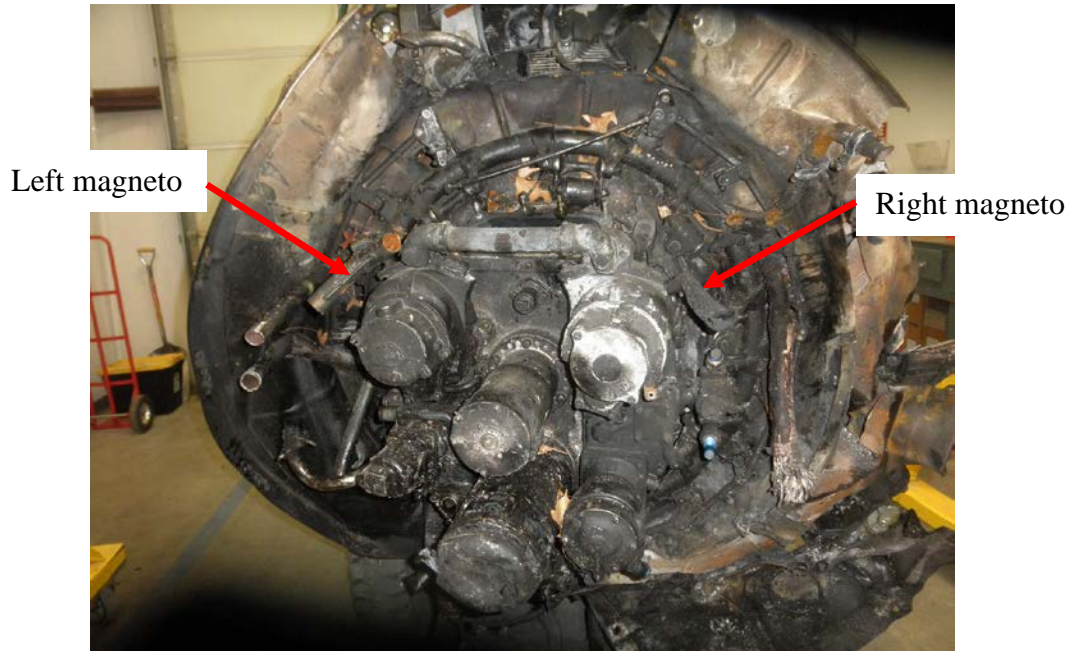
Photo No. 133: View of the rear of the engine showing the left and right magnetos were in place although the P-lead was separated from both.

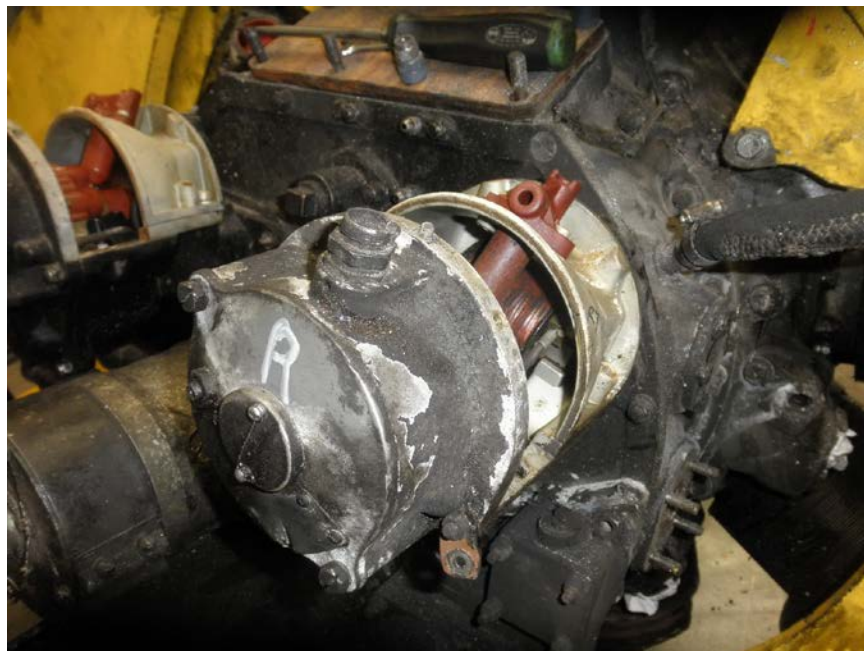
Photo No. 135: Close up view of right magneto housing showing it was intact, but the paint was blistered and partially burned away.

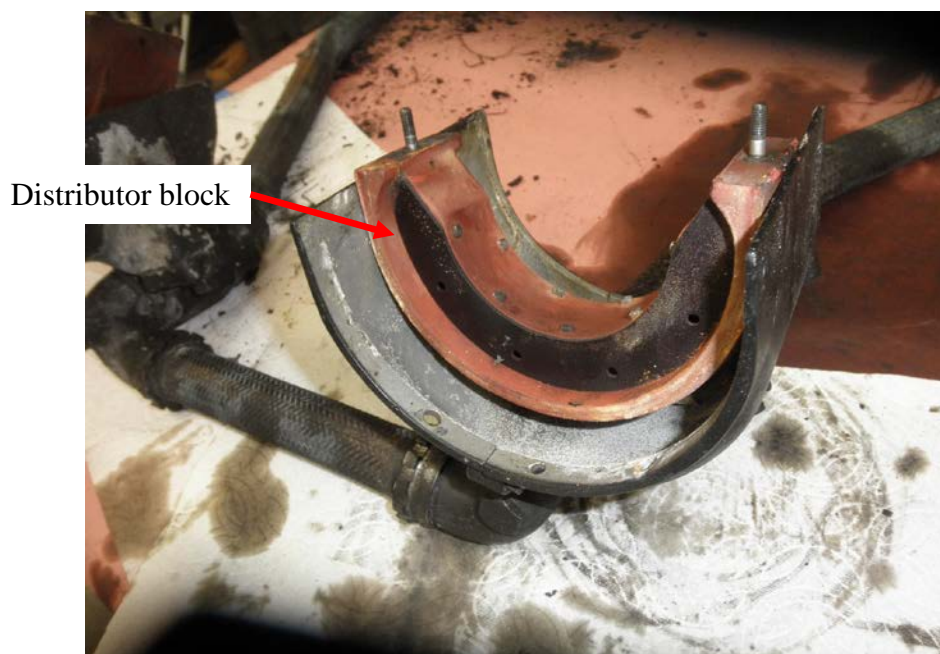
Photo No. 136: View of left magneto's distributor block showing the varnish was missing.

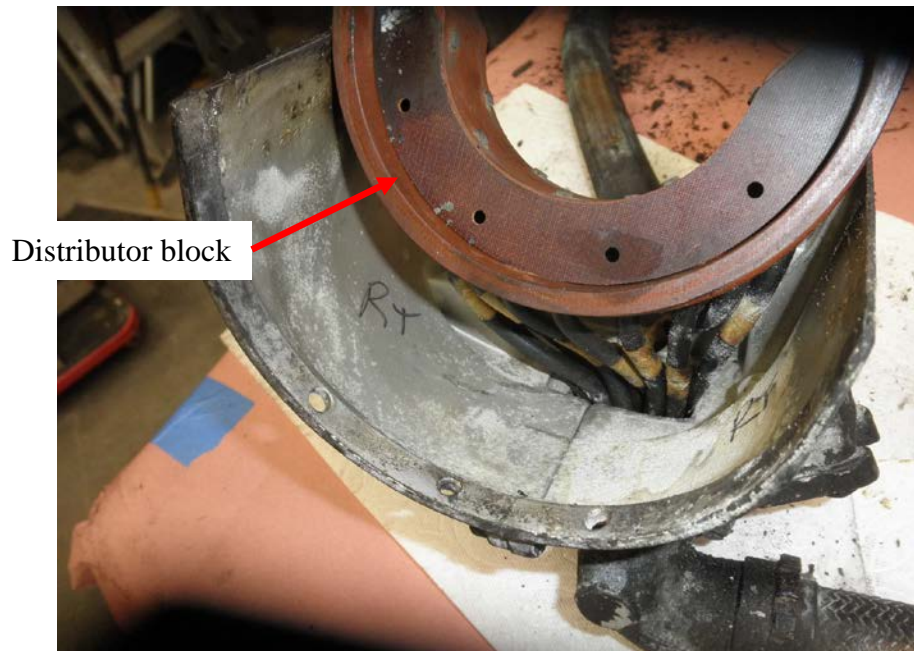
Photo No. 137: View of right magneto's distributor block showing the varnish was in place.

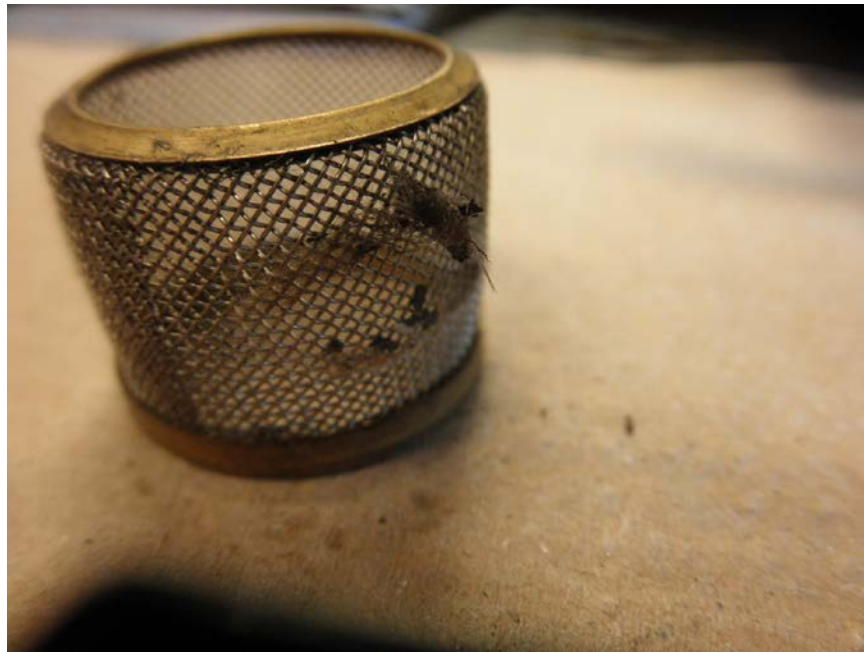
Photo No. 143: Close up view of strainer showing debris.

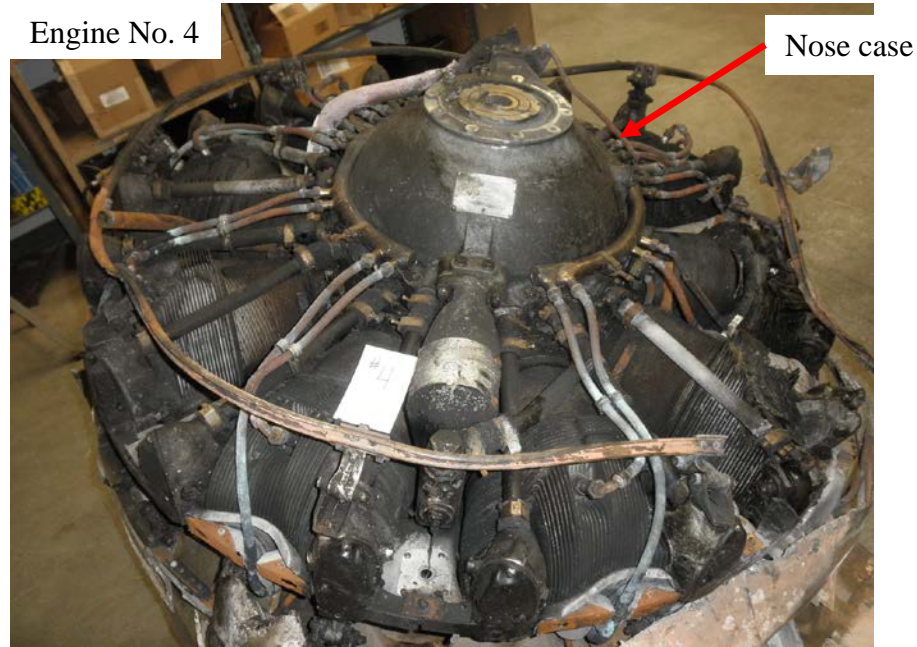
Photo No. 148: View of front of engine showing nose case in place and intact.

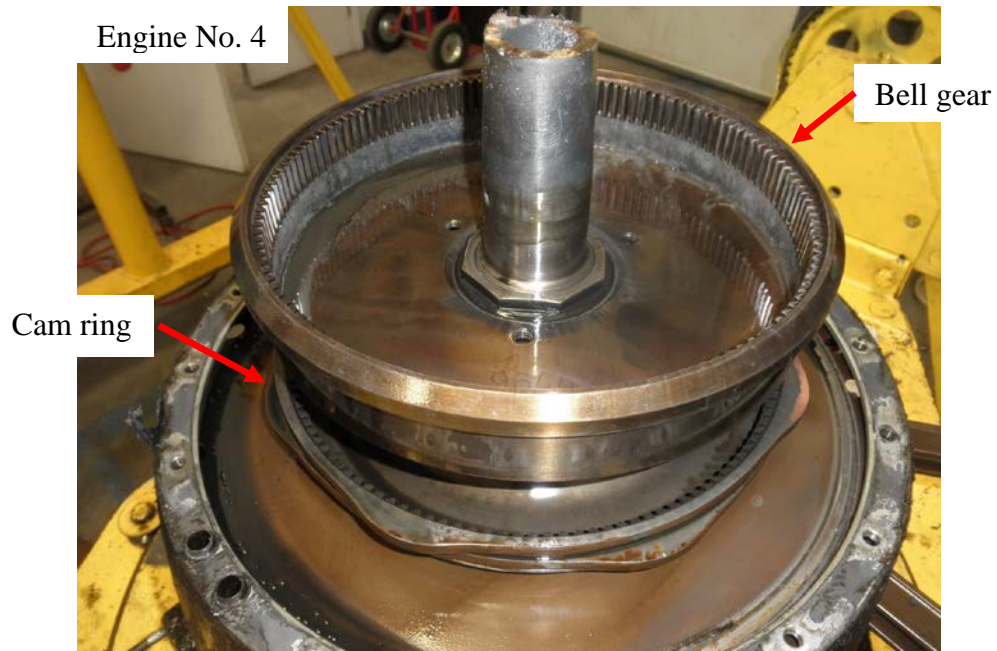
Photo No. 149: View of the bell gear showing that it was intact and had no rotational damage to the gear teeth. Also shown is the cam ring showing that it was intact.

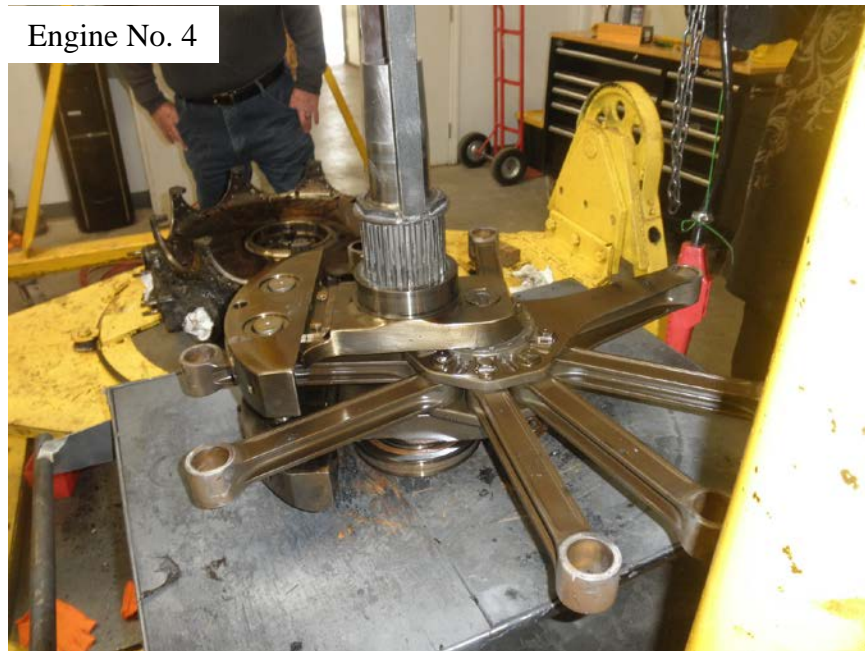
Photo No. 152: View of crank shaft showing it is intact with the two counterweights in place.

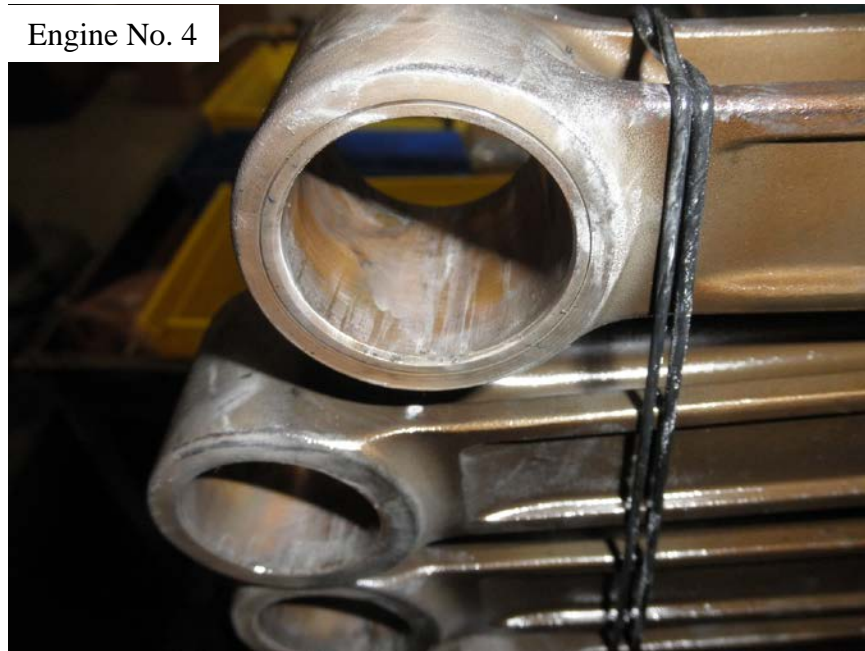
Photo No. 155: Close up view of a typical articulating rod piston pin bearing showing no damage to the bearing surface.

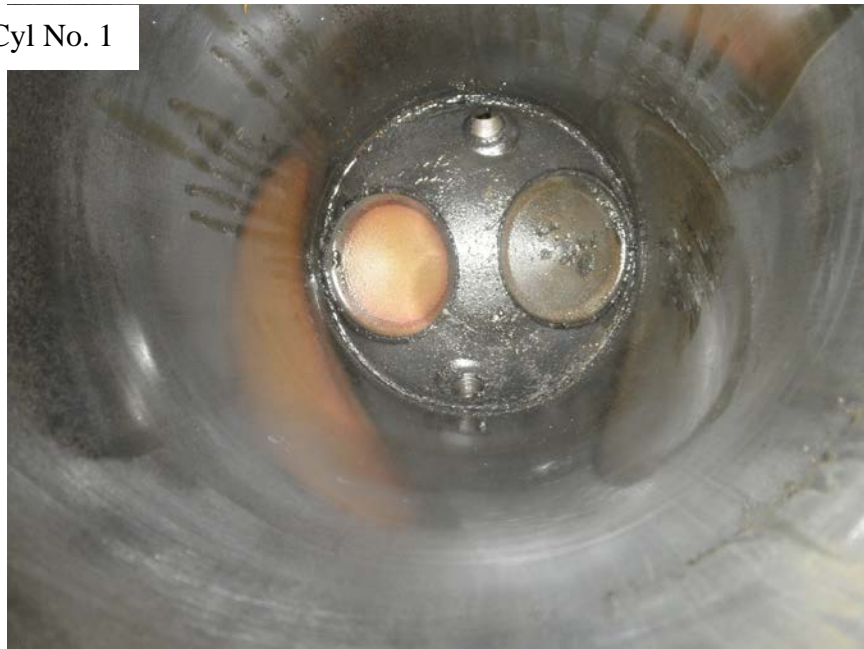
Photo No. 159: View of the inside of the No. 1 cylinder showing no damage to the barrel and the two valves were centered in place in the closed position.

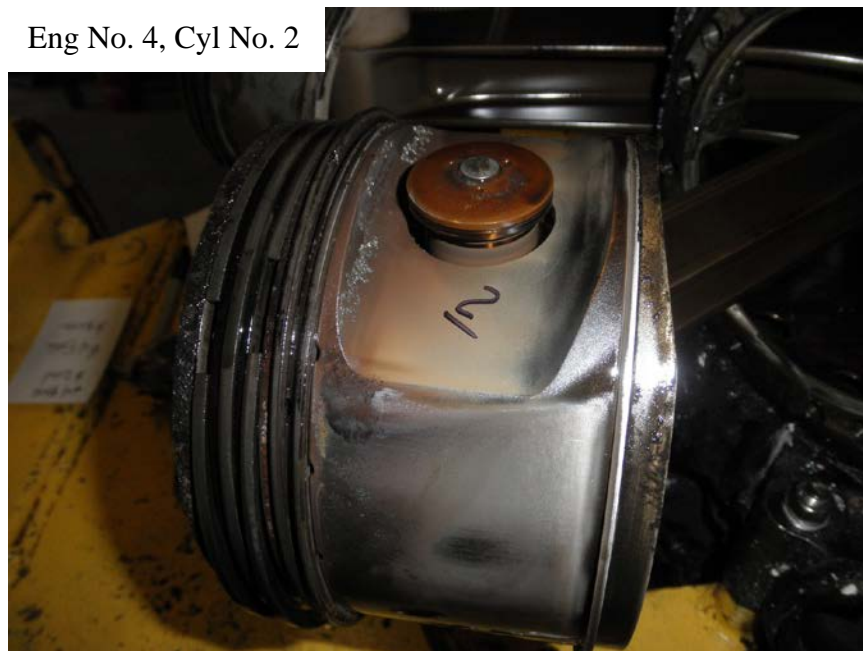
Photo No. 160: View of No. 2 cylinder's piston in place on the articulating rod showing that the piston was intact and that all of the piston rings were in place.

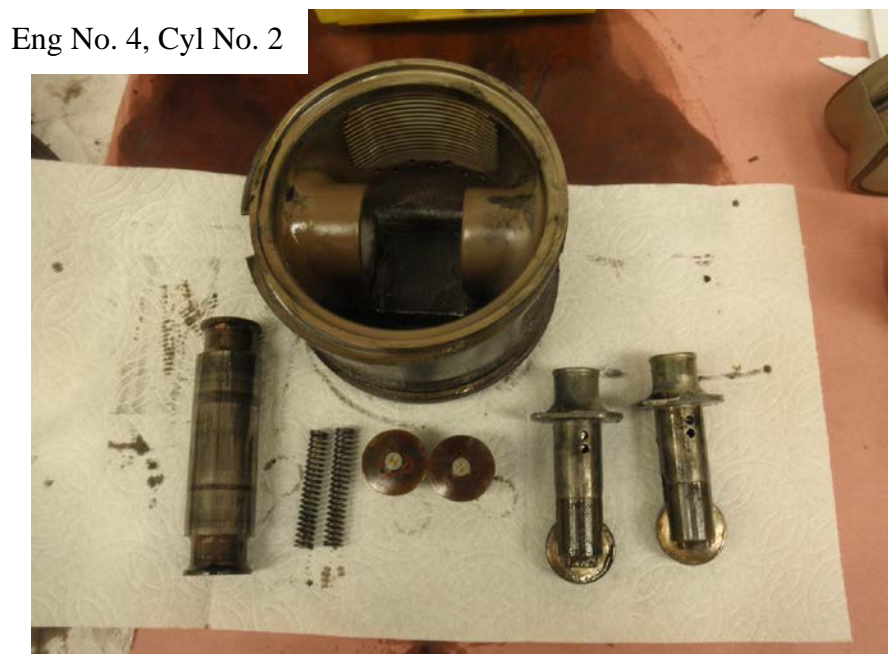
Photo No. 162: View of underside of No. 2 cylinder's piston along with the piston pin, piston pin buttons, and the cam followers showing all were intact and undamaged.

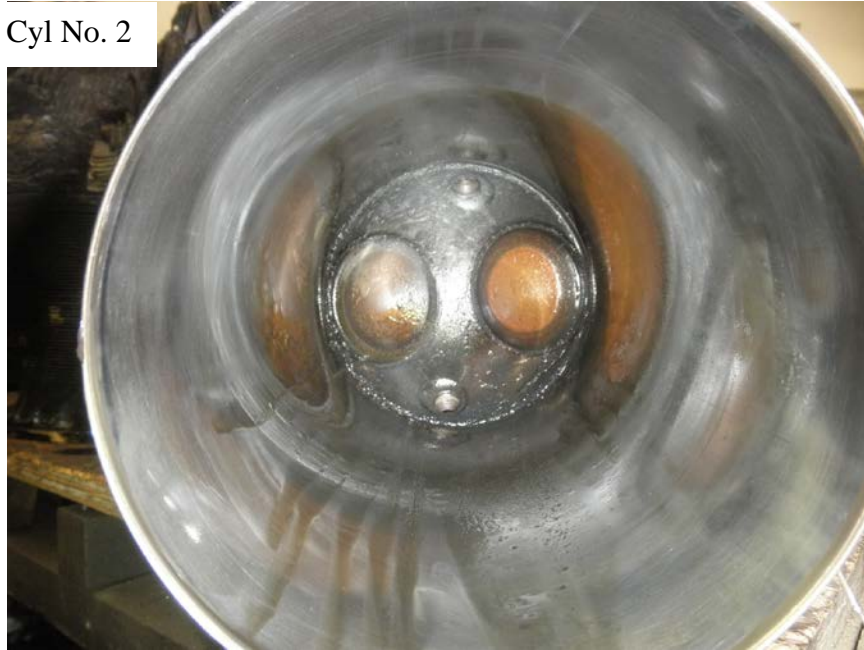
Photo No. 163: View of the inside of the No. 2 cylinder showing no damage to the barrel and the two valves were centered in place in the closed position.

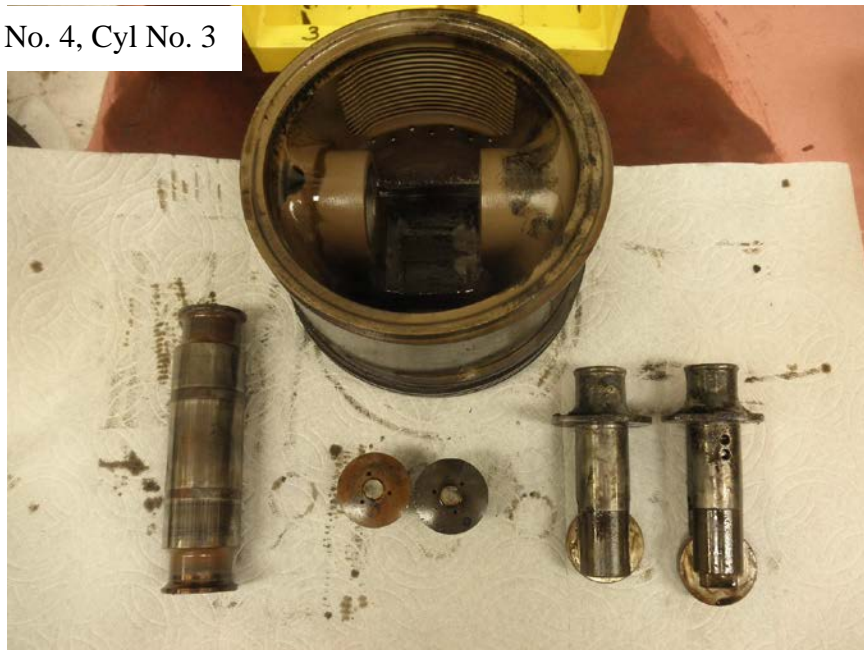
Photo No. 167: View of underside of No. 3 cylinder's piston along with the piston pin, piston pin buttons, and the cam followers showing all were intact and undamaged.

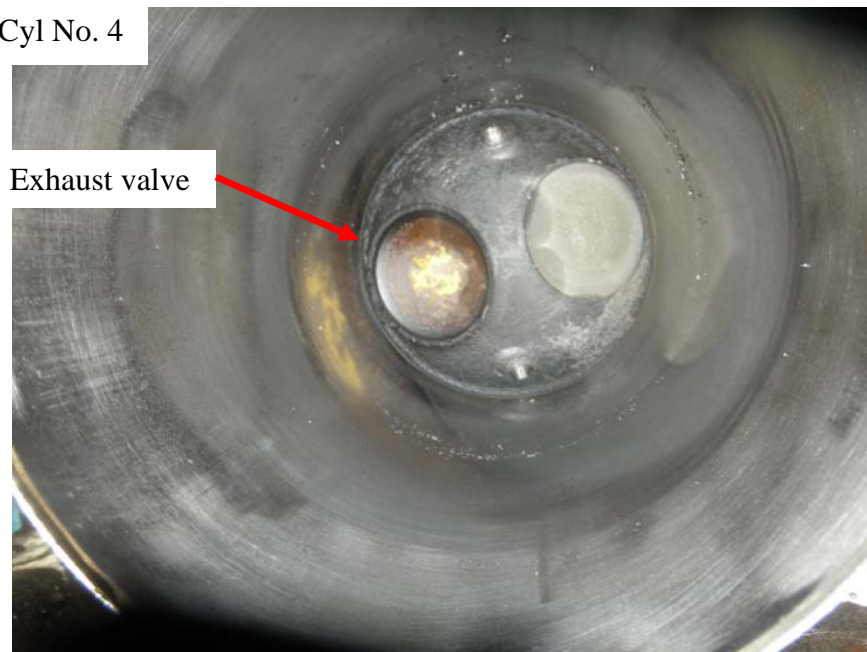
Photo No. 172: View of the inside of the No. 4 cylinder showing no damage to the barrel and the two valves were centered in place in the closed position. Also shown is what appeared to be yellow paint on the exhaust valve.

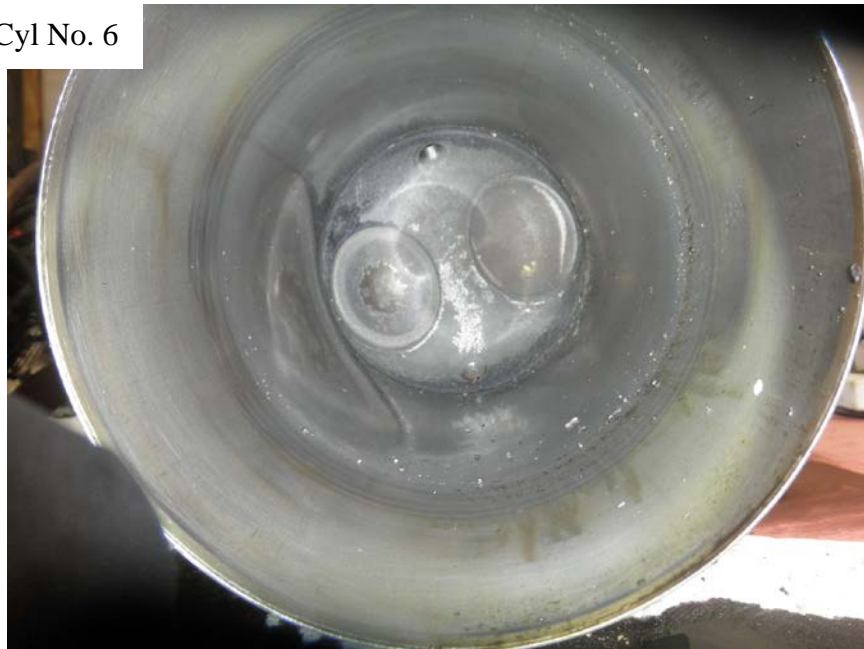
Photo No. 180: View of the inside of the No. 6 cylinder showing no damage to the barrel and the two valves were centered in place in the closed position.

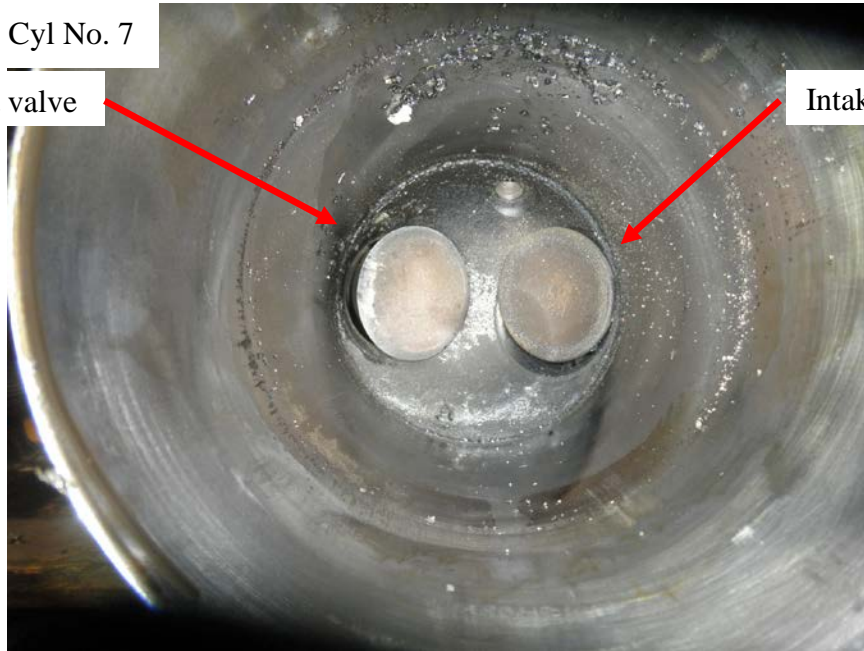
Photo No. 184: View of the inside of the No. 7 cylinder showing no damage to the barrel, although there were metal particles on the barrel wall and the two valves were open with the intake valve off center and the exhaust was off-center.

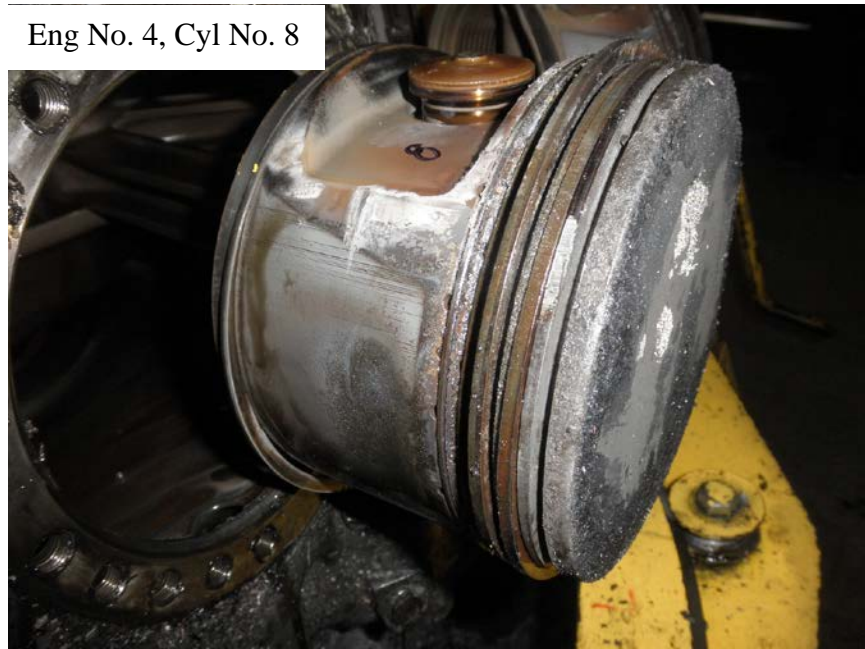
Photo No. 185: View of No. 8 cylinder's piston in place on the articulating rod showing that the piston was intact and that all of the piston rings were in place. Also shown are small metal particles in the piston rings.

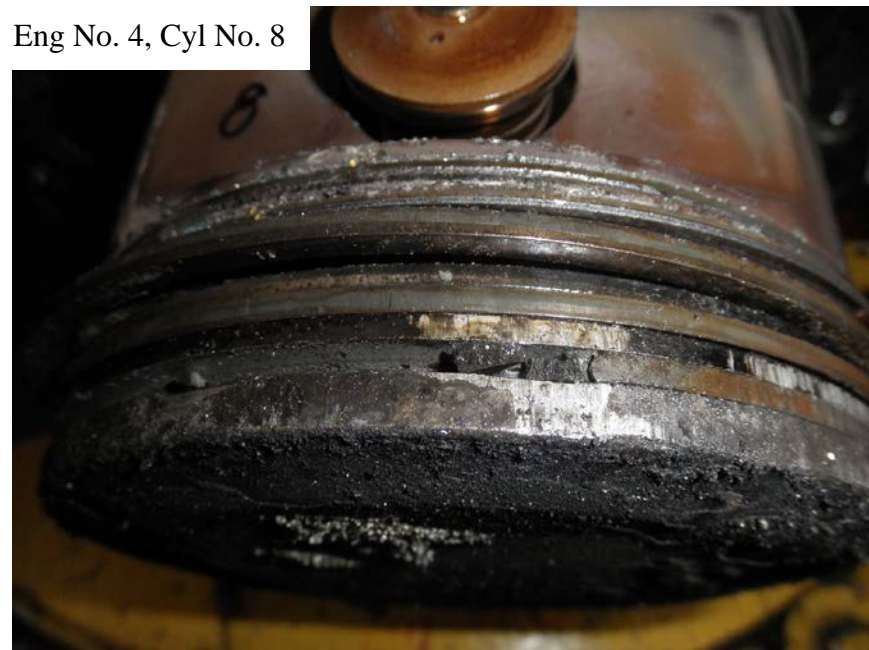
Photo No. 186: Close up No. 8 cylinder's piston showing broken No.1 piston ring.

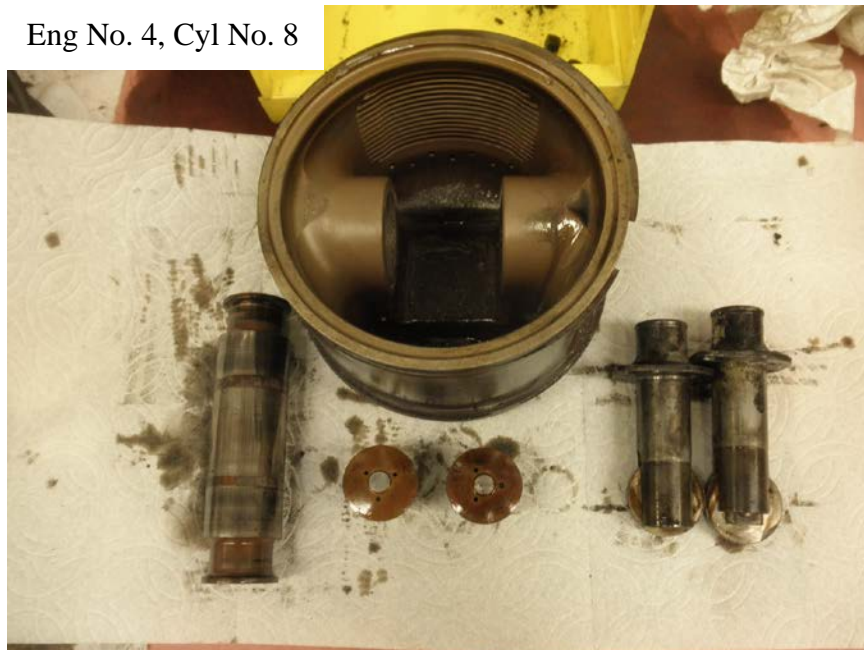
Photo No. 188: View of underside of No. 8 cylinder's piston along with the piston pin, piston pin buttons, and the cam followers showing all were intact and undamaged.

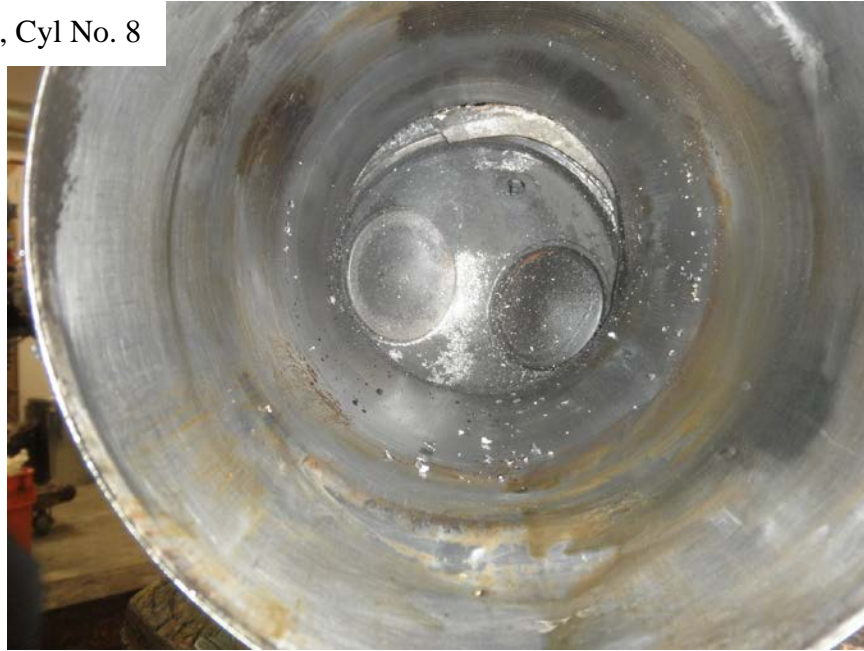
Photo No. 189: View of the inside of the No. 8 cylinder showing no damage to the barrel, although there were metal particles on the inside. Also shown is the cylinder head partially separated from the barrel, but the two valves are centered in the closed position.

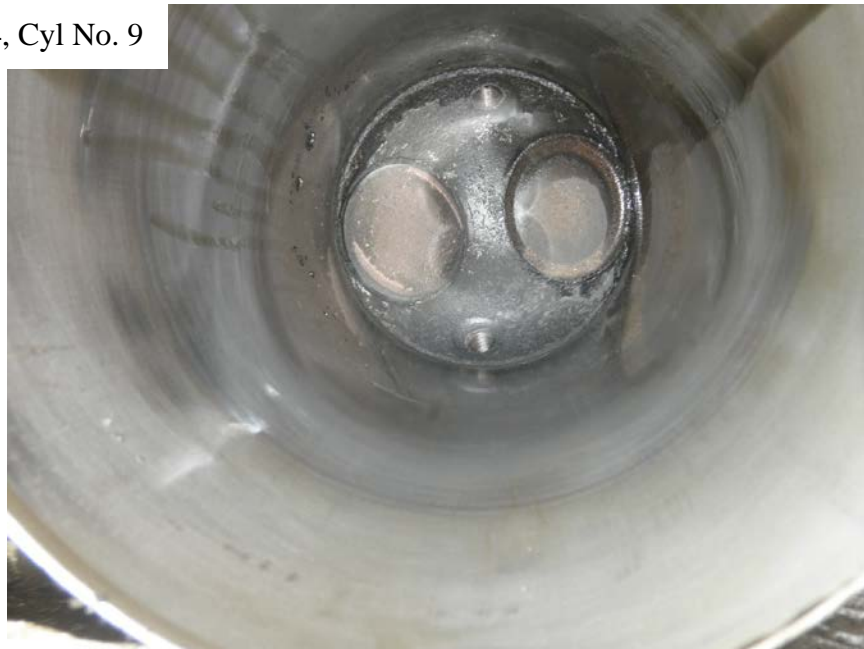
Photo No. 193: View of the inside of the No. 9 cylinder showing no damage to the barrel and the two valves centered in place in the closed position.

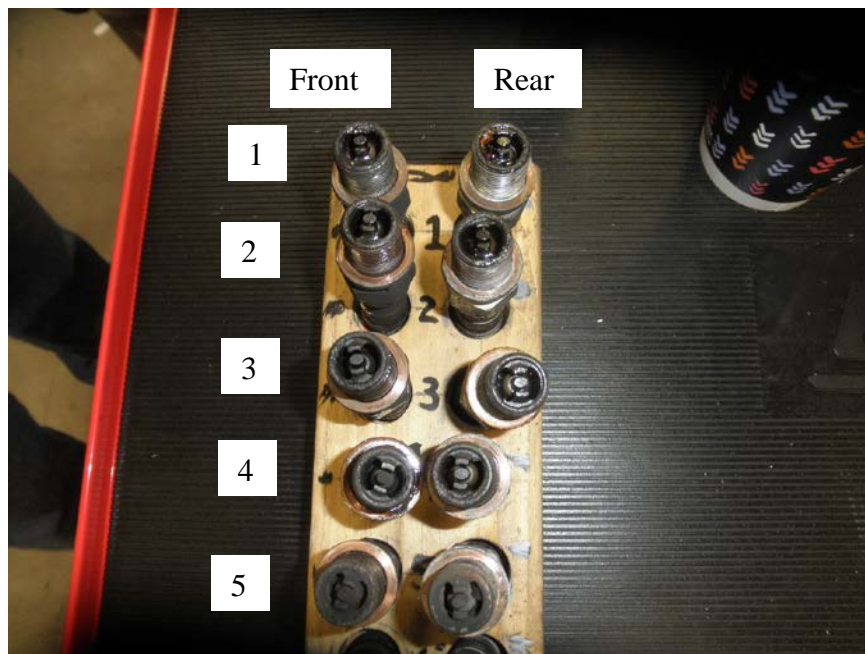
Photo No. 194: No. 4 engine's front and rear spark plugs from cylinders Nos. 1 through 5.

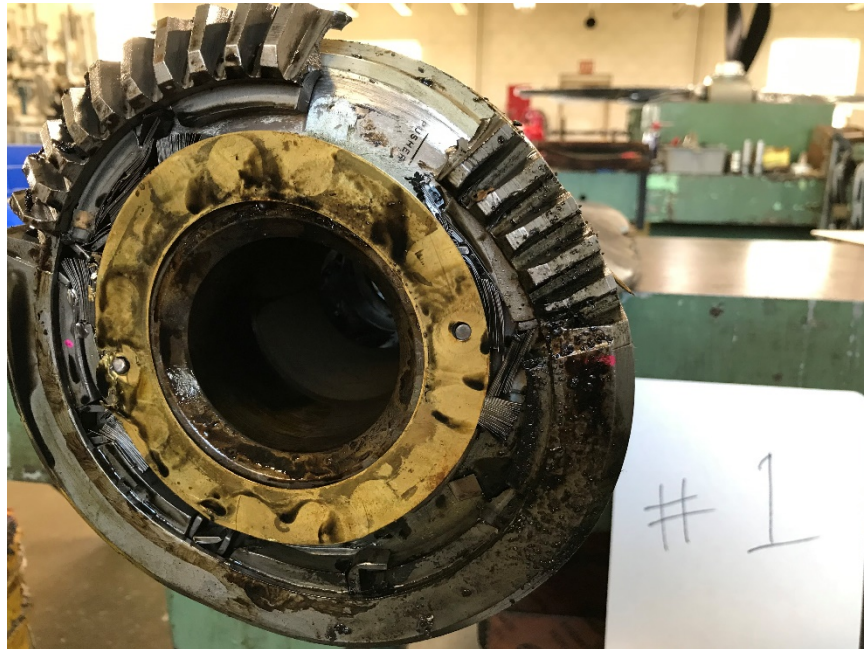
Photo No. 205: Close up view of blade No. 1's gear segment broken at the low pitch position.

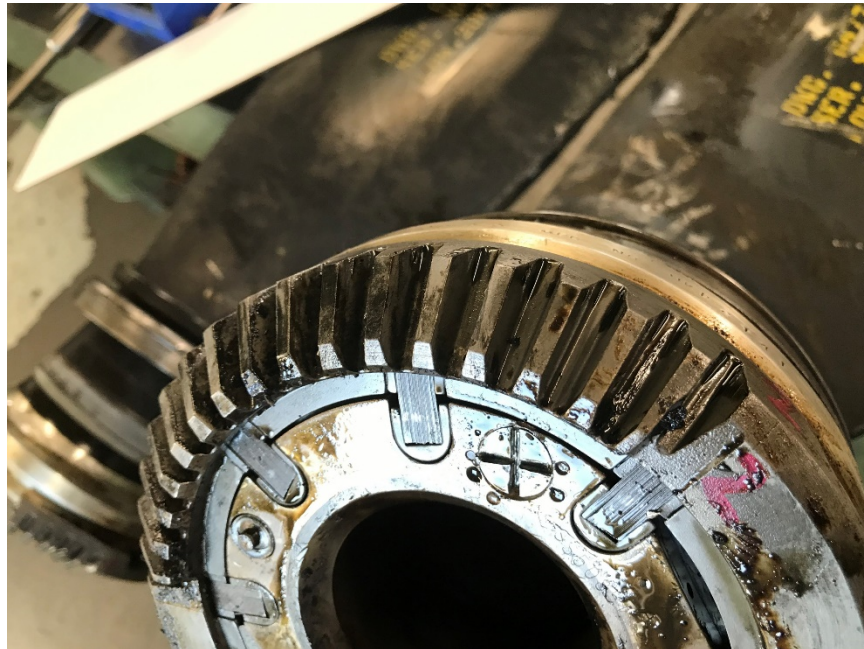
Photo No. 208: Close up of No. 2 blade butt showing the gear segment was intact and the screws in place.

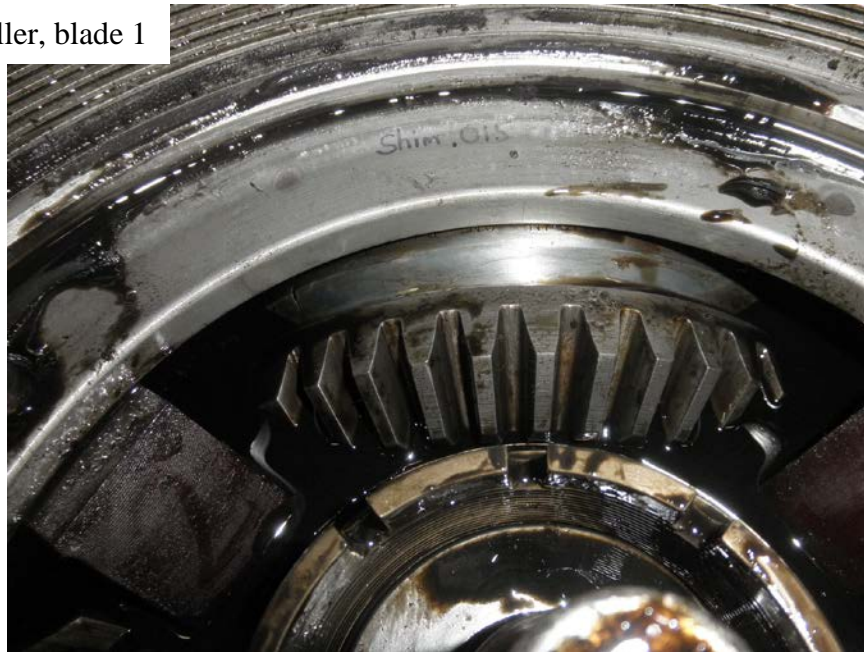
Photo No. 215: Close up view of No. 4 propeller, No. 1 blade's gear ring showing it was intact.
