RRD21LR015 San Francisco Bay Area Rapid Transit District Passenger Fatality September 16, 2021 San Francisco, California

Operations Factual Report

NTSB Accident Number: RRD21FR015
Date of Accident: September 13, 2021
Time of Accident: 3:13 p.m. (PST)

Location of Accident: Powell St. Station, San Francisco

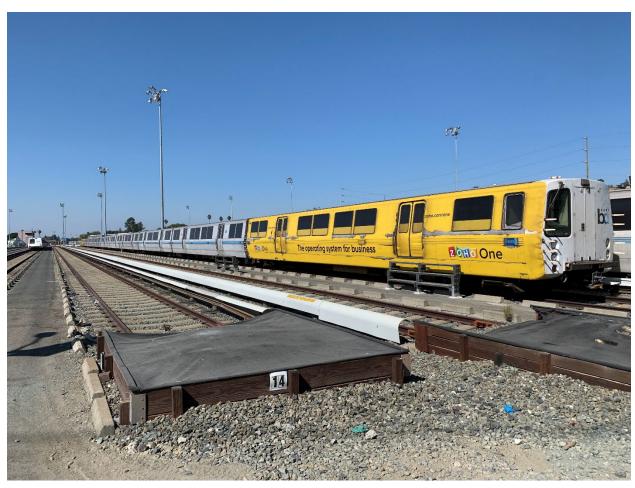
Figure 1: Image of rear of accident train located on track 16 in the Concord maintenance yard.

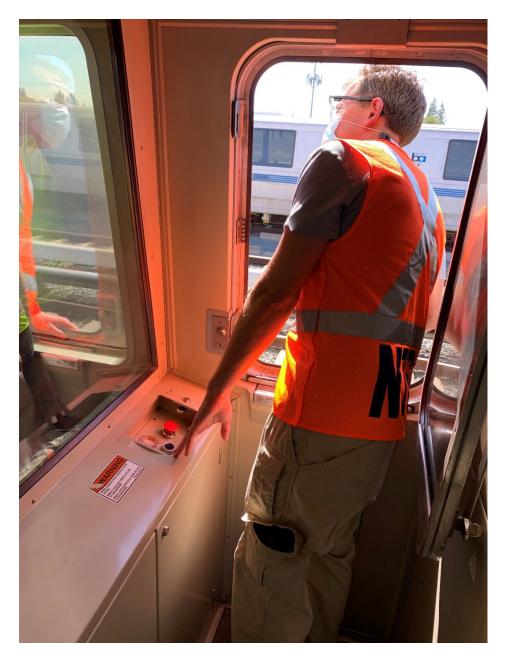
Figure 2: Investigator performing door cycling operations on accident train

- O Investigators placed several objects into the door to observe a door malfunction. During the malfunction the door would release slightly, an audible alert stating "the doors on this car are obstructed, please stand clear of the doors so the train can depart" can be heard, and red blinking lights alternated while the audible announcements were made. When the object was removed, the door would shut.

- Investigators were able to obstruct the doors with their boots, arms, and hands, and a sharpie pen.
 - Thinner items such as a work glove and phone charging cord did not activate a door malfunction and were not movable once the doors had closed

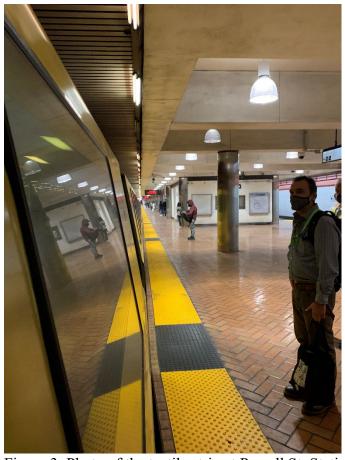
- The BART employee was wearing a burgundy polo shirt and khaki pants.
 - The BART employee stood on the tactile strip at the 9th car, 2nd door boarding location.

- When looking from the operating cab down the station platform, investigators observed that the BART employee was difficult to see.
 - The operator of the exemplar train performed the same observation and stated that she was able to see the BART employee because she was only focusing on the yellow tactile stripping. Investigators again looked down the platform utilizing this same technique and were able to see that the BART employee was standing on the platform. The operator explained that her technique comes from training and experience.

Figure 3: Photo of the tactile strip at Powell St. Station from the operating compartment window of an exemplar train. The BART employee can be seen at the end of the platform standing on the tactile strip near the 2nd doorway of the 9th car.

- Transportation
 - o Reevaluate existing "lookback" procedure and training curriculum
 - BART is installing LED lights at the end of the platform in the four downtown San Francisco stations, for an operator, clear sight lines of the lights would indicate no obstructions at the platform train interface.
 - o Consider any changes to train operator manual (TOM) related to "lookback"

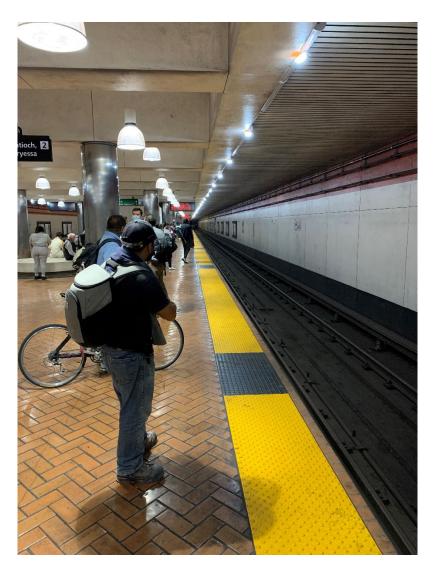
Figure 4: View of the tactile strip from the boarding position of the 2nd door, 9th car looking in the direction of travel.

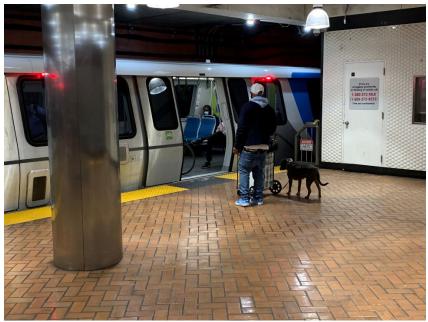
- o Investigators observed signage on the equipment and at the station outlining rules and a code of conduct for riding the BART system.
- O The group observed several trains servicing this station and passenger behavior. Passengers frequently walked over the tactile strip while trains were stationary, in movement, and not present in the station. The group observed several passengers who appeared to be intoxicated or under the influence of behavior altering substances. Several passengers had bicycles with them. The group observed some passengers riding bicycles on the station platform. The group also observed a passenger with a dog and a shopping cart. The dog's handler used a retractable style leash to corral the dog. At times, the leash extended approximately 6ft. away from the handler. The handler boarded a train with the dog and shopping cart.

Figure 5: Passenger with dog on retractable leash and shopping cart boarding train.

o Develop awareness campaign on traveling with service animals and/or pets

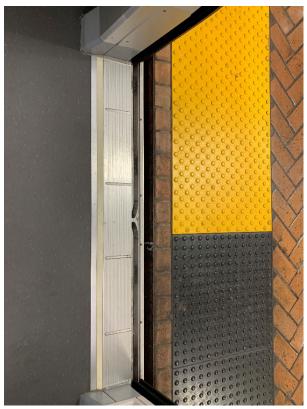
Figure 6: Platform edge gap at Powell St. Station

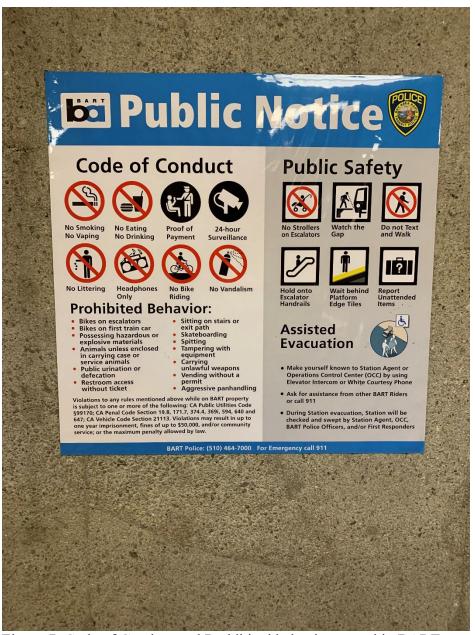
Figure 7: Code of Conduct and Prohibited behavior posted in BART system

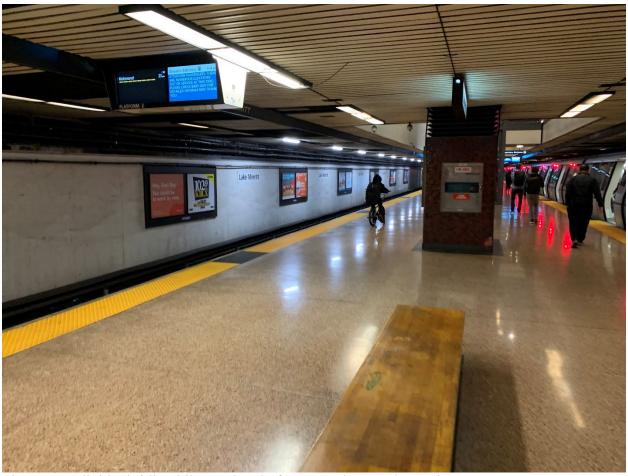
- While on the train, investigators were approached by an individual who appeared to be under the influence of a behavior altering substance, the individual was riding their bicycle on the train and made threating comments to an investigator. Investigators and BART employees were wearing reflective vests. The individual followed passengers off of the train at the Lake Merritt Station and began riding their bicycle on the station platform circling the Investigative team. At one point during the encounter, the individual almost rode their bicycle off the station platform. BART police at the station were informed of the encounter.

Figure 8: Individual riding bike on the platform at Lake Merritt Station
