Black substance examination

Accident on **17/01/2016**
in **Hanalei (Hawaii)**
to the **Rotorcraft EUROCOPTER - EC130**
registered **N11VQ**
operated by **Blue Hawaiian Helicopters**

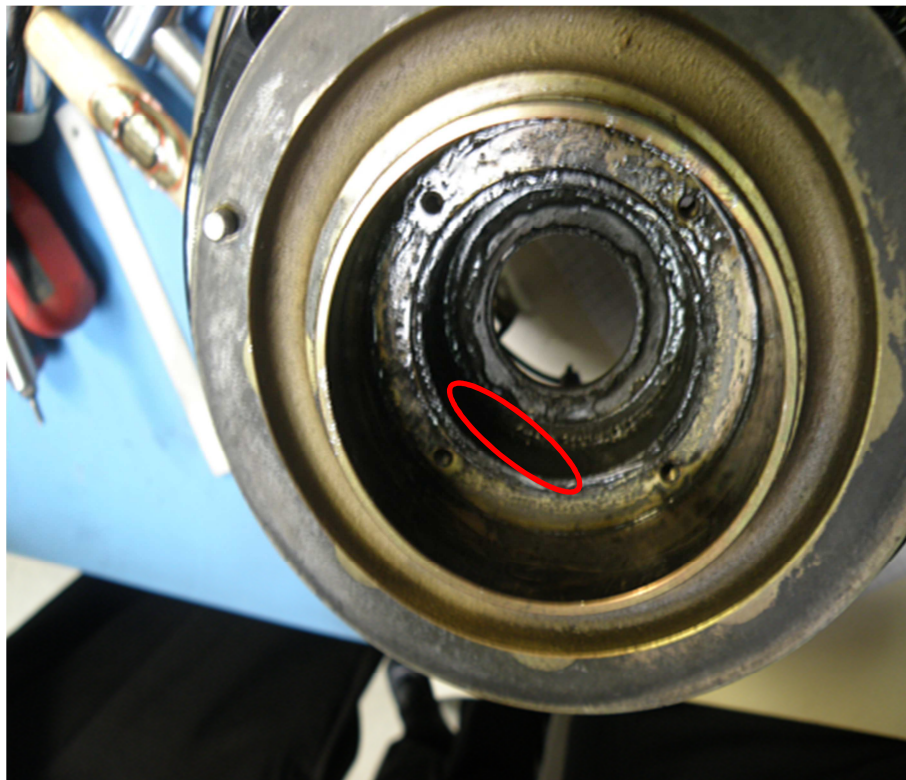
Fig. 1 – Black substance

Synthesis of examinations: These analyses confirmed the presence of Loctite 8012 and engine oil O-156 in this black substance.

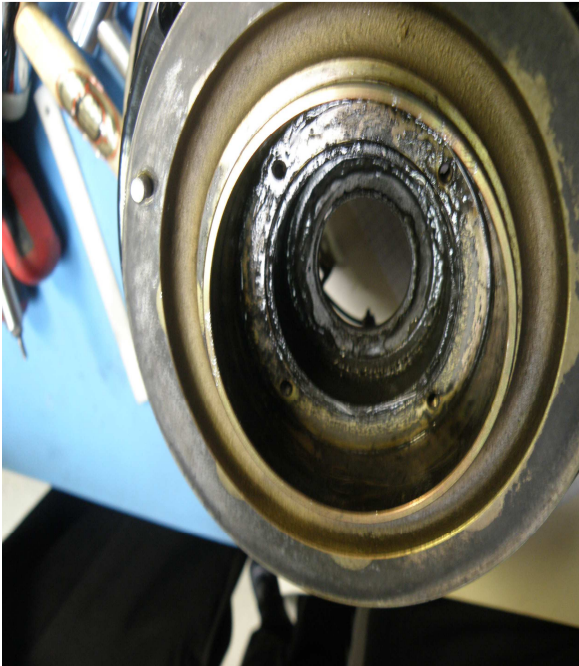
Fig. 1 - Black substance

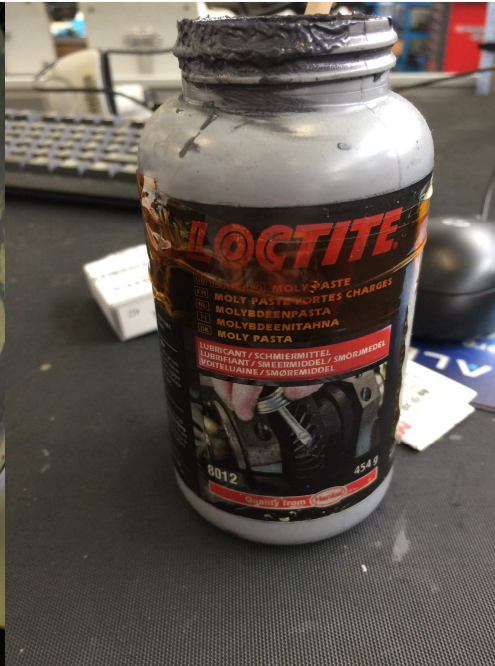
Fig. 3 – Loctite 8012

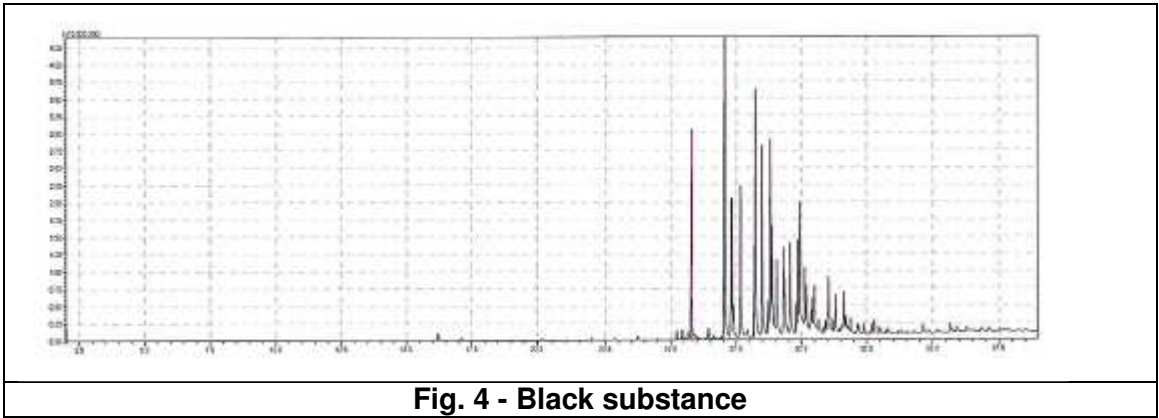
The analysis by gas chromatography-mass spectrometry (GC-MS) confirmed the presence of Loctite 8012 and engine oil O-156 in this sample.

Fig. 4 - Black substance

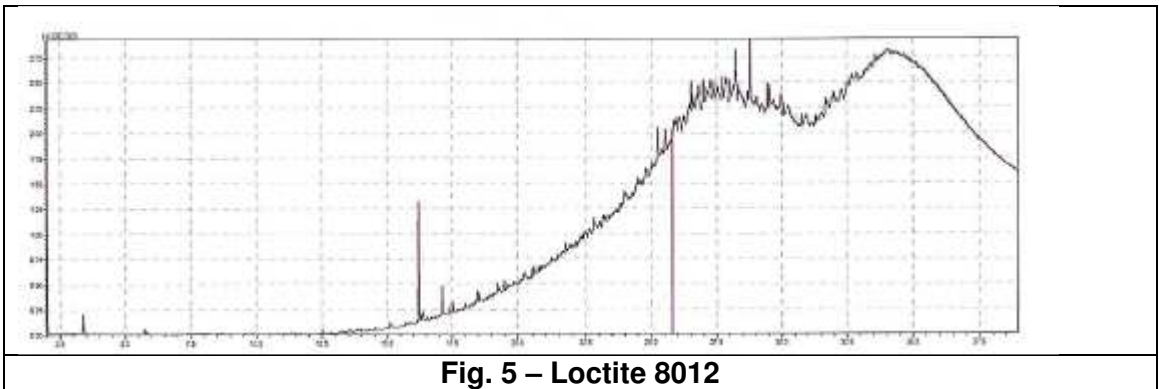
Fig. 5 – Loctite 8012

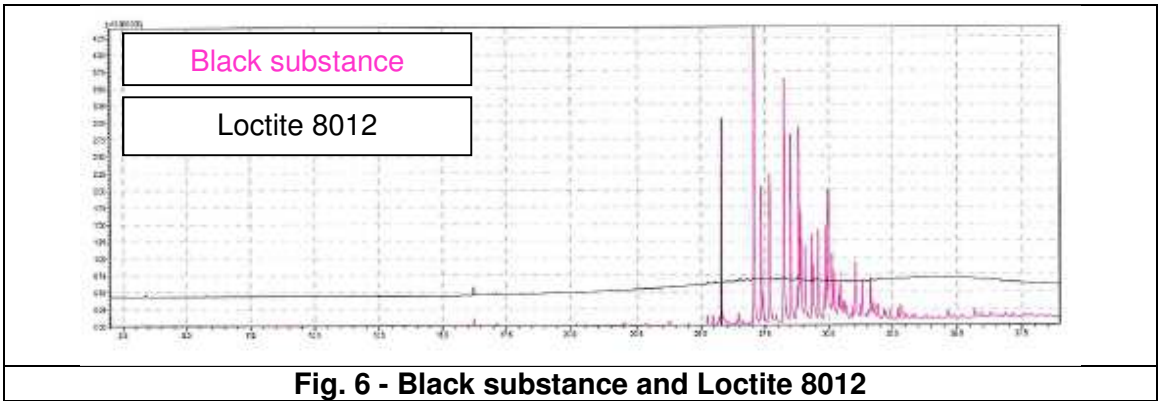
Fig. 6 - Black substance and Loctite 8012

These analyses confirmed the presence of Loctite 8012 and engine oil O-156 in this black substance.
