**BROTHERHOOD OF  
LOCOMOTIVE ENGINEERS AND  
TRAINMEN**

**NTSB Accident Number: RRD-19FR004**

**Proposed findings, probable cause, and safety recommendations in connection  
with the switching fatality on Norfolk Southern Railway Company (“NS”) at  
Bayview Yard, in Baltimore, Maryland.**

**FINAL SUBMISSION**

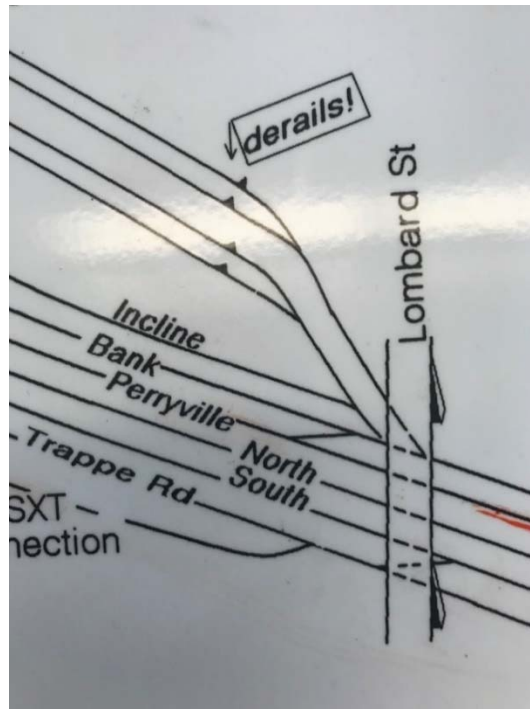
*Figure 1-* Intermodal tracks (from the top) tracks, 1, 2, 3, 4. The last switch operated by the Conductor is located from Track No. 3 under the Lombard Street bridge to shove north via the Bank track.
