**BROTHERHOOD OF LOCOMOTIVE ENGINEERS  
AND TRAINMEN**

**BEFORE THE NATIONAL TRANSPORTATION SAFETY BOARD**

**NTSB Accident Number: RRD23FR016**

**Proposed findings, probable cause, and safety recommendations in connection with the CSX Transportation employee fatality, which occurred while riding equipment during a shoving movement in the vicinity of Cumberland, Maryland on August 6, 2023**

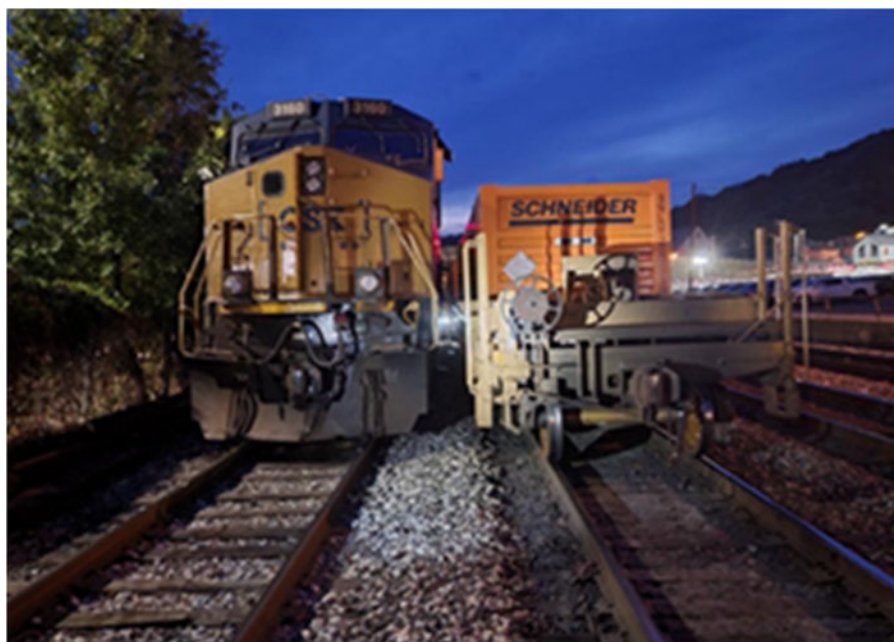
*Figure 1 – Post accident photo showing separation of involved equipment (Courtesy of BLET)*

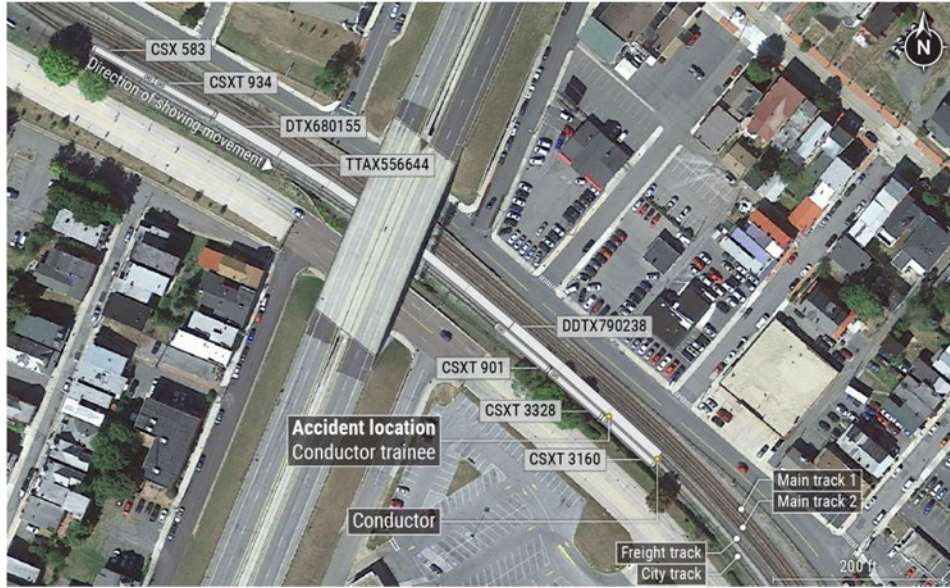
Figure 2 - Schematic of accident location, including equipment, employee and track data (Courtesy of NTSB)

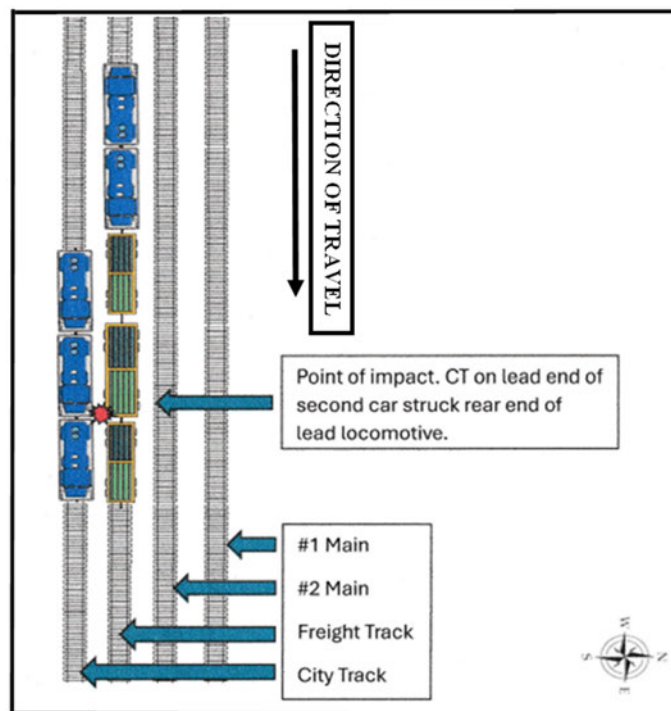
Figure 3 - Schematic of accident location (Courtesy of BLET)

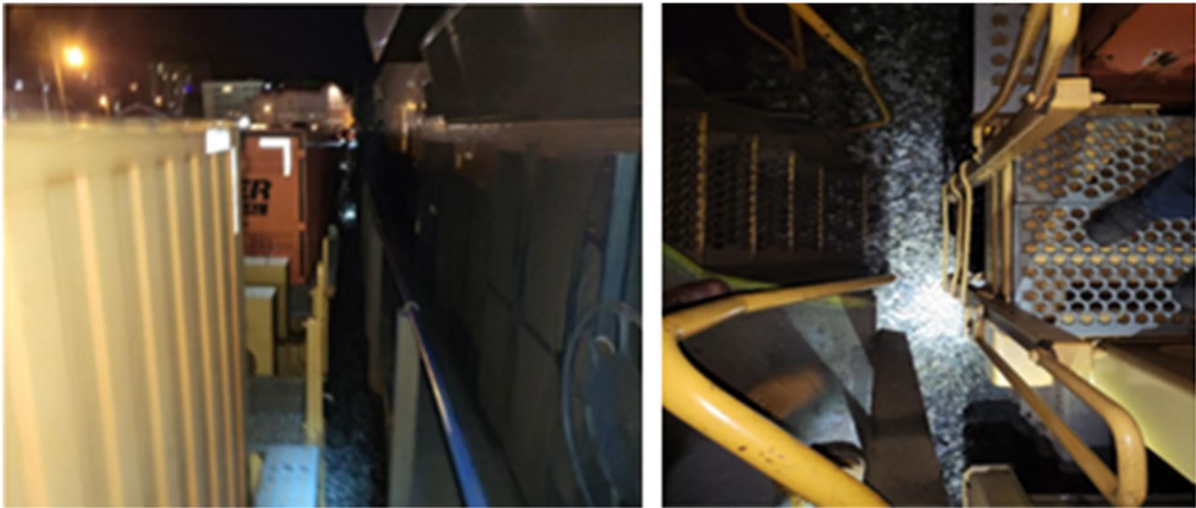
**Figure 4** – Post accident photos showing separation between equipment (*Courtesy of BLET*)

- The failure of CSXT to exercise proper precautions and protect employees from close/no clearance possibilities by developing a method of inspection which accounts for both track centerline proximity and the presence of standing equipment. At the current time, only track centerline separations are taken into account, and the responsibility of recognizing a potentially hazardous close/no clearance situation is placed solely upon the employee. When considering the movement of I13706, the initial distance between their train and the standing equipment, when first reaching the close/no clearance location, was over sixteen (16) inches, yet narrowed to approximately only seven (7) inches at the point of impact.
