**BROTHERHOOD OF LOCOMOTIVE ENGINEERS
AND TRAINMEN**

NTSB Accident Number: RRD21MR017

**Proposed findings, probable cause, and safety recommendations, in connection with
the derailment of Amtrak Passenger Train No. 7, near Joplin, Montana**

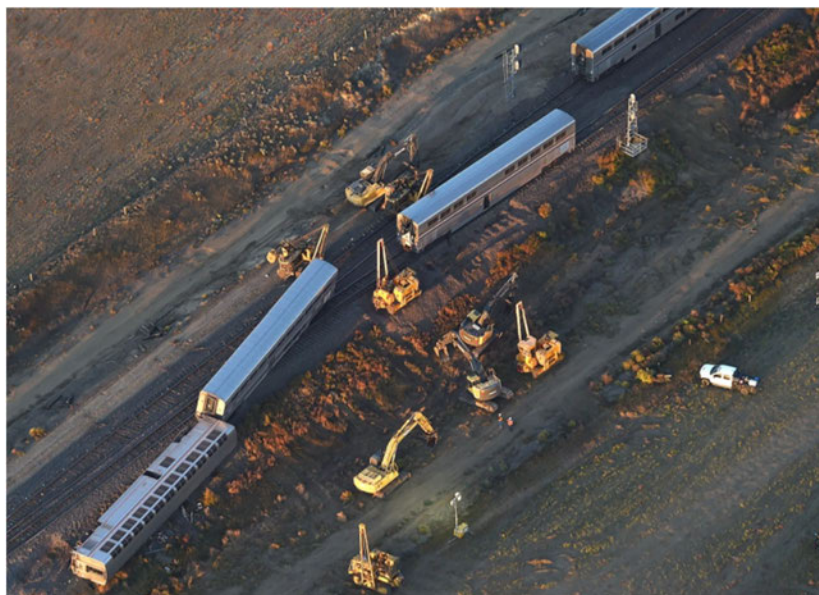
Figure 1 – Aerial photo of derailment (*Photo courtesy of Fox 4 – WDAF TV*)

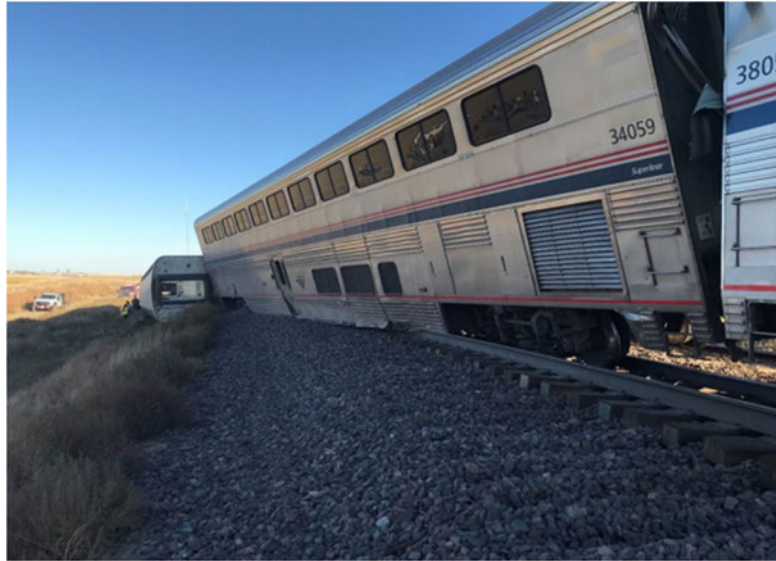
Figure 2 – Photo of derailed railcars (*Photo courtesy of NTSB*)

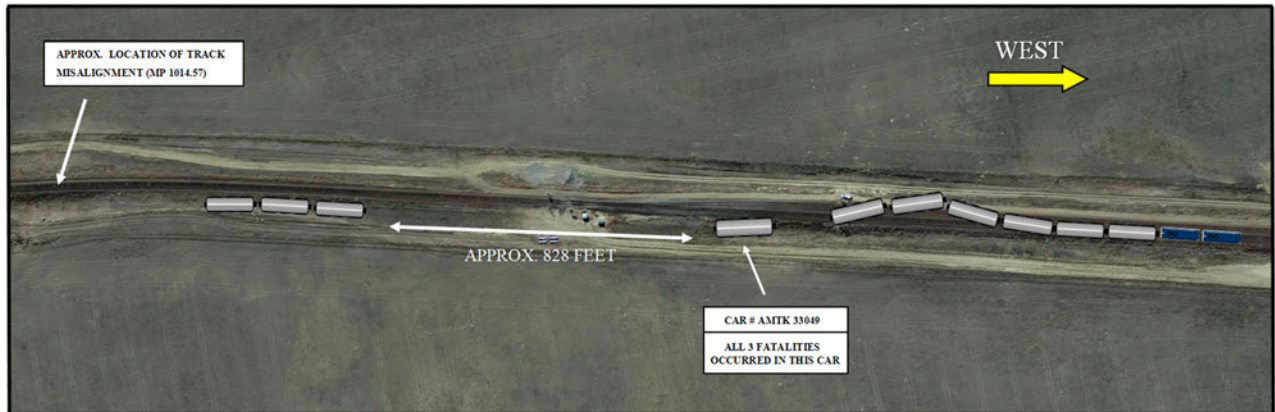
Figure 3 – Schematic of accident site (*Courtesy of BLET*)

The point of derailment (“POD”) was measured and confirmed to be at milepost 1014.57 and all eight (8) of the derailed railcars came to rest to the west of that approximate location.

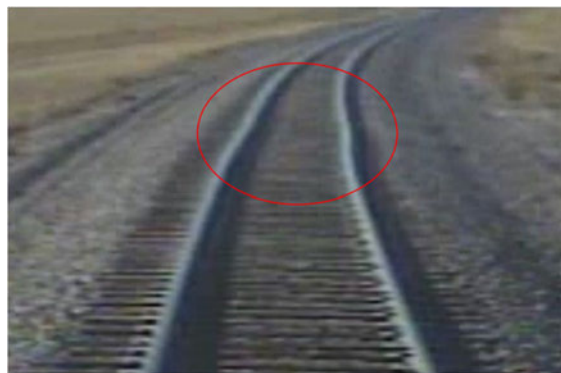
Lastly, the group observed the outward facing camera footage from Amtrak Train No. 7. which shows Amtrak Train No. 7 approaching the same area and, it was apparent that the misalignment had worsened. While attempting to pass over the area, Amtrak Train No. 7 shook laterally to the right, then left, then right again. At this point the train began to slow, and eventually stopped.

Passenger trains on freight tracks has been a safety concern of the industry for years. It is apparent that the condition of the misaligned rail worsened when the two freight trains passed over the area in the hour preceding the arrival of Amtrak train No. 7 at MP 1014.57. The FRA requires that main track be inspected twice per week with at least one day between the two required inspections. FRA regulations are minimum requirements. In the absence of technology or an appliance that could alert an operating crew to compromised track or its infrastructure, more frequent inspections where regular passenger operations are scheduled over freight tracks is indicated.

Figure 4 – Still image taken from the outward facing camera footage from the lead locomotive of Amtrak Train No. 7. This image was taken seconds before the train derailed. *(Photo courtesy of Amtrak)*

The Brotherhood of Locomotive Engineers and Trainmen concludes that the probable cause of the September 25, 2021, derailment of Amtrak Passenger Train No. 7 was the track misalignment at MP 1014.57. Amtrak Train No. 7 was travelling at the maximum authorized speed of 79 MPH when it approached the area of the track misalignment and failed to pass through the affected area safely.

1. Increase the frequency for main track inspections where regular passenger operations are scheduled over BNSF tracks until regulations or guidance are published for appliances that could alert an operating crew to compromised track or its infrastructure.
