**BROTHERHOOD OF LOCOMOTIVE  
ENGINEERS AND TRAINMEN**

**NTSB Accident Number: RRD-18FR009**

**Proposed findings, probable cause, and safety recommendations in connection with the collision of Burlington Northern Santa Fe Railway (“BNSF”) trains S-MEMSCO1-02L and W-NEESG2M1-05R in Crozier Canyon near Kingman, Arizona on June 5, 2018.**

**FINAL SUBMISSION**

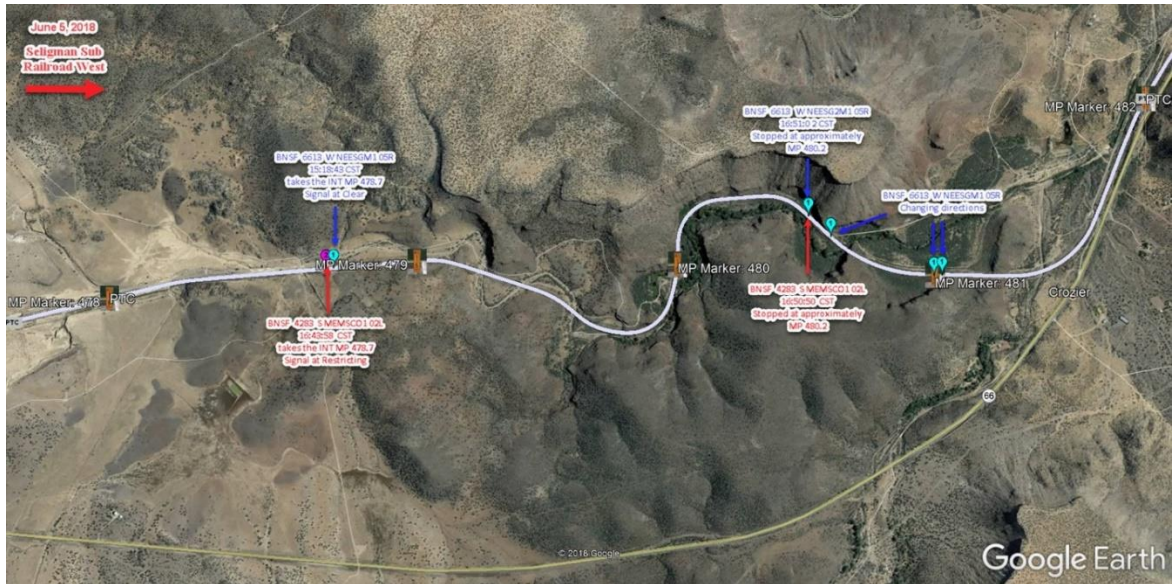
The Intermodal train was operating in a right hand 8° curve and the line-of-sight was limited by trees and vegetation. As the train negotiated the curve, they came upon the hind end of the work/rail train. When the intermodal train crew initially saw the approaching work/rail train (showing eastward towards them), they assumed that the work train was traveling east on Main Track No. 2. Moments later, both crew members realized it was on Main Track No. 1 and called out emergency on the locomotive's radio, the Locomotive Engineer simultaneously placed the train into emergency braking application. When asked if "...you could operate by the Restricting signal at intermediate signal 478.1 because you were operating at a Restricted speed under the PTC setup, and there was no warning to you that there were men or equipment in the next block" the Locomotive Engineer's response was "Correct."<sup>20</sup>

Below: Google Earth overview of layout of terrain and train movements (courtesy of BNSF).

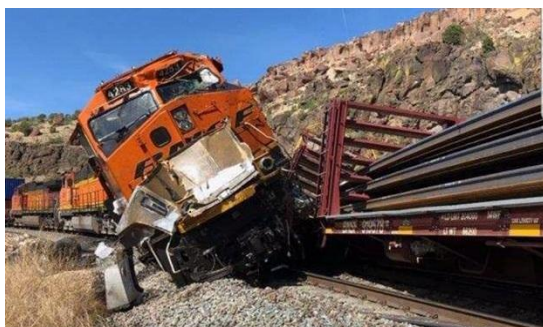
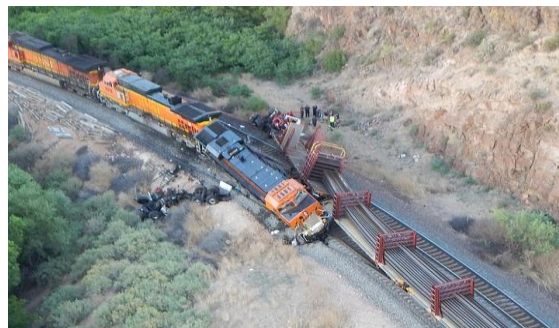
After the two (2) trains collided, the locomotive came to rest leaning to the right, and diesel fuel started to leak into the locomotive cab. Both crew members evacuated the locomotive and started looking for the crew members of the work/rail train. They immediately found the Brakeman of the work/rail train. A BNSF MOW employee that was part of the work/rail train notified the Locomotive Engineer and Conductor that there were two (2) Herzog employees trapped in the RUM truck on the south side of the tracks. The Conductor said he pulled one of the Herzog employees out of the cab of the RUM truck.

Below bottom left: photo to left is looking east at the westbound S-MEMSCO01-02L lead locomotive (courtesy of SMART)

Photo above: Drone aerial photo (photo courtesy of BNSF).

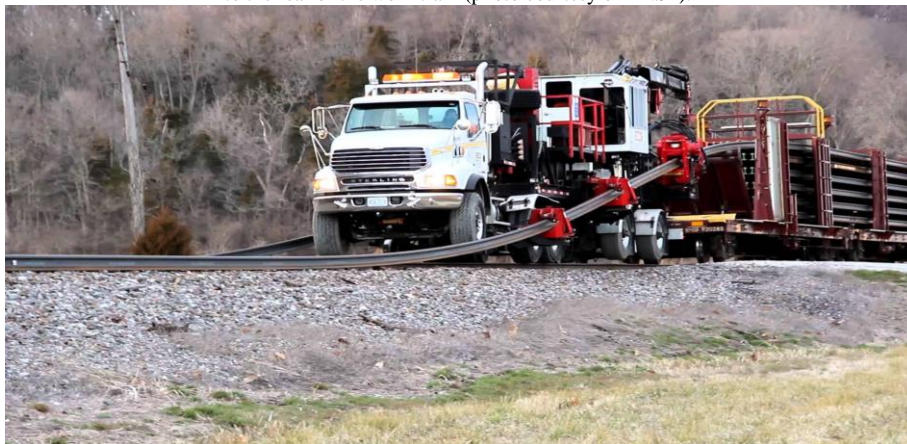
Photo below is a photo of the work train the day prior to the accident (June 4, 2019). The Rail Unloading Machine (RUM) truck is attached to the rear of the work train (photo courtesy of BNSF).

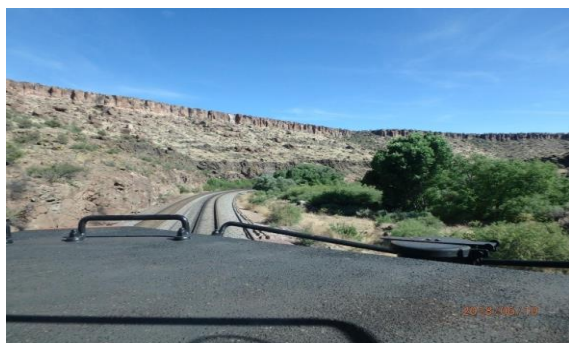
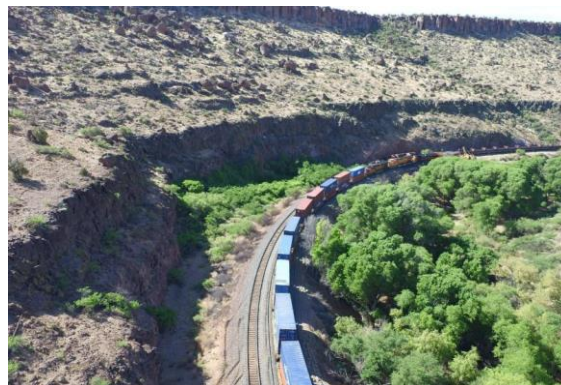
The W-NEESG2M1-05R was operating eastward in a left-hand 8° curve. Their line of sight was limited because of trees and vegetation (*see* photos below).

Photo bottom left: is of an exemplar train approaching in a westward direction where the accident occurred. Photo bottom right is overhead view of accident scene. View of the curve is obstructed by vegetation (Photos courtesy of NTSB)

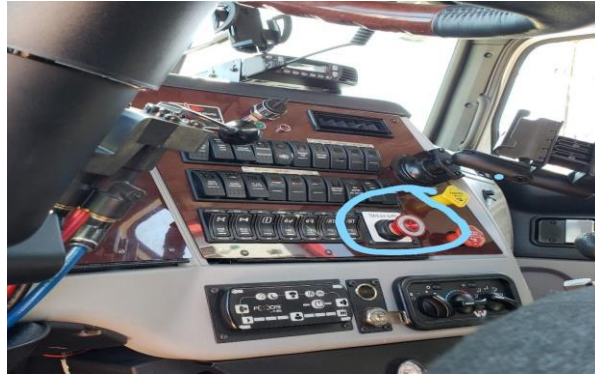
During his interview, the Brakeman stated “When we were done laying rail, we started shoving back to drop off maintenance of way person at the truck. We entered the curve, I could see 10 cars, so I gave a 10-car count. Right after that, I saw the train coming around the corner. I said hot rail on the radio to warn the work train, because it looked to be on Main 2. Seconds later I saw it was on our track. I said something over the radio. I can’t remember the exact words. I plugged<sup>26</sup> the train and jumped, jumped out of the truck, pretty much all at the same time.”<sup>27</sup> During the interview the Locomotive Engineer of the work train said, “There was communication just before the incident of somebody on the radio saying, ‘stop, stop work train’, and then ‘plug it’.”

Photo of the inside cab compartment of the RUM truck. The Trainline Emergency Switch (which the Brakeman of the work/rail train activated) is circled (photo courtesy of BLET)
