**BROTHERHOOD OF LOCOMOTIVE ENGINEERS  
AND TRAINMEN**

**NTSB Accident Number RRD22MR010**

**Proposed findings, probable cause, and safety recommendations in connection with the highway/grade crossing collision and subsequent derailment of Amtrak Passenger Train No. 4-25A near Mendon, Missouri**

**Final Submission**

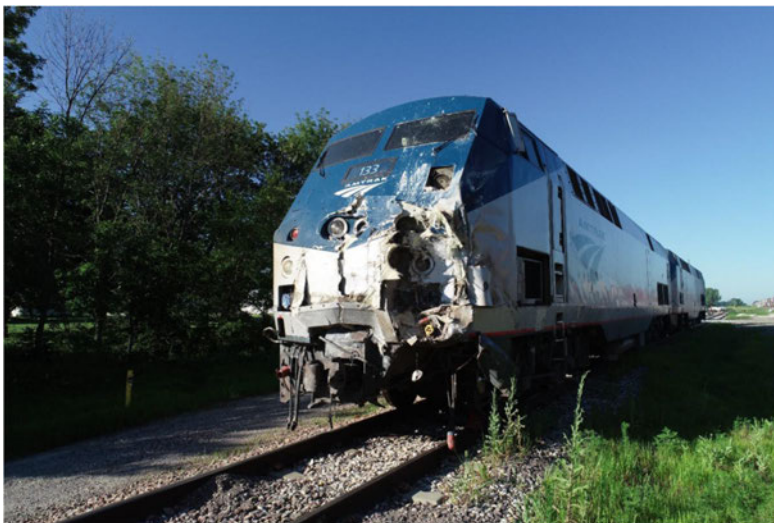
**Figure 1** – Photo showing damage to lead locomotive ATK No. 133 (*Photo courtesy of NTSB Highway Factual Report*)

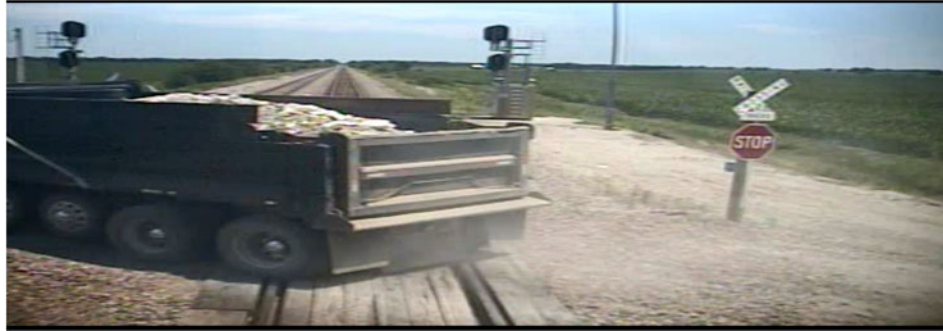
Figure 2 – Still image from the outward facing camera (a.k.a. a TIR) from ATK 133 prior to impact (*Photo courtesy of NTSB*)

At 12:42:36 p.m., the Locomotive Engineer sounded the horn while traveling at 89 MPH. The whistle continued for approximately 2.7 seconds as Train No. 4-25A traveled approximately 353 feet. The Locomotive Engineer sounded the whistle again approximately one (1) second later while still traveling at 89 MPH as Train No. 4-25A traveled an additional 391 feet. Locomotive event recorder data indicates the two (2) horn warnings were sounded at identical lengths and spacing. The locomotive event recorder revealed that after the second whistle warning was sounded, the Locomotive Engineer attempted to further warn the approaching vehicle by sounding a succession of short whistle blasts. In the review of the TIR, the vehicle was observed proceeding through the crossing without stopping.

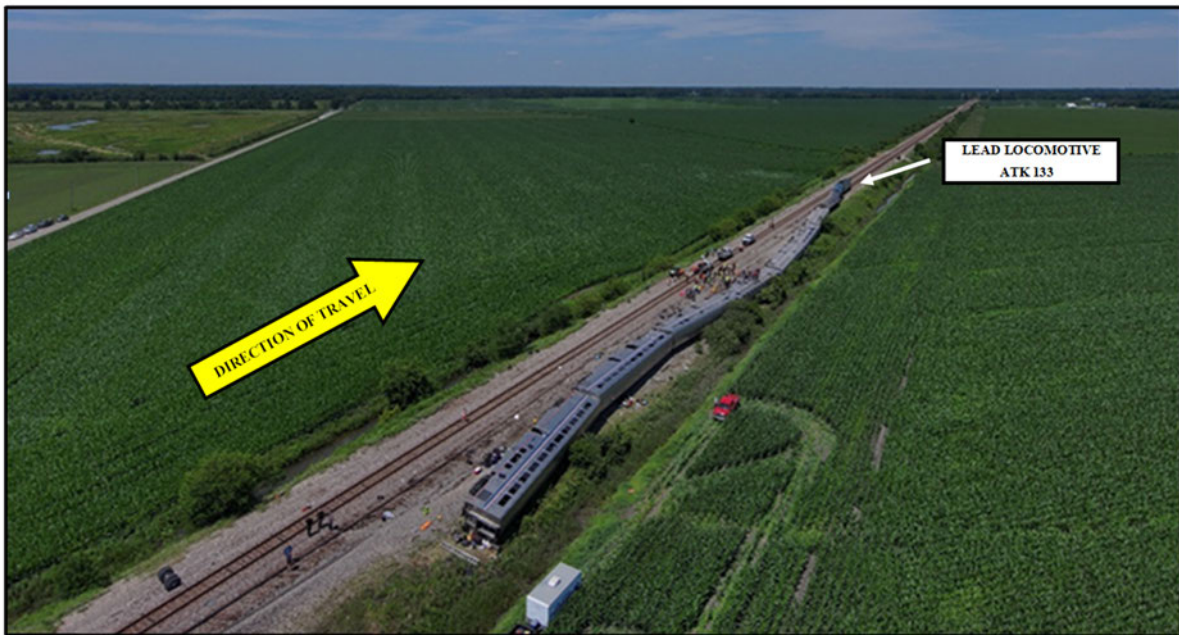
**Figure 3** – Post accident aerial view of Amtrak Train No. 4-25A (Photo courtesy of Missouri Highway Patrol with graphics added by BLET)

After impact, Amtrak Train No. 4-25A traveled an additional 1,111 feet in approximately 16 seconds before coming to rest at 12:43:02 p.m. A review of the BNSF Train Dispatcher recordings revealed that at 12:43:35 p.m. the Locomotive Engineer provided the Train Dispatcher the details of the accident location. The Locomotive Engineer then exited the locomotive and observed that all of the train’s passenger cars were derailed with many on their sides. He returned to the locomotive and informed the Train Dispatcher to send as many emergency response personnel as possible.

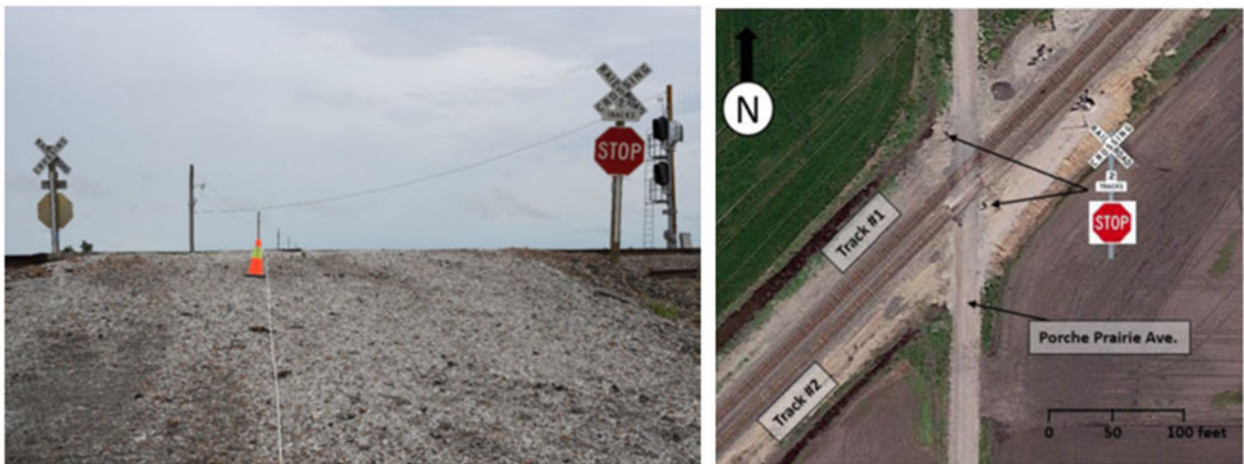
**Figure 4-** View of stop sign, crossbucks, and grade at Porsche Prairie crossing (Photos courtesy of Missouri Highway Patrol and NTSB Highway Factual report)

The crossing was equipped with passive traffic control devices, consisting of stop signs and crossbucks, located on the right side of the road in direction of travel. The signage was approximately fourteen (14) feet from the roadway edge. The crossing of Porsche Prairie Avenue over BNSF trackage is on a right skew of approximately 45°.

Early recommendations of the American Association of State Highway and Transportation Officials (“AASHTO”) manual recommended that intersection of no less than 60°. An AASHTO manual revision in 2018 recommends crossing angles be as close to 90° as practical and no less than 75°. The AASHTO manual describes “skew” intersections as anything less than 90°. The

manual further describes skewed intersections as undesirable because they can result in a driver having to turn their head at a larger angle to see, with components within the vehicle potentially obstructing or restricting drivers view. The current AASHTO policy recommends roadway approach surface not slope down more than 3 inches in 30 feet from the nearside rail.

1. Commence audit to identify grade-crossings along trackage where the grade-crossings have fallen out of AASHTO standardization and close or bring identified grade-crossing up the current AASHTO standards.
2. Immediately bring County Road 113 (Porsche Prairie Avenue) up to AASHTO standards, or permanently close the grade-crossing if the crossing cannot be brought up to the standards.

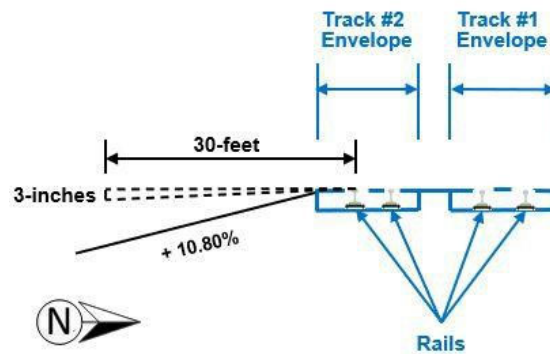
- The highway grade crossing at County Road 113 (Porsche Prairie Avenue) was of such a severe grade and angle it hindered driver visibility and navigation.

**Figure 5** – Diagram showing the AASHTO standard related to the actual grade crossing approach measurements. (Graphic courtesy NTSB Highway Factual Report)
