**BROTHERHOOD OF LOCOMOTIVE ENGINEERS
AND TRAINMEN**

BEFORE THE NATIONAL TRANSPORTATION SAFETY BOARD

NTSB Accident Number: RRD20LR005

Proposed findings, probable cause, and safety recommendations, in connection with the derailment and subsequent partial fire of railcars on a Union Pacific Railroad (“UPRR”) mixed freight train near Tempe, Arizona on July 29, 2020

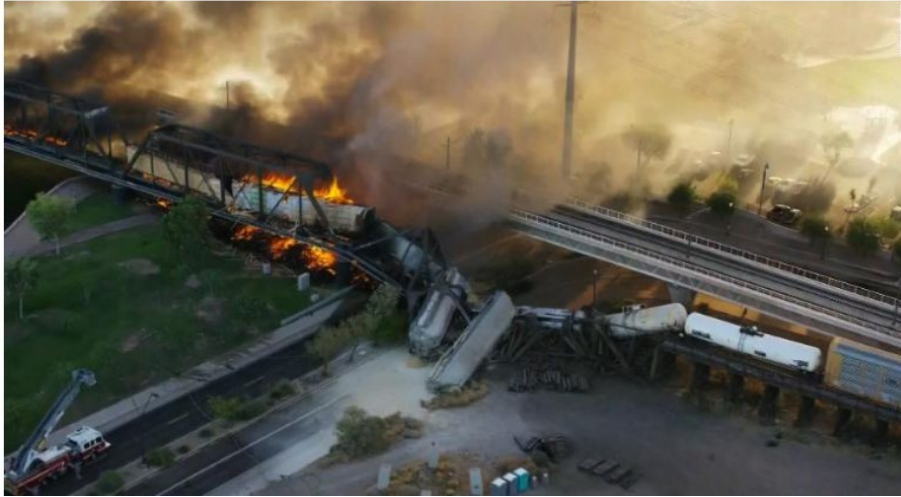
The derailment occurred on the Tempe Town Lake Bridge, resulting in a bridge strike, fire and collapse of the first bridge span. The derailed cars included three (3) hazardous material tank cars of cyclohexanone,⁴ two of which fell from the bridge. Weather reports from the nearby Phoenix Sky Harbor International Airport reflected at the time of the derailment established the temperature was approximately 90° F with winds from the north to northwest at five (5) to eight (8) miles per hour (“MPH”). The skies were clear with a visibility of ten (10) miles. Damages are estimated at approximately \$8.5 million.

Figure 1 - Overview of derailment (Photo courtesy of CNN)

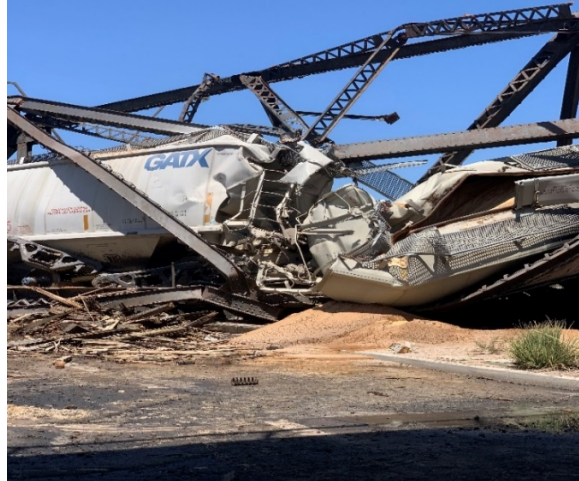
The derailment and subsequent fire caused the Tempe Town Lake Bridge to collapse onto the Rio Salado Parkway (*see figure 2*). The Parkway was shut down on account of debris, fire containment and hazardous material clean up. A relatively small area was evacuated. Air traffic from Phoenix Sky Harbor International Airport was diverted away from the area account heavy black smoke accumulation. Two emergency responders were treated and released from a local hospital for minor injuries.

Figure 2- Photo of Rio Salado Park way after bridge collapse (Photo courtesy of SMART-TD)

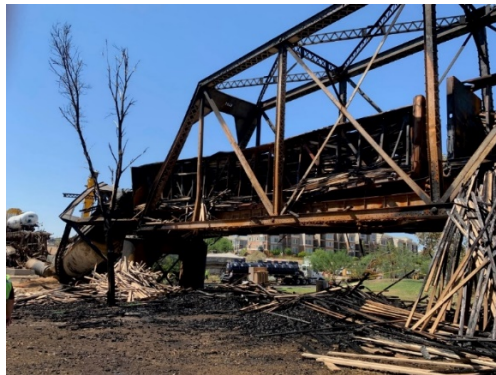
The point of derailment (“POD”) was estimated to be MP 913.9 and the general pileup of the twelve (12) derailed cars came to rest to the north of that approximate location (*see Figure 3 below*).

Figure 3 – Photo of derailed cars after fire was extinguished (Photo courtesy of SMART-TD)

The Brotherhood of Locomotive Engineers and Trainmen concludes that the probable cause of this accident and the derailment of twelve (12) railcars was the failure of the north rail at MP 914.0 due to compound fracture fissures. The derailment, led directly to the subsequent bridge strike and eventual partial bridge collapse.

1. Ensure compliance with existing UP Bridge Safety Management Program (“BSMP”) standards and procedures emphasizing inner guardrails on bridges spanning areas that are commonly occupied by citizens, or areas that would pose great risk to the environment.
