**BROTHERHOOD OF LOCOMOTIVE ENGINEERS
AND TRAINMEN**

NTSB Accident Number: RR21FR008

**Proposed findings, probable cause, and safety recommendations in connection
with the switching fatality on Burlington Northern Santa Fe Railway Company
("BNSF") property at Buena Park Yard, in La Mirada, California.**

FINAL SUBMISSION

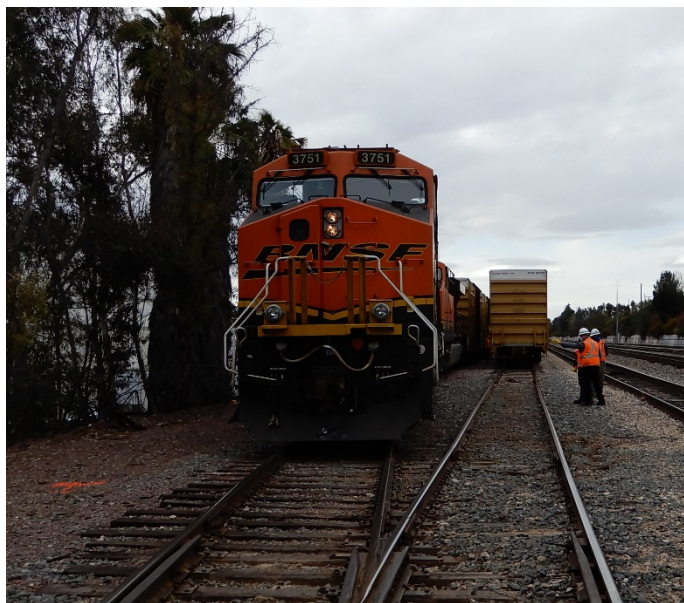
Figure 1- View of accident scene. Photo was taken post-accident. Car TBOX 642811 has been moved to the west to facilitate emergency response *(Photo courtesy of NTSB)*

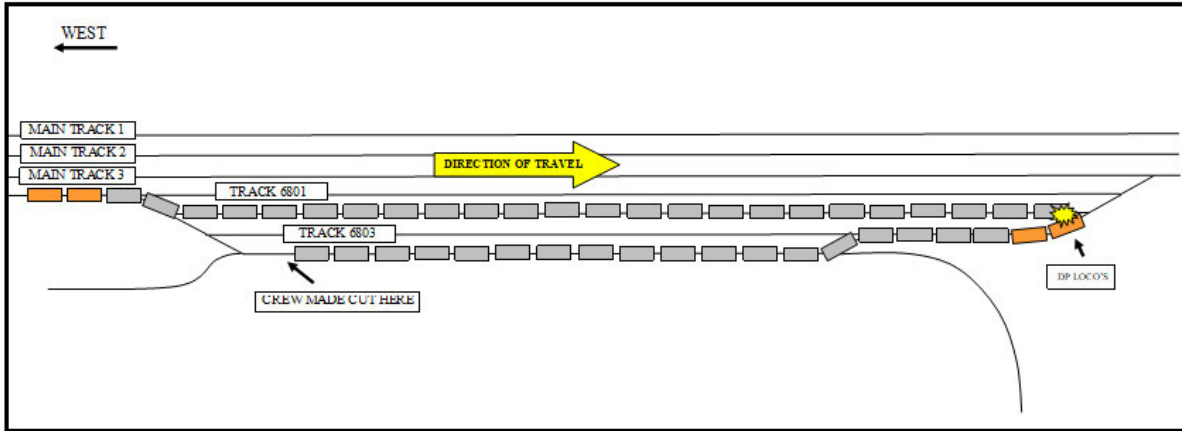
Figure 2- BNSF Buena Park Yard schematic of accident (Courtesy of BLET)

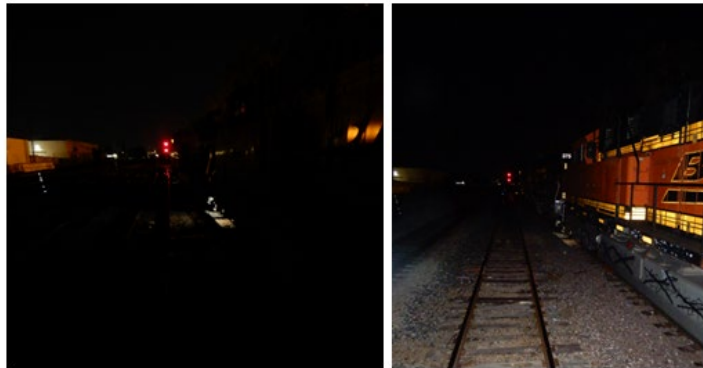
1. The Buena Park Yard facility contains no fixed lighting. Thus, the Conductor's visibility was reduced. The fouling point would have been much harder to determine, because he would have been relying solely upon a handheld lantern or flashlight (*see Figure 3*).

Figure 3 – Side by side comparison of view from the railcar that was being ridden by the Familiarizing Conductor and the fatally injured Conductor (TBOX 642811). Picture on left shows view with no lighting as probably seen by Conductor. Picture on right shows perspective when ambient lighting is provided. (*Photos courtesy of NTSB*)

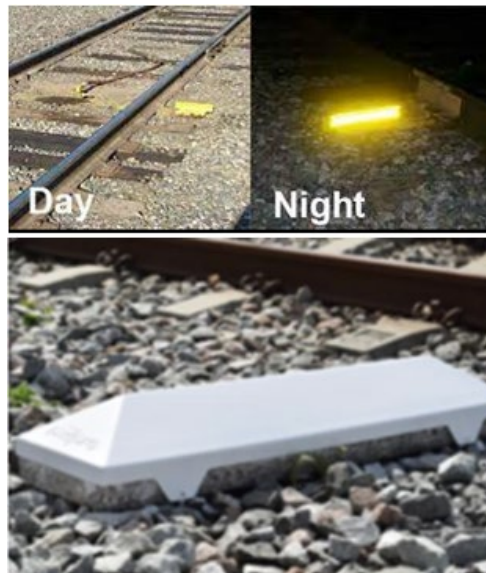
Figure 4 – *Examples of illuminated clearance markers*

1. Enhance the training program to document that Conductor Trainees are trained on every aspect of their assignment and are aware of restricted safety tracks that could cause injury prior to qualifying.
2. Enhance the training program to include extensive training on dismounting moving equipment in emergency situations.
3. Install high visibility clearance markers (*see Figure 4*) in all areas where regular switching operations occur throughout all times of day.
4. Identify and implement changes to improve yard lighting in all areas where regular switching operations occur.
