**BROTHERHOOD OF LOCOMOTIVE ENGINEERS
AND TRAINMEN**

BEFORE THE NATIONAL TRANSPORTATION SAFETY BOARD

NTSB Accident Number: RRD21LR009

Proposed findings, probable cause, and safety recommendations, in connection with the switching fatality that occurred on the Burlington Northern Santa Fe (“BNSF”) Railway within the Dyno Nobel facility in Louisiana, Missouri

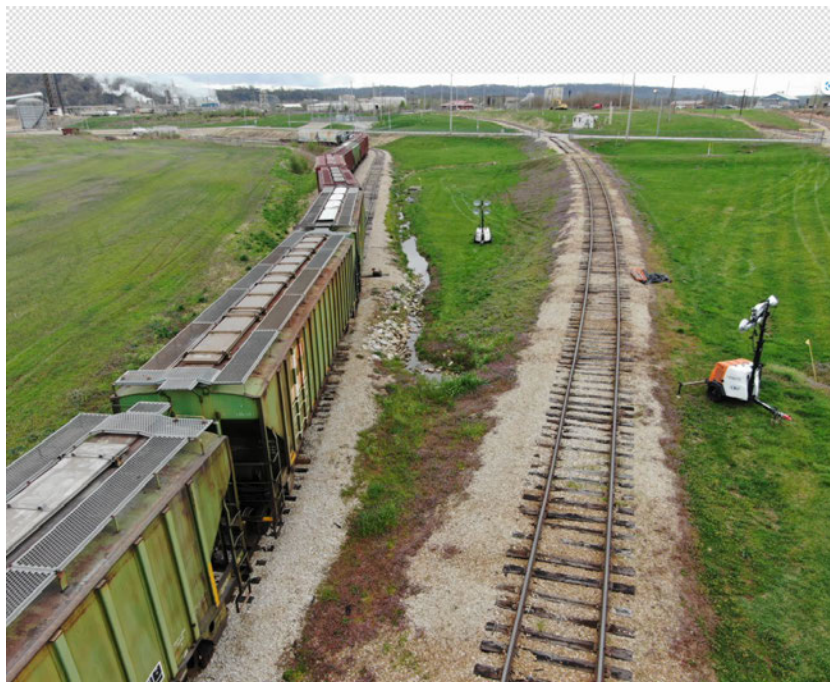
Figure 1 – Photo of accident site (Photo courtesy of NTSB)

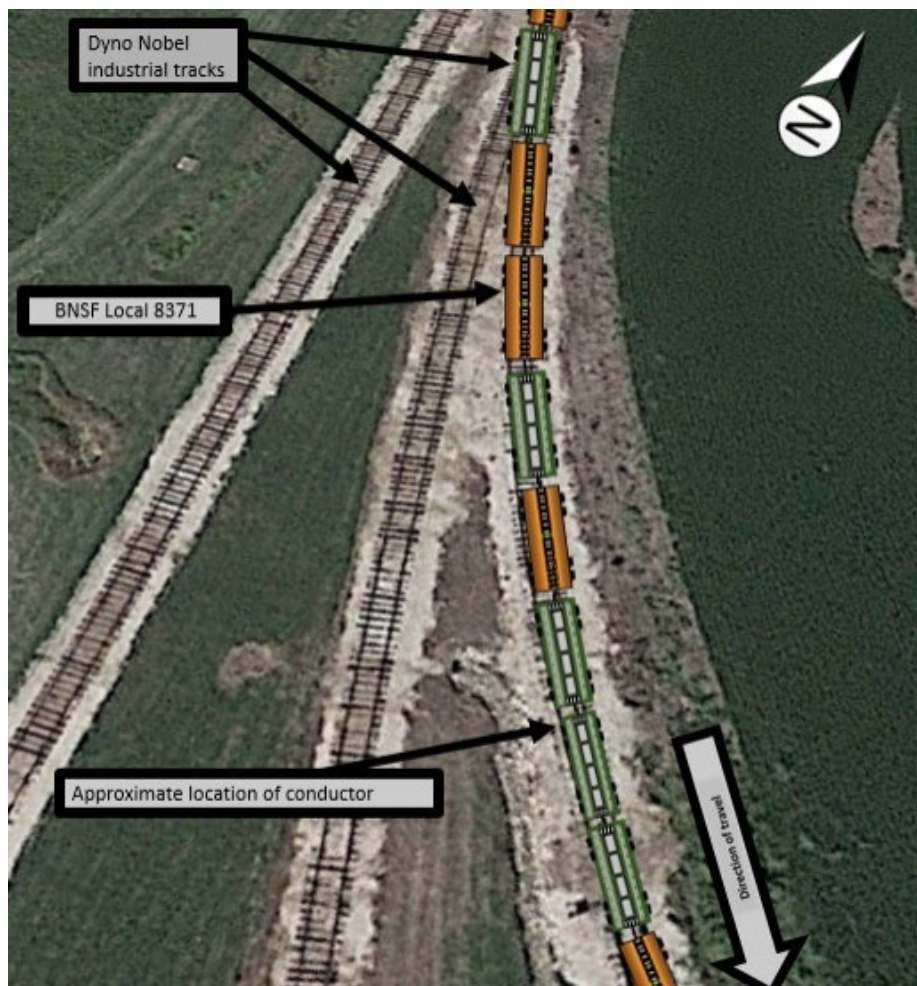
Figure 2 – Schematic of accident site (Courtesy of NTSB)

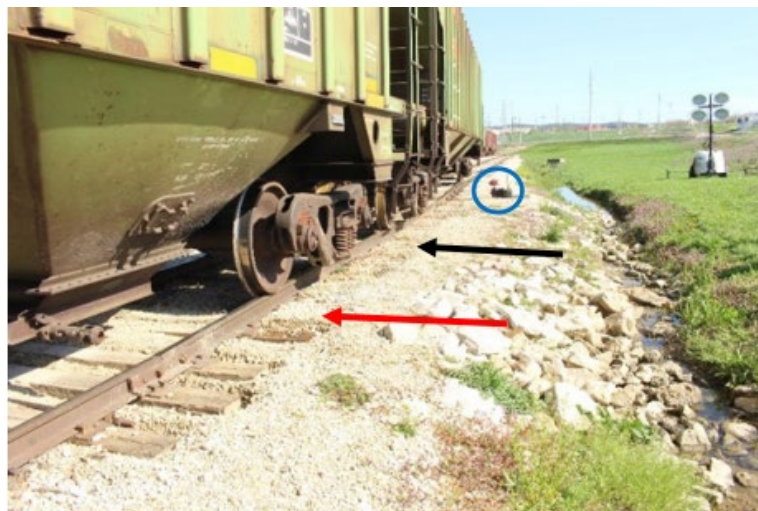
Figure 4 - Photo of the accident site. The red arrow indicates the location of the slide marks found by the coroners. The black arrow indicates the location of the final resting position of the Conductor. *(Courtesy of NTSB)*

During the inspection of the area, it was noted that large rocks were located on the south side of the track near a decline leading to a drainage ditch (in the area where the Conductor was walking). The measurements taken revealed the distance from the end of the rail ties to the large rocks only allowed twenty-one (21) inches of walking space.

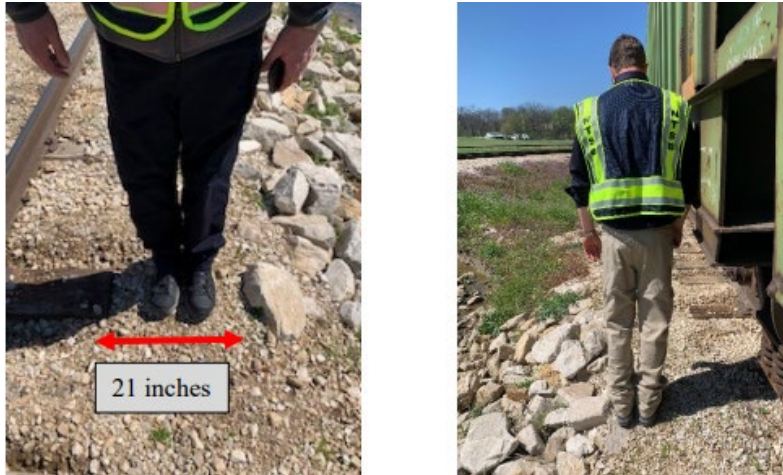
Figure 5 – Photos showing walking condition at the Dyno Nobel facility. The photo on the left shows the width of the walking space between the edge of the railroad ties and the adjacent rocks where the slide marks in the ballast were found. The photo on the right shows the walking space for an average sized person. *(Courtesy of NTSB)*

The State regulatory requirement is clear and the location where the employee was fatally injured is not in compliance with the State regulation. The record of the accident investigation is devoid of any existing waivers issued to the facility. Nor are there any records of State inspections. The BNSF employees are not trained by BNSF, or any other employer for that matter, on the requirements of the State regulations for walkways within Industrial Railroad tracks.

The Brotherhood of Locomotive Engineers and Trainmen concludes that the probable cause of the April 7, 2021, switching fatality at the Dyno Nobel facility was the noncompliant walkway provided by the facility for the employee to perform trackside duties. The employee's decision to

1. Ensure all industries where BNSF switch crews perform service have acceptable walking conditions. Verify that locations where regular switching occurs there is proper clearance for train crews to perform their duties.
2. Enhance the safety culture to prevent accidents and incidents in the future, including enhancements and improvements to local safety processes to ensure employees can report any unsafe conditions to their supervisors.
3. Ensure, through regular inspections, that all customers are in compliance with all Federal, State and Local regulations regarding Industrial Railroad tracks.
