**Reed, PA
RRD22LR003**

**NTSB Accident Number:
RRD22LR003
December 8, 2021**

**Proposed findings, probable cause, and safety recommendations, in connection with the fatal
injury of a National Salvage Employee working on
Norfolk Southern Railway Company- Buffalo Line near Reed, Pennsylvania**

Final Submission

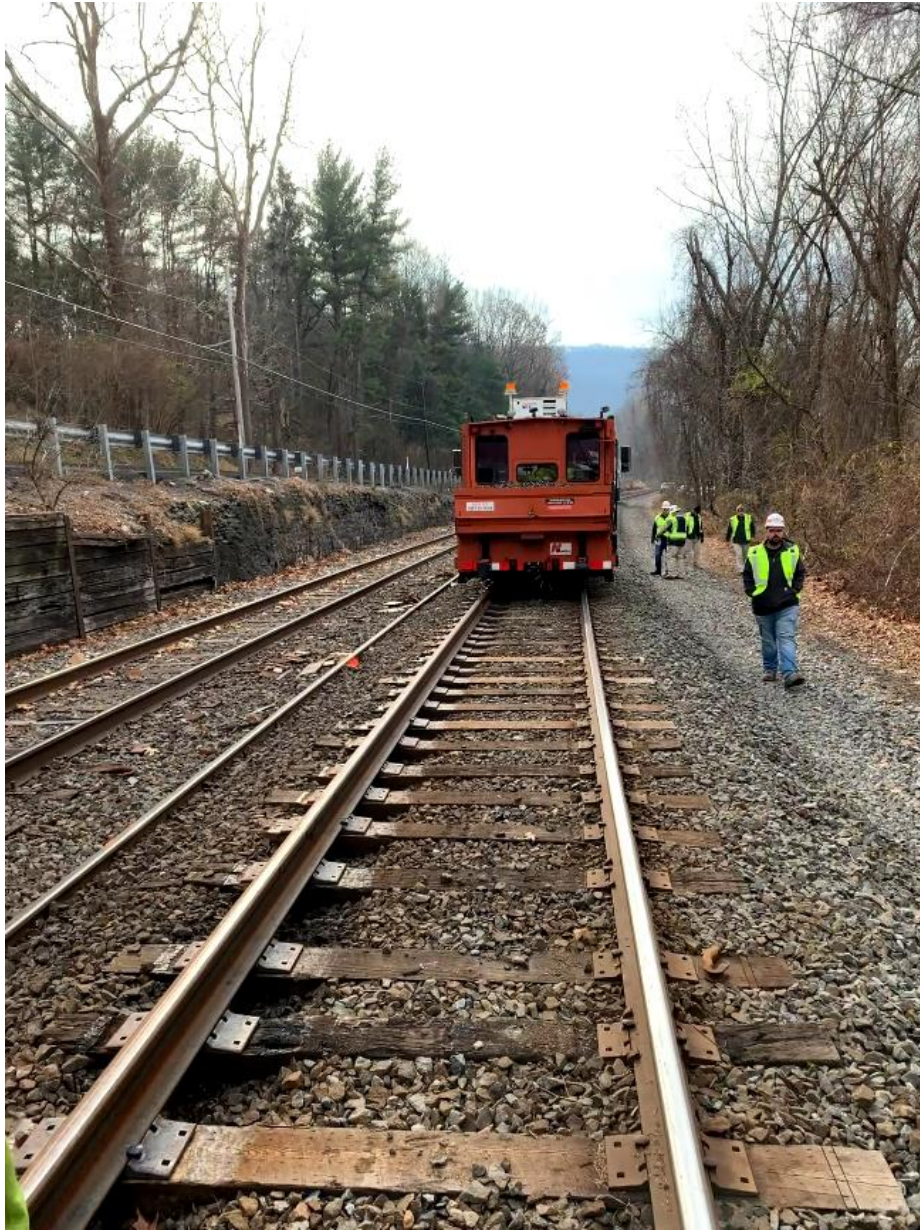
After the old rail was removed and the new rail installed, the spiking machine involved in the accident (known as Spiker No. 2) was installing cut spikes to secure the newly installed continuous welded rail (CWR) to the crossties. At the time, Spiker No. 2 was working southward and was situated between two other working spiking machines to the front and rear. The operator of the second machine, Spiker No. 2, observed that he had closed the gap between his equipment and Spiker No. 1 and decided to back up to assist Spiker No. 3. The NSSC employee was assigned to work with the NS gang that was replacing rail. The NSSC employee was marking rail to be removed and collected by other members of the work crew positioned behind Spiker No. 3. The NSSC employee was seen crossing from the east side to the west side of the track in front of Spiker No. 1 approximately five to seven minutes before the accident. He then crossed behind Spiker No. 1 from the west side to the east side of the track, continuing past Spiker No. 2 in a north direction between the main track and siding track. Subsequently, Spiker No. 2 had worked up to Spiker No. 1. Spiker No. 2's operator changed his spiking pattern from rail-spike pattern to anchor-spike pattern and spiked the tie he was on. He said he blew his horn three times, looked in the left rear-view mirror, and moved the machine in reverse, traveling north to help Spiker No. 3. During the reverse movement, Spiker No. 2 struck the NSSC employee, coming to a stop on top of him. The operator immediately called for help over the radio. Crews tried to utilize the equipment's turntable to free the NSSC employee but were unsuccessful. A crane was later used to lift the equipment to extricate the injured worker. The employee sustained fatal injuries as a result of the accident. Information obtained at the scene, when the accident occurred, the employee stood within the track gauge.

Figure 1: Rear of Spiker No. 2, viewed from the north.

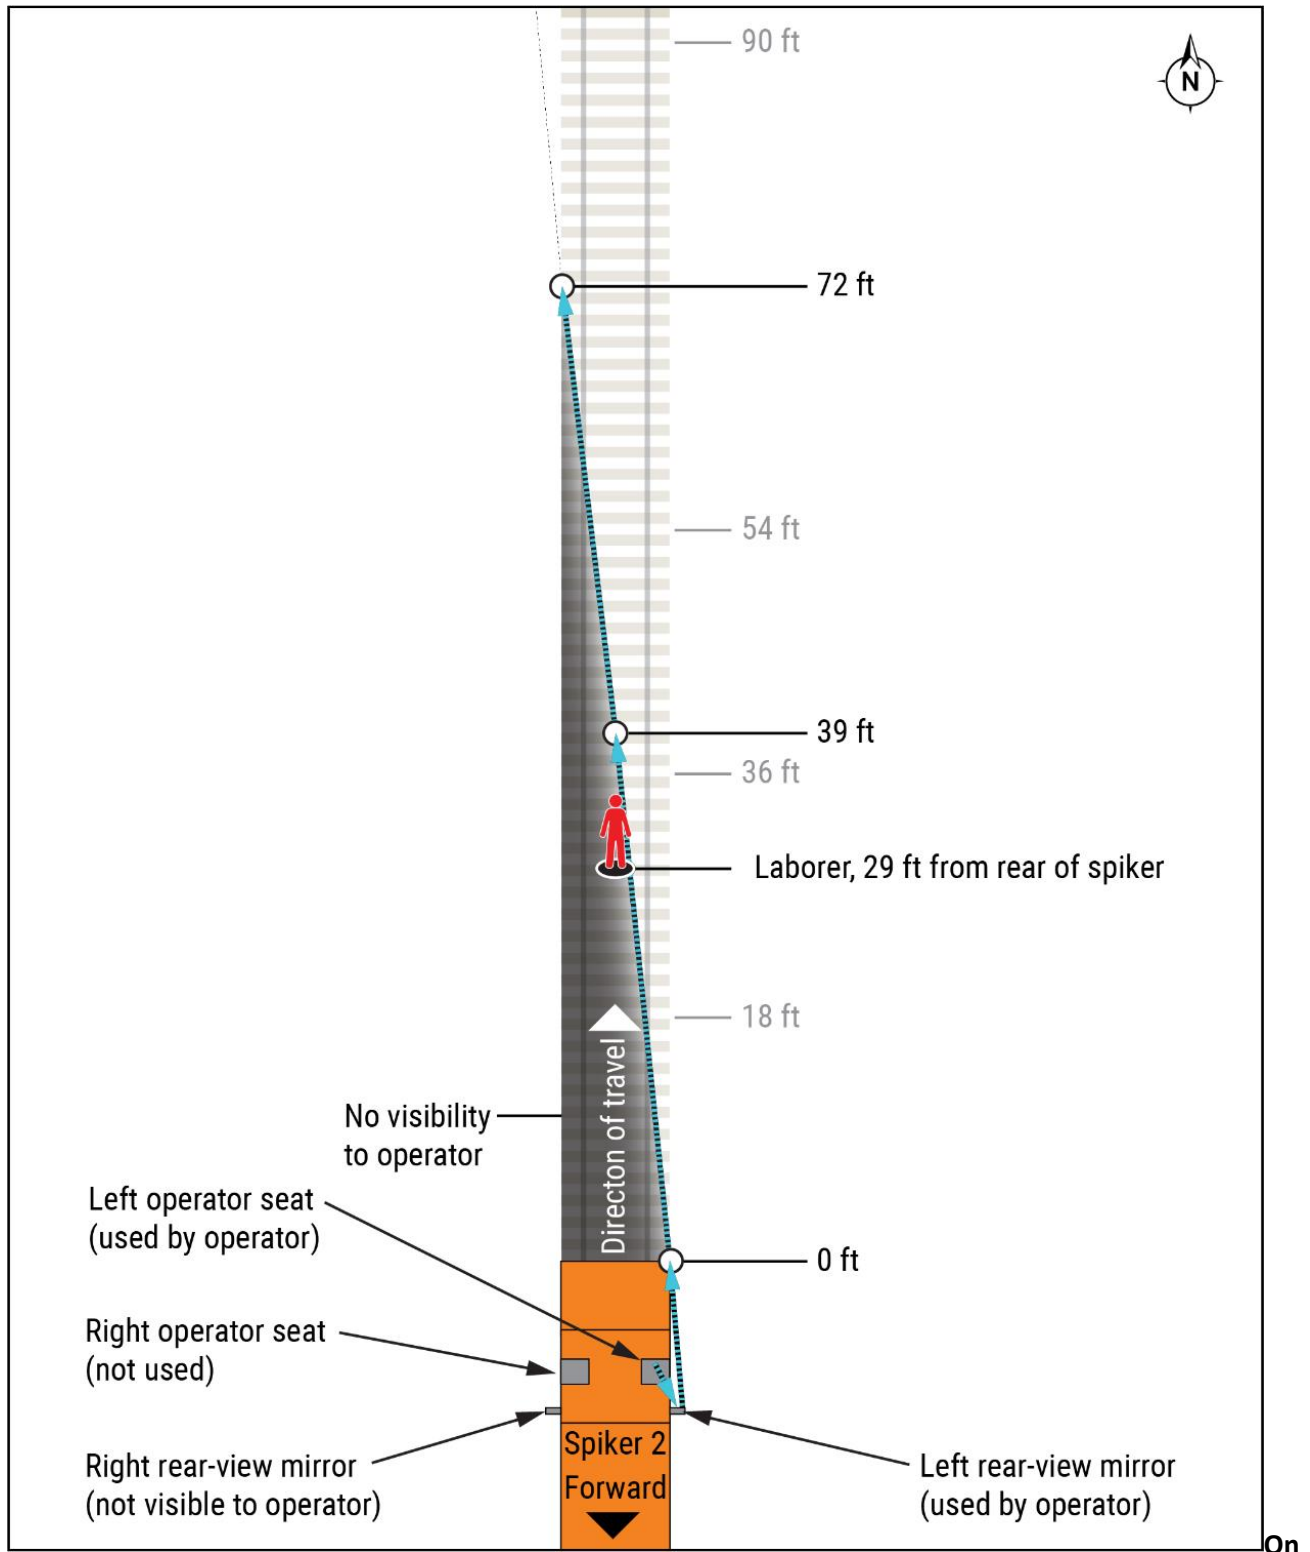
Table 1. Spiker 2 Visualization of Visibility Observation Test (Provided by NTSB)

Investigators conducted a visibility observation test. Two investigators roughly about the same sizes as the Spiker No. 2 operator and the NSSC employee were chosen. One investigator sat in the cab of Spiker No. 2 and looked out the left rear-view mirror while sitting in the left seat.² The right mirror is not visible from this position. The other investigator moved to different positions behind the spiker. Specifically, the team member

stood on the left side of the track (on the tie – outside the gauge) and walked north (away from the spiker) until partially visible, then fully visible, and the distances were noted (see chart below). Making the same observations and having the team member stand on both the center and right sides of the track was recorded.

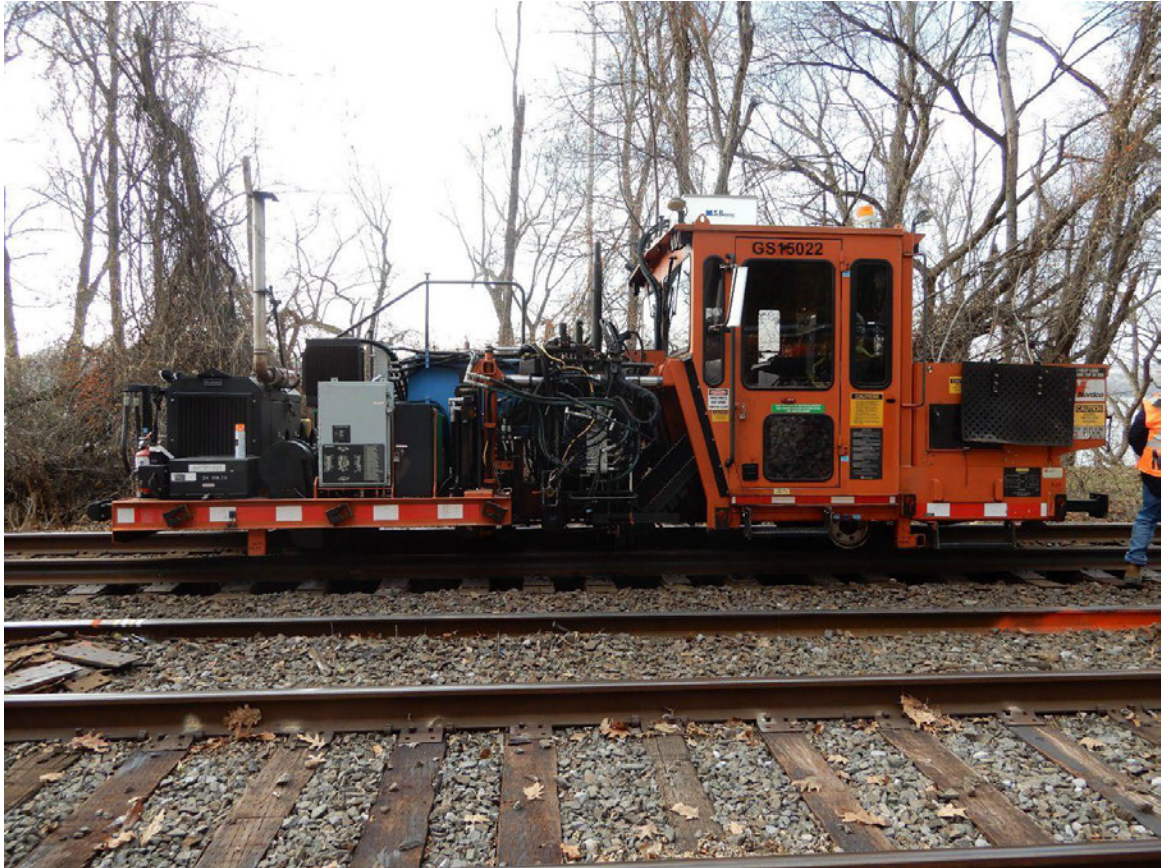
Spiker No. GS 15022 was the second spiker in Gang R12 and the RMM involved in this fatal accident. It was built in December 2015 by Nordco, Inc. The machine is known as a “SE Hammer, Production Spike Driver.” A spiker is a rail-bound machine designed to drive spikes into place using opposing hydraulically driven, high-impact spiking hammers. The spikes are fed from a bin on the rear of the machine into a loading mechanism by the operator or a track laborer in the cab. The enclosed climate-controlled cab is designed with seating for two spike hammer (gun) operators (one on each side) and one feed tray operator (laborer). The machine is powered by a 140-horsepower, 140 Amp alternator, Tier III diesel engine. Travel along the rail is accomplished with a variable hydrostatic pump and motors through a four-wheel, dual-axle, chain-driven propulsion system. The friction brake system includes spring-applied, hydraulically released brake shoes on each of the four wheels. The machine includes a 90-gallon diesel fuel tank and a 110-gallon hydraulic fluid tank. The operator controls the system with electronic joysticks positioned at both operator seats.

Figure 2. Photograph of NS Spiker GS 15022 near its post-accident resting position (NSTB Photo)

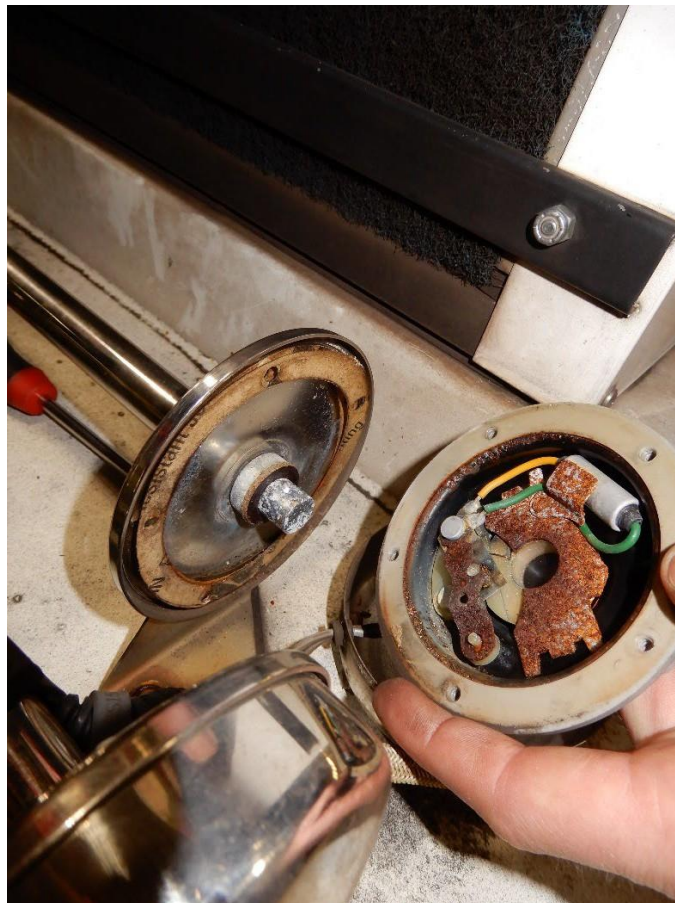
During subsequent investigative activities on the following days, investigators noted the horn on Spiker GS 16043 was noticeably louder than Spikers 2 or 3. Investigators were able to secure Spiker 2 in a secure NS facility in Enola, PA, on December 13, 2021. At this location, an investigator positioned himself on the roof of the spiker. The horn system consists of four trumpets, two facing forward and two facing backward. Investigators cycled through each button in the cab for horn activation. It was determined that only one trumpet produced sound, a front-facing trumpet. The other front-facing trumpet, and both rear-facing trumpets, did not make any audible sound. Investigators returned to the spiker on January 25, 2022. The rear cover of the leftmost, rear-facing horn was removed. The interior of the horn motor coil, contacts, and the plate were photographed. All these internal parts were heavily corroded and rusted.

Figure 3. The interior condition of a horn trumpet.

The horn was reassembled. The forward-facing and the rear-facing banks of horns were unplugged from the roof-mounted connectors. A new, known working set of horns were temporarily connected to each horn connector (one for the forward-facing bank, one for the rearward-facing bank). The horn circuit was tested from a horn button in the cab; the new horns properly functioned while plugged into each connector.

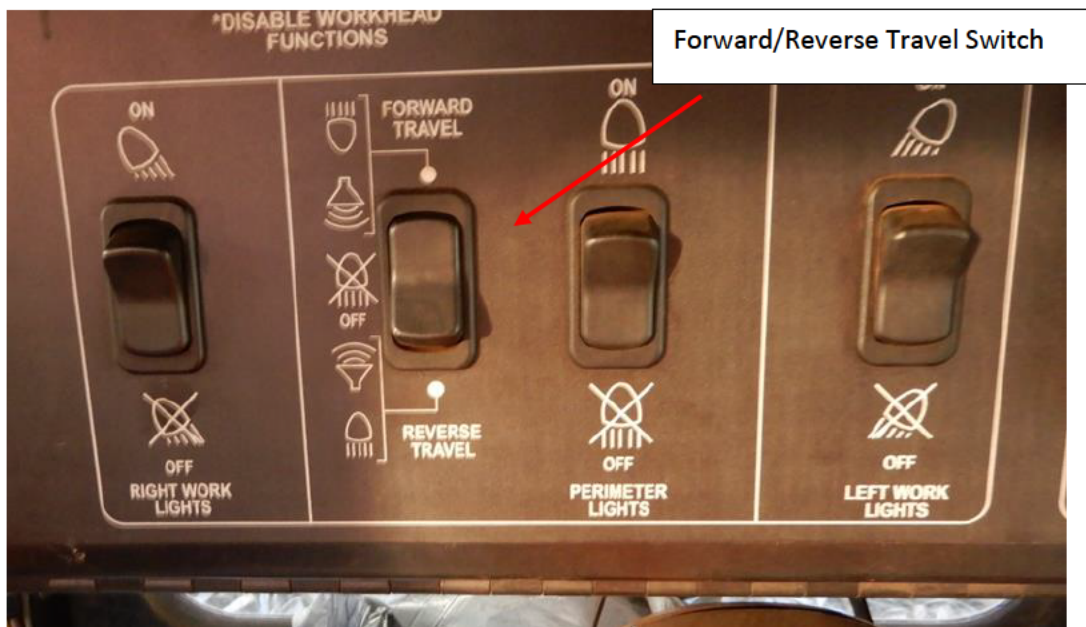
Spiker GS 15022 is equipped with an automatic change-of-direction alarm which is designed to activate based on the position of a “Forward/Reverse Travel Switch” and the direction of travel pedal used by the operator. The “Forward/Reverse Switch” is a three-position toggle switch (Forward/Center/Reverse) located on the Main Control Cabinet (MCC).

Figure 4. GS 15022 MCC with Forward/Reverse Travel Switch. Icons indicate the intended function of lights/alarms. (NTSB Photograph)

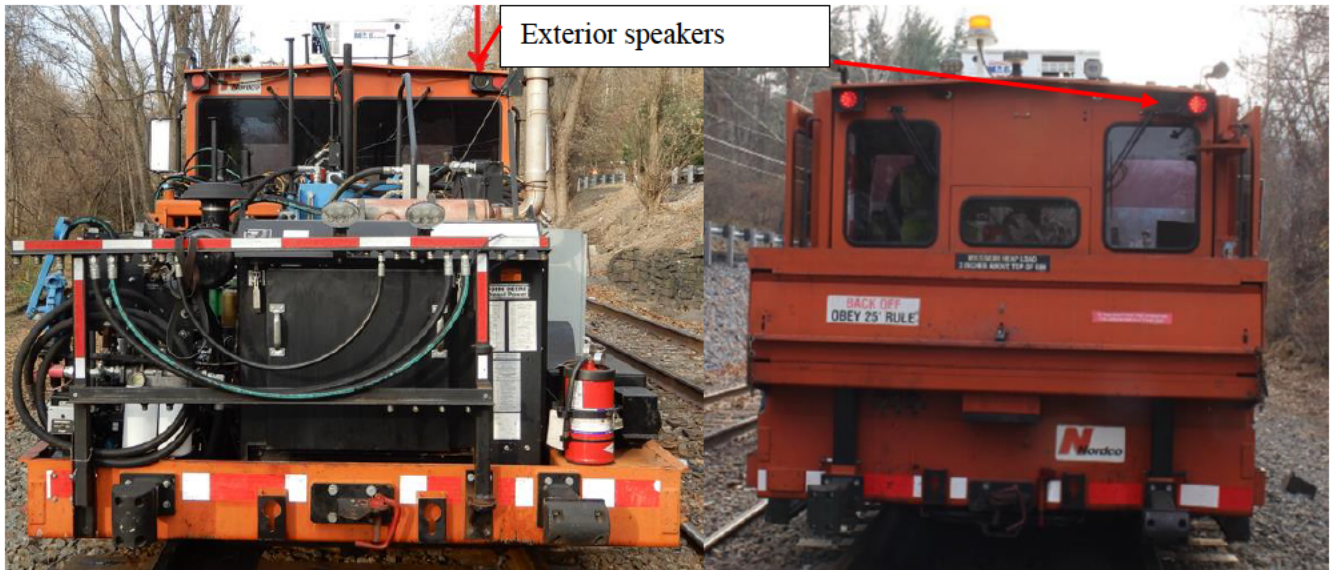
The change-of-direction alarm system has two exterior speakers, one mounted on the upper front left corner of the operating cab and one mounted on the upper rear right corner of the cab.

Initial on-scene testing revealed that the change of direction system was not working as intended. The initial investigation also revealed that the rear exterior speaker was unplugged; investigators plugged it back in. Even after being reconnected to the system, the speaker did not perform as designed.

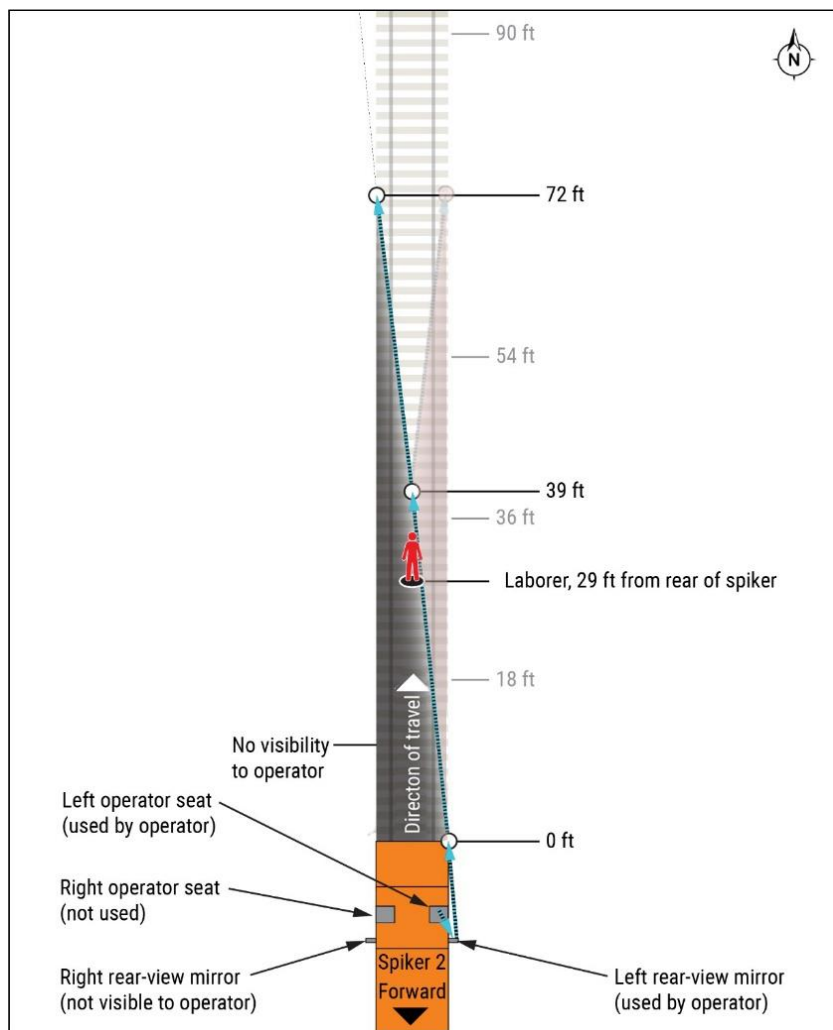
1. Create a formal process to document the daily inspection conducted by the RMM operator. (See Appendix A for two examples)
2. Develop annual training on how to identify NSRR-approved PPE. As well as how to approach a coworker or contractor who is out of compliance.
3. Change spikers spacing rules from 25' to 50' as shown in the diagram.³ Workers in the track gauge are visible until about the 40' mark, regardless of which seat operates the machine.

³ Diagram created from NTSB on site visibility test. In this diagram both operator seats are taken into consideration.

1. Evaluate all Nordoco equipment designs for blind spot identification and initiate a blind spot elimination program.
2. Design a retro fit blind spot elimination kit that can be easily installed on any existing Nordco equipment.
3. Develop a program to encourage all owners of existing Nordco equipment to install the newly designed blind spot elimination kit.
