BEFORE THE NATIONAL TRANSPORTATION SAFETY BOARD

**NTSB Accident Number: RRD21MR017 Class: Major
September 25, 2021**

**Proposed findings, probable cause, and safety recommendations, in connection with
the derailment of Amtrak Passenger Train No. 7, near Joplin, Montana**

Final Submission

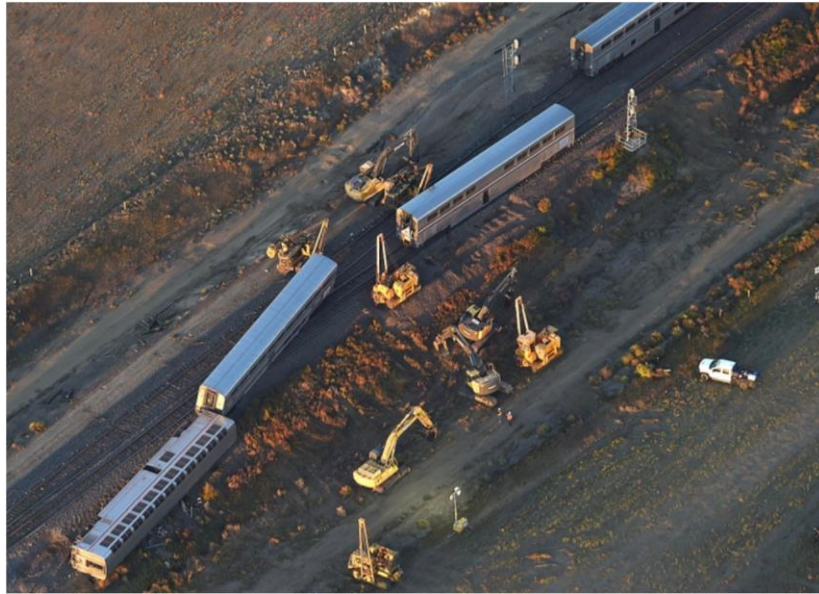
On September 25, 2021, at approximately 3:56 p.m. Mountain Standard Time (“MST”),¹ Amtrak Passenger Train No. 7 derailed near Joplin, Montana. A total of eight (8) railcars derailed. The train consisted of two (2) locomotives and ten (10) cars. There were 141 passengers, four (4) operating crew members, and nine (9) onboard personnel for a total of 154 people on the train. Three (3) passengers riding in the lounge car were fatally injured.²

Figure 1 – Aerial photo of derailment (*Photo courtesy of Fox 4 – WDAF TV*)

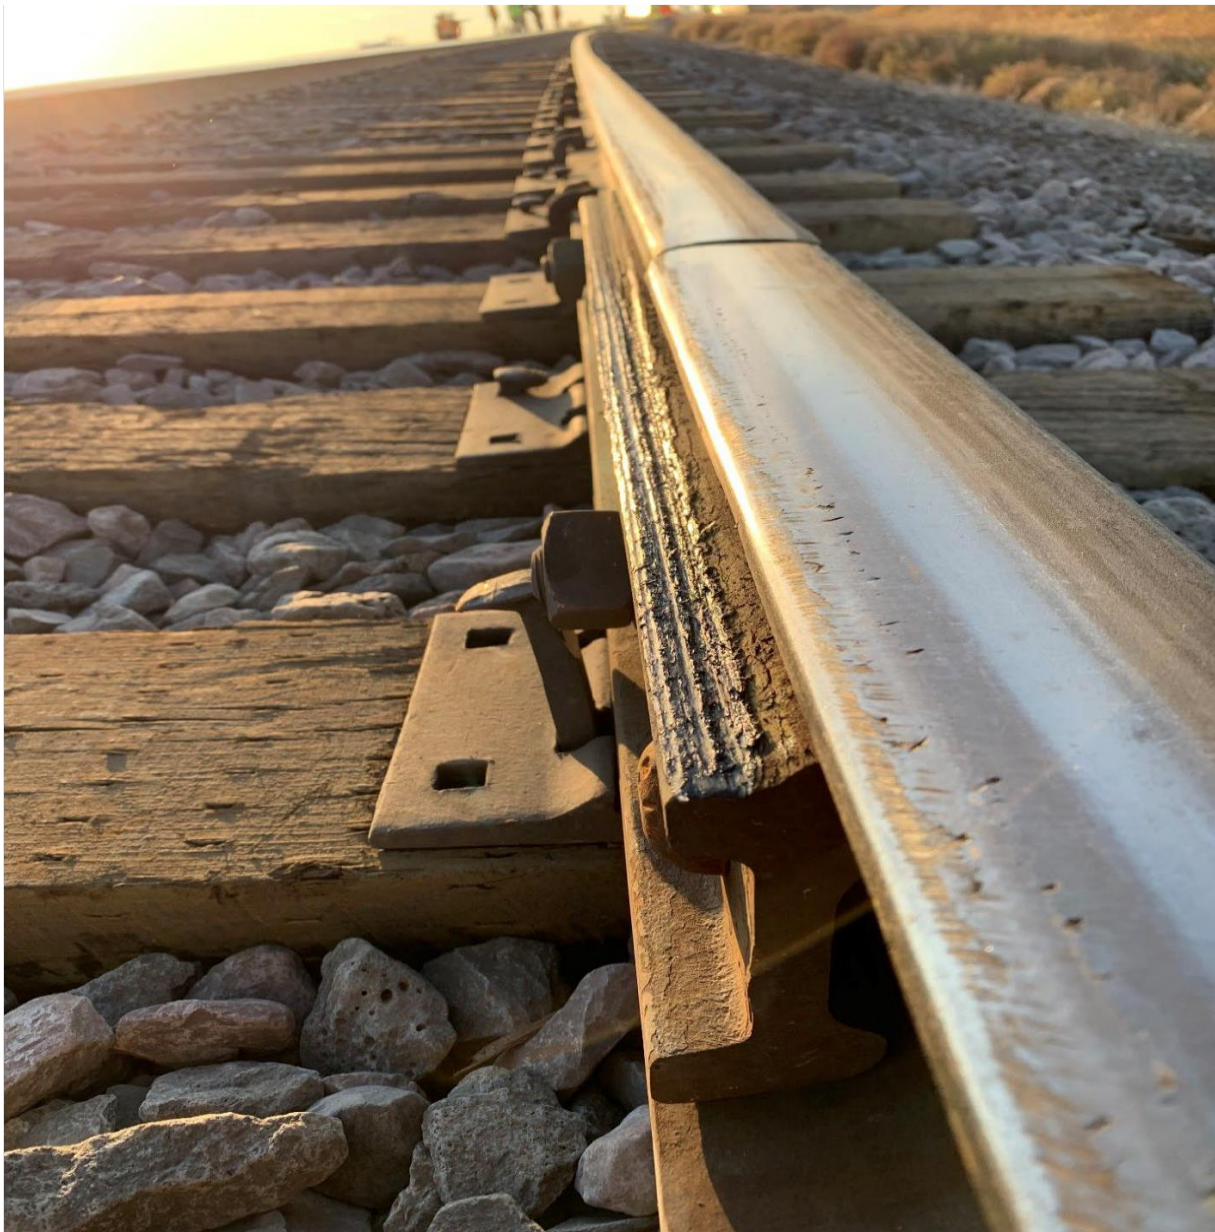
MP 1014.55 with two bolted suspended rail joints that measured 19'6" long. The 19'6" plug rail comprised of a 132-pound—RE—CC—USS—Illinois—manufactured in January 1982. The bolted plug rail was secured to the existing low side running rail with standard six-hole joint bars measuring 36" long. Each plug rail joint was drilled for in-track welding, and had four-6.5" standard bolts, nuts and locking washers securing the joint bars. Investigators noted that the east suspended plug rail joint had evidence of train wheel flange contact at the top surface of the gauge side joint bar. (See figure 2)

Figure 2 – East low/north plug rail joint showing indication of wheel flange contact Photo
courtesy of NTSB

The 19'5" plug rail was installed on July 23, 2021, due to a 10% rail weld defect discovered by BNSF's rail flaw detection car. The east suspended plug rail joint had evidence of train wheel flange contact at the top surface of the gauge side joint bar. As discovered during post-accident track inspections, investigators noted that the east low-side suspended plug rail joint was hanging out of the crosstie plates about 1-inch, with evidence of an additional 1-inch of underloading. As discovered during post-accident track inspections, investigators noted that the east low-side suspended plug rail joint was hanging out of the crosstie plates about 1-inch, with evidence of an additional 1-inch of underloading vertical deflection (movement up and down) measured on the sides of the crossties. Investigators also noted during post-accident track inspections that the west low-side suspended plug rail joint was also hanging out of the crosstie plates about 5/8" (.625 inches), with an additional 1/2" (.50 inches) of vertical deflection measured on the sides of the crossties. (See figure 3)

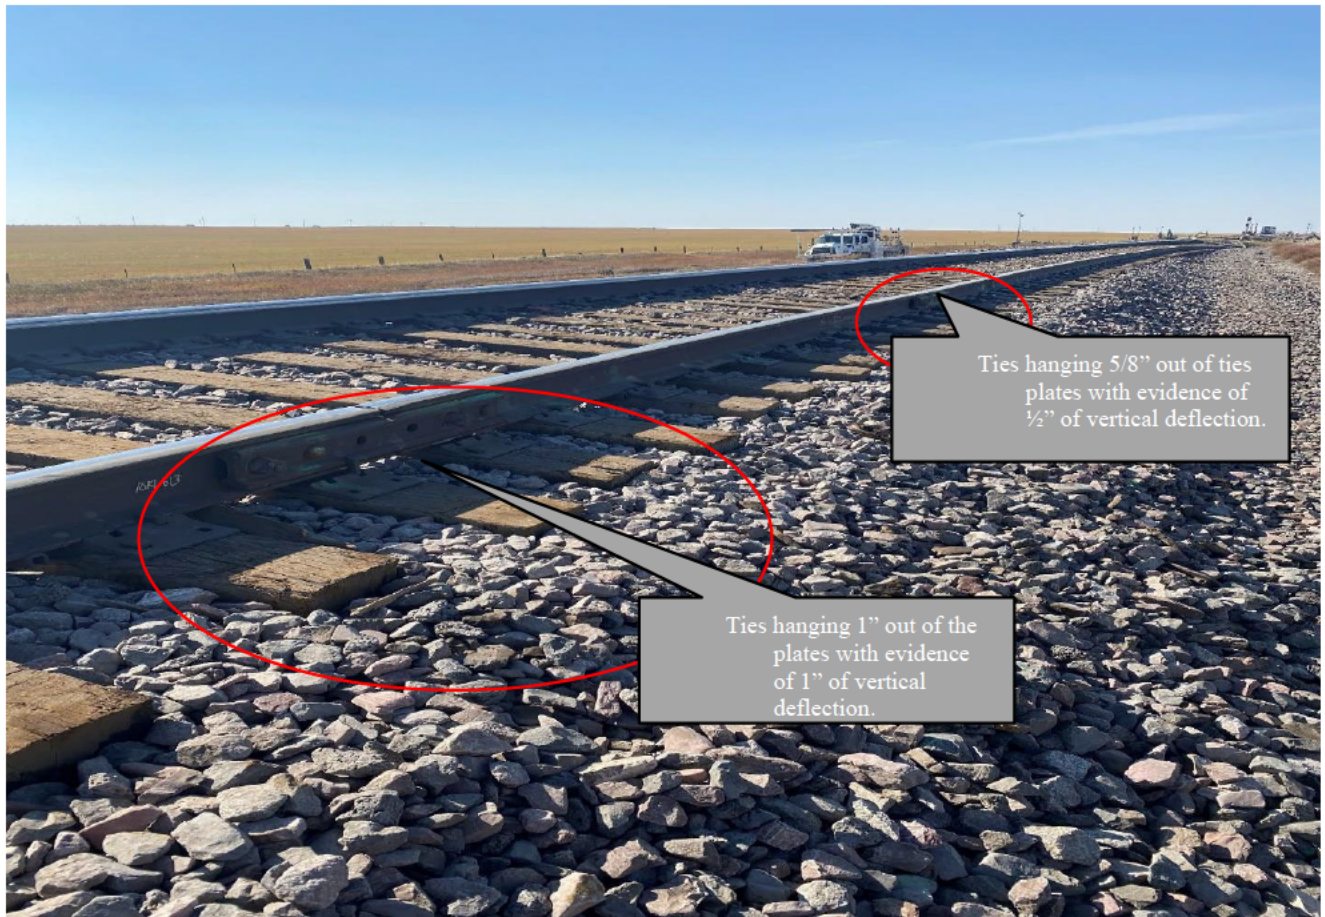
Figure 3 – “As found” by investigators - non-supporting ties under suspended plug rail joint

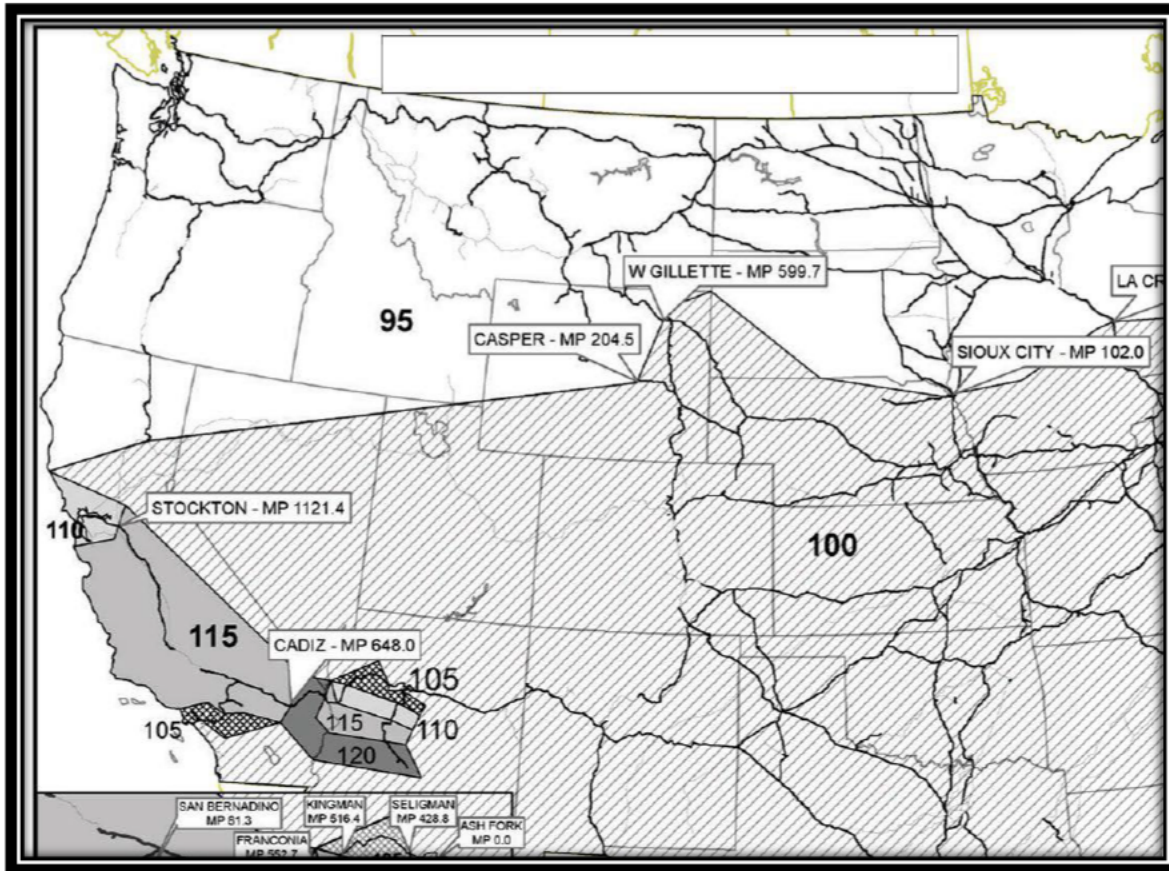
(Figure 5 – BNFS target rail laying temperature reference map)

The curve at MP 1014 had had multiple maintenance procedures performed over the last year that had dramatic affects on the RNT. In BNSF's CWR Adjustment log as of 10/20/21, the RNT of the derailment area was somewhere between 114°- 117° F. At the maximum values allowed per BNSF Procedures for Installation, Adjustment, Maintenance, and Inspection of the CWR program as required by CFR §213.118 Effective March 4, 2021. Further inspections showed indications of track lateral movement on both ballast shoulders by the indications of ballast voids at the ends of the crossties

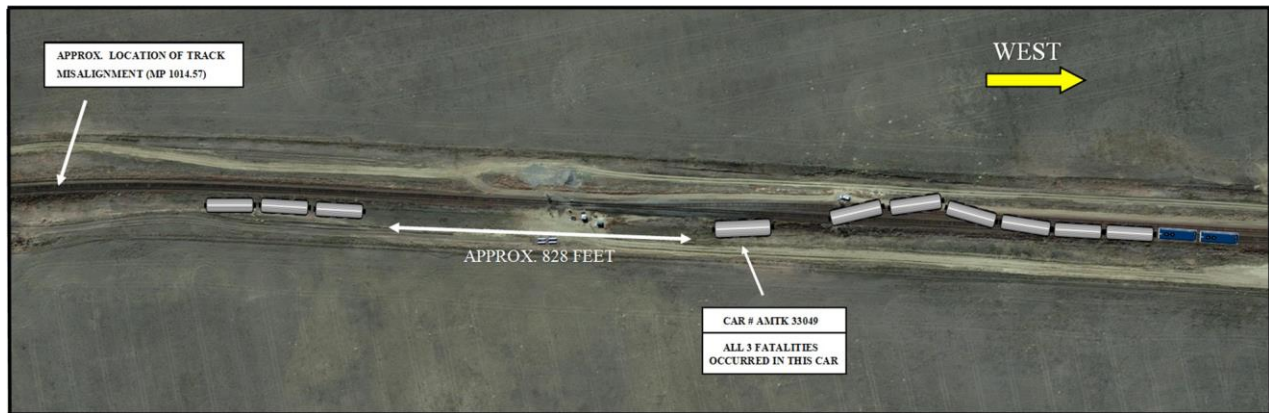
Figure 6 – Schematic of accident site

The point of derailment (“POD”) was measured and confirmed to be at MP 1014.57 and all eight (8) of the derailed railcars came to rest to the west of that approximate location. The POD was located 100’ west of the west plug rail bolted joint and 119.5’ west of the eastern bolted rail joint.

At 79 MPH, Amtrak Train No. 7 would have covered this distance in about 1 second. (See figure

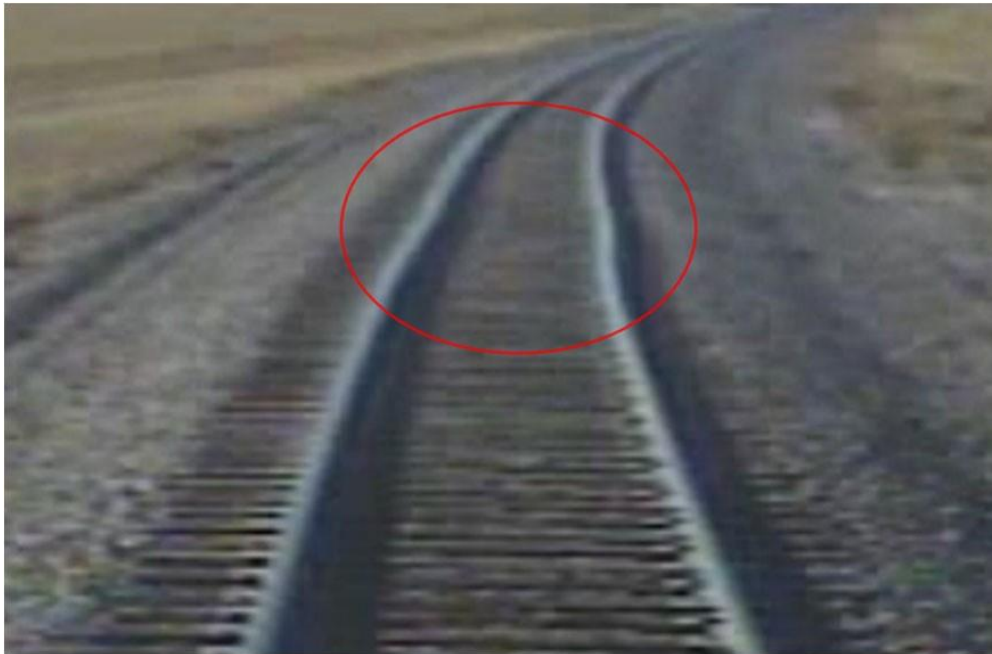
Lastly, the group observed the outward facing camera footage from Amtrak Train No. 7. which shows Amtrak Train No. 7 approaching the same area and, it was apparent that the alignment deviation had worsened. While attempting to pass over the area, Amtrak Train No. 7 shook

Figure 7 – Still image taken from the outward facing camera footage from the lead locomotive of Amtrak Train No. 7. This image was taken seconds before the train derailed.

laterally to the right, then left, then right again. At this point the train began to slow, and eventually stopped.
