**BROTHERHOOD OF MAINTENANCE OF WAY  
EMPLOYEES DIVISION**  
A DIVISION OF THE RAIL CONFERENCE  
INTERNATIONAL BROTHERHOOD OF TEAMSTERS

NTSB Accident Number: RRD19FR002  
Class: Regional

**Proposed Findings, Proposed Probable Cause, and Proposed Safety Recommendations in  
the matter of CSXT Transportation train # F-794-30 Striking an Engineering Employee  
at Estill, South Carolina**

Final Submission January 31, 2020

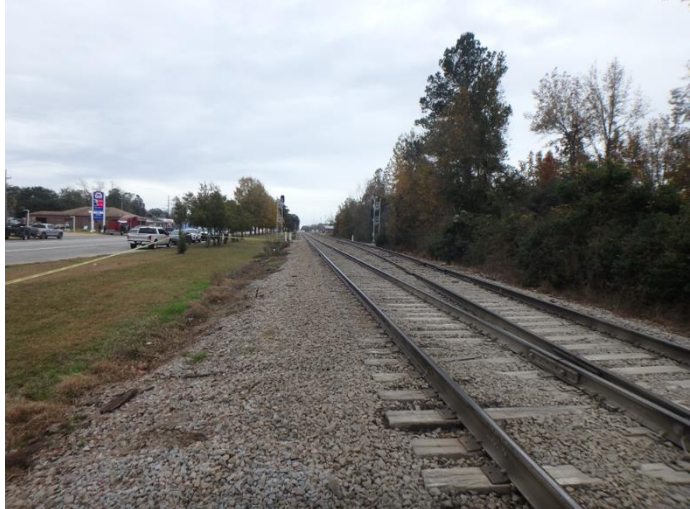
Figure 1. Photo standing near the accident location, facing south. The track to the left in the photo is the main track, the track on the right-hand side is the Estill Siding.

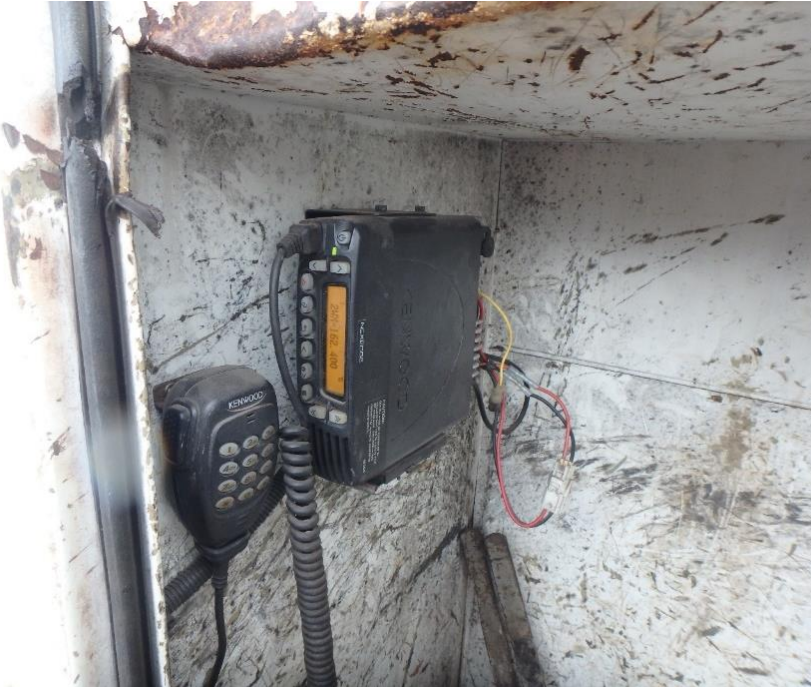
**Figure 2.** Photo showing the external radio mounted inside of a cabinet on the body of CSXT welding truck No. 240150.

Investigators determined that the radio located in the cab of the welding truck was functional, however, the external radio (mounted inside a cabinet on the body of the truck) was not able to be heard. The external radio was disconnected from a speaker mounted on the body of the truck, near the middle, on the passenger’s side. Two other speakers were in the same cabinet as the radio, however, neither of those were properly connected to the radio.

2. Immediately implement a safety stand down to inspect radio systems on all maintenance of way equipment to insure proper functionality, with a focus on outside audible speakers.

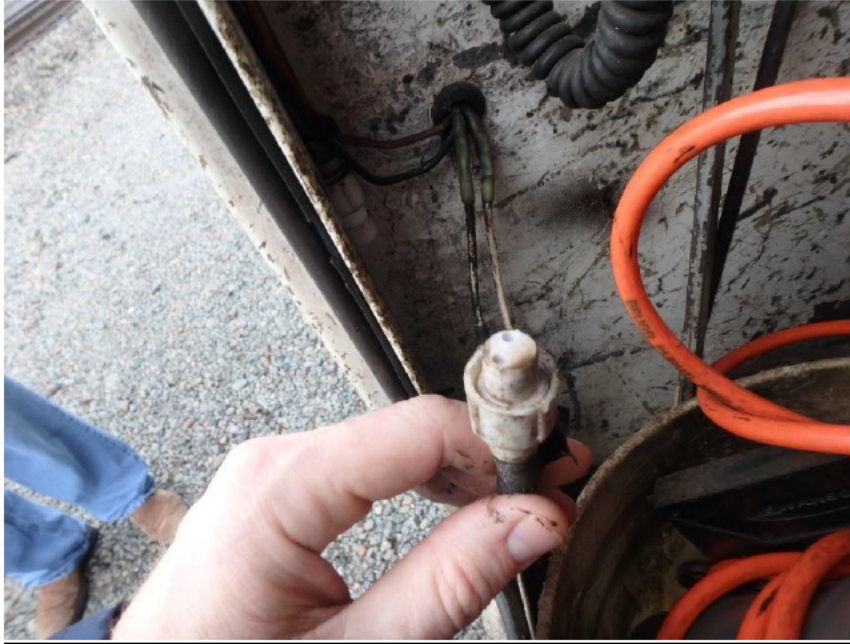
**Figure 3.** Photo showing disconnected white wire connector that was intended to connect the external mounted speaker to the external radio. The wire was disconnected from the radio and hanging inside the cabinet.

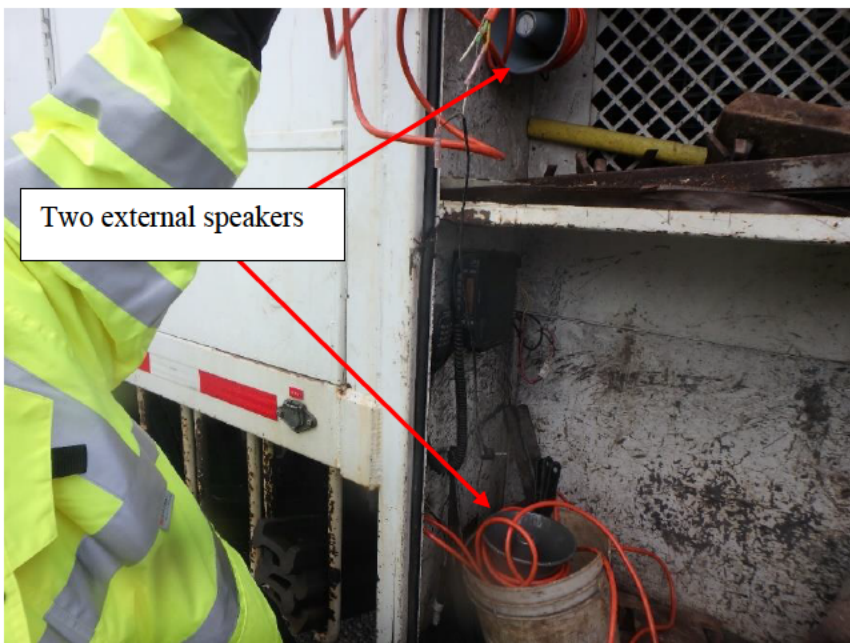
**Figure 4.** Photo showing two disconnected external speakers that were stored inside the truck cabinet that contained the external radio. Also shown are multiple wires, many of which are not connected.

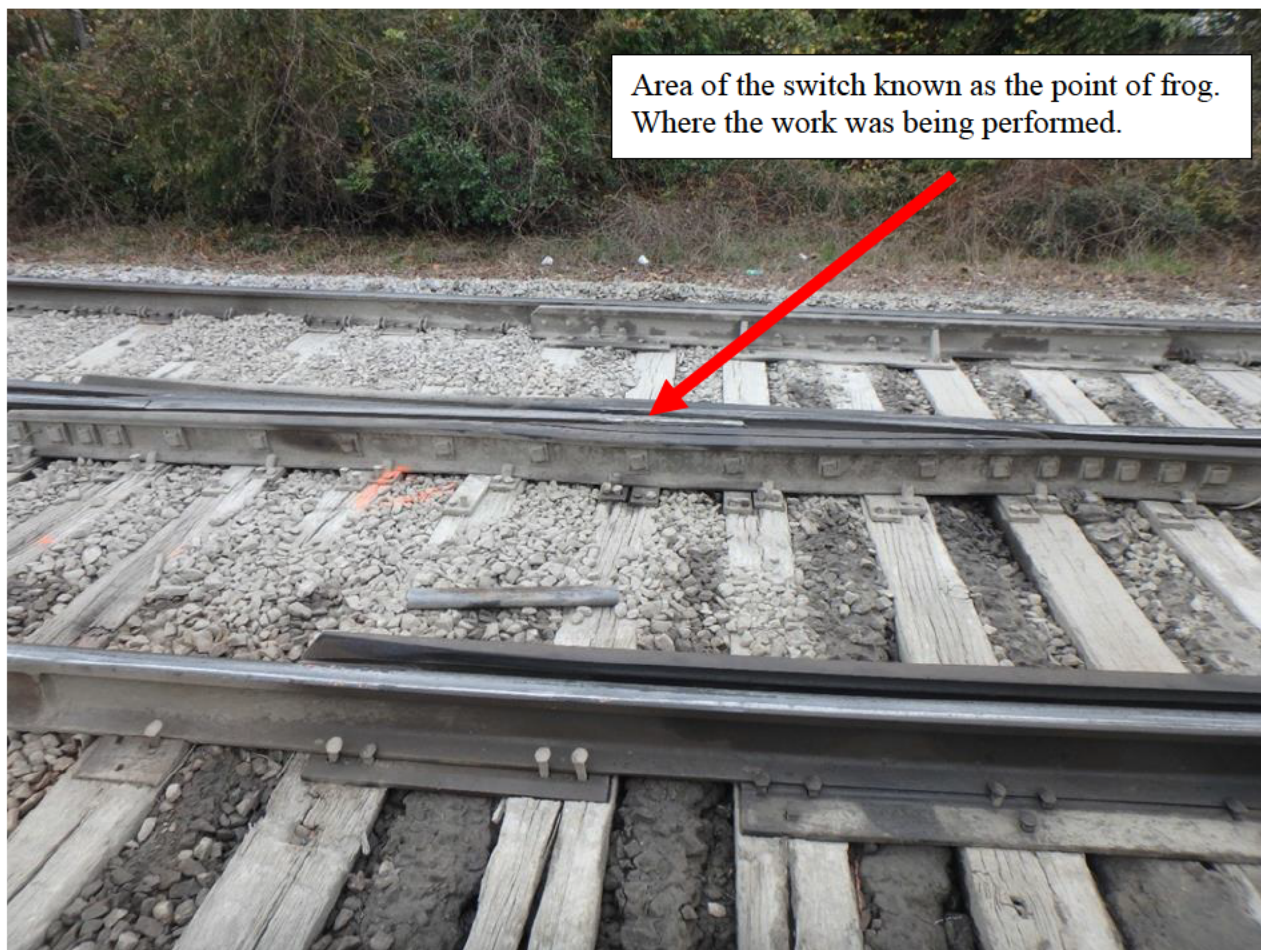
The welder and trackman had been performing frog maintenance work for several hours prior to the accident. The work consisted of removing damaged material at the point of frog and then rebuilding it. This is a very time consuming, loud and cumbersome operation. The trackman noted “... various noises going on such as the Truck running, Welding machine running, traffic, and

**Figure 5.** Photo of track frog at the accident location.

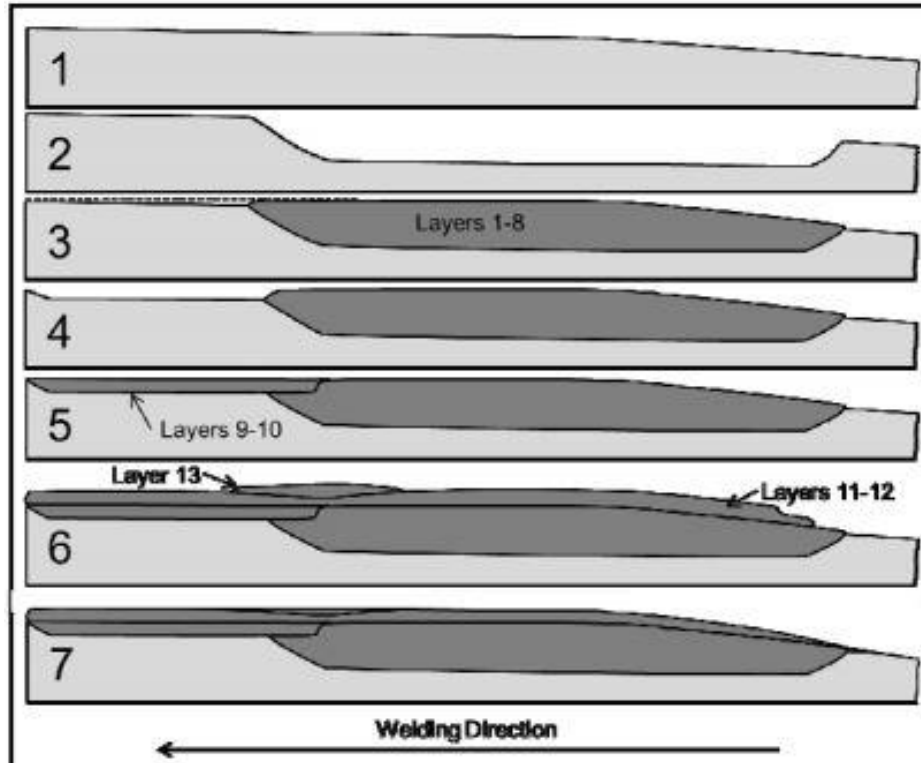
Frog Repair Sequence:

- (1) The original frog geometry is documented.
- (2) Damaged material is removed from the frog point using a grinder or carbon arc gouging and grinding.
- (3) Multiple layers of metal are laid down by the welder to build up the removed material.
- (4) Often times additional material towards the heel of the point must be removed according to the damage that is present.
- (5) Additional layers of metal are deposited to build up the removed material.
- (6) Additional layers are deposited that are nearly the full length of the repair to build up the height of the point to match the height of the wings.
- (7) The frog is ground to final shape.<sup>5</sup>
