September 30, 2019

Mr. Troy A. Lloyd, *Investigator in Charge*

**RE: Proposed Findings, Proposed Probable Cause, and Proposed Safety Recommendations in the matter of Amtrak Train #86 Striking an Engineering Employee near Bowie, Maryland on April 24, 2018; NTSB Docket No. RRD18FR006.**

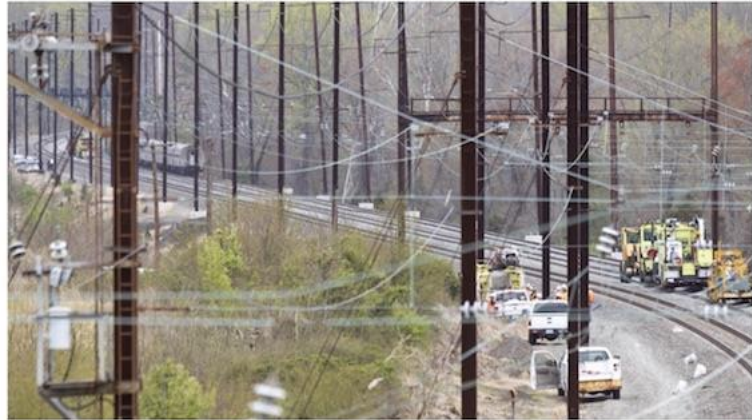
Looking North towards Curve 403 from the southbound platform at Bowie State Station. Train #86 is stopped in the distance.

Approaching the POI from the south, trains will traverse track with a descending grade from MP 120 to MP 118. The alignment of the track is curved, and there are two (2) Hot Spots<sup>2</sup> identified due to those curves. Those Hot Spots are at MP 119.7 for Curve 404, and at MP 118.4 for Curve 403. These Hot Spots are not identified with placards or decal stickers. The accident occurred at MP 119.2

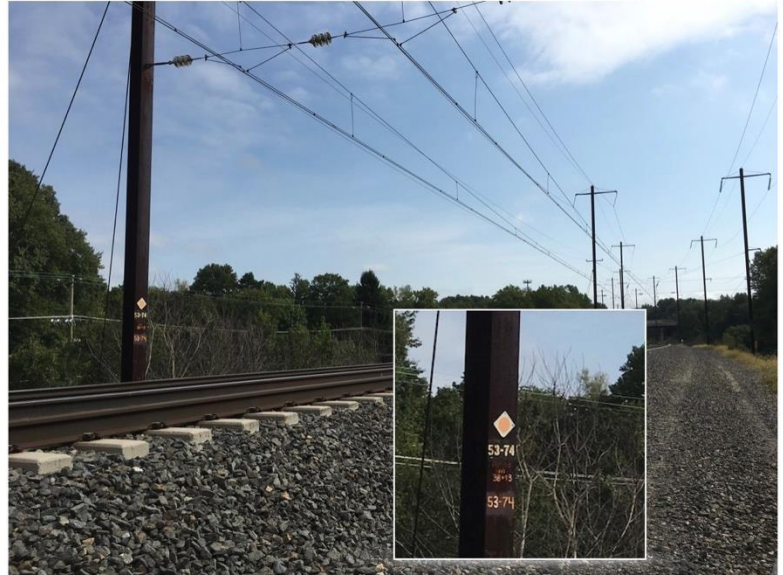
Typical decal or placard at MP 53.74 denoting Hot Spot due to limited visibility Curves 344-345 on Amtrak's Mid-Atlantic Division

On April 24, 2018, the work being performed was located between back-to-back Hot Spots. There was a Hot Spot at Curve 404, near MP 119.7, and another Hot Spot at Curve 403 at MP 118.4. The fatally injured employee was struck at MP 119.2. These Hot Spots were not marked with placards or decals.
