Railroad Investigation Report: RIR-23/02

Passenger Fatality

Bay Area Rapid Transit

San Francisco, California
September 13, 2021

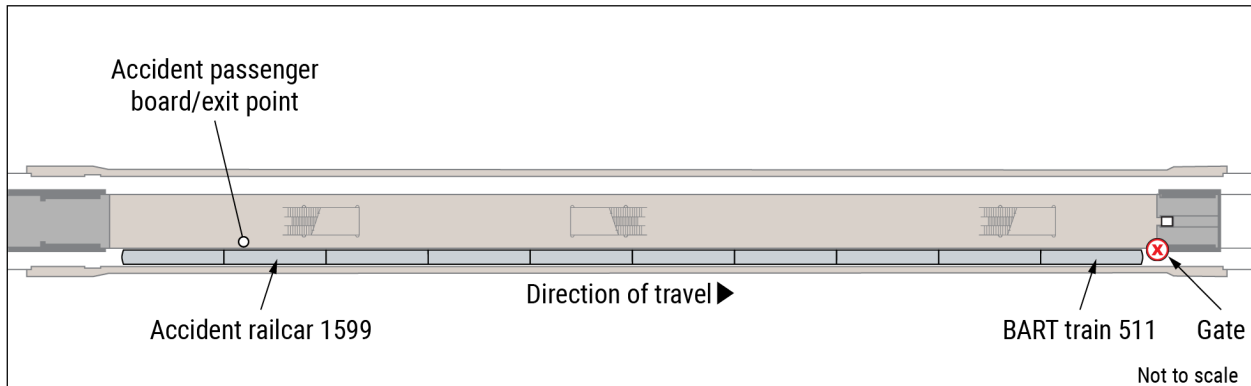
and collided with the gate at the end of the platform. (See figure 1.) The canine was not injured.

Figure 1. Diagram of BART Powell St. Station platform at the time of the accident.

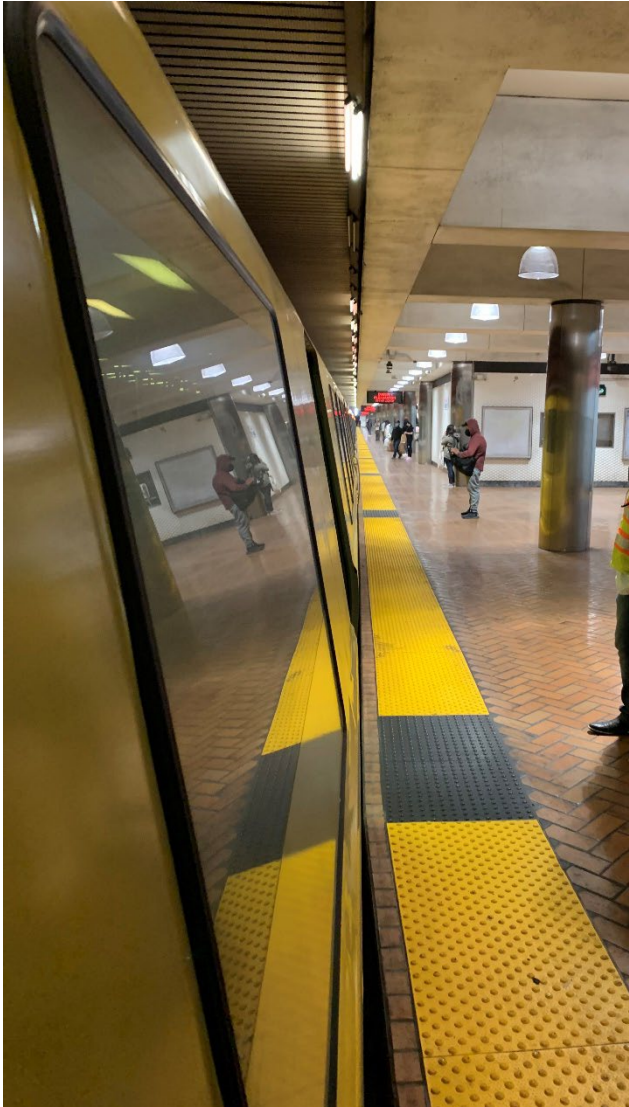
NTSB investigators also observed that ambient lighting conditions at the Powell St. Station at the time of the accident reduced the conspicuity of activity toward the far end of the platform.

Figure 2. Powell St. Station platform before completion of lighting improvements.

Postaccident sight distance observations conducted by NTSB investigators at the Powell St. Station revealed that dim ambient lighting conditions present in the station platform area at the time of the accident reduced the conspicuity of passenger activities toward the far end of the station platform. Specifically, the lighting conditions likely made it difficult for the train operator to reliably monitor and evaluate passengers exiting and entering the rear of the train at the platform when the operator performed his look-back procedure. BART has since completed lighting and painting improvements at the Powell St. Station and other nearby stations, increasing visibility for train operators. BART also has widely distributed an awareness campaign to educate passengers on safe travel practices with service animals and pets.

At the time of the accident, BART was in the process of replacing the platform lighting at the Embarcadero, Montgomery, Civic Center, and Powell St. stations with LED lighting, an upgrade from the original lighting. BART was also in the process of repainting the walls of the station platform areas a brighter color. The lighting and painting improvements at the Powell St. Station were completed in July 2022. These actions increased the illumination of the environment, improving visibility for operators performing the look-back procedure at their stations. (See figures 2 and 3.) BART is procuring more replacement lights and expects to complete lighting improvements at the 16th St. and 24th St. stations by spring 2023.

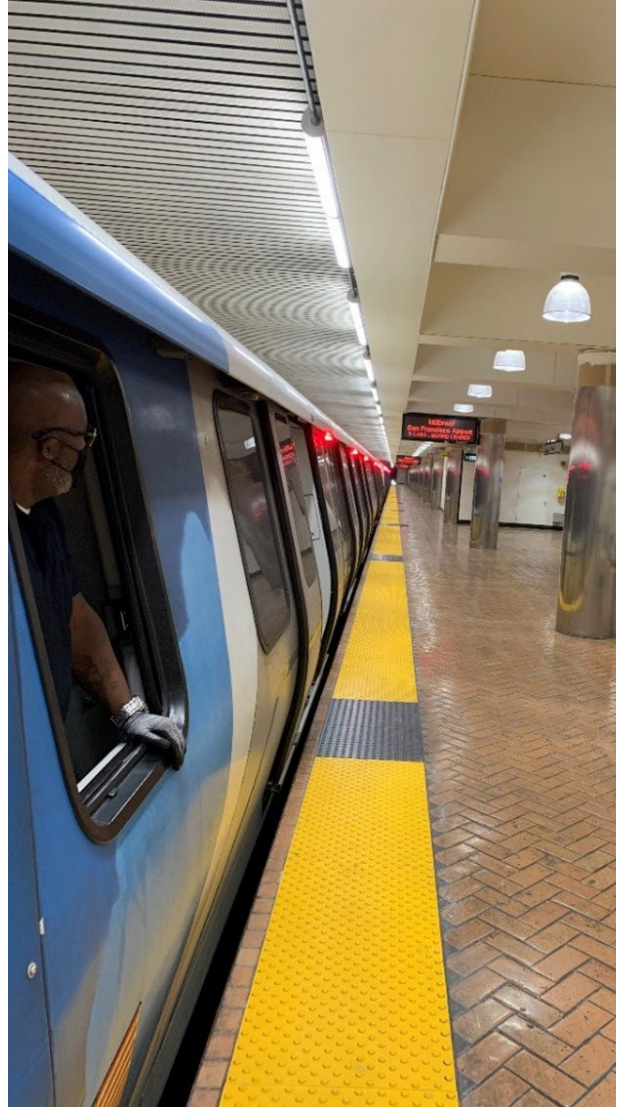
Figure 3. Powell St. Station platform after completion of lighting improvements.
