Safety Communiqué

Models: Beechcraft 33, 35, 36 Bonanza & Debonair Series

Subject: ATA 27 – Control Cable Turnbuckle Terminals

SAIB: CE-19-13
Date: July 2, 2019

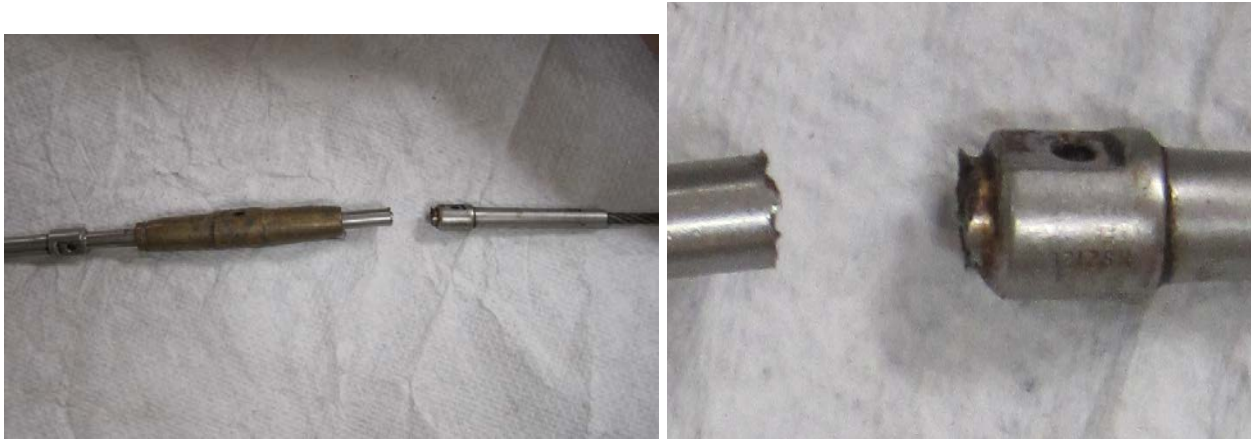
The specific focus of this SAIB is on the connecting fittings that are attached (swaged) to the flight control cables and threaded onto the turnbuckles. These fittings are typically manufactured from a type of stainless steel that is susceptible to stress corrosion cracking under certain conditions over time. Based on multiple part examinations, the stress corrosion cracking originates at general corrosion pits on the surface of the parts. Because the cracks are primarily below the surface, they can be extremely difficult to detect. Because stress corrosion cracking is usually preceded by or accompanied with visible corrosion, any presence of even light or moderate corrosion on these fittings is cause for concern.

Factors that contribute to stress corrosion cracking for stainless steel fittings of this type are exposure to contamination (chlorides) along with being under sustained tensile stress. Heat is also a contributing factor. It is therefore likely to occur more quickly in a warm, humid, salt air environment, and progresses based on calendar time rather than flight time. A number of failures have occurred in areas of the airplane adjacent to heating and ventilating ducts, thus raising the possibility that elevated temperatures and/or condensation associated with the ducting was an aggravating factor. Owners and operators of certain Beechcraft Bonanza and Debonair airplane models should be aware that multiple failures of an aileron cable terminal have occurred in a location just forward of the rear spar and underneath a ventilation/heating duct. This applies to most airplane Models 33, 35, and 36 manufactured between approximately 1964 and 1977, after which the aileron

A picture from a recent incident involving failure of such a fitting is shown in the photographs below. Note the small amount of corrosion adjacent to the fracture location.

- b. Replace any removed safety wire with new safety wire in accordance with normal procedures.
3. If any sign of corrosion, pitting or cracking is present on any fitting, replacement of the associated fitting and/or cable assembly is recommended.
