**SUBJECT: REVISION A TO ALERT SERVICE BULLETIN 407-10-93:  
TAILBOOM ATTACHMENT HARDWARE, REPLACEMENT OF.**

NO. 407-10-93

**MODEL AFFECTED:** 407

**HELICOPTERS AFFECTED:** Model 407 Helicopters serial number 53000 through 53990.

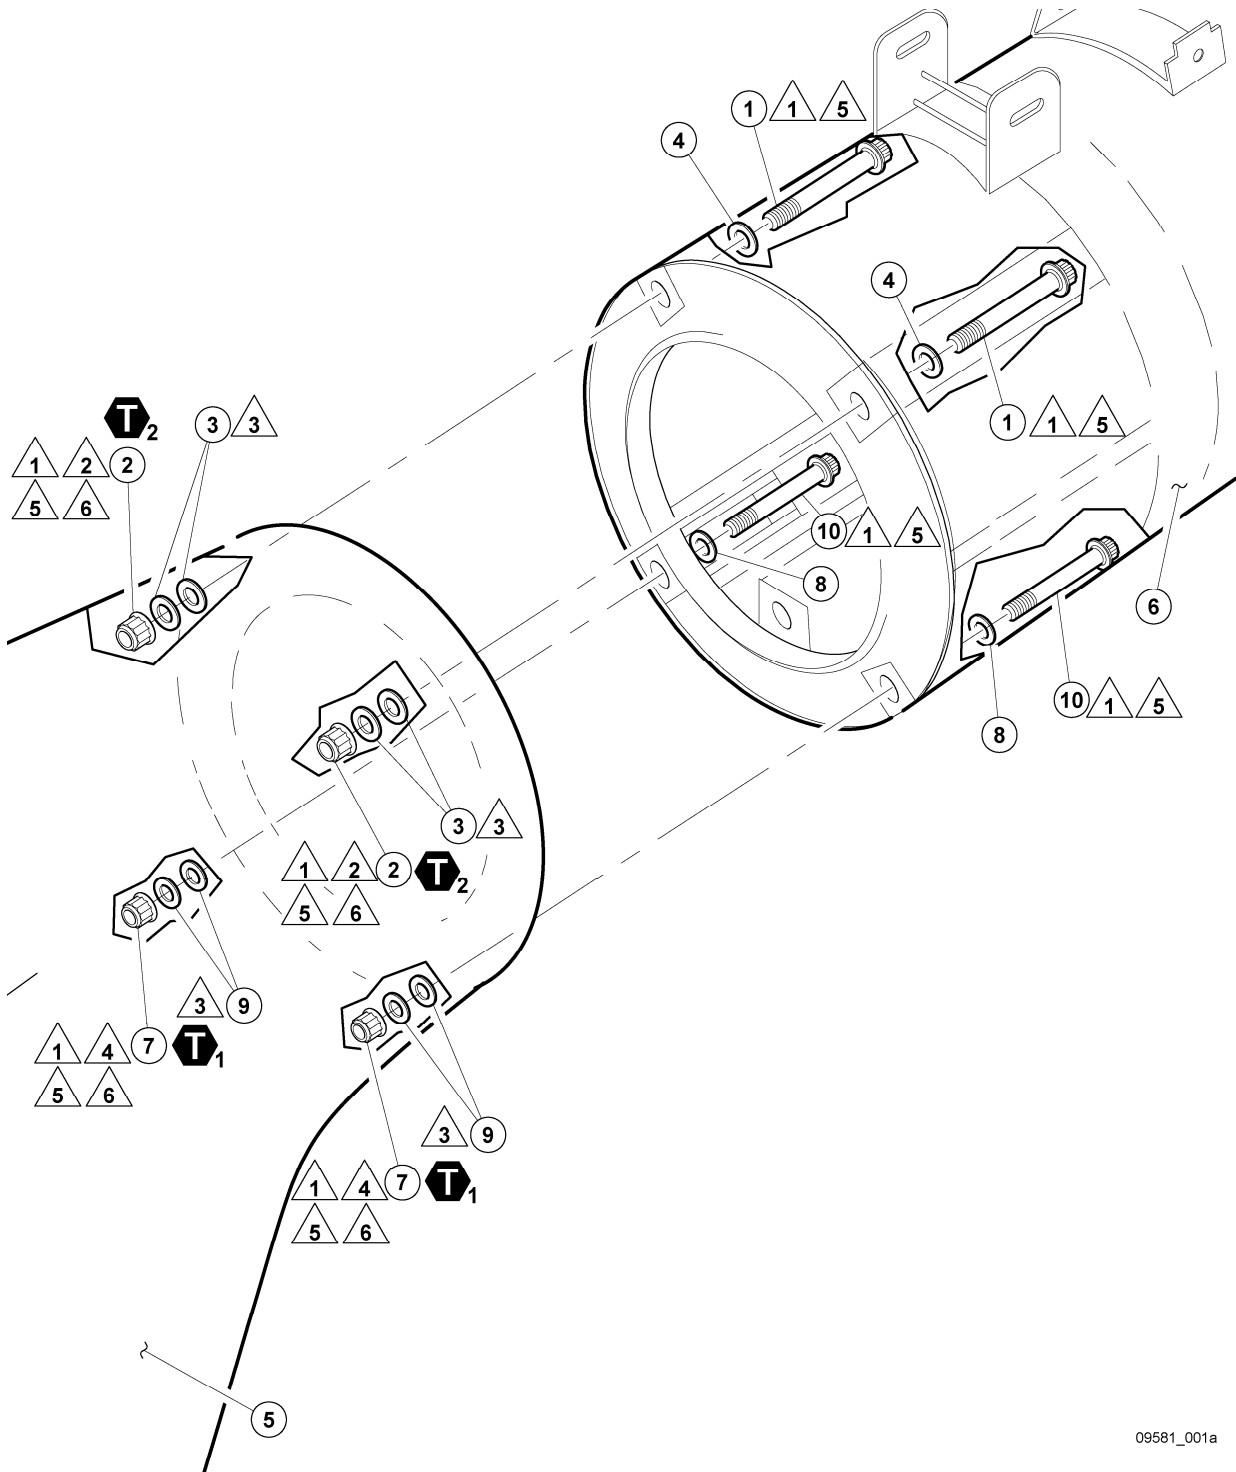
FIGURE 2: Replacement of tailboom upper attachment bolts (Sheet 1 of 2)

Bell Helicopter has reviewed the tailboom attachment installation of the Model 407. It has been determined that the torque values specified in the maintenance manual and used during assembly of the 407 for the tailboom attachment bolts exceed the specified torque range recommended for subject bolts.

360 TO 370 INCH/LBS  
(40.6 TO 41.8 Nm)

570 TO 580 INCH/LBS  
(64.4 TO 65.5 Nm)

1. (Ref. Figure 2) Remove left upper attachment bolt (1) and nut (2) but retain the chamfered washer (4) and the regular washers (3). Discard the nut (2) and the bolt (1) you have removed.

2. Install a new bolt (1) procured from a BHT-Approved supply source as follows:
  - a) Coat the shank of the new bolt (1) and the faying surfaces of the chamfered washer (4) with anti-corrosion compound ([C-586](#)). Do not apply compound on any threads of the bolt (1).
  - b) Fit the new bolt (1) (with the chamfered washer (4) against head of bolt (1)) through the tailboom and the fuselage upper mating fittings.
  - c) Select a sufficient number of washers (3) for opposite end of bolt (1) to obtain a minimum of 1 to a maximum of 3 threads showing beyond the nut (2) after proper torque is obtained. Coat the faying surfaces of these washers (3) with anti-corrosion compound ([C-586](#)) and fit over shank of the new bolt (1).

3. Install a new nut (2) on the forward end of the bolt (1) as follows;
  - a) Coat the nut (2) faying surface prior to assembly. Do not apply compound on any threads of the nut (2).
  - b) Run the nut (2) on the threads of the mating bolt (1) with a dial indicator type torque wrench and measure existing tare.
  - c) Torque the nut (2) between 570 to 580 inch/lbs (64.4 to 65.5 Nm) of torque plus the tare of the nut (2), using socket P/N 407-230-001-101 or equivalent tool.
  - d) Back off nut (2) at least a minimum of  $\frac{3}{4}$  of a turn before re-applying the same torque between 570 to 580 inch/lbs (64.4 to 65.5 Nm) plus the existing tare of the nut (2).
  - e) Coat bolt (1) head, nut (2) and washers (3, 4) with anti-corrosion compound (C-586).
4. Repeat Steps 1 through Step 3 for the opposite right upper bolt (1) and mating nut (2).

5. (Ref. Figure 2) Remove left lower attachment bolt (10) and nut (7) but retain the chamfered washers (8) and the regular washers (9). Discard the nut (7) and the bolt (10) you have removed.

6. Install a new bolt (10) procured from a BHT-Approved supply source as follows:
  - a) Coat the shank of the new bolt (10) and the faying surfaces of the chamfered washer (8) with anti-corrosion compound (C-586). Do not apply compound on any threads of the bolt (10).
  - b) Fit the new bolt (10) (with the chamfered washer (8) against head of bolt (10)) through the tailboom and the fuselage lower mating fittings.
  - c) Select a sufficient number of washers (9) for opposite end of bolt (10) to obtain a minimum of 1 to a maximum of 3 threads showing beyond the nut (7) after proper torque is obtained. Coat the faying surfaces of these washers (9) with anti-corrosion compound (C-586) and fit over shank of the new bolt (10).

7. Install a new nut (7) on the forward end of the bolt (10) as follows;
  - a) Coat the nut (7) faying surface prior to assembly. Do not apply compound on any threads of the nut (7).
  - b) Run the nut (7) on the threads of the mating bolt (10) with a dial indicator type torque wrench and measure existing tare.
  - c) Torque the nut (7) between 360 to 370 inch/lbs (40.6 to 41.8 Nm) of torque plus the tare of the nut, (7) using proper tool.
  - d) Back off nut (7) at least a minimum of  $\frac{3}{4}$  of a turn before re-applying the same torque between 360 to 370 inch/lbs (40.6 to 41.8 Nm) plus the existing tare of the nut (7).
  - e) Coat bolt (10) head, nut (7) and washers (8, 9) with anti-corrosion compound (C-586)
8. Repeat Steps 5 through Step 7 for the opposite right lower bolt (10) and nut (7).

Replace existing bolts and nuts by new ones.
-

Upper nut must have tare above minimum value of 14 inch-pounds (1.58 Nm).
-

Lower nut must have tare above minimum value of 9.5 inch-pounds (1.07 Nm).
-

Torque nut to indicated value then back off nut a minimum of 3/4 of a turn before retorquing again.
7. Perform torque check 1 to 5 hours after initial installation. Repeat this torque check at repetitive periods between 1 to 5 hours until torques stabilize at all 4 locations.
8. Perform torque check of all hardware every 300 hours of component operation.
