ALERT SERVICE BULLETIN

407-11-95

407

UPPER LEFT LONGERON (CHANNEL) 206-031-314-037/-177 AND SPARE ASSEMBLY 206-031-314-219B, INSPECTION OF.

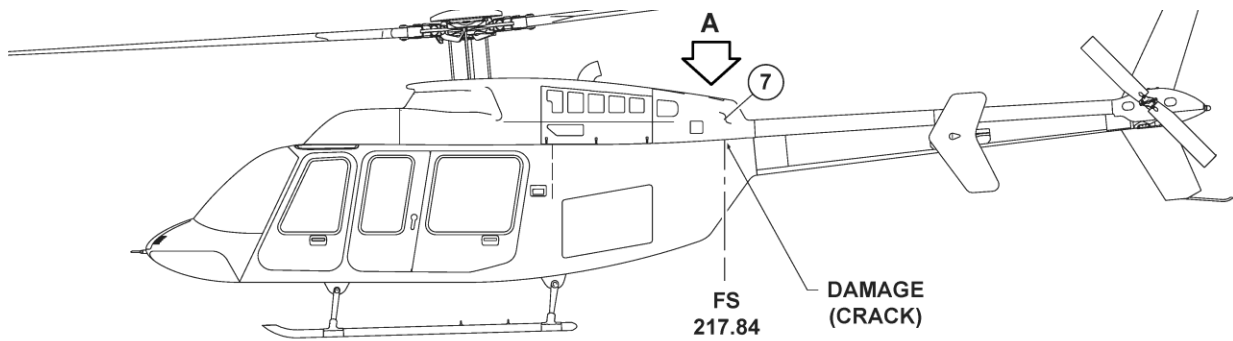
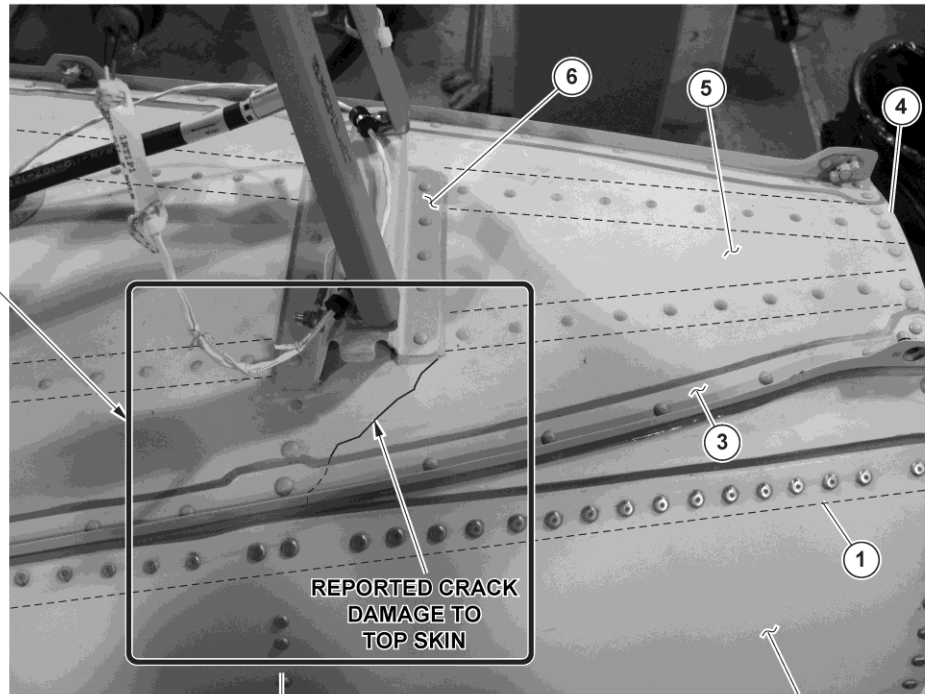
Figure 1 - Inspection of Aft Fuselage Upper Skin

CRITICAL ZONE
 TO INSPECT

Clean upper skin surface and visual inspect all visible sections of the upper skin from the edge of the left side carbon fiber skin panel to the oil reservoir aft support bracket for a possible crack. Use a 10X magnifying glass and inspect the upper skin at edge of the aft cowl retainer and at the edge of the left side skin panel for cracks in the area defined.
-

Crack may be hidden by cowl retainer. Clean and visual inspect lower side of skin in the same area from the tailboom hardware access aperture.

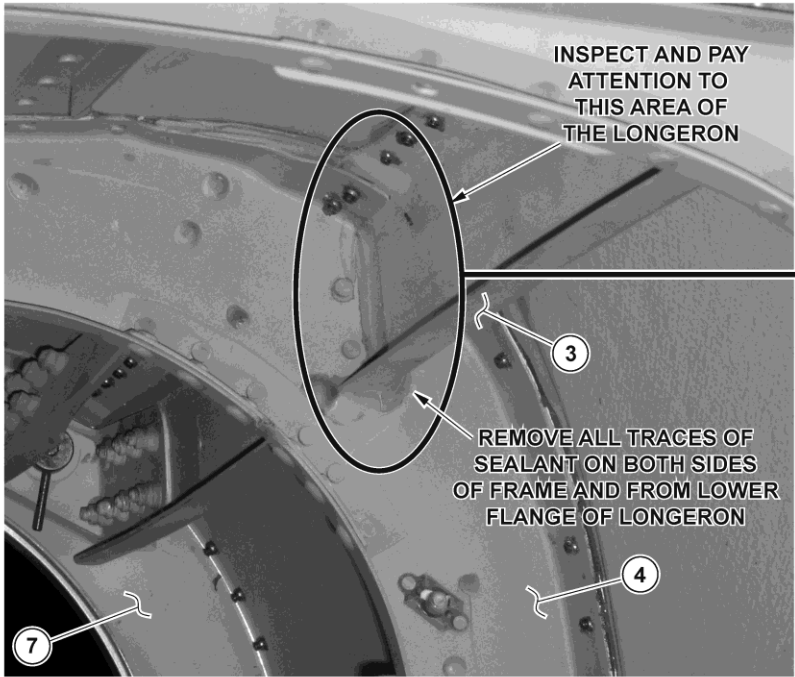
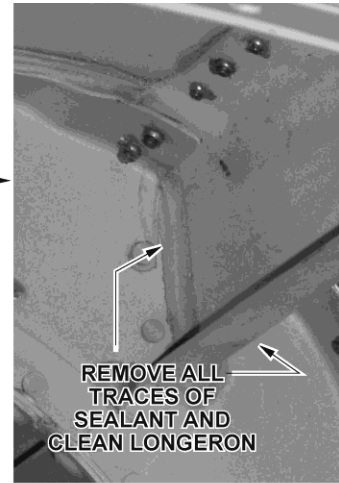
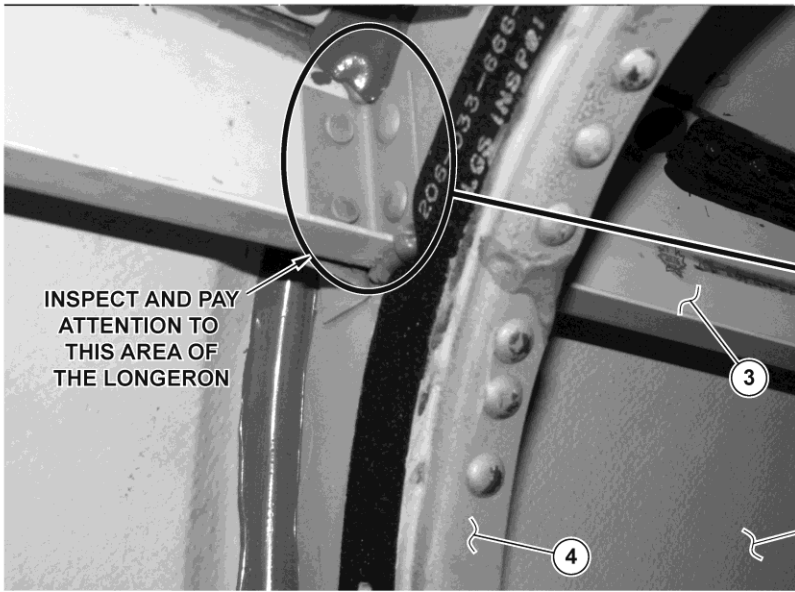
Figure 2 – Inspection of Upper Left Longeron Channel (sheet 2 of 3)

4. Make sure the area is clean and visually inspect all visible sections of the upper left longeron (3) between aft fuselage frame (7) at STA 231.472 and frame (6) at STA 204.92 for general condition, corrosion and crack. Pay particular attention to Area 1 and Area 2.

AREA 1

AREA 2

5. If corrosion is found, submit details to Product Support Engineering for evaluation and possible repair.
6. If the longeron (3) is found cracked, it may be replaced using 206-031-314-237B, 407-030-067-105, or repaired in accordance with PART IV of this bulletin. Installation of a new longeron assembly 206-031-314-237B or 407-030-067-105 done in conjunction with accomplishment of PART III of this bulletin (installation of three external strap doublers) is considered by Bell as a terminating action to this bulletin.

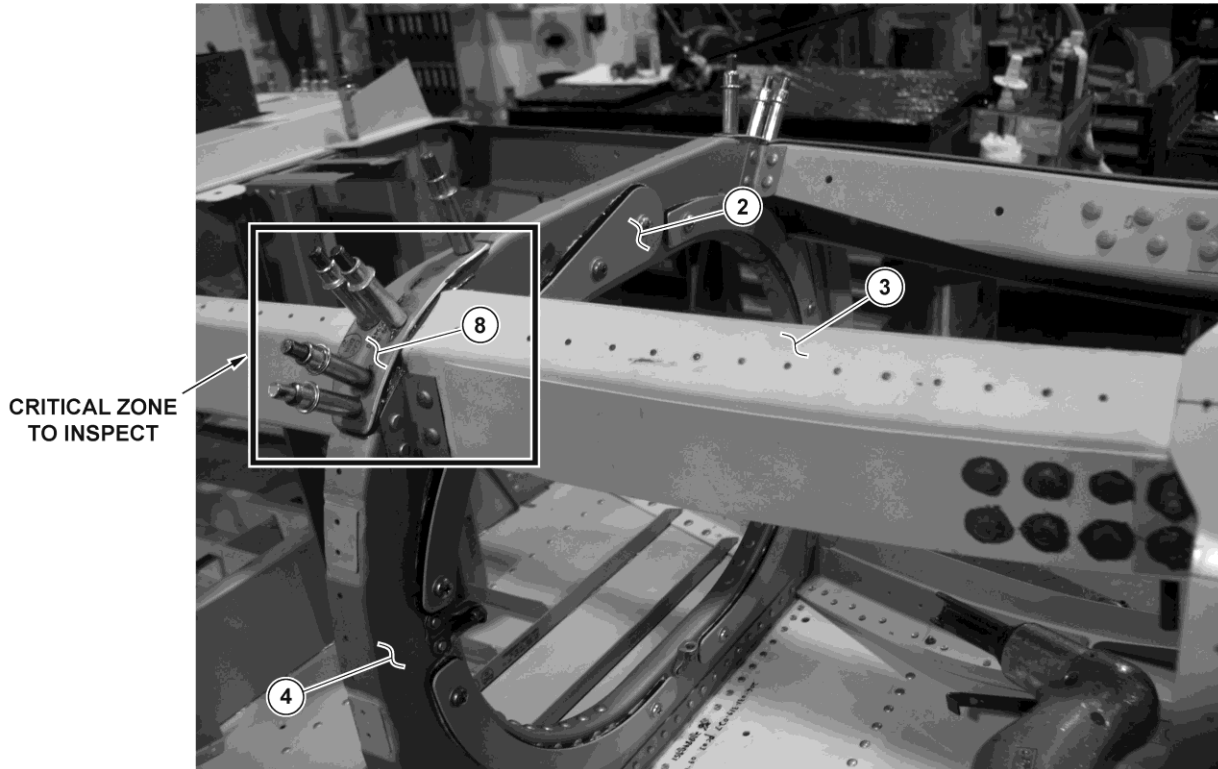
Figure 2 – Inspection of Upper Left Longeron Channel (sheet 3 of 3)

- c. Remove all traces of sealant on the upper flange of the longeron (3) at STA 217.84 and inspect for a crack. Pay attention to the transition area (narrowing section) of the upper flange (STA. 217.84). If the longeron (3) is found cracked, go to step 6.

If upper skin was found to be cracked, remove skin and splice. Clean sealant residue and inspect top flange of longeron for a crack close to frame (FS 217.84).

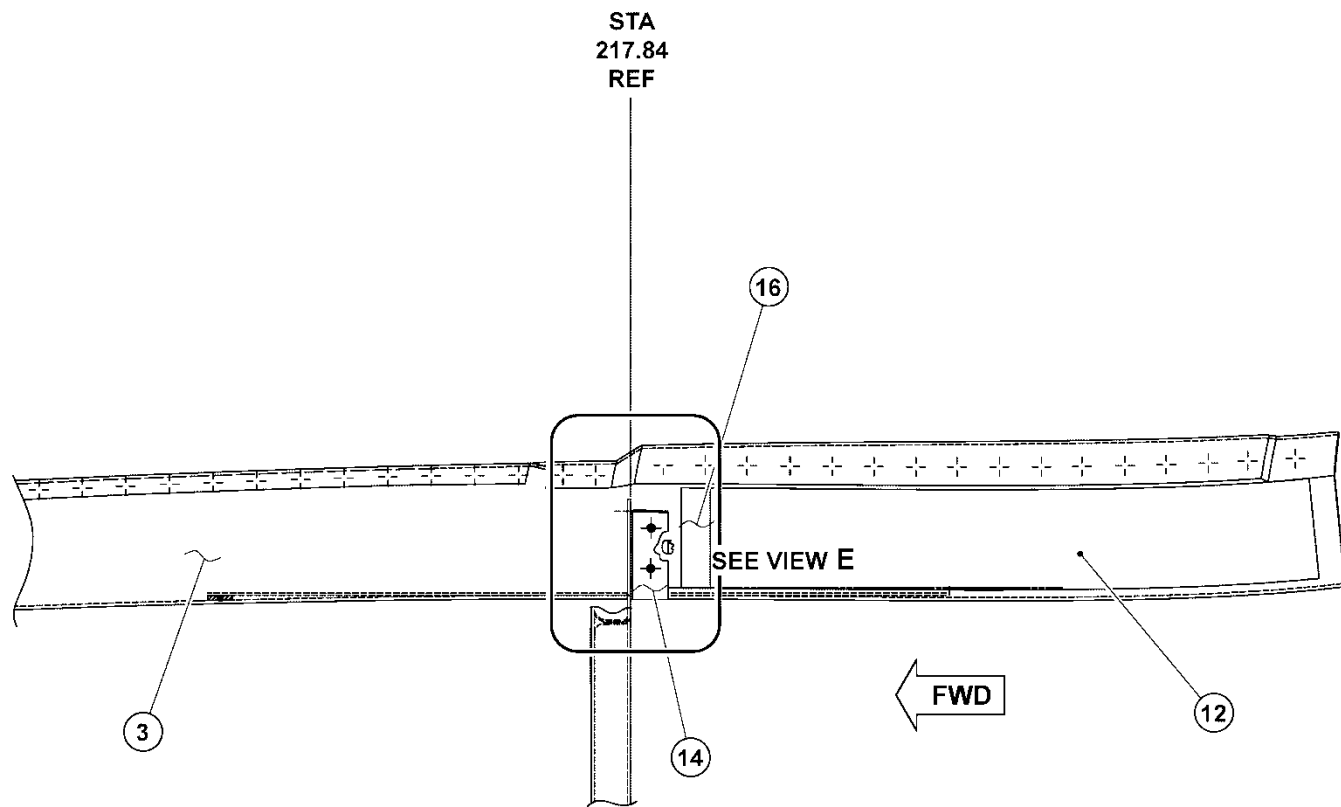
Figure 4 - Repair of Cracked Longeron (sheet 3 of 14)

- b. Treat bare aluminum alloy metal surfaces with chemical film (C-100) and primer (C-204).
5. If the crack in the longeron (3) (View D and View E) has migrated through the complete unit (complete failure), omit step 6 and go to step 7.

VIEW D
 LOOKING INBOARD
 SKINS REMOVED FOR CLARITY

6. If the crack has not migrated through the complete longeron (3) (not a complete failure), stop drill the crack (BHT-ALL-SRM, procedure 3-2-1.c.).

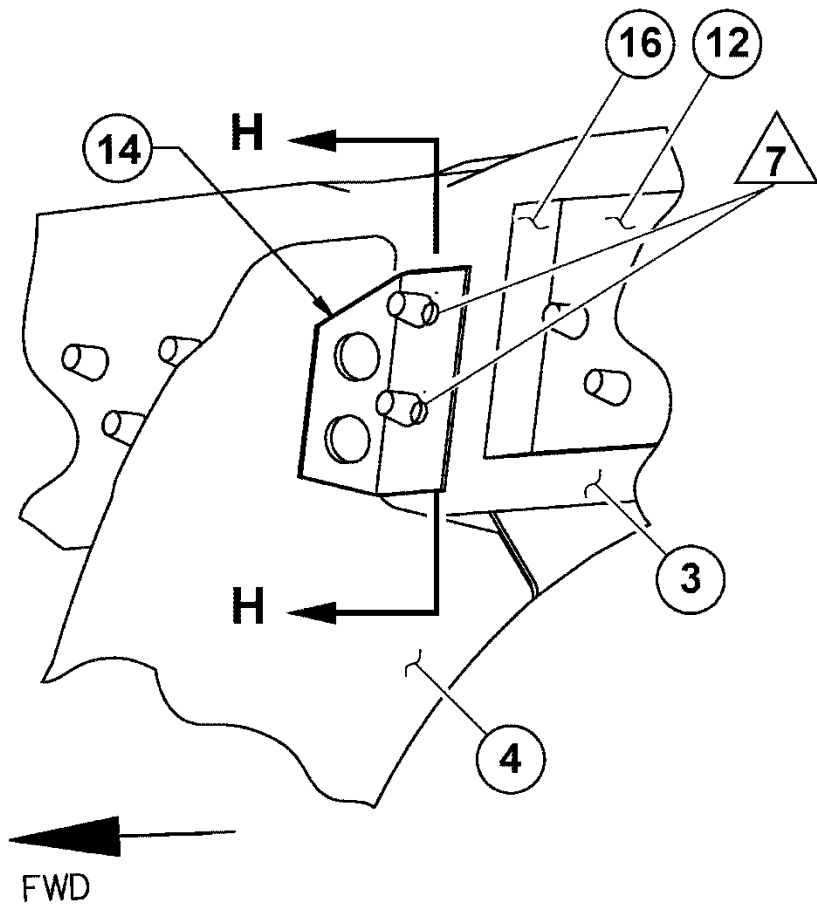
Figure 4 - Repair of Cracked Longeron (sheet 6 of 14)

FOR LONGERON WITH CRACK
 CONTAINED WITHIN CRACK ZONE "A" ONLY
 LOOKING INBOARD
 SKINS REMOVED FOR CLARITY

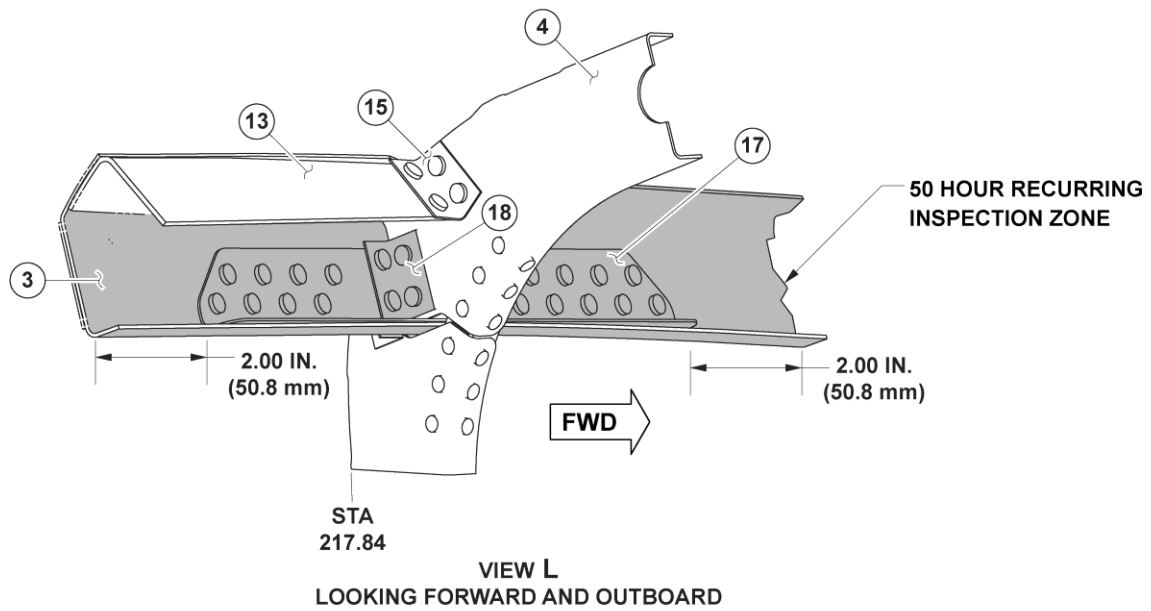
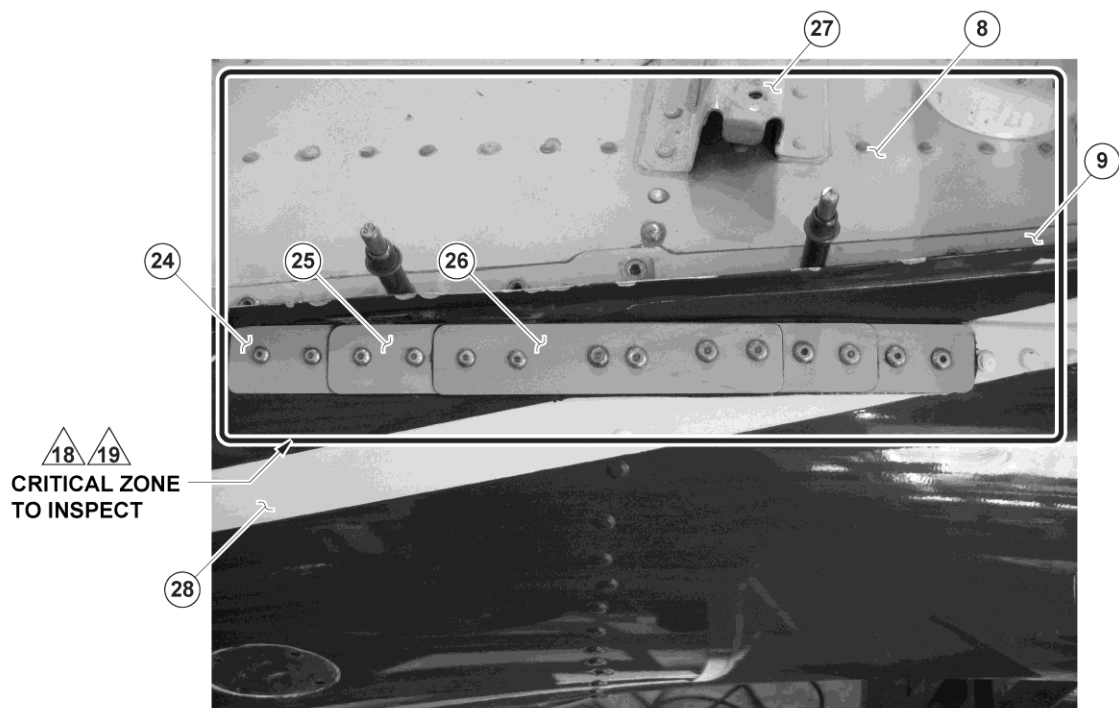
Figure 4 - Repair of Cracked Longeron (sheet 10 of 14)

VIEW M
50-HOUR RECURRING INSPECTION, FINAL REPAIR

Installation of strap doublers (24, 25, and 26, Figure 4, View M) is mandatory as part of the airworthiness limited repair of a cracked longeron (13) as described in PART IV of this bulletin and/or as part of the installation of the new longeron assembly 206-031-314-237B or 407-030-067-105 as described in PART V of this bulletin.
