## **ALERT SERVICE BULLETIN**

**407-22-128**

**MODEL AFFECTED:** 407

**SUBJECT:** TAILBOOM ATTACHMENT HARDWARE AND FITTINGS, ONE-TIME TORQUE CHECK AND INSPECTION OF.

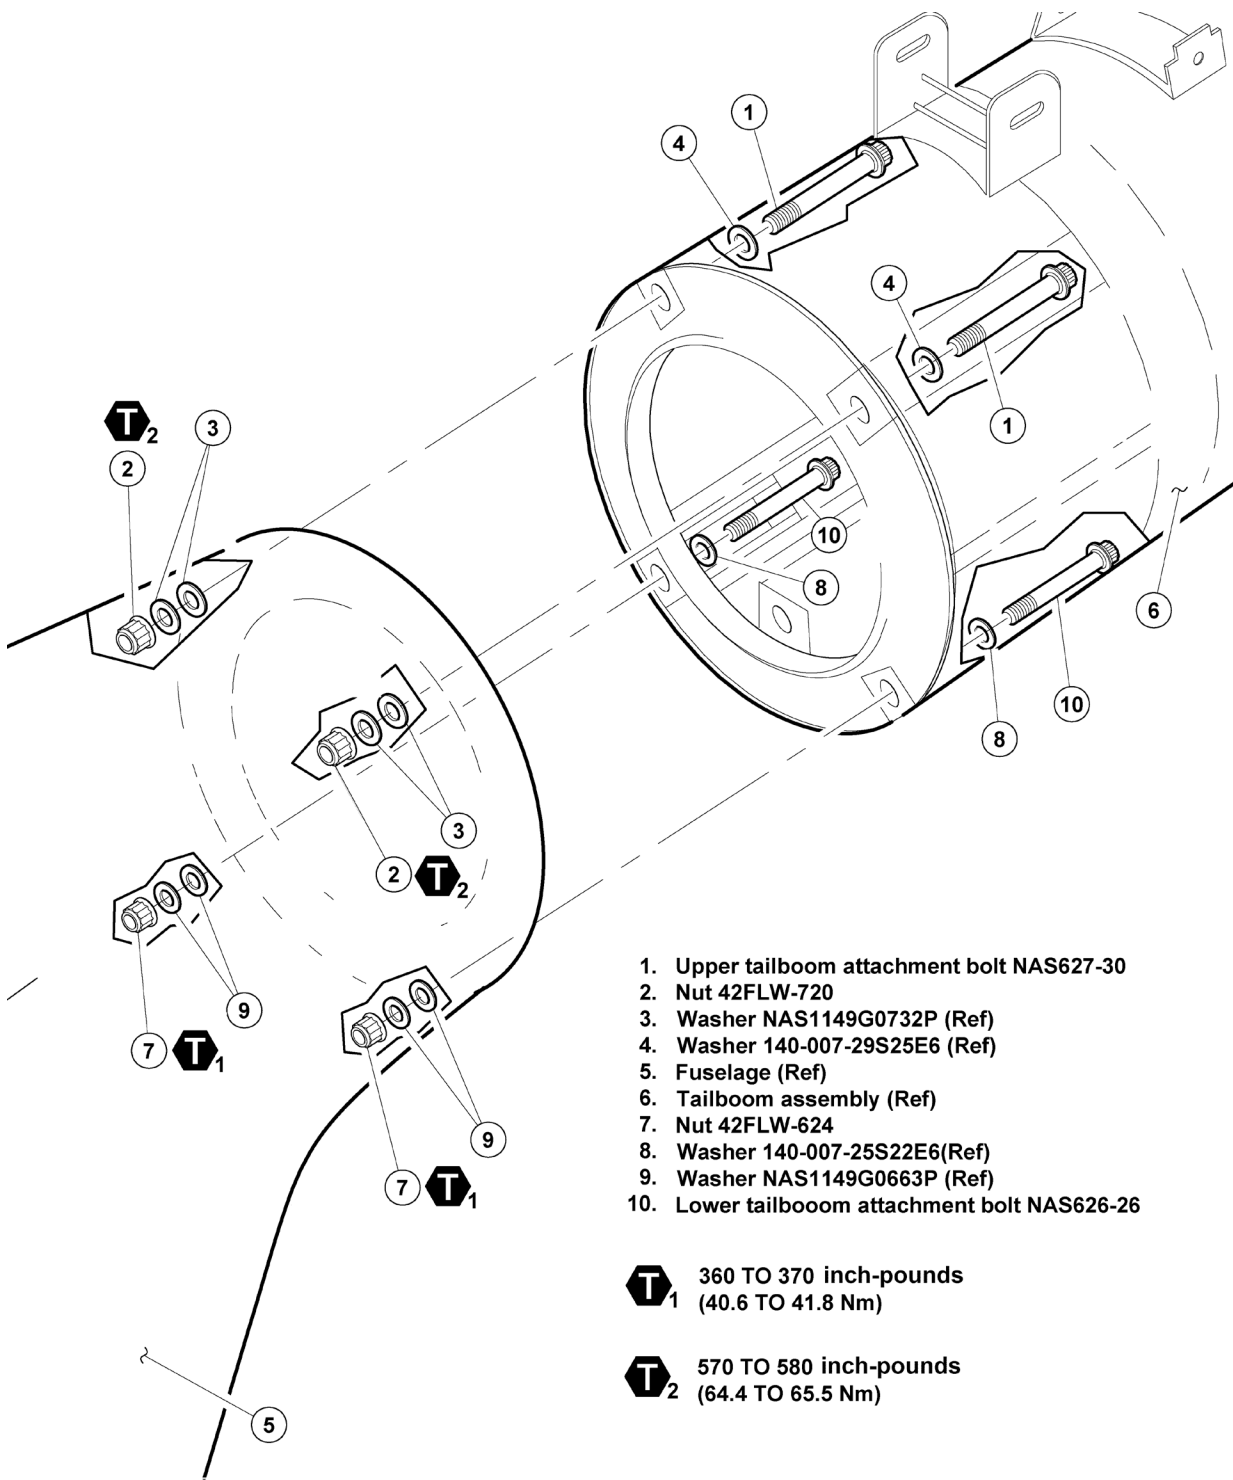
**Figure 2 – Tailboom Attachment Hardware**

The torque values of the upper and lower nuts (2 and 7, Figure 2) are different. Refer to Figure 2 for the specified torque values.

For torque check purposes, the assembly torque to be applied is the minimum specified torque, plus the minimum acceptable tare torque of 14 inch-pounds (1.58 Nm) for the upper nuts and 9.5 inch-pounds (1.07 Nm) for the lower nuts ([BHT-ALL-SPM, Chapter 2, Standard Practices Manual](#)).

- b. Examine the four bolt holes in the tailboom and fuselage fittings for elongation. The maximum permitted diameter (after rework) is 0.453 inch (11.5 mm) for the two upper holes and 0.391 inch (9.93 mm) for the two lower holes.

3. Do a torque check of the tailboom to the aft fuselage attachment nuts (2 and 7, Figure 2) ([DMC-407-A-53-01-00-00A-720A-A](#)).
  - a. If a nut fails the torque check, replace affected bolt(s) and nut(s) with new bolt(s), nut(s), and washer(s) as applicable. Retain removed hardware for further investigation by Product Support Engineering.

- (1) Refer to [DMC-407-A-53-01-00-00A-720A-A](#) for hardware installation procedures.
    - (2) If hardware replacement is required, fly 1 to 5 flight hours and perform the Tailboom Attachment Hardware Torque Check special inspection at all four locations ([DMC-407-A-05-40-00-00A-283A-A](#)). Repeat torque check every 1 to 5 flight hours until the torque has stabilized at all four locations.

- b. Apply corrosion preventive compound (C-586) to the heads of the bolts, washers, nuts, and the exposed threads after final torque is applied.
  - c. Record in **Annex A** the torque value at which the attachment hardware was torque checked.

- (1) Refer to Figure 2 of [DMC-407-A-53-01-00-00A-280A-A](#) for tailboom fitting damage and repair limits.
  - c. Discard previously installed bolts (1 and 10, Figure 2) and nuts (2 and 7). Examine the washers (3, 4, 8, and 9) for damage or corrosion. Replace as required.
